# Task I – Exterior Building Conditions Assessment

## Northbridge Memorial Town Hall Northbridge, Massachusetts

February 15, 2012

## TASK I – EXTERIOR BUILDING CONDITIONS ASSESSMENT

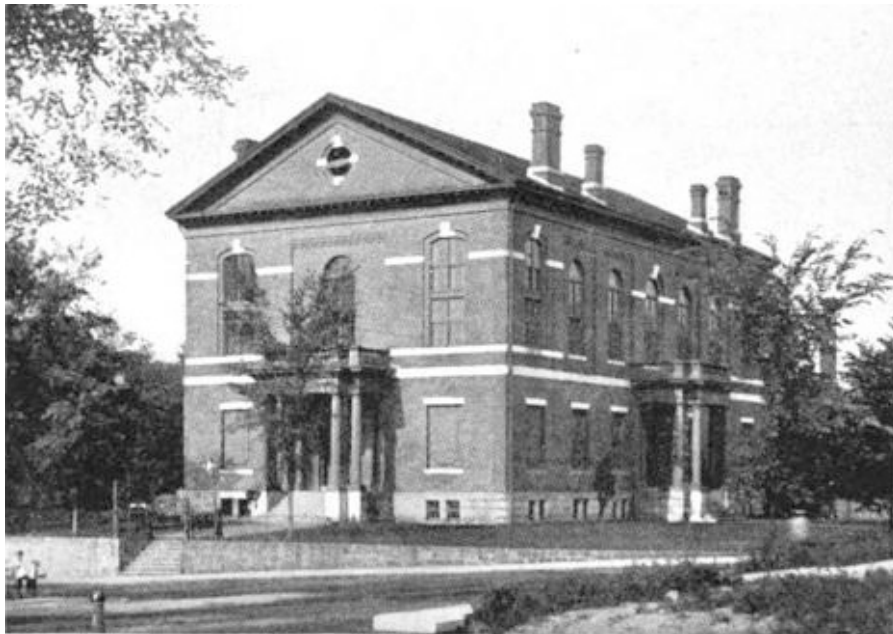
*Photo 1*

The Northbridge Memorial Town Hall (Photo 1) began construction in 1872 and was completed in 1876 on a corner lot donated by the local manufacturing family, Whitin (Whitinsville). The building is designed in the classical revival style having a slate roof with red brick pedimented gables, red brick masonry bearing walls, granite stringcourses, keystones, sills and rock faced granite foundation. The property is listed on the National Register of Historic Places as a contributing building to the Whitinsville Historic District. In the year 2000, a preservation restriction in perpetuity was recorded.

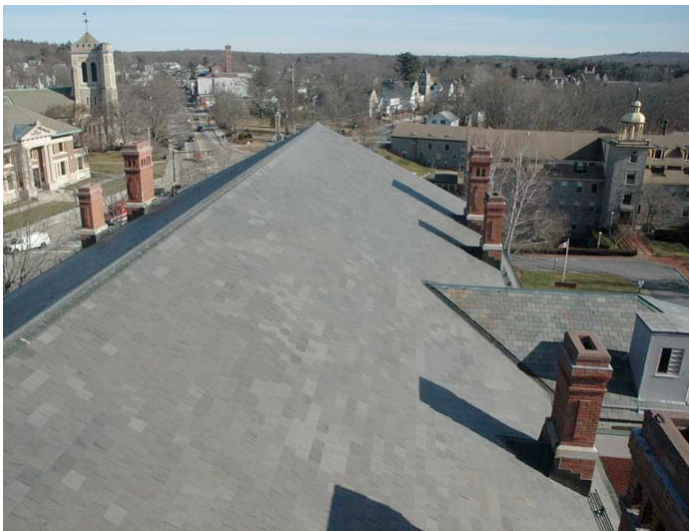
*Photo 2*

The slate on the gabled main roof (Photo 2), completely replaced in the year 2000, and the hipped roof of the stair tower are both in good condition and require simple maintenance-related repairs. Approximately a dozen slates are broken (Photo 3) or missing from both roofs. The annual loss of a small number of roof slates is typical and should be part of a scheduled maintenance plan. Slates typically break due to foot traffic during installation or roof repairs, failure of the slates themselves and over nailing. Two pipes on separate snow guards have slid sideward and should be fixed during routine roof maintenance.

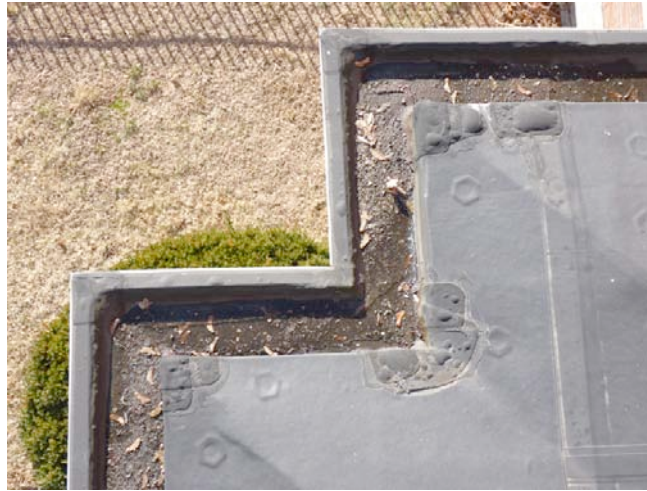
*Photo 4*

The membrane roofs over the porticos at the north and east entrances are nearing the end of their service life and should be replaced in the next 3-4 years. The membrane patches (Photo 4) at edges and corners of the roof are failing and require immediate replacement.

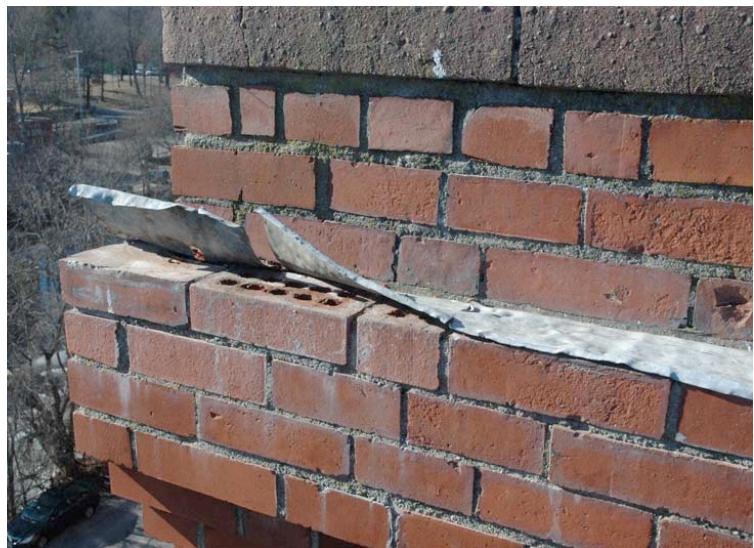
*Photo 6*

Generally the red copper ridge, valley and chimney flashing are in good condition. The copper ridge flashing at the stair tower roof has loose hold down clips that prevent the ridge flashing from wind damage and should be soldered to ridge. The sealant is failing at joints between the chimney and flashing (Photo 5) and needs to be replaced. The lead chimney flashing at the upper-corbelled ledges (Photo 6) is in need of replacement in the next two years.

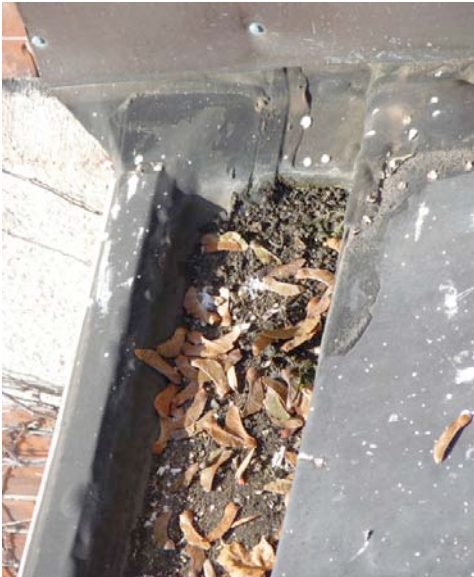
*Photo 7*

The gutters and downspouts at the main roof are in good condition. The membrane lined gutters and outlets at the two portico roofs are clogged with leaf debris (Photo 7) and should be cleaned immediately. The below grade drainpipes connected to the downspouts are clogged and should have all debris removed and the pipes inspected by video camera to assess the condition of the below grade system. During a rainstorm, it was observed that the gutters were overflowing (Photo 8) at four locations at the main roof. The roof inspection revealed the gutter outlets were not clogged and there was no standing water in the gutters. Due to the clogged underground pipes (Photo 9) the rainwater is backing up the entire height of the downspouts and overflowing at the gutters outlet. The water cascading off the main and portico roofs due to clogged gutter outlets and underground drainpipes is causing the painted wood cornice and soffit (Photo 10) below to rot.

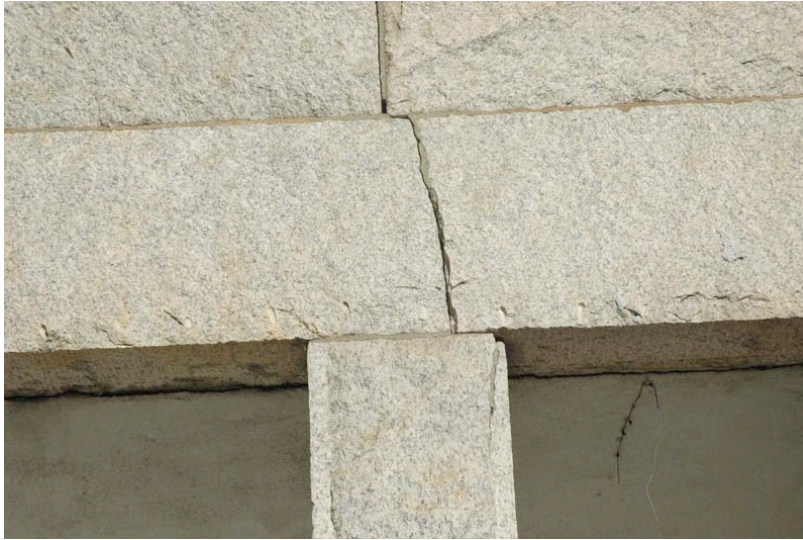
*Photo 15*

The granite building foundation, trim, lintels and posts are in good condition except for three cracked lintels (Photo 15) and minor cracks at selective stones at stringcourses. See structural survey report by MacLeod Consulting, Inc for analysis of granite lintels and trim.

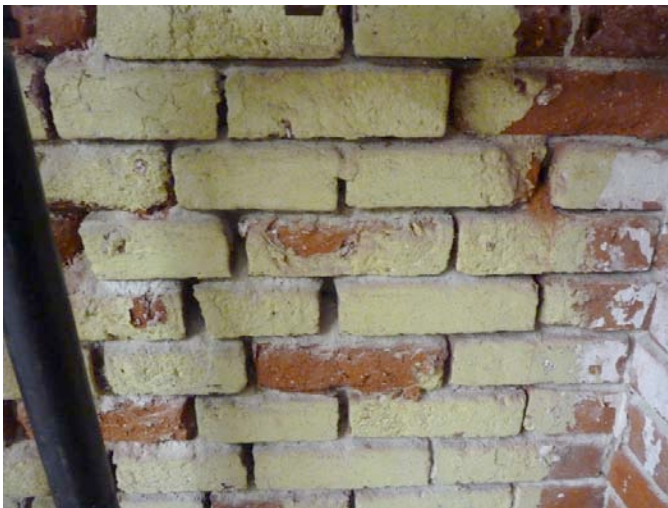
*Photo 16*

The interior granite and brick walls along the western and northwestern foundation are missing mortar to a maximum depth of 1¼" (Photo 16) and need to be repointed. Painted interior brick walls along the eastern foundation are exhibiting efflorescence through the painted mortar joints (Photo 17) indicating moisture migration through the masonry from the exterior. This efflorescence is likely aggravated by roof water saturating the ground from the adjacent portico roof.

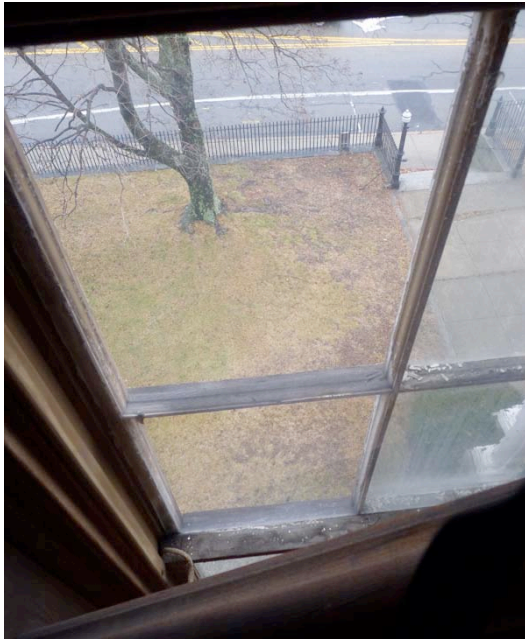
*Photo 18*

At present the broken and missing glass (Photo 18), failed glazing putty and sealants at window perimeters (Photo 19), failed paint (Photo 20) and broken/missing window hardware at the original historic windows are the major cause of water and air infiltration (Photo 21) into the building. The window repair work needs to be completed as the highest priority to prevent further damage to the interior and consequently escalating repair costs and loss of historic fabric. Overall the wood components of the historic windows are in repairable condition, which is the preferred course of action given by *Secretary of the Interior's Standards for the Treatment of Historic Properties*.

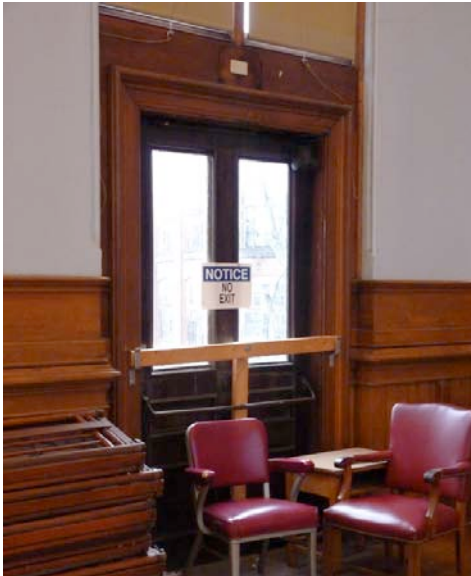
*Photo 22*

The exterior doors, thresholds and hardware are overall in serviceable condition. The blocked (Photo 22) and no longer code-required (due to the construction of exit tower) exit door from the auditorium to the 1947 steel fire escape leaks water at the threshold (Photo 23) and perimeter and minimally needs to be sealed to the weather.

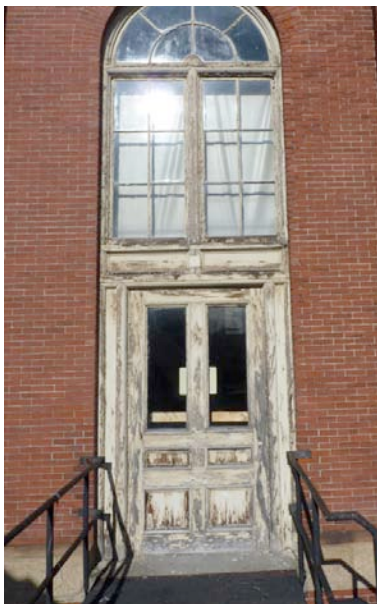
*Photo 24*

The source of the water infiltration and a good coat of paint are necessary to halt the decay of wood architectural elements (Photo 24), rotted wood cornices and capitals (Photo 25) and trim. Most of the exterior woodwork is in salvageable condition with only local repairs. Preparation will require the removal of biological growth (Photo 26), repair and then painting.

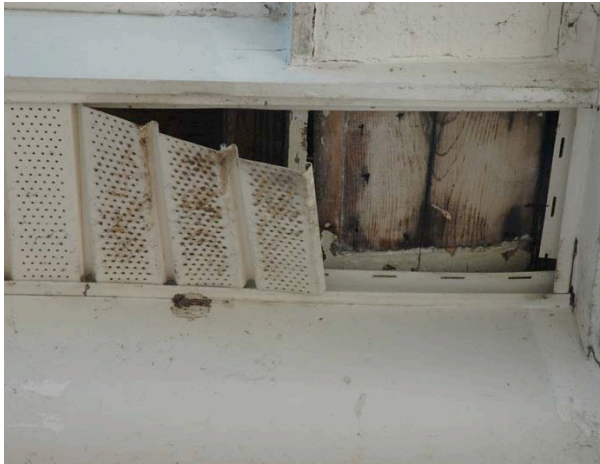
*Photo 27*

The continuous soffit vent at the stair tower has missing (Photo 27) and separated sections of vent that need to be repaired to prevent access by insects and animal pests.

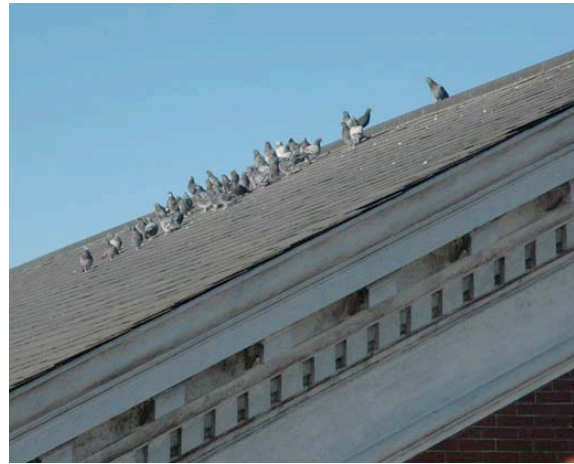
*Photo 28*

The large congregation of pigeons (Photo 28) on the slate roof can be controlled by the installation of a bird deterrent system eliminating potential health risks.

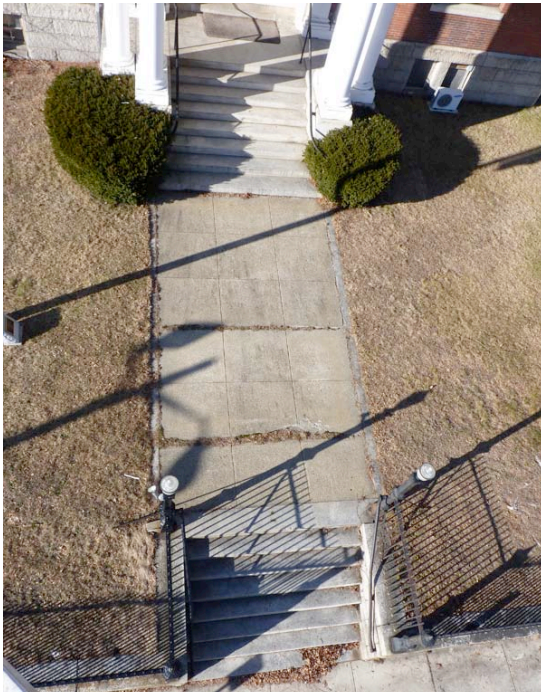
*Photo 32*

The concrete sidewalk in front of the closed east entrance has missing and spalling concrete (Photo 32) at half of the twelve sections and should be repaired before the entrance/exit is reopened for public safety concerns.

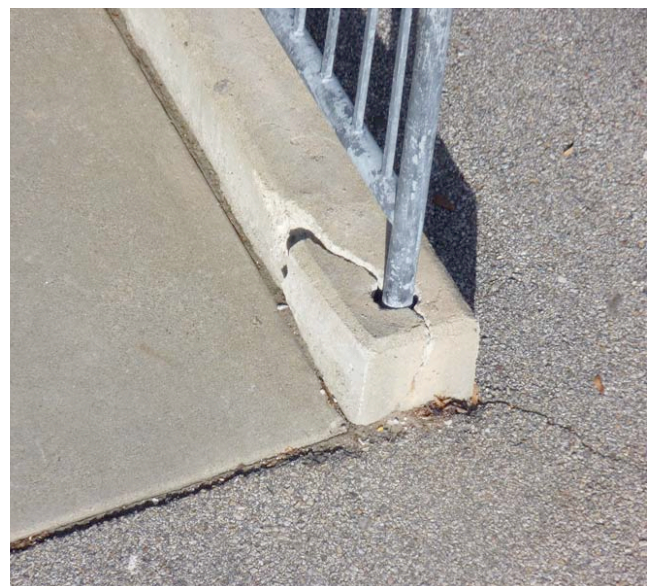
*Photo 33*

The concrete ramp curb (Photo 33) at the southern access to the stair tower has spalled at the posthole and should be repaired. The spall is a tripping hazard and should be removed immediately.

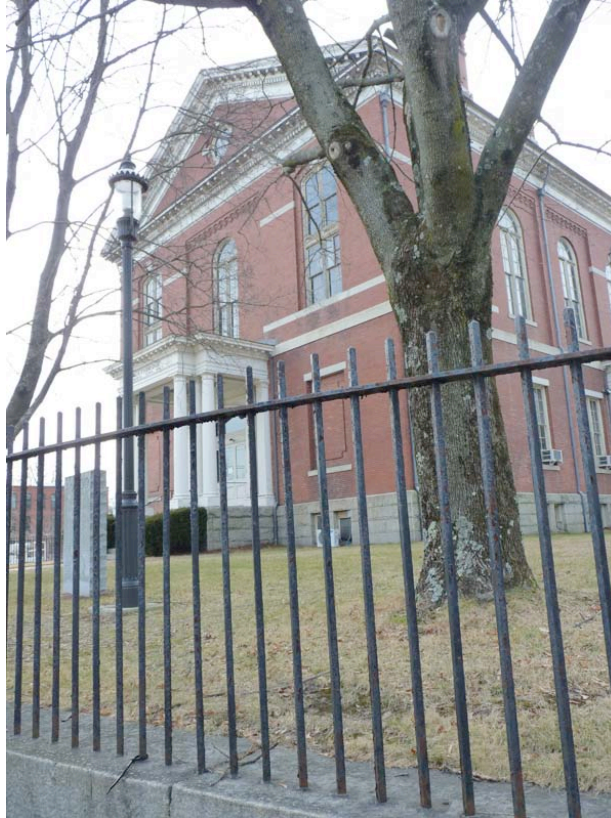
*Photo 34*

The existing iron fencing with decorative cast iron posts (Photo 34) at entrances is in good physical condition and requires maintenance painting. The bent balustrades near the north entrance pose no structural or safety issue. Any repairs would be cosmetic.

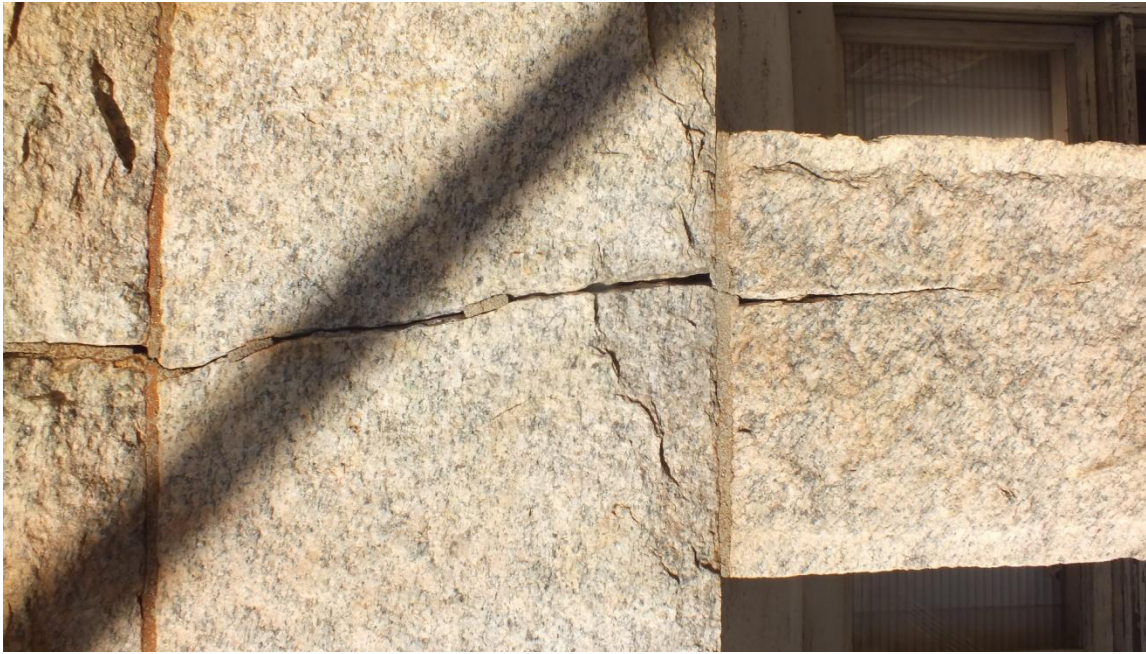
1. A cracked stone lintel on the south elevation over the second window from the west (photo 1). The crack originates in the stone head joint above and ends part way down the stone post below.
2. A cracked stone lintel on the south elevation over the third window from the west (photo 2). The crack originates near the stone head joint above and ends at the bottom of the lintel.
3. A cracked stone lintel on the south elevation over the fourth window from the west (photo 3). The crack originates in the stone head joint above and ends at the bottom of the lintel.
4. A cracked stone lintel on the west elevation over the first window from the south (photo 4). The crack originates in the stone head joint above and ends part way down the stone post below.

1. Stone window lintels, posts, and jambs. The lintels are double span type and are breaking at their center supports. The flexural load for the triangular area supported is too small to generate stresses to break the lintels. The vertical breaks suggest to me that tensile stresses caused by a horizontal expansion of the backup masonry are the principal force stretching the facing leading to tensile stress cracks. A likely cause of the backup expansion is moisture growth of brick, a process that would largely have ceased about fifteen years after firing the brick. The process should be inactive now as is evident that deteriorating earlier patches fill the width of the crack. The flexural stresses are highest over the center support and likely aggravate tensile stresses over the center supports causing the breaks there. The cracked lintels appear to have dragged the top surface of the supporting posts and jambs leading to vertical cracking in them. The double span lintels now work as sets of two simple spans. These are adequate for safe support. The cracked posts and jambs should have sufficient strength to support the lintels as long as they do not shear at an oblique angle at their bottom ends.

1. Lintel at south elevation second window opening from west.

1. Stone window lintels. Patch the existing cracks with a mix of 70 percent granite stone dust and 30 percent white Portland cement. The intent is to provide a mix and tooling that will match the parent stone.

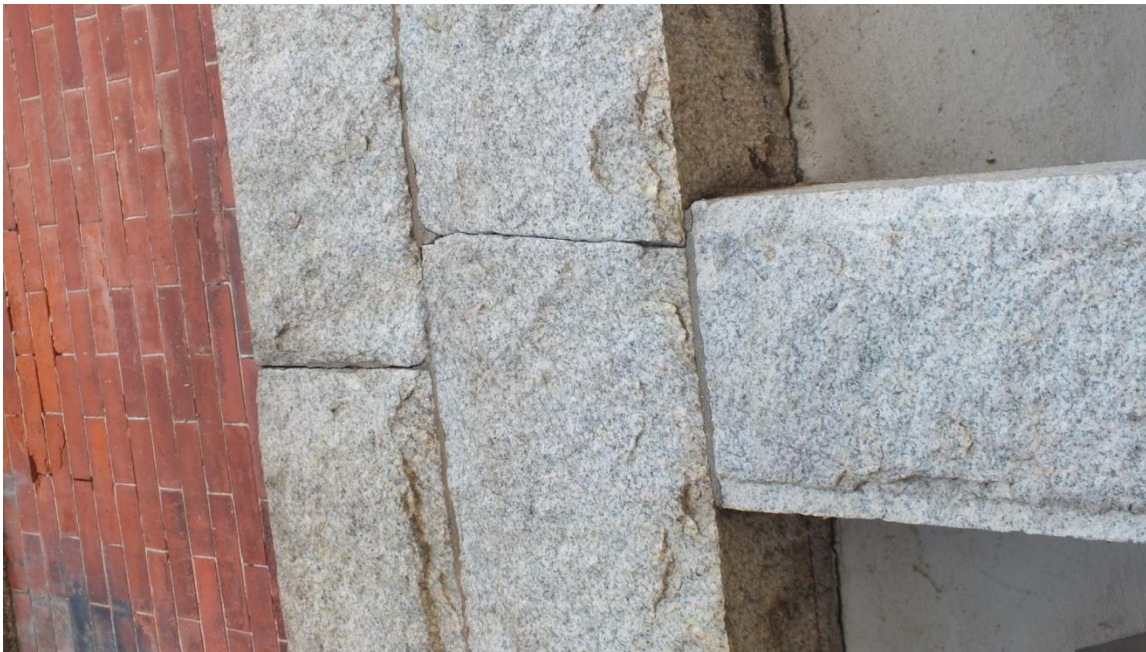
2. Lintel at south elevation third window opening from west.

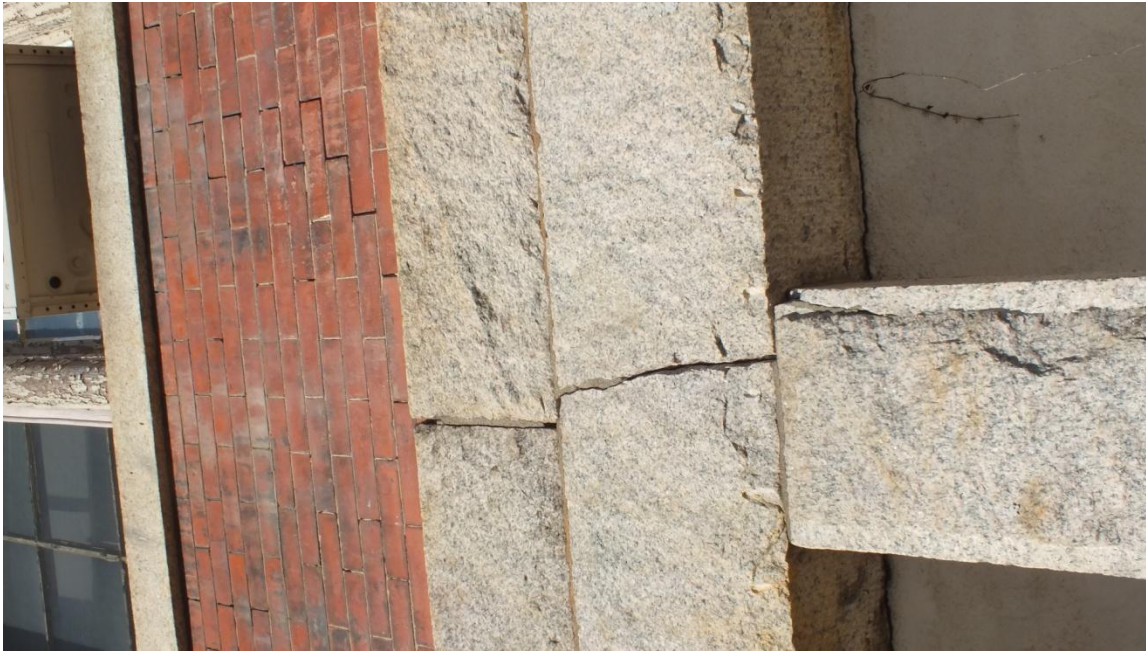
3. Lintel at south elevation fourth window opening from west.

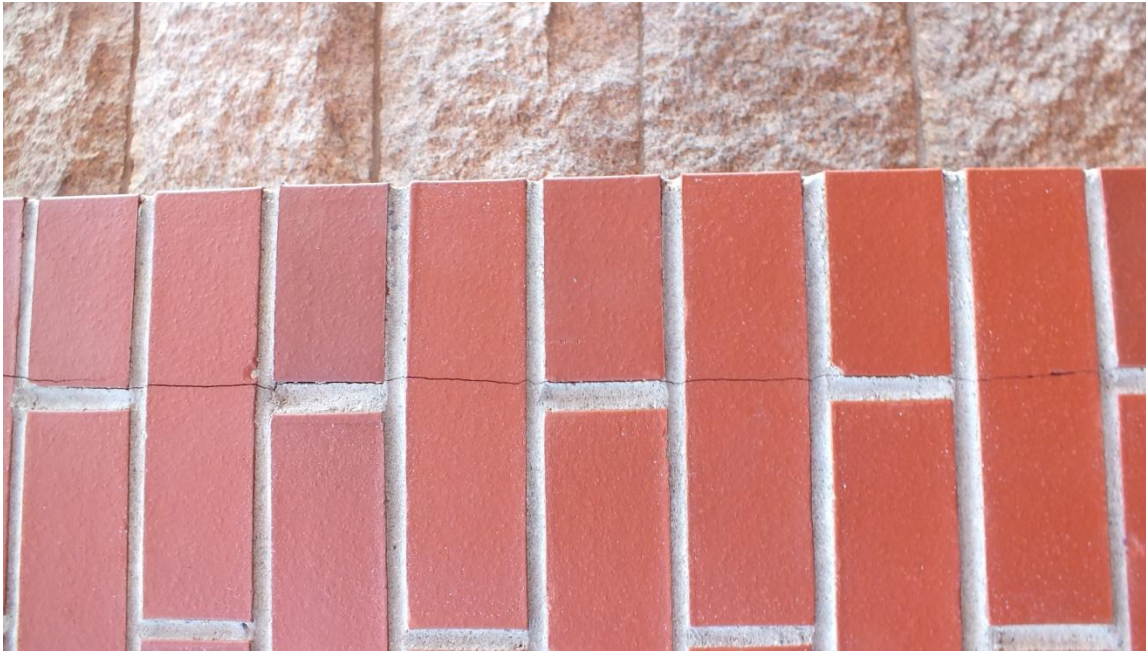
5. Cracks in the new chimney on the west elevation. One crack starts several feet above grade and ends at the first floor along the south edge of the west face (photo 5). The crack is four inches from the south edge. Another crack starts several feet above the first floor and ends several feet below the second floor four inches from the north edge.

2. Chimney. The thin cracks in the chimneys located four inches from one side or the other suggest a volumetric expansion between facing and flues one wythe in from the face. As the cracks are near the basement where hot gases would enter the chimney, I suspect that the flue bears against the facing. In cold weather, the hot liners are pushing against the cold contracted facing leading to these cracks.

5. West chimney west face crack at ground level.

3. Chimney. Cut out the cracked brick and rebuild the corners. Install corner joint reinforcing every eight inches vertically. Use either custom joint reinforcing such as Stitching Anchors as made by Cintec or deformed wire joint reinforcing available from specialty reinforcing suppliers. Extend the reinforcing across the west face and return eight inches around the corners.

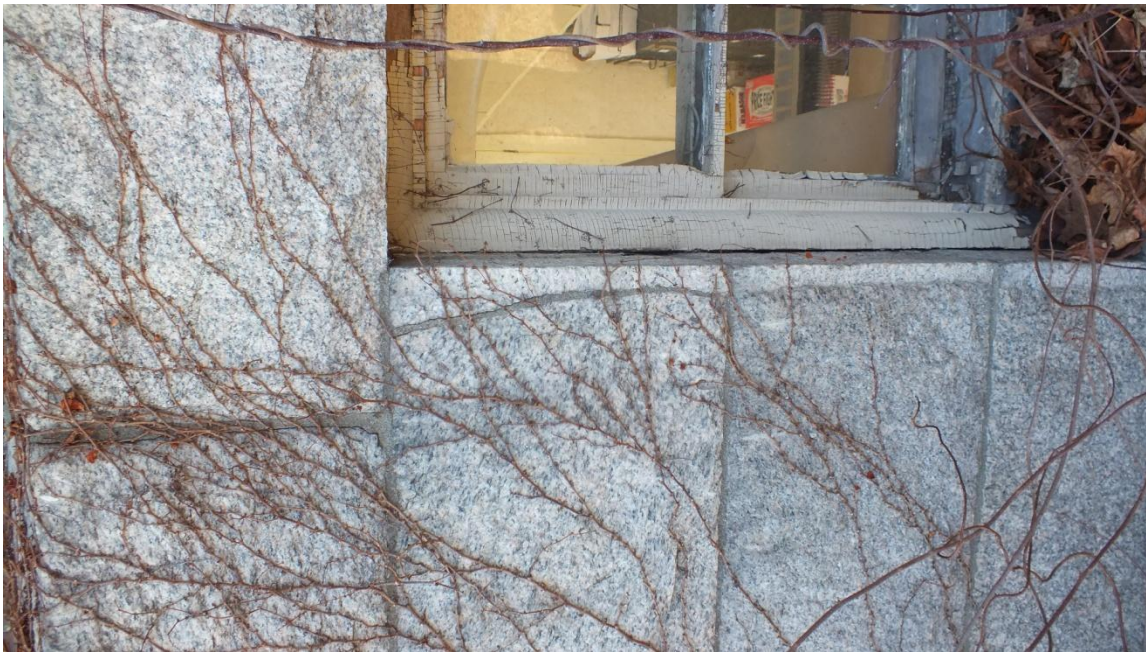
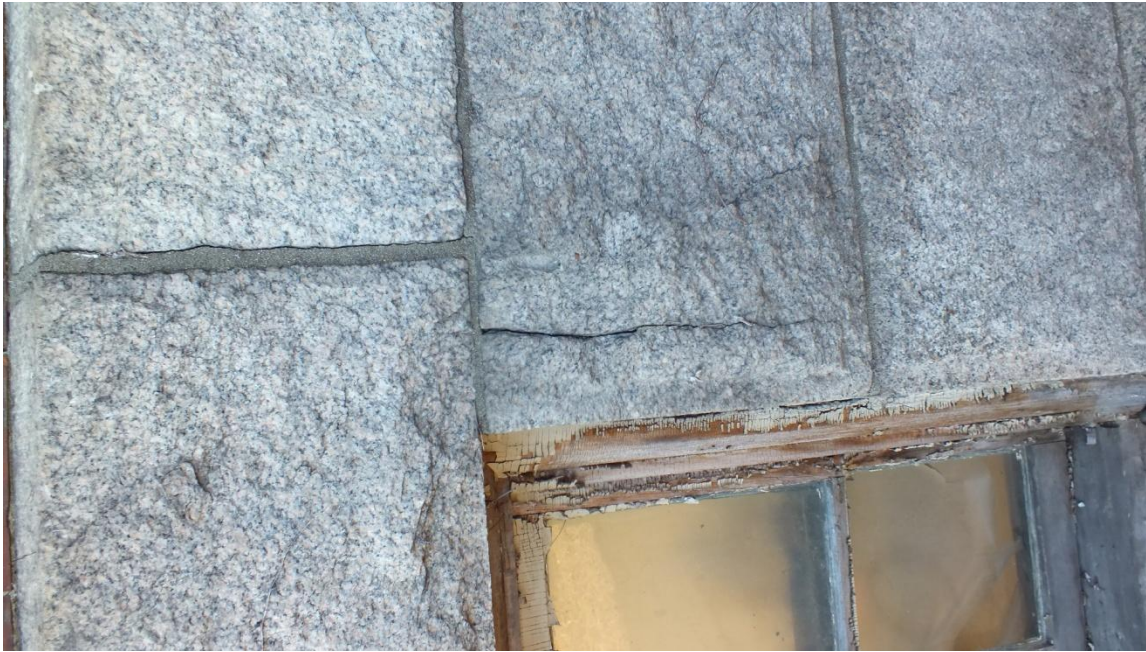
6. Cracks in stone jambs at window on east elevation first one from the south (photos 6 & 7).
7. Dislocation in retaining wall along the west property edge (photo 8). The wall is generally tipping. The dislocation is greatest at tree locations.

6. Cracked stone jamb at east elevation on left side of first window from south.

7. Cracked stone jamb at east elevation on right side of first window from south.

2. Stone jambs and posts. Strengthen the vertical cracks by installing stainless steel threaded rods perpendicular to the cracks set in Portland cement grout. Recess the pins behind the surface and patch the pins and cracks with the stone dust-Portland cement mix described above.

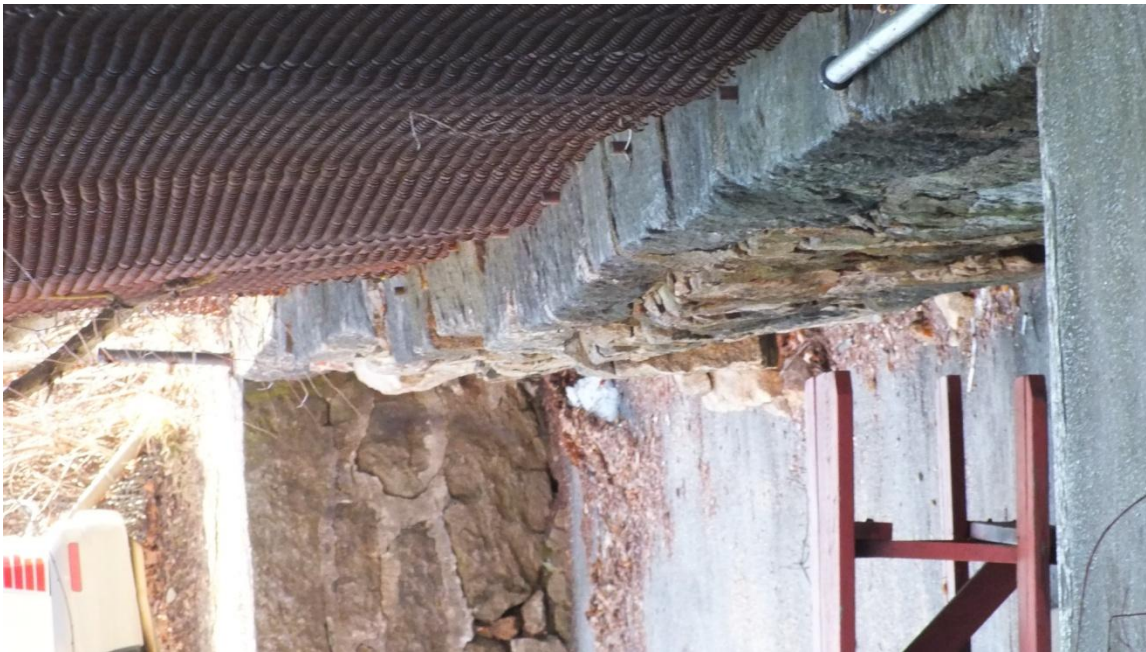
- c. West lot line wall. As one moves between and further from the ends of the west wall, the stones are ever more dislocated. The dislocation is very distinct at the several trees against and on the high side of the walls. Between the trees, earth pressure appears to have overcome the mass of the wall. This is a rubble gravity wall. One in which its proportions are meant to be sufficient to resist earth pressures. As the wall is generally dislocated, I believe the proportions are undersized. The process of dislocation will continue until portions completely tip over. This is a danger to people who would be near this wall. The ownership of this wall is unknown to me.

8. Retaining wall along west property line viewed from north.

- b. South lot line wall. Identify the owner of the wall. If not the Town, advise the owner of dislocated capstones which if further dislocated will be a danger. If the Town, reset the dislocated capstones and repair the guard railing.
- c. West lot line wall. Identify the owner of the wall. If not the Town, advise the owner of a dangerous condition. If the Town, rebuild the wall with gravity rubble wall of proper proportions in keeping with an historic district. Remove offending trees.

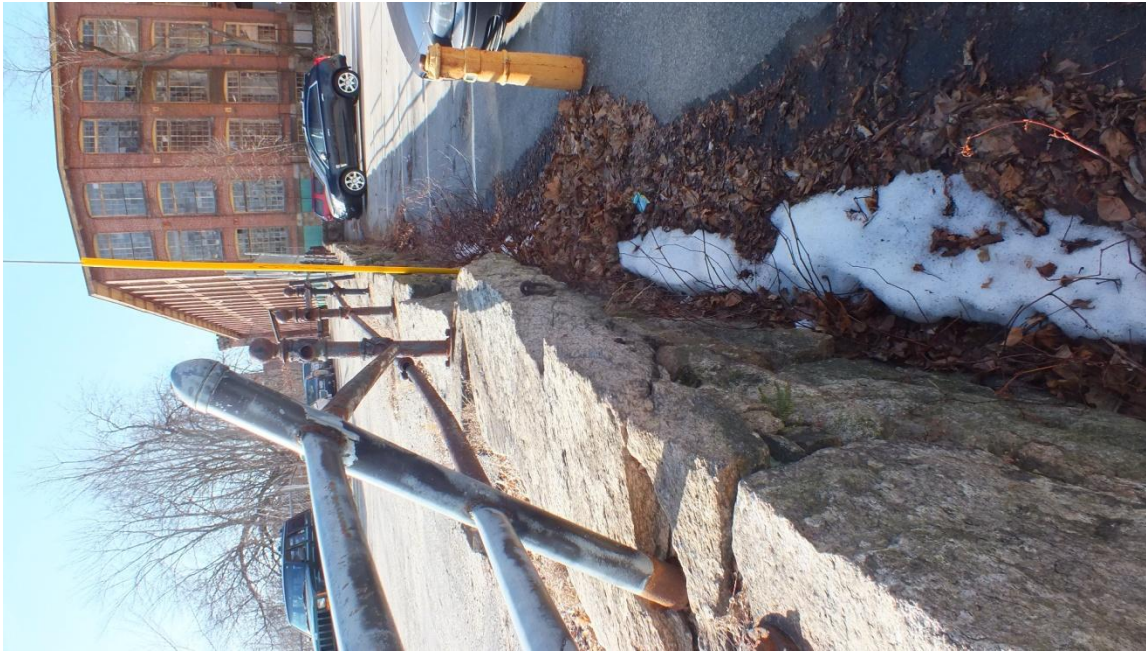
8. Dislocation in retaining wall along the south property edge (photo 9). Some coping is dislocated apparently from vehicles pushing the guard railings.

- b. South lot line wall. In general, the wall appears sufficiently proportioned to retain earth pressures. The dislocation of the cap stones appears the result of vehicles on the abutter's side crashing into the guard railings. The guard railings are continuous and have worked successfully to restrain the dislocated capstone from falling off the wall. The ownership of this wall is unknown to me.

9. Retaining wall along south property line viewed from east. Coping dislocated by impact on railing.

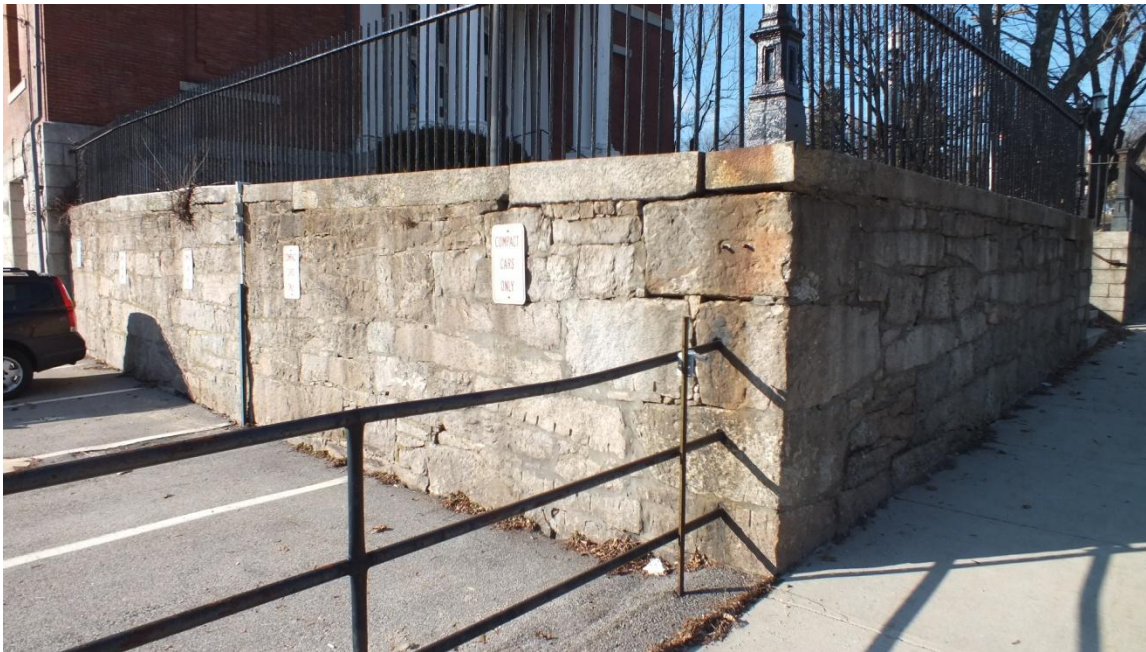
9. Joint deterioration in top portion of the retaining wall along Douglas Road and along the parking area. Dislocation in the cheek walls on the retaining wall serving the east entry.

3. Stone retaining walls.
  - a. Douglas Road wall. Stone coping (cap stones) admits water in head joints leading to disintegration of mortar more rapidly near the top of the wall. I did

see roots from a former tree or shrub embedded in the wall along the parking area. At the cheek walls, the dislocated stones are likely not sufficiently massive to resist earth pressures.

10. Retaining wall along Douglas Road and parking area viewed from southeast. (This photo not rotated.)

4. Stone retaining walls.
  - a. Douglas Road wall. Repoint the deteriorated joints along the sidewalk and parking area. Improve the deflection of water through the head joints by adding an elastomeric sealant along the bottom of the head joint, adding a weep cord on top of the sealant and then pointing the joint. The idea is to sacrifice the head joint alone with the sealant protecting joints below from water seeping through the head joints while maintaining an authentic pointed masonry wall.

Reset the dislocated stones in the cheek walls. Improve their resistance to dislocation by adding weep tubes to better drain water trapped behind them.
