## **Town of Northbridge, MA**

Sewer Infrastructure Assessment

PROJECT NO: 2090242.A

October 2009

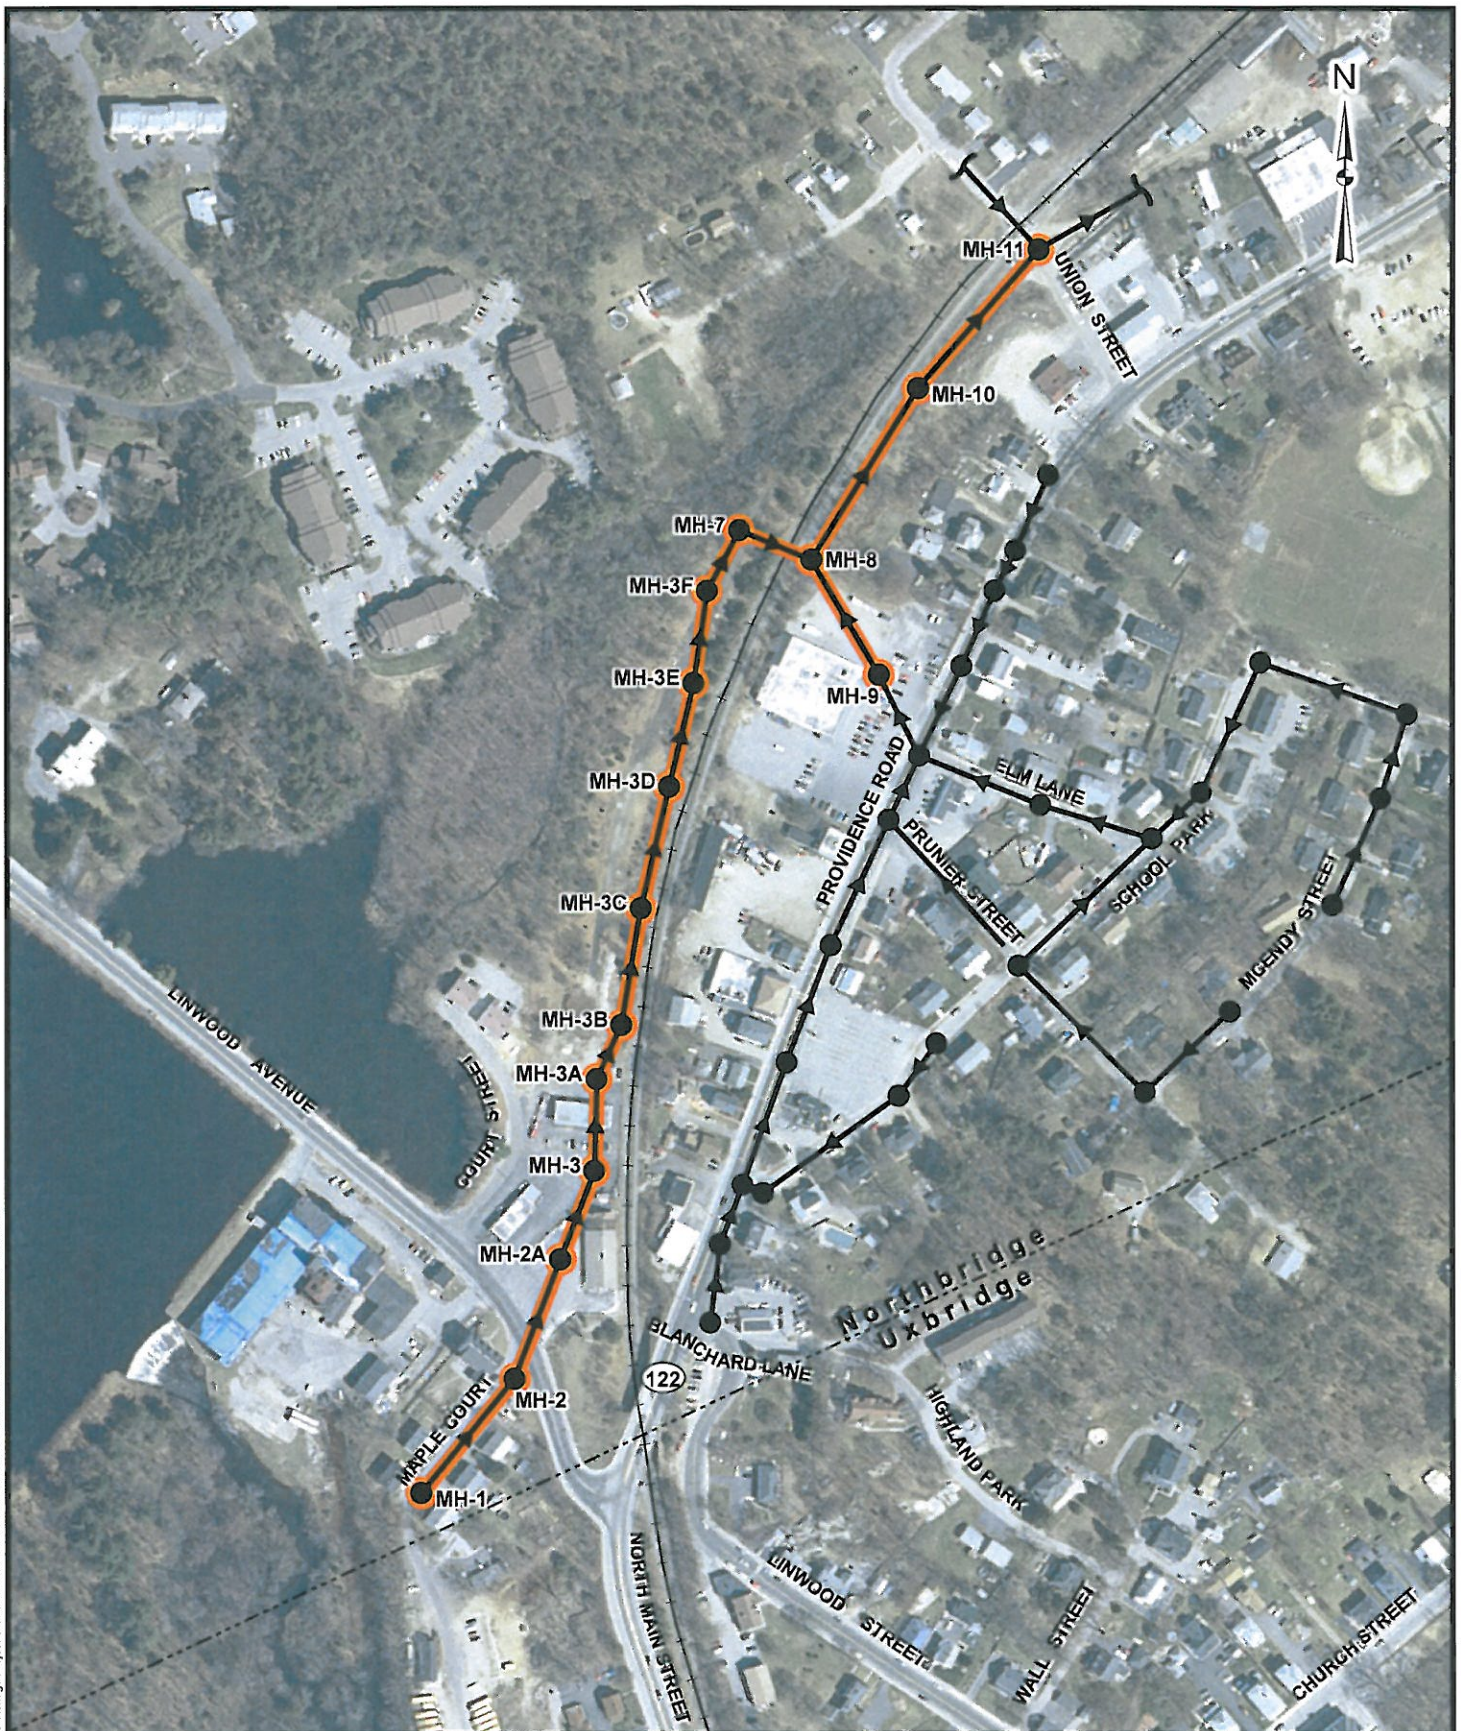
FIGURE 1  
TOWN OF NORTHBRIDGE, MASSACHUSETTS  
**SEWER INFRASTRUCTURE ASSESSMENT  
HYDRAULIC CAPACITY ANALYSIS**

Weston & Sampson evaluated the hydraulic capacity of approximately 2,822 lf of sewers. The pipes included in the hydraulic capacity analysis are highlighted in orange in Figure 1 in Appendix A.

- Root treat and rehabilitate manholes 8 and 10 - \$3,000
- Enlarge invert in manhole 3A for access purposes - \$600
- Clean and televise all 2,822 feet of sewers downstream of the discharge point of the redeveloped site to verify pipe condition (See Table 1 in Appendix B) – Town forces, or sewer service contractor at approximately \$2.00 to \$5.00 per lf.
- Perform an I/I analysis of sewers tributary to the project area. The analysis should include manhole and television inspections and pre- and post-construction flow isolation. This work should be conducted during a period of high groundwater and includes approximately 3,880 feet of sewers and 24 manholes (See Figure 1 in Appendix A).
