# Task II - Comprehensive Window Survey

## Northbridge Memorial Town Hall

Northbridge, Massachusetts

March 8, 2012

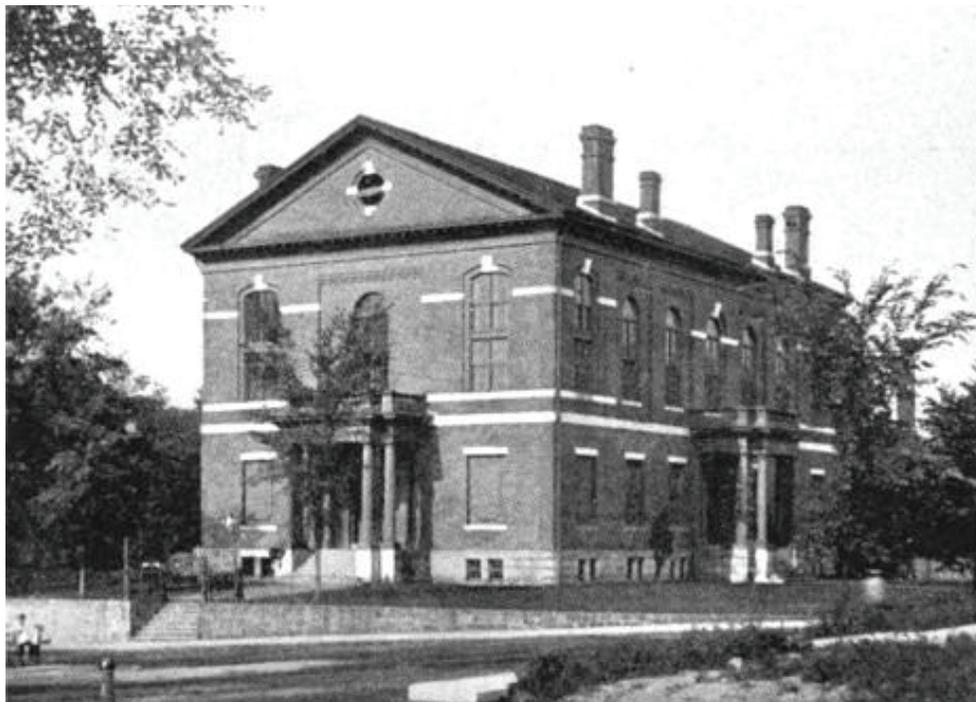
*Photo 1: Historic Photograph of Northbridge Memorial Town Hall, ca. 1899*

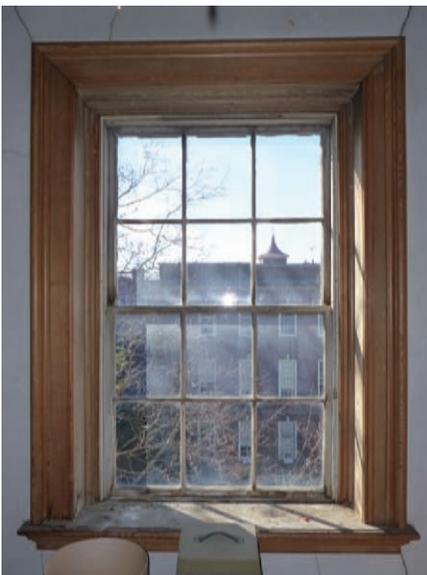
*Photo 2*

The existing historic windows, doors and trim are in repairable condition (Photo 2), which is a positive statement about the quality of old growth clear white pine, considering the extended length of time the paint has failed and remained unpainted. Generally the existing window hardware has been removed and disposed of with no replacement. The exception is an original sash lock (Photo 3) discovered on a salvaged first floor window removed during construction of the stair egress tower and stored on the Third Floor. The majority of the cotton sash chords (Photo 4) have frayed and failed, rendering the windows inoperable. The fact that most of the sash chords are present is an indication that the sash weights are present and makes the restoration of the windows to operable condition an easier task.

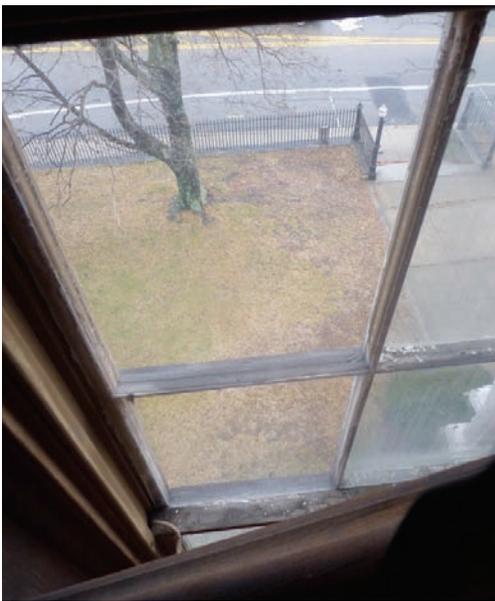
Photo 5

At present the broken and missing glass (Photo 5), failed glazing putty and sealants at window perimeters (Photo 6), failed paint (Photo 7) and broken/missing window hardware at the original historic windows are the major cause of water and air infiltration (Photo 8) into the building. The window repair work needs to be completed as the highest priority to prevent further damage to the interior and consequently escalating repair costs and loss of historic fabric. Overall the wood components of the historic windows are in repairable condition, which is the preferred course of action given by Secretary of the Interior's *Standards for the Treatment of Historic Properties*.

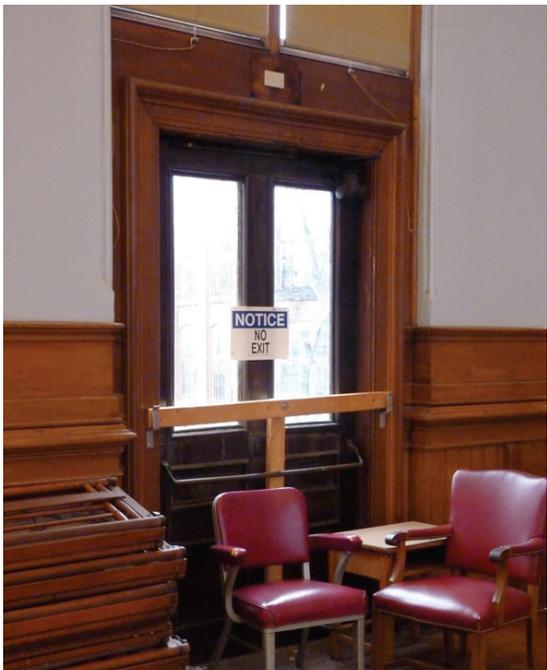
*Photo 9*

The exterior doors, thresholds and hardware are overall in serviceable condition. The blocked (Photo 9) and no longer code-required (due to construction of exit tower) exit door from the auditorium to the 1947 steel fire escape leaks water at the threshold (Photo 10) and perimeter and minimally needs to be sealed to the weather.

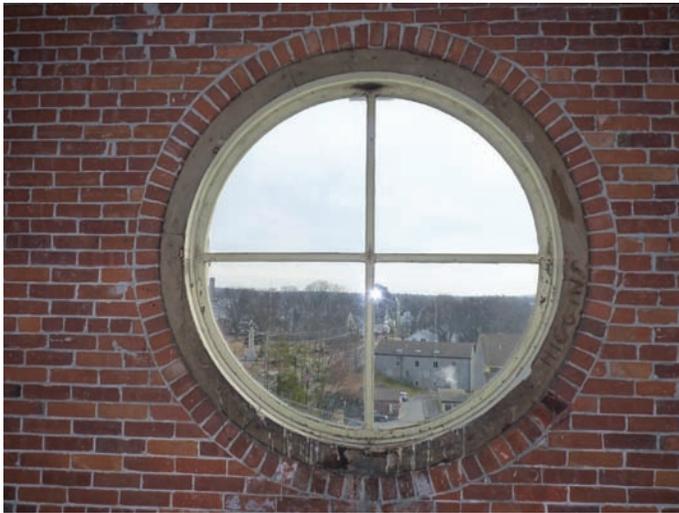
E001 (Interior) - Attic, Replacement Sash After 1975

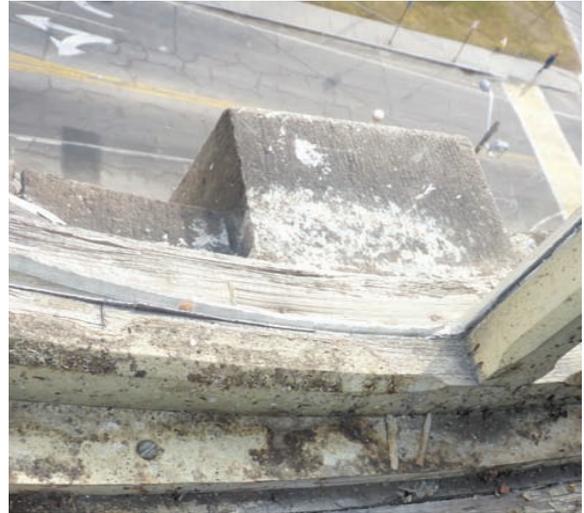
E001 - Rotted Exterior Stop at Sill

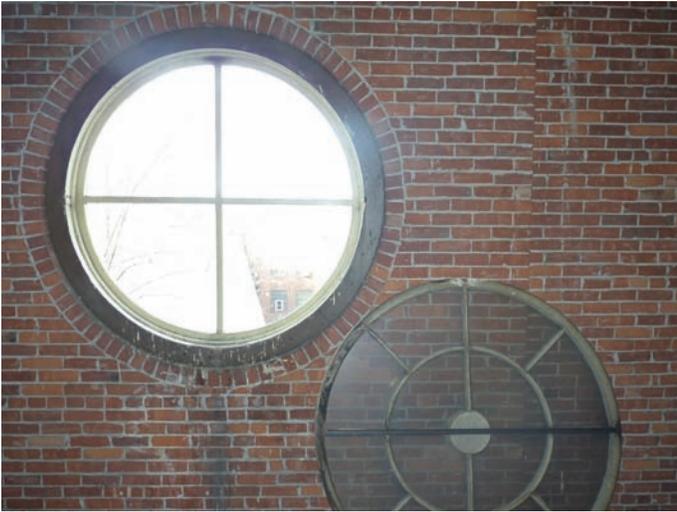
W001 (Interior) - Attic, Replacement and Salvaged Historic Sash (Lower Right)

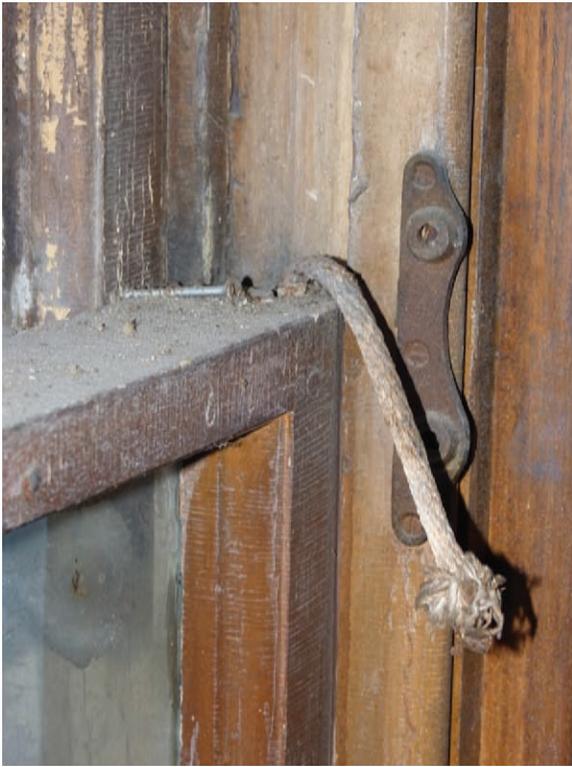
Hardware 001 - Broken Cotton Sash Chord, Shade Hardware and Screws Fixed to Upper Sash at Great Hall

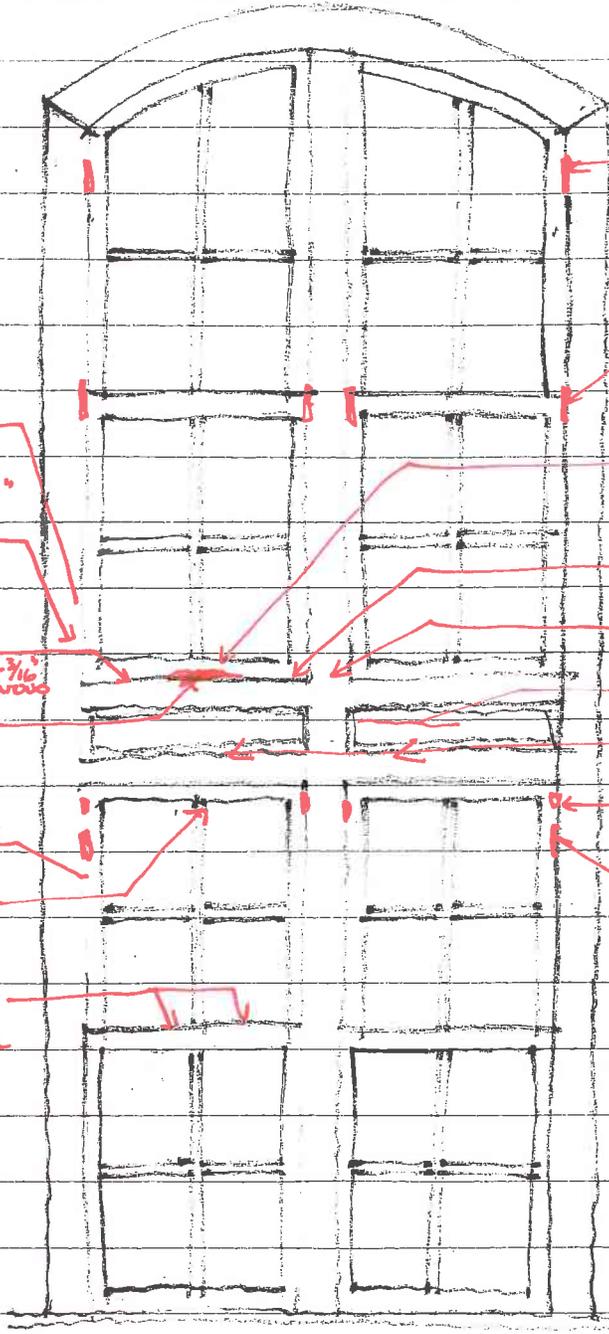
CHECKED EXT. SILL + SURFACE ROT 12" x 6" x 1/8-3/16 REMOVE TO SOUND WOOD ROTING BOTTOM RAIL 6" x 1/4" x 1/2"

MISSING SCREW AT STOP

TOP OF MULLION SEPARATING FROM TOP RAIL

CHECKED INT. TOP OF UPPER SASH WITH RAIL

PULLEY W/ BROKEN COTTON SASH CHORD BOTH SIDES.

PROTRUDING WOOD DOWEL AT MULLION + TRUSS JOINT

CRACK @ PANEL

WATER DAMAGE FINISH

PULLEY W/ BROKEN COTTON SASH CHORD BOTH SIDES

RESET LOWER 24" of QTR. RD BRICK MOLD AND REPLACE LOWER 6"

EPOXY CONSOL. LOWER 6" OF JAMB BTWN STOPS

CHECKED INTERIOR TOP OF BOTTOM RAIL EPOXY CONSOLIDANT

EPT. REFURGE LOWER 6" OF HALF RD MULLION

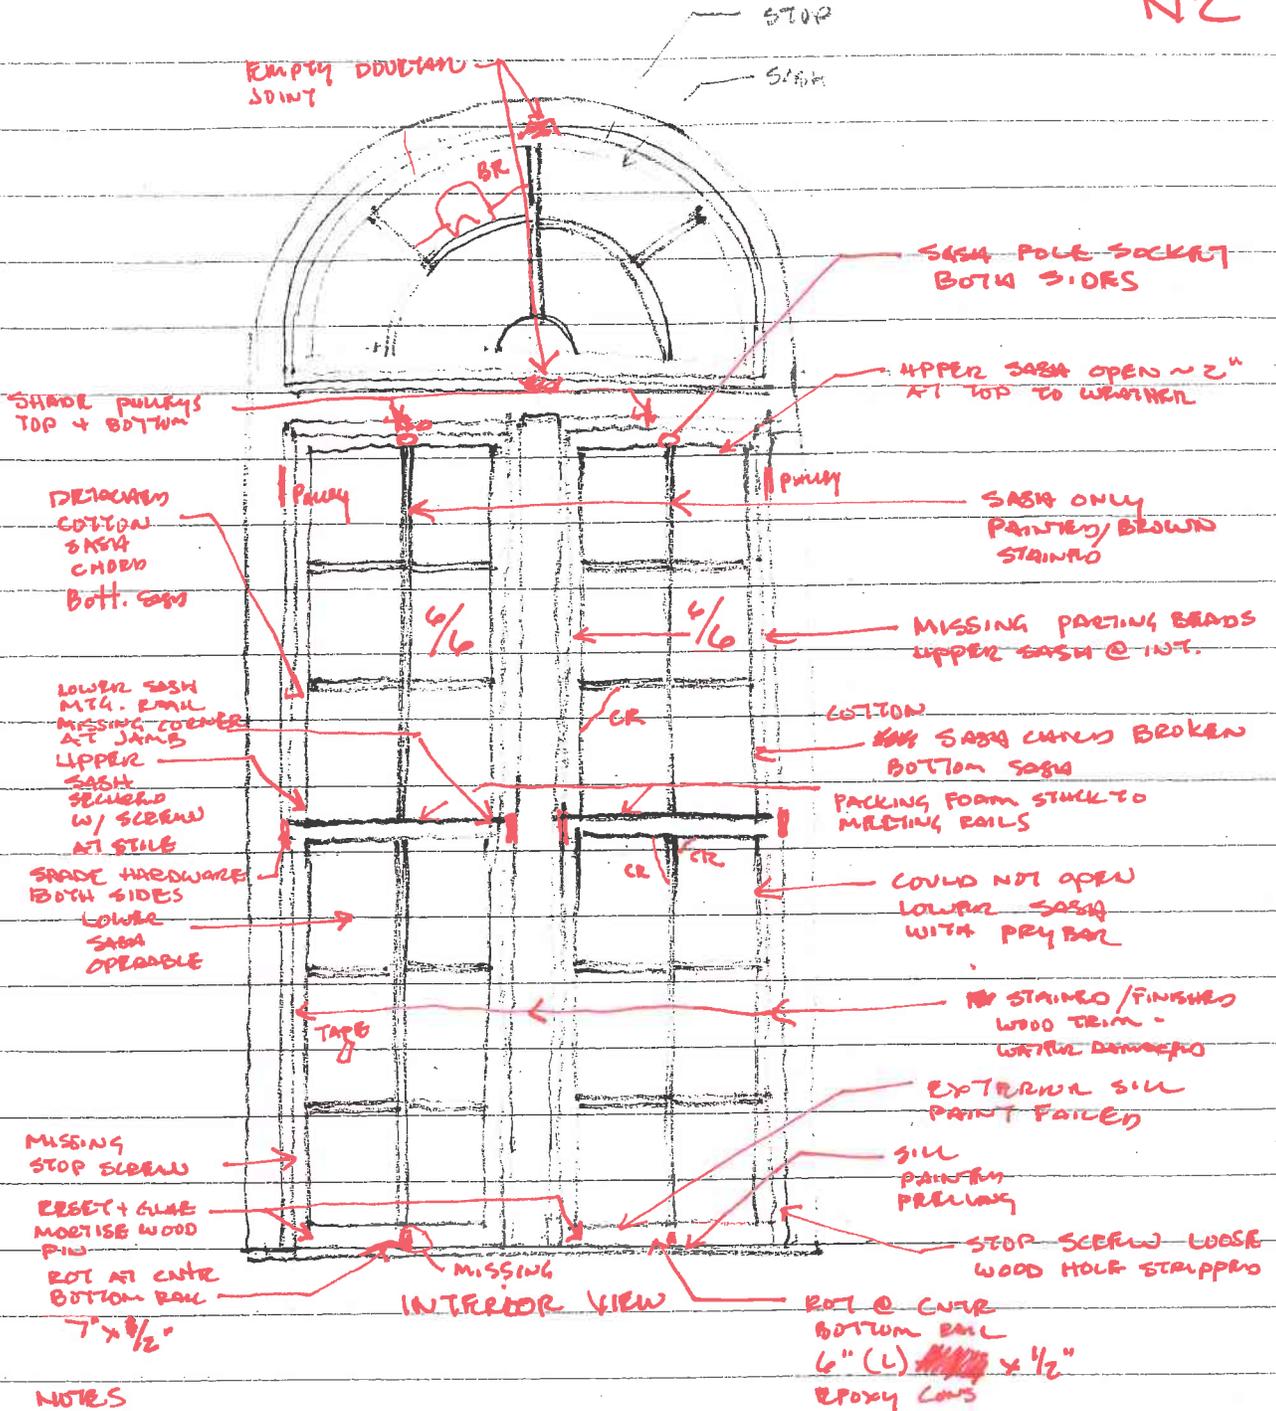
N3

1. REGLAZE. PUTTY CRACKED, MISSING, FAILED
2. PREP + PAINT AND STAIN INTERIOR
3. EXT. SILL, BOTTOM OF TRIM AT GRANITE SILL: WOOD SOUND, PREP AND PAINT
4. ? NO SASH LOCKS
5. SHADES BEYOND REPAIR CHORDS + VINYL SHADES - NOT OPERABLE

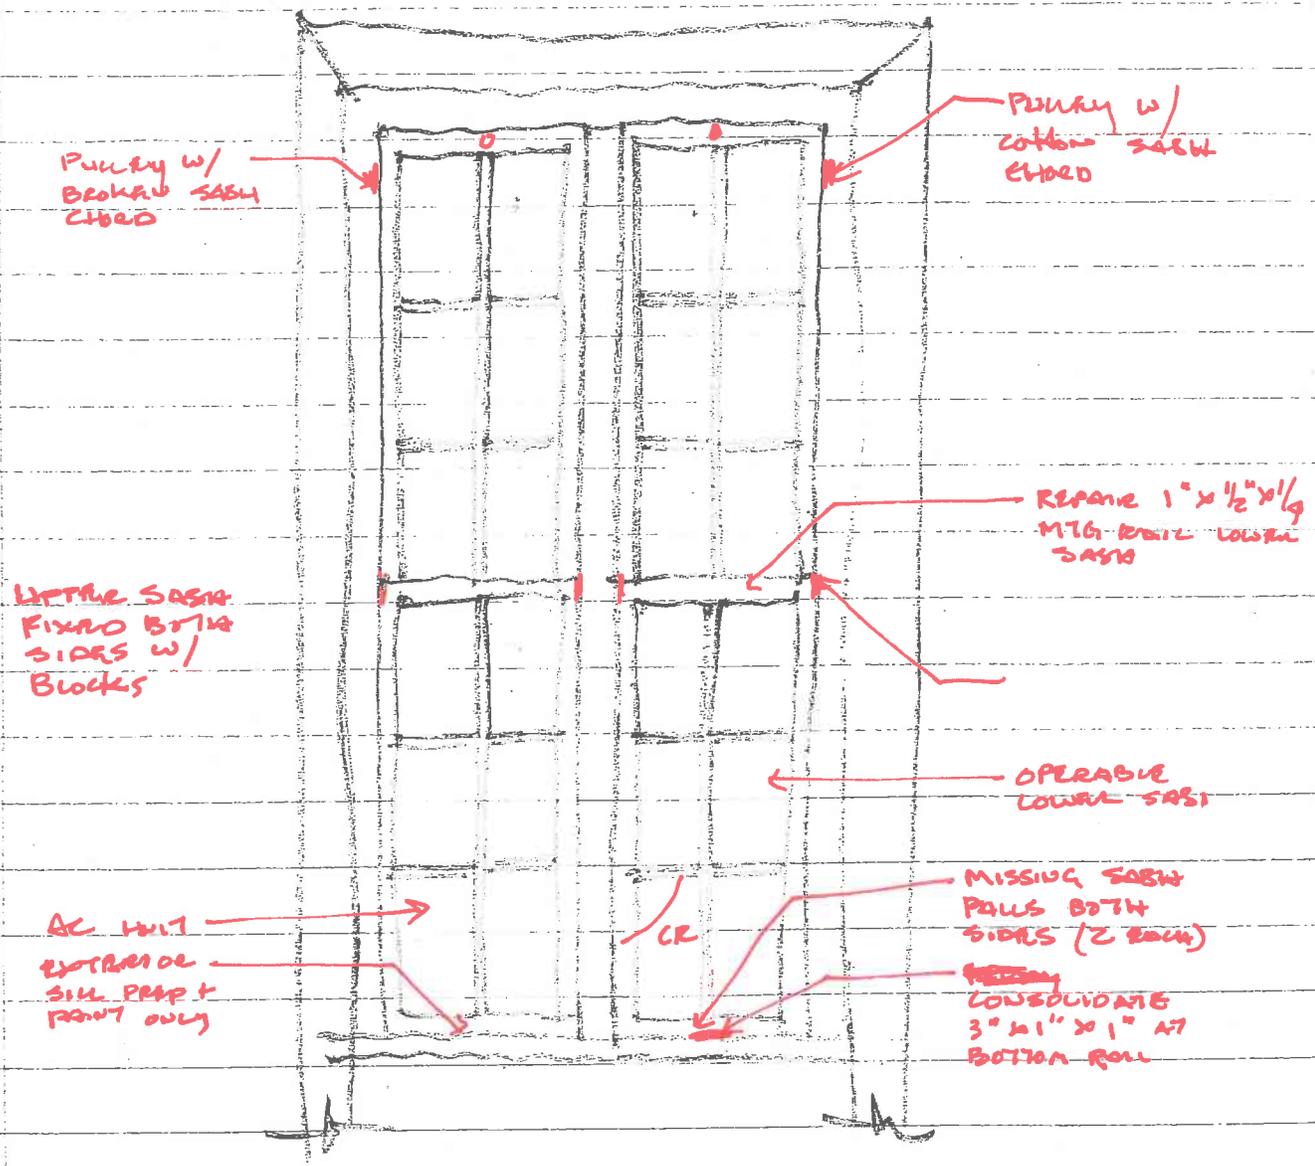
AC UNIT  
EXTENDED  
SIDE PROP +  
PAINT ONLY

MISSING SASH  
PULS BOTH  
SIDES (2 EACH)

REPAIR  
CONSOLIDATE  
3" x 1" x 1" AT  
BOTTOM RAIL

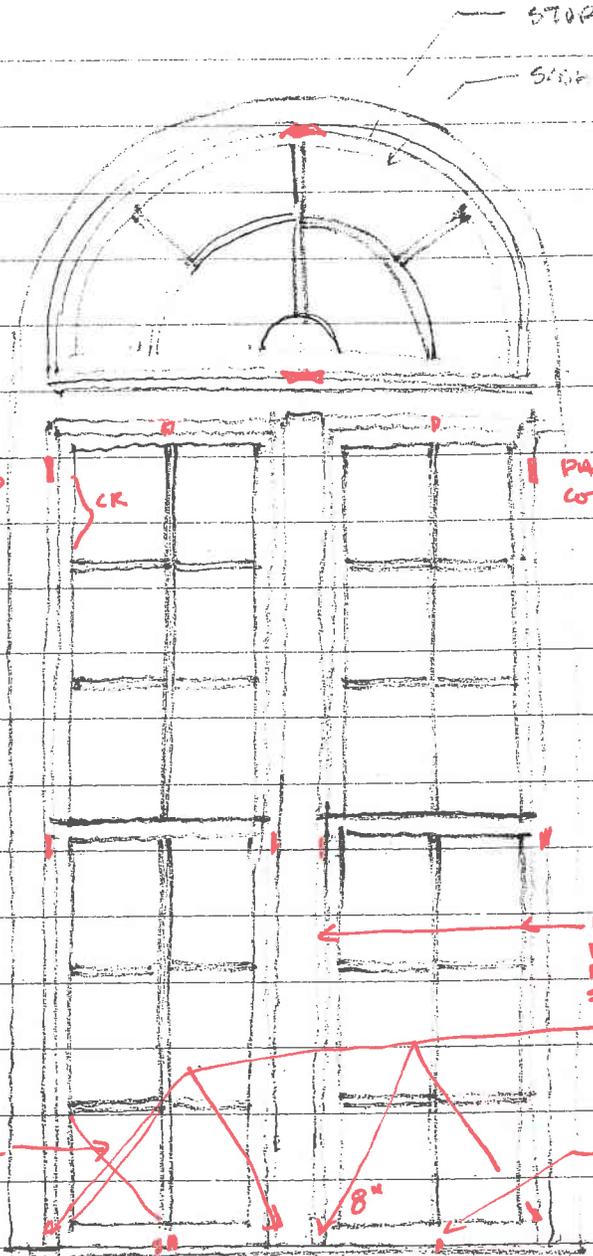
PULLY BROKEN COTT. SASH CORD

REPLACE PARTING BEADS (WORN - SASH OUTSIDE TRACK)

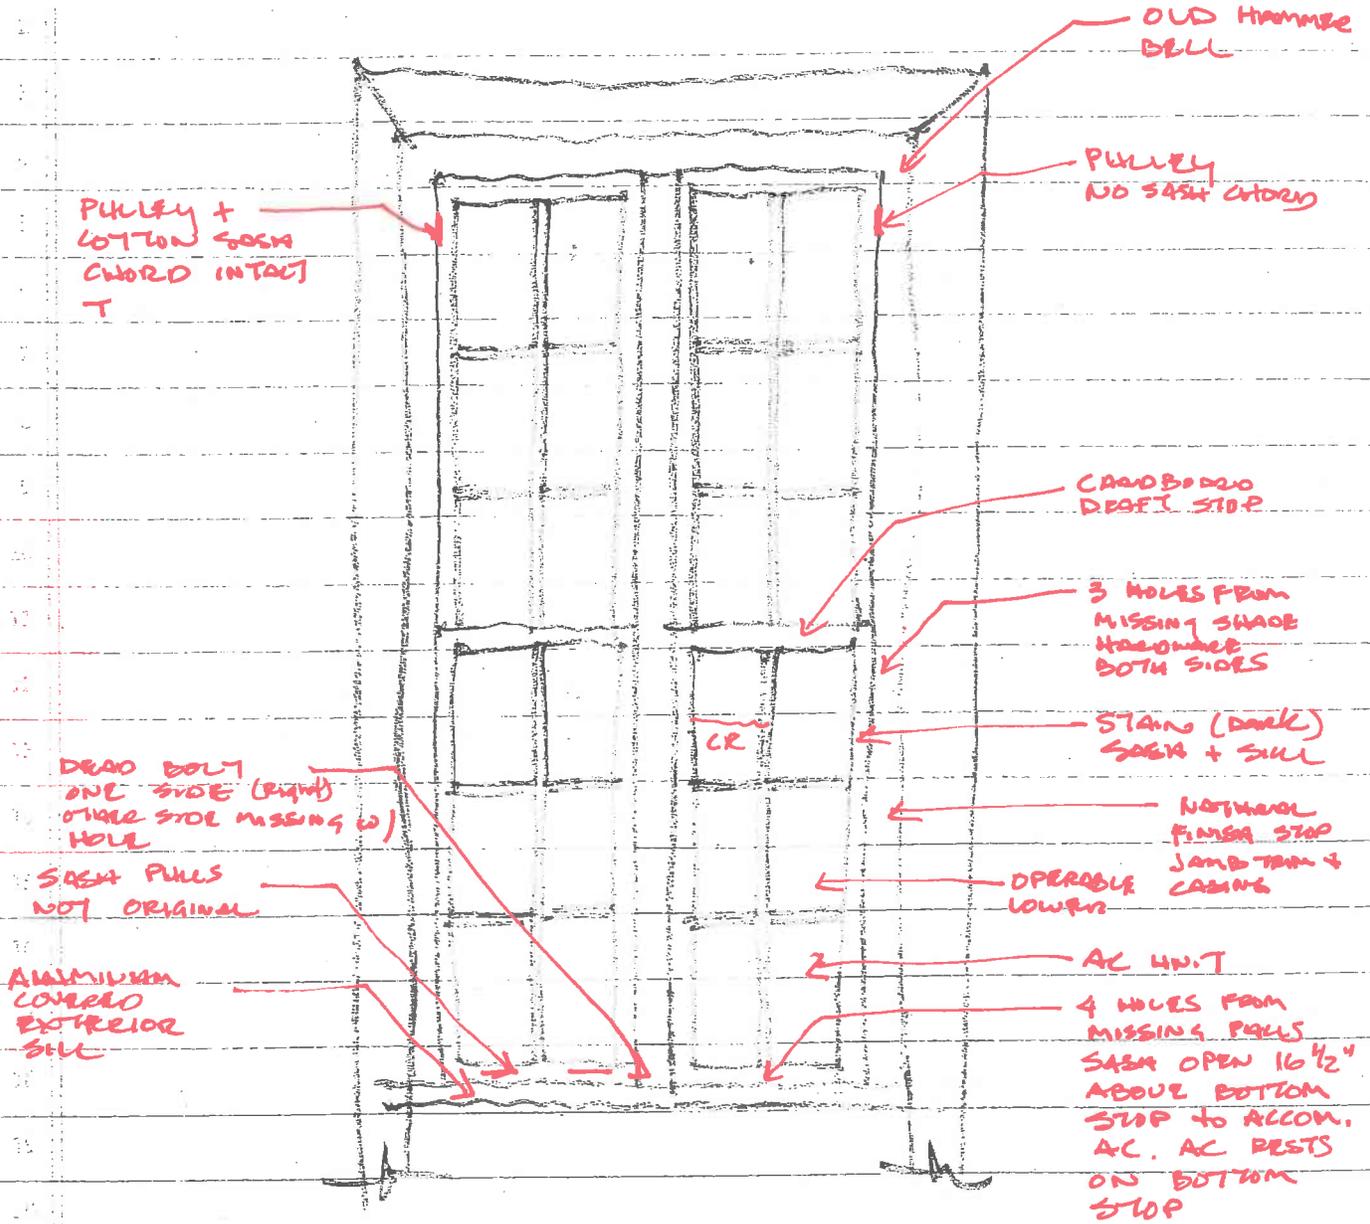
PULLEY + COTTON SASH CHORD INTACT

3 HOLES FROM MISSING SHADE HOUSING BOTH SIDES

DEAD BOLT ONE SIDE (RIGHT) OTHER SIDE MISSING W/ HOLE

4 HOLES FROM MISSING PULS SASH OPEN 16 1/2" ABOVE BOTTOM STOP TO ACCOM. AC. AC RESTS ON BOTTOM STOP

PULLY w/  
BROKEN COTTON  
SASH CORD
