#### **XIV. ACTIVE AND PASSIVE RECREATIONAL FACILITIES ASSESSMENTS**

## **Town Common/Memorial Square Accessibility Assessment**

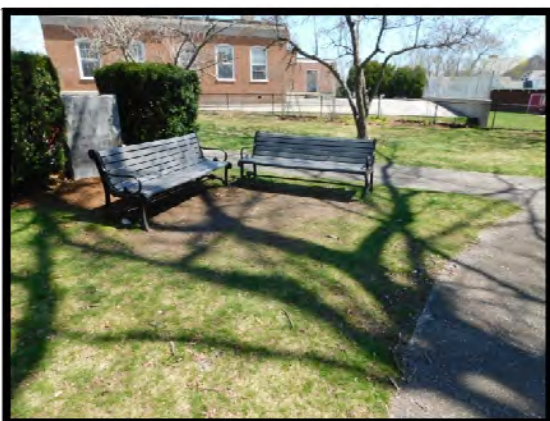
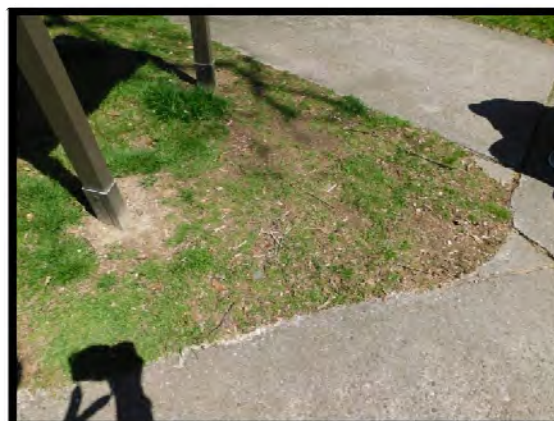
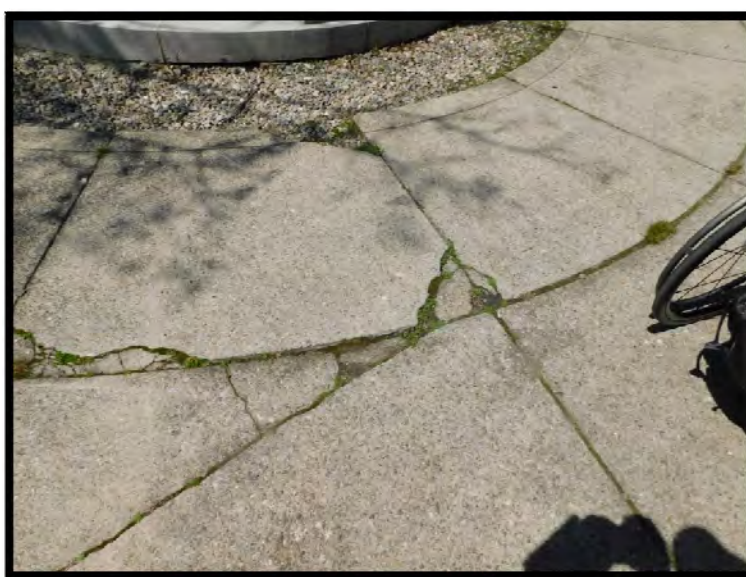
Only one of the dispersed benches is on an accessible route of travel with an accompanying level area for a wheelchair. The Linwood Street interpretive sign lacks a level area and stable surface for a wheelchair to view the sign. There are abrupt changes in level surface on the route of travel to the Civil War Monument. Although the running slopes to access the common exceed 8.3% in all but one of the entry points, the natural topography of the site prevents compliance from occurring, so no further action is required.

<u>General Description of Obstacle</u>	<u>2010 ADAAG</u>	<u>MAAB 521 CMR</u>	<u>Type of Action to be Taken</u>	<u>P</u>	<u>F</u>	<u>TF</u>	<u>Cost Estimate</u>
<b><u>Accessible Route and Benches</u></b> Only one bench is on an accessible route with an accompanying level area for a wheelchair. There are abrupt, unbeveled changes in level surface on the route of travel at the Civil War Monument. There is no accessible route directly to and no level area for a wheelchair at the Linwood Street interpretive signage.	402 303 403	19 20 22 14	Relocate one of the benches on the Linwood Street side to the concrete walkway.  Provide a stone dust walkway and level wheelchair area at the location with the paired benches (See Photo Town Common 1). The wheelchair space should be 36" wide x 60" deep per wheelchair. The accessible route s/b 48" per 521 CMR with a 2% maximum cross slope	2	2	N	Up to \$500+

See Photos Town Common 1, 2, and 3.		<p>and a 5% maximum running slope.</p> <p>Repair/modify the concrete at the Civil War Monument to eliminate the abrupt changes in level surface and to provide a stable surface.</p> <p>Provide a stone dust accessible route and level area for a wheelchair at the Linwood Street side interpretive signage.</p>				
-------------------------------------	--	--	--	--	--	--

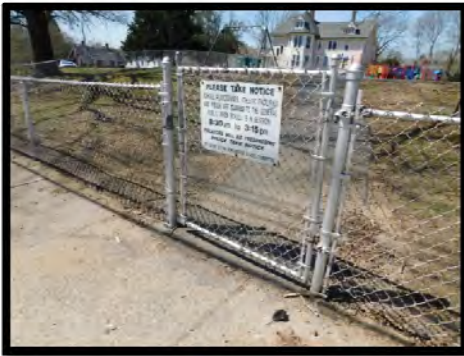
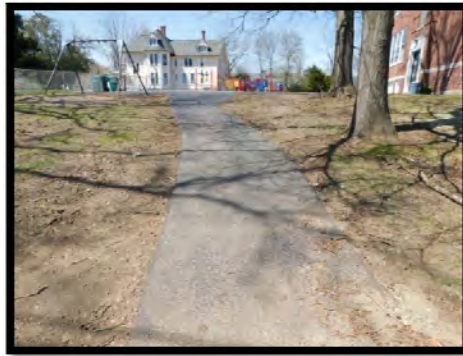
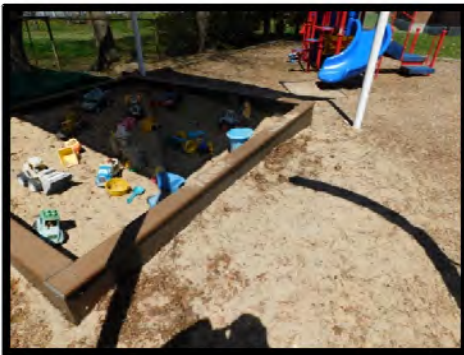
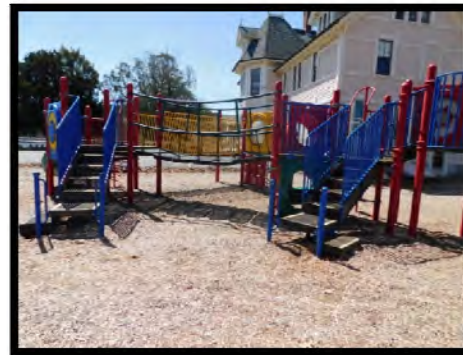
**General Description or Obstacle Which Limits Mobility or Access:** The chain link gate to enter the playground is not smooth at the base. The walkway from the sidewalk to the playground has a running slope of up to 12.0%. There is no accessible route of travel fully around the entirety of the playground (one side only). There is no accessible route of travel to the play equipment, sandbox, and bench. Non-compliant wood chips are the primary surface throughout the playground. There are no accessible play components.

<b><u>General Description of Obstacle</u></b>	<b><u>2010 ADAAG</u></b>	<b><u>MAAB 521 CMR</u></b>	<b><u>Type of Action to be Taken</u></b>	<b><u>P</u></b>	<b><u>F</u></b>	<b><u>TF</u></b>	<b><u>Cost Estimate</u></b>
<b>Entrance Gate</b> The existing gate to the playground does not comply with the 2010 ADA Standards for a smooth surface within 10 inches of the ground on the push side for the full width of the gate.  <a href="#">See Photo Cross Street 1.</a>	404.2.10	NA	Remove gate or install smooth plating at base of gate.	2	2	N	\$100

<p><b><u>Accessible Route of Travel</u></b></p> <p>The accessible route from the sidewalk to the playground has a roughly 35 foot segment with a running slope that varies from 7.0% to 12.0%.</p> <p>There is no accessible route of travel to and fully around the playground and to and between play equipment as well as to the bench and sandbox (up to 9" abrupt change in level surface).</p> <p>Non-compliant woodchips is the surface treatment for the entirety of the play areas. Woodchips may be acceptable in the fall zone area, but not as part of an accessible route of travel.</p> <p>There is no accessible playground equipment in the playground area.</p> <p>See Photos Cross Street 2, 3, and 4.</p>	403	22	<p>An accessible route of travel needs to be provided to all areas available to the public. Construct an accessible route of travel fully to and around the playground area and to and between playground equipment and components including the bench and sandbox. The accessible route of travel must be compliant with width (48" per 521 CMR) and slope (2% max. cross, 5% max. running) requirements as well as changes in level surface (no &gt; than ¼" unbeveled or between ¼" and ½" beveled w/a slope of no &gt; 1:2). Create an approach and wheelchair level area at the bench. The space should be 36" wide x 60" deep per wheelchair. If a front/rear approach, the depth can be reduced to 48" as opposed to 60" for a side approach. Construction options include compacted stone dust, asphalt or similar surfaces that meet the requirement of stable, firm, and slip resistant. Costs will vary depending on material used.</p> <p>Play area ground surfaces immediately around play components and in the fall zone must comply with ASTM F 1951 and ASTM F 1292. Depending on the type, age, and quality of woodchips, they may be considered acceptable as a fall zone ground surface.</p> <p>Accessible compliant playground equipment and swings should be incorporated into the playground area.</p>	2	3	N	Up to \$50,000+

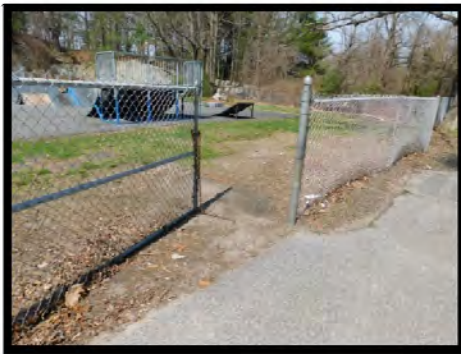
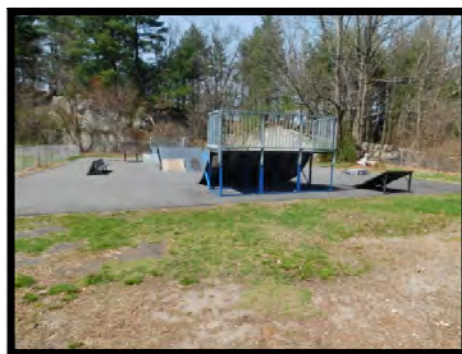
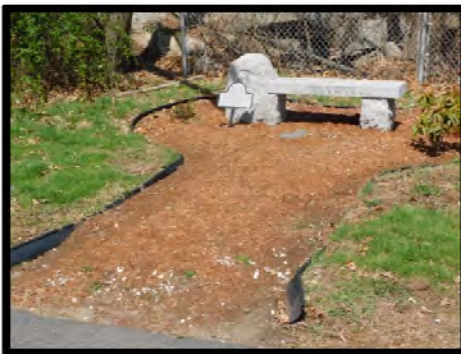
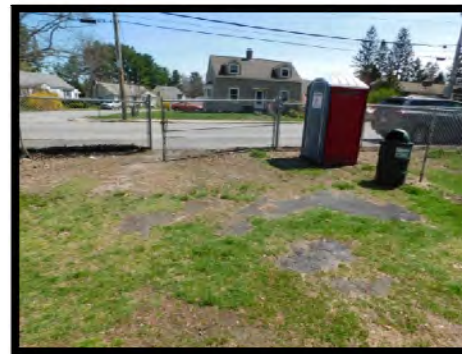
**General Description or Obstacle Which Limits Mobility or Access:** The chain link gate to enter the abandoned ballfield is not smooth at the base. There is no improved accessible route of travel to the skate park, memorial bench and portable toilet. The portable toilet is not accessible.

<u>General Description of Obstacle</u>	<u>2010 ADAAG</u>	<u>MAAB 521 CMR</u>	<u>Type of Action to be Taken</u>	<u>P</u>	<u>F</u>	<u>TF</u>	<u>Cost Estimate</u>
<b><u>Accessible Route of Travel</u></b> There is no accessible route of travel to the skate park and to the memorial bench with the latter being a woodchip surface.  See Photos Plummer 1, 2, and 3.	403	22	An accessible route of travel needs to be provided to all areas available to the public. Construct an accessible route of travel to the skate park and memorial bench. The accessible route of travel must be compliant with width (48" per 521 CMR) and slope (2% max. cross, 5% max. running) requirements as well as changes in level	2	2	N	Up to \$2,000

surface (no > than ¼" unbeveled or between ¼" and ½" beveled w/a slope of no > 1:2). Construction options can include compacted stone dust as long it is compacted to meet the requirement of stable, firm, and slip resistant.				
<b>Portable Toilet</b> The portable toilet near the entrance to the park is not an accessible portable toilet and is not on an accessible route of travel.  See Photo Plummer 4.	308.2 308.3 604.7 309.4 604.4 604.	30.12 30.7.6 30.8.5 30.7.2 26.9	Replace the existing portable toilet with an "ADA Compliant" toilet such that soap/towel dispensers are no more than 42" a.f.f.; the toilet paper dispenser s/b a minimum of 24" a.f.f. and s/b 7" min. to 9" max. in front of the water closet measured to the centerline of the dispenser; the height of the water closet s/b 17" to 19" a.f.f. to the top of the seat; the water closet s/b 18" from the nearest sidewall, at least 42" from the farthest sidewall, and 42" from the front of the water closet to the nearest wall or fixture; and a door closing speed that is at least 6 seconds. The accessible portable toilet must be placed on a level surface (less than 2.0% slope) and on an accessible route of travel.	3	2	I	TBD

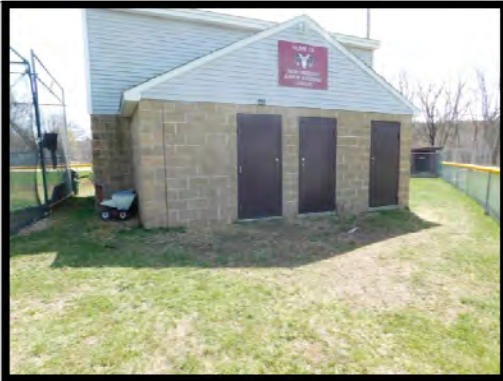
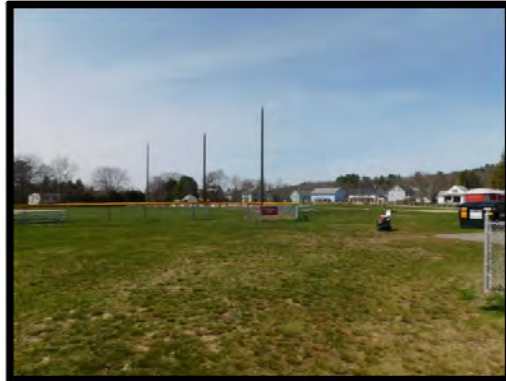
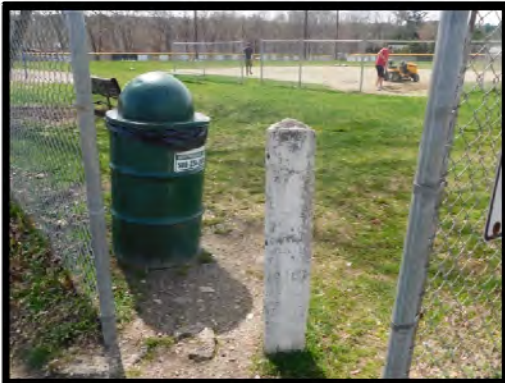
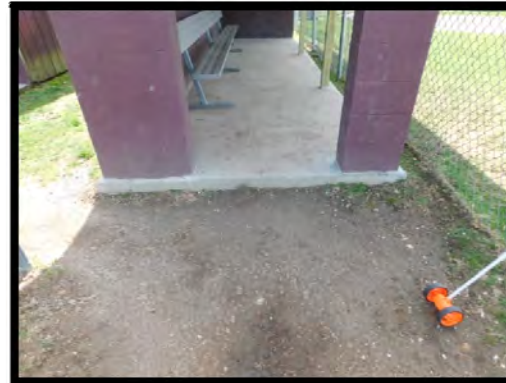
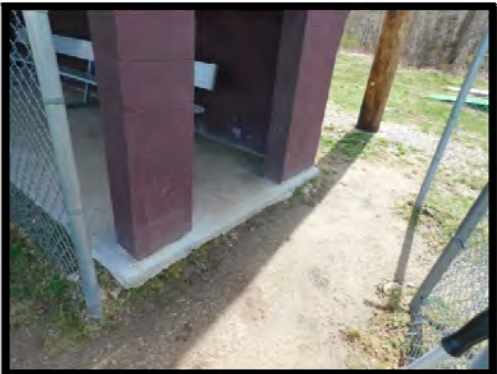
**General Description or Obstacle Which Limits Mobility or Access:** There lacks an accessible route of travel to the swings, concession stand, ballfields, bleachers, batting cages, and portable accessible toilet. There is reduced clear width at the entrance (s) into the facility. The dugouts next to the concession stand have 4” abrupt changes in level surface to access, reduced clear width to one dugout and chain link gates which are not smooth at the base. The concession stand has a 3” abrupt change in level surface to enter and 4” to 8” abrupt changes in level surface to access the outside service counters. The 2 counters are also 7” to 9” too high. The “accessible” portable toilet is not ADA compliant. There is no designated accessible parking in the adjacent paved parking.

<b>General Description of Obstacle</b>	<b><u>2010 ADAAG</u></b>	<b><u>MAAB 521 CMR</u></b>	<b><u>Type of Action to be Taken</u></b>	<b><u>P</u></b>	<b><u>F</u></b>	<b><u>TF</u></b>	<b><u>Cost Estimate</u></b>
<b><u>Parking</u></b> There are no designated accessible parking spaces inclusive of access aisle and signage.	502 703.7.2	23	Stripe and designate at least one van accessible parking space and one passenger vehicle accessible parking space. The van accessible space s/b at a width of either 11’ with a 5’ access aisle or 8’ wide parking space with an 8’ access aisle (2010 ADA Standards). The passenger vehicle accessible space s/b 8’ wide with a 5’ access aisle.	1	2	I	Up to \$450

Signage must be set such that the signage height should be a minimum of 60" high at the bottom (2010 ADAAG Standards) and a maximum of 96" at the top (MAAB 521 CMR) and located no more than 10' in front of the space. Van accessible signage s/b provided at the van accessible space. Slopes for the parking and access aisles should not exceed 2.0% in any direction.				
<p><b><u>Accessible Route of Travel</u></b></p> <p>There is no accessible route of travel to the ball field, dugouts, bleachers, batting cages, swings, accessible portable toilet, or concession stand.</p> <p>Clear width at entrances and to one of the dugouts near the concession stand have clear widths of less than 32".</p> <p>There are abrupt changes in level surface of 4" to 8" to access the concession stand service counter, up to 3" to access the inside of the concession stand, and up to 4" to access the 2 baseball dugouts next to the concession stand.</p> <p>See Photos Rockdale 1, 2, 3, 4, and 5.</p>	403	22	<p>An accessible route of travel needs to be provided to all areas available to the public. Construct an accessible route of travel fully to and around the swings, ball fields dugouts, bleachers, batting cages, concession stand, and portable accessible toilet. Entry clear widths must be modified so they are at least 32" wide.</p> <p>The accessible route of travel must be compliant with width (48" per 521 CMR) and slope (2% max. cross, 5% max. running) requirements as well as changes in level surface (no &gt; than ¼" unbeveled or between ¼" and ½" beveled w/a slope of no &gt; 1:2). Create an approach and wheelchair level area at the bleachers. The space should be 36" wide x 60" deep per wheelchair. If a front/rear approach, the depth can be reduced to 48" as opposed to 60" for a side approach. Construction options include compacted stone dust, asphalt or similar surfaces that meet the requirement of stable, firm, and slip resistant. Costs will vary depending on material used.</p>	2	3	N	Up to \$75,000+

<p><b><u>Portable Accessible Toilet</u></b></p> <p>The portable "accessible" toilet is not ADA compliant as the soap dispenser is 10" too high and located over the grab bars; the toilet paper dispenser is too close to the front of the toilet and is located over the grab bars; the toilet is 2" too high, 2" too close to the near wall, and 10" too close to the door in front of the toilet; and the door closing speed is too fast.</p>	308.2 308.3 604.7 309.4 604.4 604 404.2.8	30.12 30.7.6 30.8.5 30.7.2 26.9	Replace the existing portable "accessible" toilet with an ADA Compliant toilet such that soap/towel dispensers are no more than 42" a.f.f.; the toilet paper dispenser s/b a minimum of 24" a.f.f. and s/b 7" min. to 9" max. in front of the water closet measured to the centerline of the dispenser; the height of the water closet s/b 17" to 19" a.f.f. to the top of the seat; the water closet s/b 18" from the nearest sidewall, at least 42" from the farthest sidewall, and 42" from the front of the water closet to the nearest wall or fixture; and a door closing speed that is at least 6 seconds. The accessible portable toilet must be placed on a level surface (less than 2.0% slope in any direction) and on an accessible route of travel.	3	2	I	TBD

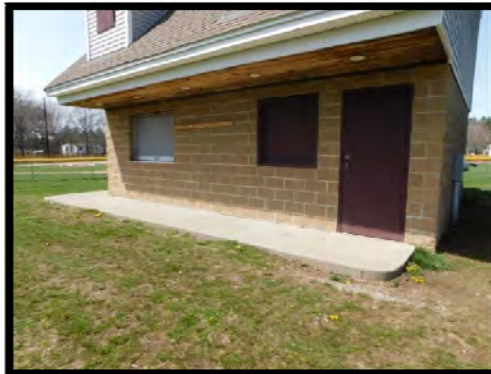
Photo Rockdale 6

<p><b><u>Concession Stand Counters</u></b></p> <p>The counters (2) are 7" to 9" too high.</p> <p>See Photo Rockdale 6.</p>	904.5	17.6.2	Create a 36" wide counter no higher than 34" a.f.f. below one of the existing counters.	2	2	N	Up to \$350
<p><b><u>Gates</u></b></p> <p>The existing gates (2) to the dugouts near the concession stand do not comply with the 2010 ADA Standards for a smooth surface within 10 inches of the ground on the push side for the full width of the gate.</p>	404.2.10	NA	Remove the gates or install smooth plating at the base of the gates.	2	2	N	\$200

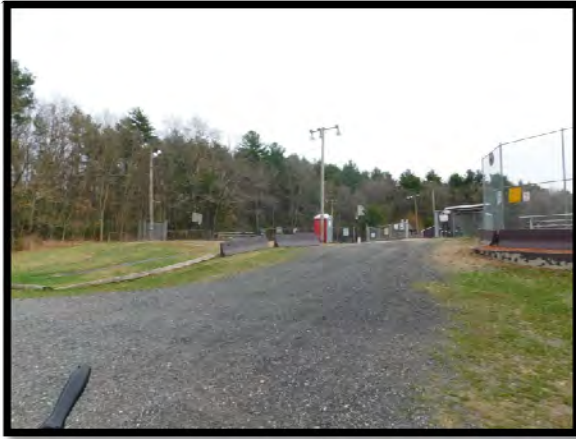
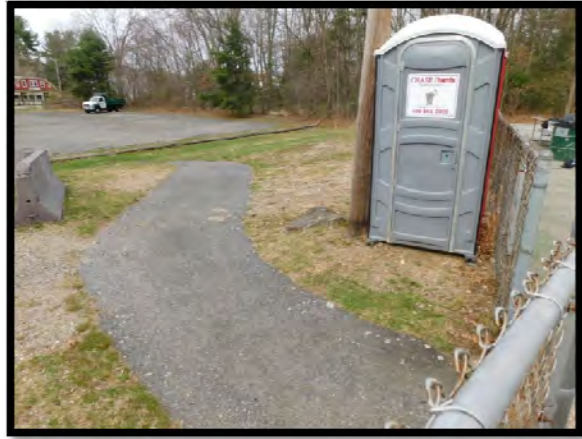
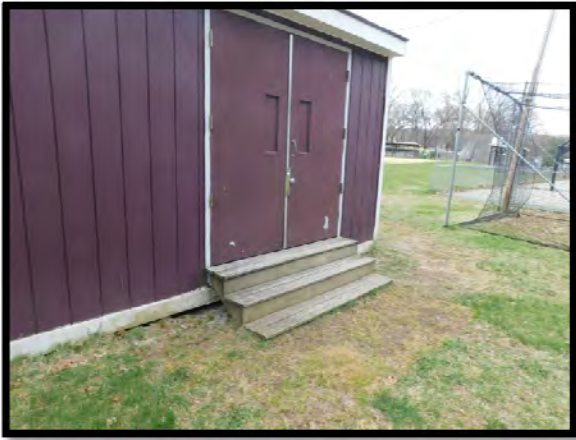
**General Description or Obstacle Which Limits Mobility or Access:** There is no accessible route of travel to the recreational facility or to the swings, concession stand, ballfields, basketball courts, bleachers, bench, and accessible toilet. There is no designated accessible parking. The interior of the concession stand is only accessible by a set of stairs, which lack railings. The concession stand counter is 19½" too high. The portable toilet is not accessible.

General Description of Obstacle	<u>2010</u> <u>ADAAG</u>	<u>MAAB</u> <u>521 CMR</u>	<u>Type of Action to be Taken</u>	<u>P</u>	<u>F</u>	<u>TF</u>	<u>Cost</u> <u>Estimate</u>
<b>Parking</b> There are no designated accessible parking spaces inclusive of access aisle and signage.	502 703.7.2	23	Stripe and designate at least one van accessible parking space and one passenger vehicle accessible parking space. The van accessible space s/b at a width of either 11' with a 5' access aisle or 8' wide parking space with an 8' access aisle (2010 ADA Standards). The passenger vehicle accessible space s/b 8' wide with a 5' access aisle. Signage must be set such that the signage height should be a minimum of 60" high at the bottom (2010 ADAAG	1	2	N	Up to \$3,500+

Standards) and a maximum of 96" at the top (MAAB 521 CMR) and located no more than 10' in front of the space. Van accessible signage s/b provided at the van accessible space. Slopes for the parking and access aisles should not exceed 2.0% in any direction.				
<p><b><u>Accessible Route of Travel</u></b></p> <p>There is no accessible route of travel to the basketball courts, ball fields, bench, bleachers, swings, portable toilet, or concession stand.</p> <p>The interior of the concession stand can only be accessed by a set of 3 stairs. The stairs lack railings.</p> <p>See Photos Linwood 1, 2, 3, and 4.</p>	403	22	<p>An accessible route of travel needs to be provided to all areas available to the public. Construct an accessible route of travel fully to and around the swings, ball fields, basketball courts, bleachers, bench, concession stand, and portable toilet.</p> <p>The accessible route of travel must be compliant with width (48" per 521 CMR) and slope (2% max. cross, 5% max. running) requirements as well as changes in level surface (no &gt; than ¼" unbeveled or between ¼" and ½" beveled w/a slope of no &gt; 1:2). Create an approach and wheelchair level area at the bleachers. The space should be 36" wide x 60" deep per wheelchair. If a front/rear approach, the depth can be reduced to 48" as opposed to 60" for a side approach. Construction options include compacted stone dust, asphalt or similar surfaces that meet the requirement of stable, firm, and slip resistant. Costs will vary depending on material used.</p> <p>If public access is allowed within the concession stand, including volunteers, a ramped approach would be required fully compliant with S. 405 and S. 505 of the 2010 ADA Standards and S. 24 of 521 CMR.</p> <p>Due to the terrain from the parking to the recreational facility, a switchback ramp with compliant paired railings would be required.</p>	2	3	N	Up to \$100 K+

<p><b><u>Portable Toilet</u></b></p> <p>The portable toilet near the entrance to the park is not an accessible portable toilet and is not on an accessible route of travel.</p>	308.2 308.3 604.7 309.4 604.4 604.	30.12 30.7.6 30.8.5 30.7.2 26.9	Replace the existing portable toilet with an "ADA Compliant" toilet such that soap/towel dispensers are no more than 42" a.f.f.; the toilet paper dispenser s/b a minimum of 24" a.f.f. and s/b 7" min. to 9" max. in front of the water closet measured to the centerline of the dispenser; the height of the water closet s/b 17" to 19" a.f.f. to the top of the seat; the water closet s/b 18" from the nearest sidewall, at least 42" from the farthest sidewall, and 42" from the front of the water closet to the nearest wall or fixture; and a door closing speed that is at least 6 seconds. The accessible portable toilet must be placed on a level surface (less than 2.0% slope) and on an accessible route of travel.	3	2	N	TBD

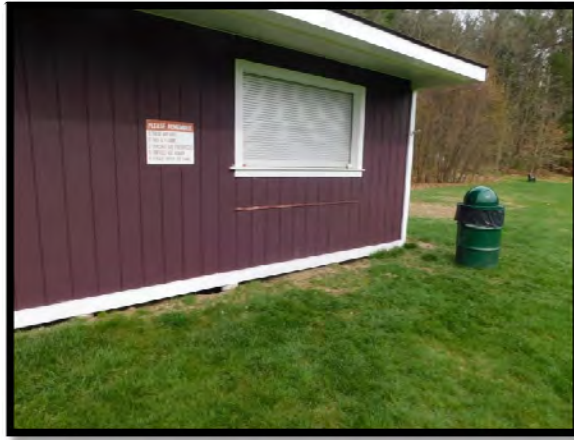
Photo Linwood 4

<p><b><u>Concession Stand Counter</u></b></p> <p>The counter is 19½" too high.</p> <p>See Photo Linwood 4.</p>	904.5	17.6.2	Create a 36" wide counter no higher than 34" a.f.f. below the existing counter.	2	2	N	Up to \$175

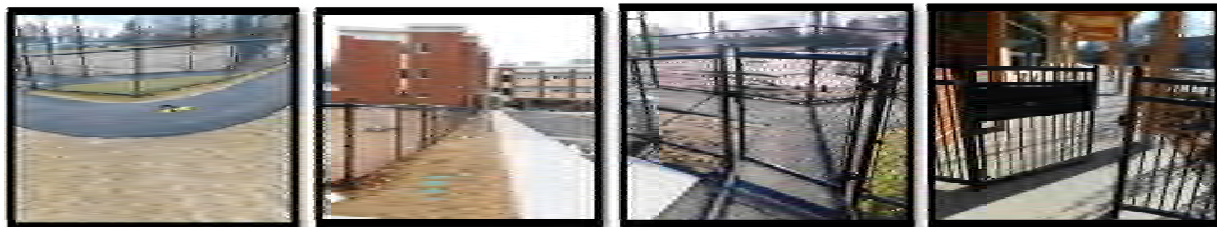
The two parking spaces at the front ball field and the two parking spaces near the rear field have signage that is 7" to 15½" too high. One of the front ball field spaces has a running slope of 2.4% to 2.8%.

The asphalt walkway behind the front baseball field (home plate area) has a segment of roughly 3 to 5 feet with a running slope of up to 5.7%. The walkway at the side playground and basketball court has 2 locations where the walkway crosses a travel lane resulting in abrupt changes in level surface (granite curbing) of ½" to 2". Some of the practice fields at the side and rear of the school do not have an accessible route from the adjacent walkway to the field. Access gates into playing fields and the playgrounds are not smooth on the push side of the gates.

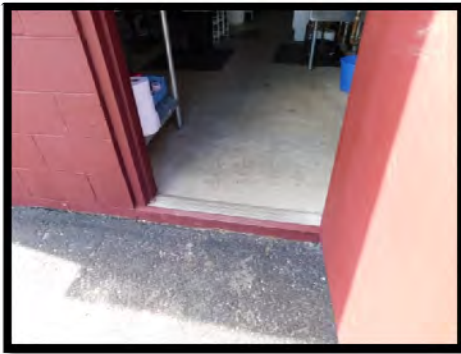
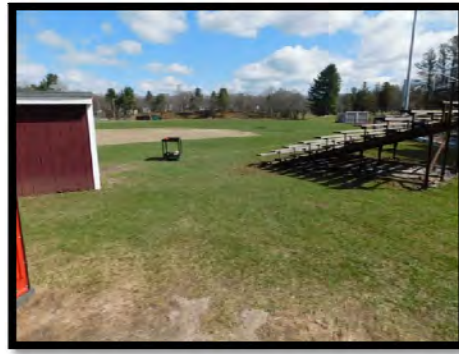
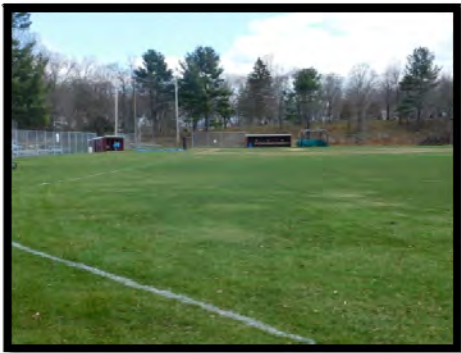
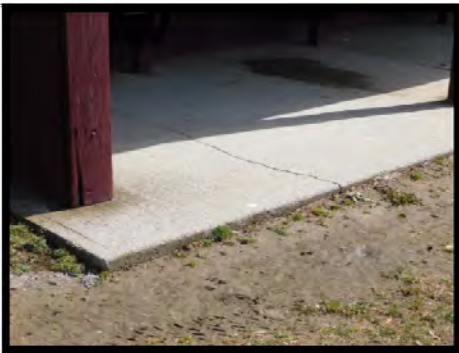
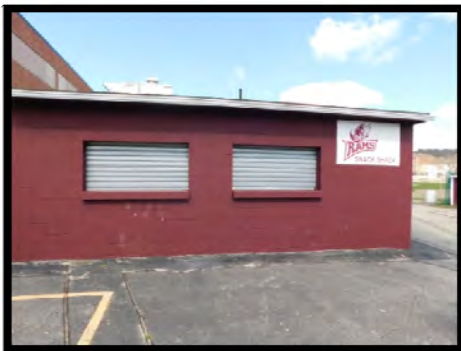
**General Description or Obstacle Which Limits Mobility or Access:** There is no accessible route of travel to the 2 baseball fields, baseball bleachers and dugouts. The baseball bleachers lack a level area for a wheelchair. There is a 3" abrupt change in level surface to access the interior of the concession stand. The concession stand sinks lack knee clearance and a towel dispenser is 13" too high. The concession stand service counters (2) are 14" to 14½" too high. The portable toilets (2) are not accessible and only one is on an accessible route of travel. The chain link gate to the track and multi-purpose field is not smooth at the base. The last 4 feet at the bottom of the ramp to the bleachers has a running slope of 8.5%, which exceeds the maximum allowed of 8.3%. The door into the broadcast booth has a glass pane that exceeds the maximum allowed height by 14".

<u>General Description of Obstacle</u>	<u>2010 ADAAG</u>	<u>MAAB 521 CMR</u>	<u>Type of Action to be Taken</u>	<u>P</u>	<u>F</u>	<u>TF</u>	<u>Cost Estimate</u>
<p><b><u>Accessible Route of Travel</u></b> There is no accessible route of travel to the baseball fields, dugouts, and bleachers. In addition, there are no level areas for a wheelchair next to the bleachers. There is up to a 2" abrupt change in level surface to access the dugouts.</p> <p>There is a 3" abrupt change in level surface to access the interior of the concession stand.</p> <p>See Photos Lasell 1, 2, 3, and 4.</p>	403	22	<p>An accessible route of travel needs to be provided to all areas available to the public. Construct an accessible route of travel fully to and around the ball fields, baseball bleachers, and dugouts.</p> <p>The accessible route of travel must be compliant with width (48" per 521 CMR) and slope (2% max. cross, 5% max. running) requirements as well as changes in level surface (no &gt; than ¼" unbeveled or between ¼" and ½" beveled w/a slope of no &gt; 1:2). Create an approach and wheelchair level area at the bleachers. The space should be 36" wide x 60" deep per wheelchair. If a front/rear approach, the depth can be reduced to 48" as opposed to 60" for a side approach. Construction options include compacted stone dust, asphalt or similar surfaces that meet the requirement of stable, firm, and slip resistant. Costs will vary depending on material used.</p> <p>If public access is allowed within the concession stand, including volunteers, a ramped approach would be required fully compliant with S. 405 and S. 505 of the 2010 ADA Standards and S. 24 of 521 CMR.</p>	2	3	N	Up to \$15,000+

<p><b><u>Portable Toilet</u></b> Neither of the 2 portable toilets are accessible.</p>	308.2 308.3 604.7 309.4 604.4 604.	30.12 30.7.6 30.8.5 30.7.2 26.9	Replace one of the existing portable toilets with an "ADA Compliant" toilet such that soap/towel dispensers are no more than 42" a.f.f.; the toilet paper dispenser s/b a minimum of 24" a.f.f. and s/b 7" min. to 9" max. in front of the water closet measured to the centerline of the dispenser; the height of the water closet s/b 17" to 19" a.f.f. to the top of the seat; the water closet s/b 18" from the nearest sidewall, at least 42" from the farthest sidewall, and 42" from the front of the water closet to the nearest wall or fixture; and a door closing speed that is at least 6 seconds. The accessible portable toilet must be placed on a level surface (less than 2.0% slope) and on an accessible route of travel.	3	2	N	TBD
<p><b><u>Concession Stand Counters</u></b> The counters are 14" to 14½" too high.</p> <p>See Photo Lasell 5.</p>	904.5	17.6.2	Create a 36" wide counter no higher than 34" a.f.f. below one of the existing counters.	2	2	N	Up to \$175

<p><b><u>Concession Stand Interior</u></b> The sinks lack knee clearance and the towel dispenser is 13" too high.</p>	306.3 308	32.7 6.5 6.6	As may be required due to a reasonable accommodation request, modify the sink to provide at least 27" of knee clearance and lower the towel dispenser to a height of no more than 48" a.f.f.	2	2,3	L	TBD
<p><b><u>Ramp</u></b> The last 4 feet at the bottom of the ramp to the bleachers has a running slope of 8.5%, which exceeds the maximum allowed of 8.3%.</p>	405.2	24.2	Seek a variance to retain the existing 8.5% running slope.	2	1	I	\$0
<p><b><u>Glass pane</u></b> A glass pane to the broadcast booth from</p>	404.2.11	NA	Doors, gates, and side lights adjacent to doors or gates,	4	2	I	\$0

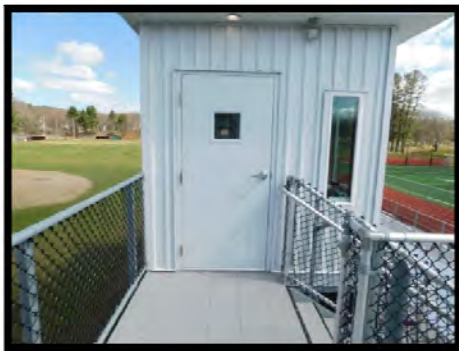
Photo Lasell 6

the lift side (accessible route of travel) is 57" a.f.f., which is 14" too high.  See Photo Lasell 6.			containing panels on accessible routes of travel that permit viewing through the panels shall have the bottom of at least one panel located 43 inches maximum a.f.f.  Frost or block the glass panes.				
<b>Gates</b> The gate to the track and multi-purpose field does not comply with the 2010 ADA Standards for a smooth surface within 10 inches of the ground on the push side for the full width of the gate.	404.2.10	NA	Remove the gate or install smooth plating at the base of the gate.	2	2	N	\$100

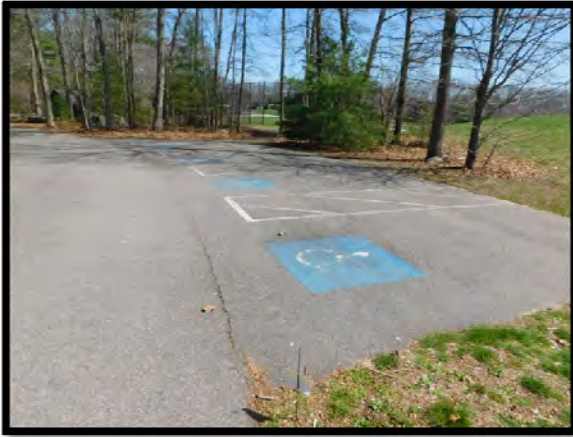
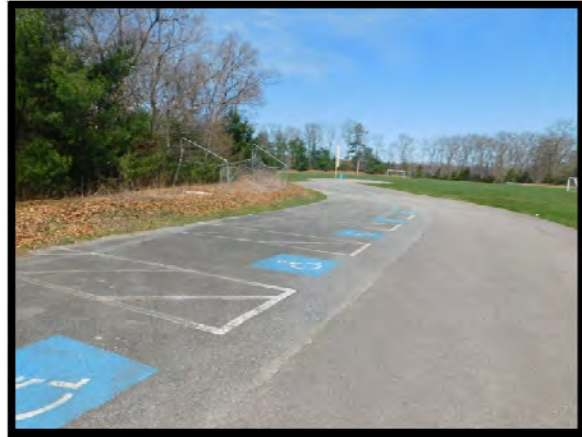
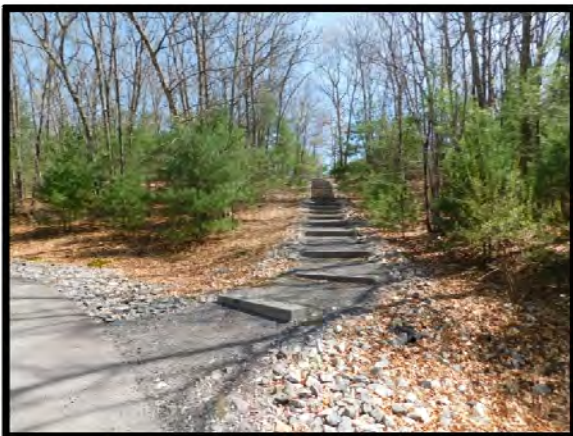
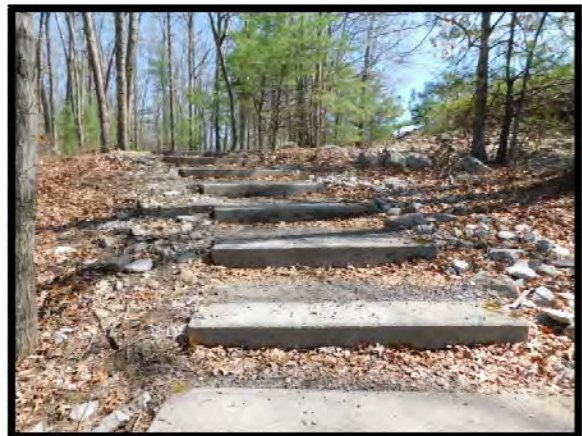
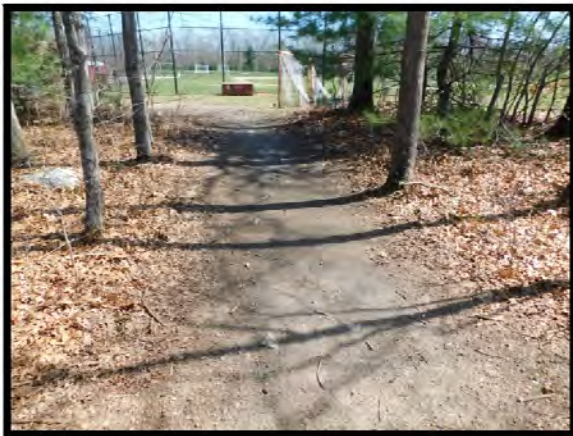
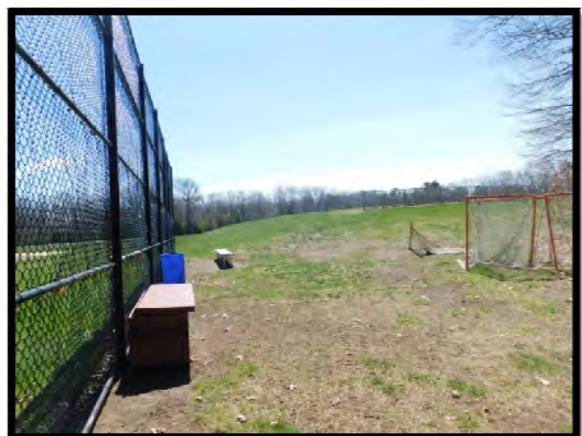
**General Description or Obstacle Which Limits Mobility or Access:** There is no accessible route of travel fully around the soccer fields and baseball field and to player benches and bleacher seating. The designated accessible parking lacks signage and lacks van designated spaces. The portable “accessible” toilet is not on an accessible route of travel and is not ADA compliant. The stairs to the facility are not uniform and lack railings. Although the chain link gate at the entrance lacks a smooth surface at the base, it is not on an accessible route of travel so no further action is required.

General Description of Obstacle	<u>2010 ADAAG</u>	<u>MAAB 521 CMR</u>	<u>Type of Action to be Taken</u>	<u>P</u>	<u>F</u>	<u>TF</u>	<u>Cost Estimate</u>
<b>Parking</b> The 17 designated accessible parking spaces lack signage and none of the spaces are designated as van accessible. The farthest 2 spaces at the soccer field have running slopes that vary up to 3.4%, which exceeds the maximum allowed by 1.4%.  See HS Fields 1 and 2.	502 703.7.2	23	Stripe and designate at least one van accessible parking space at both the baseball field and soccer field(s) parking areas. The van accessible space s/b at a width of either 11’ with a 5’ access aisle or 8’ wide parking space with an 8’ access aisle (2010 ADA Standards). The accessible passenger vehicle spaces must be 8 feet wide with a 5 foot access aisle. Signage must be set such that the signage height should be a minimum of 60” high at the bottom (2010 ADAAG Standards) and a maximum of 96” at the top (MAAB 521 CMR) and located no more than 10’ in front of the space. Van accessible signage s/b	1	2	I	Up to \$1,750+

<p>provided at the van accessible space. Slopes for the parking and access aisles should not exceed 2.0% in any direction.</p> <p>As the number of accessible spaces provided far exceeds that required, it is recommended that the 2 non-compliant spaces (excessive running slopes) at the soccer fields be taken out of service as formally designated accessible spaces but be reserved for elderly or persons with other mobility issues.</p>				
<p><b>Stairs</b></p> <p>The stairs to the athletic fields are not uniform and lack railings.</p> <p>See HS Fields 3 and 4.</p>	504 505	27	<p>As feasible, modify the stairs so that they are uniform in width and height (at least 11" wide and 4" to 7" high) and provide compliant railings (34" – 38" a.f.f. on both sides with top and bottom extensions).</p>	1	3	L	TBD
<p><b>Accessible Route of Travel</b></p> <p>There is no accessible route of travel fully around the soccer fields and baseball field and to player benches and bleacher seating. There is no level wheelchair area at the bleachers.</p> <p>See HS Fields 5 and 6.</p>	403	22	<p>An accessible route of travel needs to be provided to all areas available to the public. Construct an accessible route of travel fully to and around the playing fields, bleachers, and player benches.</p> <p>The accessible route of travel must be compliant with width (48" per 521 CMR) and slope (2% max. cross, 5% max. running) requirements as well as changes in level surface (no &gt; than ¼" unbeveled or between ¼" and ½" beveled w/a slope of no &gt; 1:2). Create an approach and wheelchair level area at the bleachers. The space should be 36" wide x 60" deep per wheelchair. If a front/rear approach, the depth can be reduced to 48" as opposed to 60" for a side approach. Construction options include compacted stone dust, asphalt or similar surfaces that meet the requirement of stable, firm, and slip resistant. Costs will vary depending on material used.</p> <p><u>Main Soccer Field Accessible Route of Travel</u></p> <p>Option #1: Due to the terrain from the parking to the first soccer field with bleacher seating, a switchback ramp with compliant paired railings would be required.</p> <p>Option #2: Create additional designated accessible parking spaces and turn-around at the end of the soccer field.</p>	2	3	N	\$60,000 to \$160K+

<p><b>Portable Accessible Toilet</b></p> <p>The portable "accessible" toilet is not ADA compliant as both the soap dispenser and toilet paper dispenser are too high and located over the grab bars; the toilet is ¾" too high, 2" too far from the near wall and 9" too close to the door in front of the toilet; and the door closing speed is too fast. In addition, the portable toilet is not on an accessible route of travel.</p>	308.2 308.3 604.7 309.4 604.4 604 404.2.8	30.12 30.7.6 30.8.5 30.7.2 26.9	<p>Replace the existing portable "accessible" toilet with an ADA Compliant toilet such that soap/towel dispensers are no more than 42" a.f.f.; the toilet paper dispenser s/b a minimum of 24" a.f.f. and s/b 7" min. to 9" max. in front of the water closet measured to the centerline of the dispenser; the height of the water closet s/b 17" to 19" a.f.f. to the top of the seat; the water closet s/b 18" from the nearest sidewall, at least 42" from the farthest sidewall, and 42" from the front of the water closet to the nearest wall or fixture; and a door closing speed that is at least 6 seconds. The accessible portable toilet must be placed on a level surface (less than 2.0% slope in any direction) and on an accessible route of travel.</p>	3	2	I	TBD
