## LANDSCAPE ASSESSMENT

### EXECUTIVE SUMMARY

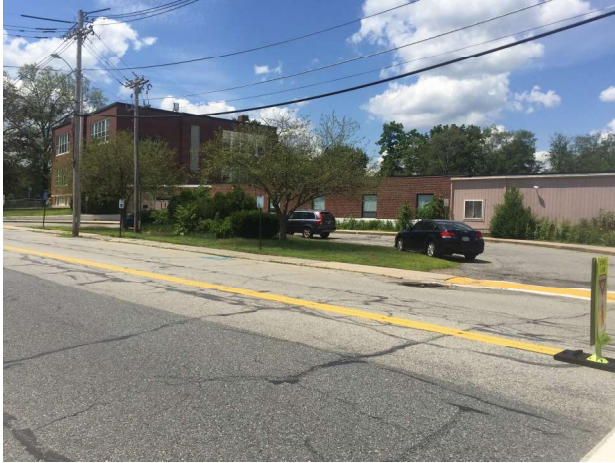
*Figure 1—Ornamental plantings at entrance*

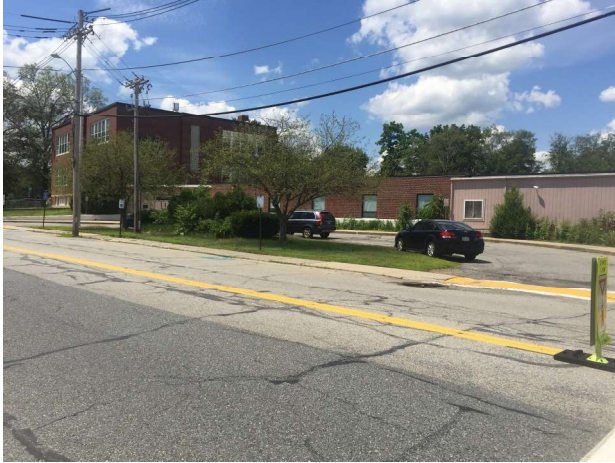
Figure 7—Original building with two additions

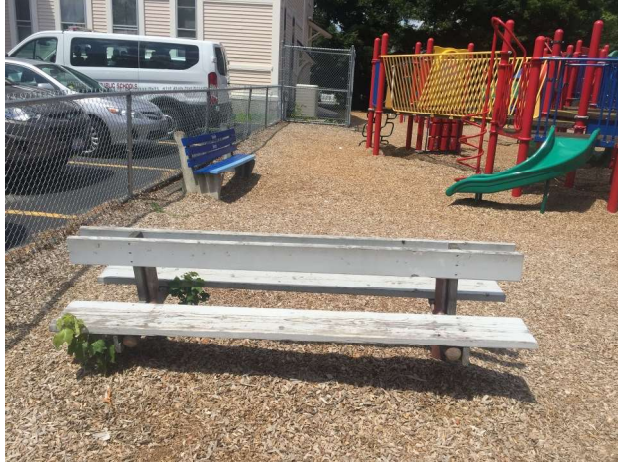
Figure 13 Bench at play area

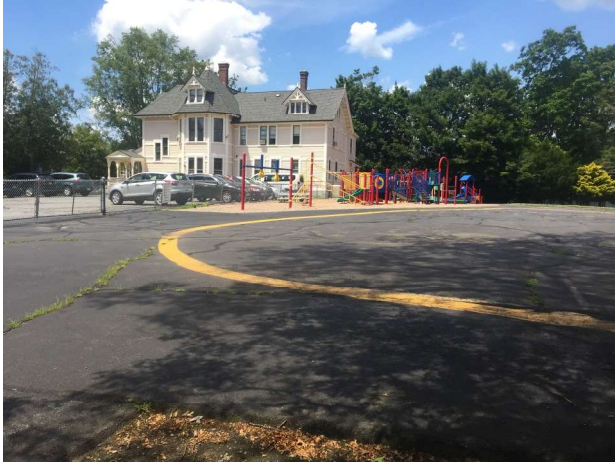
Figure 19—Schoolyard and School District Office.

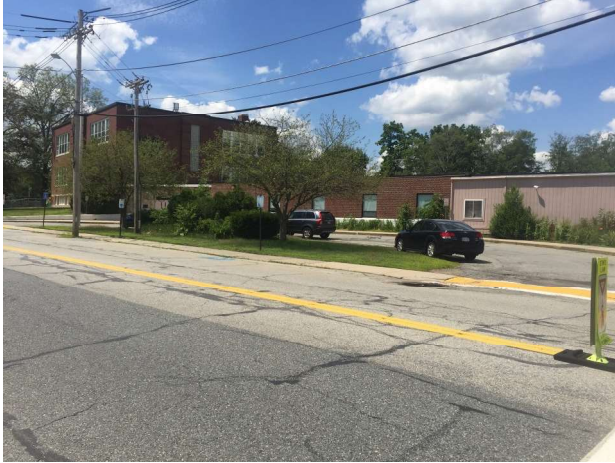
Figure 25—Entrance at school drop-off

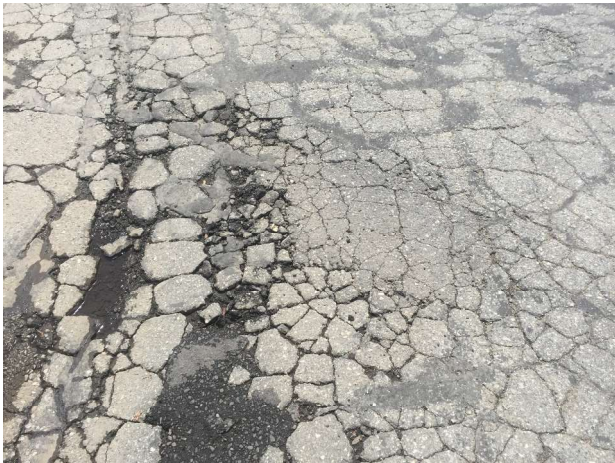
Figure 27—Poor condition of bituminous concrete

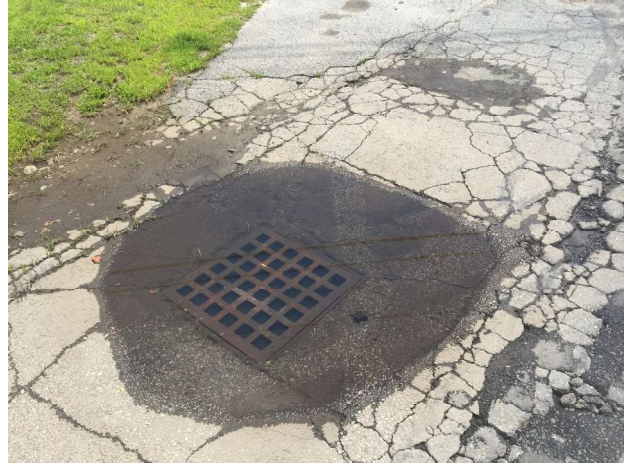
Figure 28—Catch basin at drop-off loop

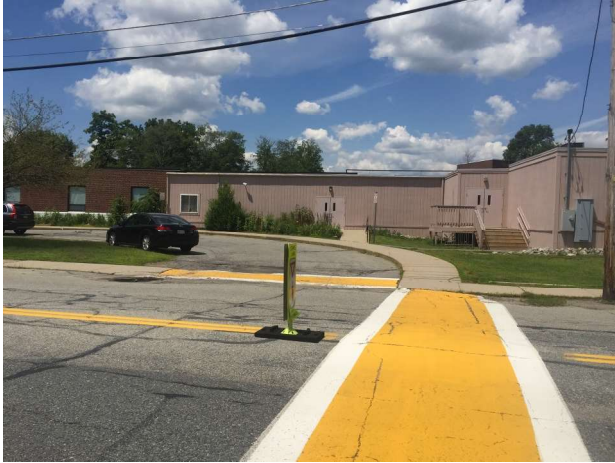
Figure 31—Pedestrian crosswalk at school

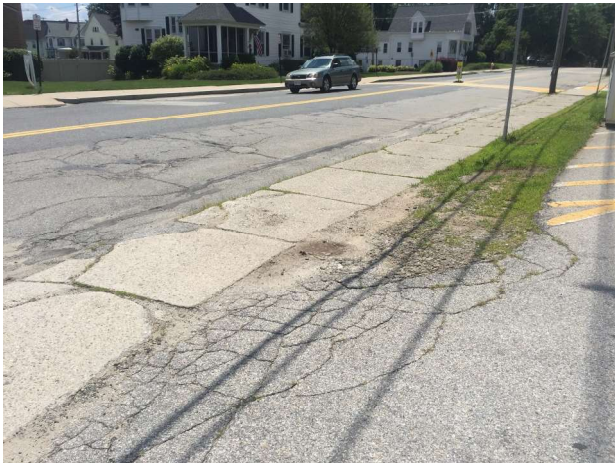
Figure 33—Damaged pedestrian surfaces

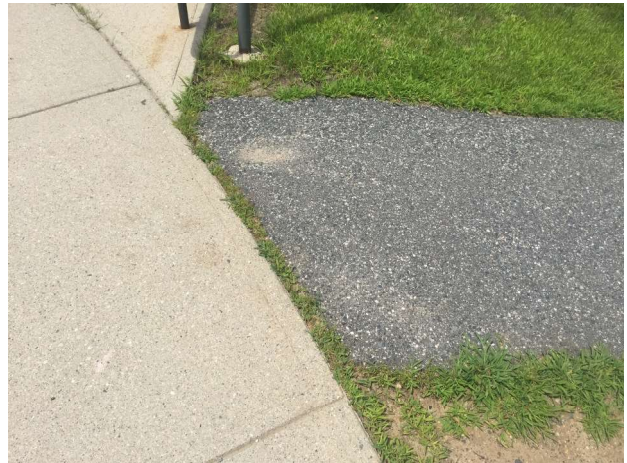
Figure 34—Gap at union of sidewalk materials

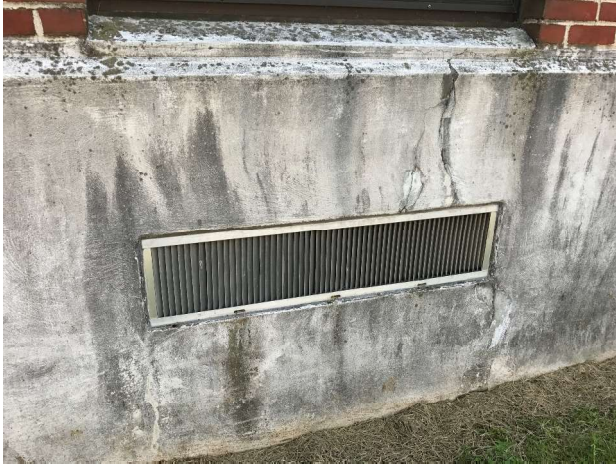
Figure 1—Cracking at unit vent grille

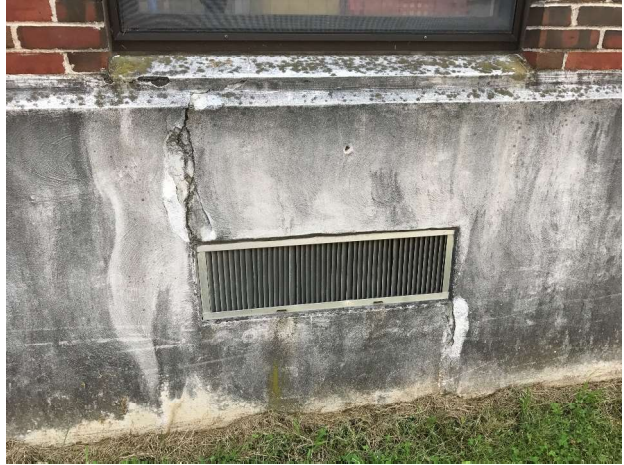
Figure 2—Cracking at unit vent grille

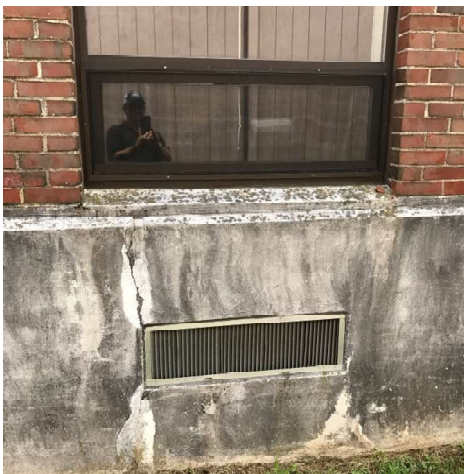
Figure 3—Cracking at unit vent grille

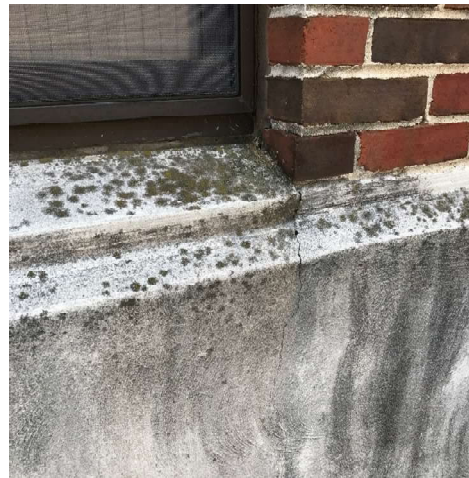
Figure 4—Discolored and dirty foundation wall

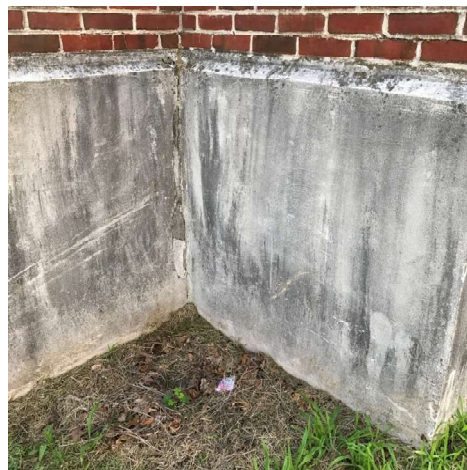
Figure 5—Discolored and dirty foundation wall

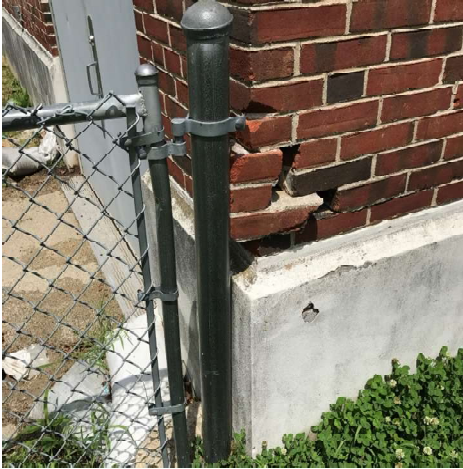
Figure 6—Cracked and displaced brick NW corner

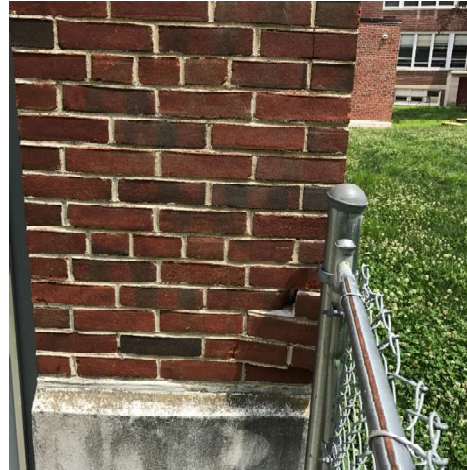
Figure 7— Cracked and displaced brick NW corner

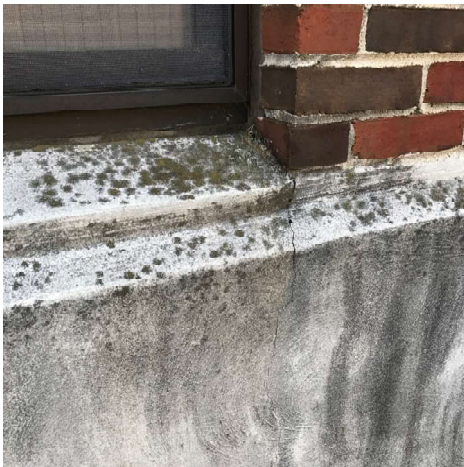
Figure 8—Crack at precast concrete window sill

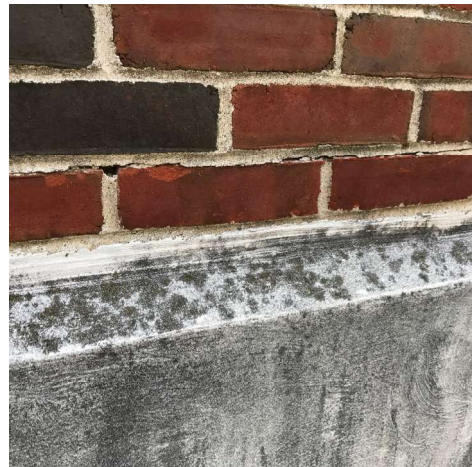
Figure 9— Degrading mortar joints typical

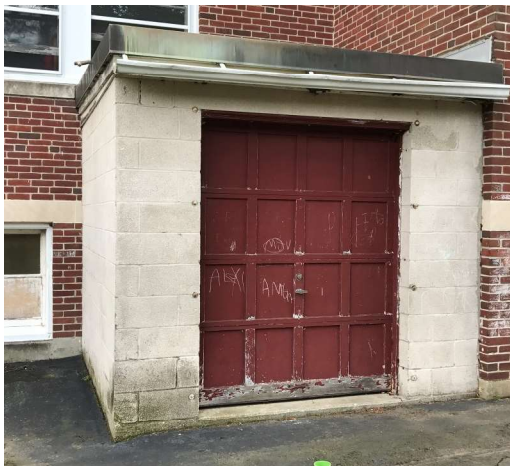
Figure 10—Garage attached to '52 building

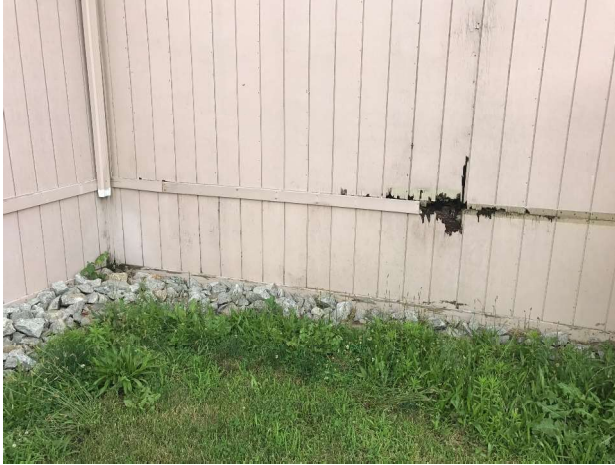
*Figure 12—Rot at exterior wall of modular classrooms*

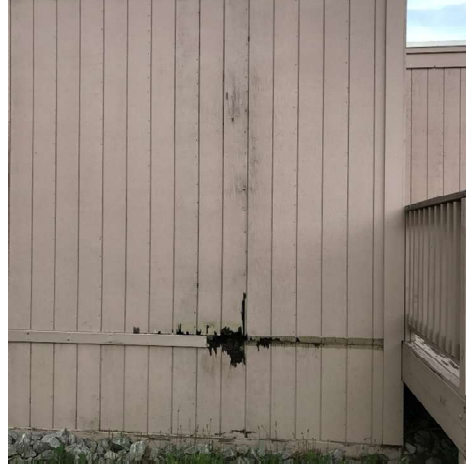
*Figure 13—Rot at exterior wall of modular classrooms*

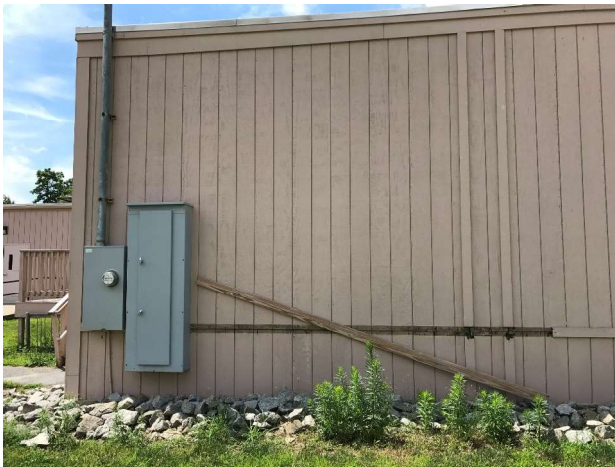
*Figure 14—Trim board fallen of side of modulars*

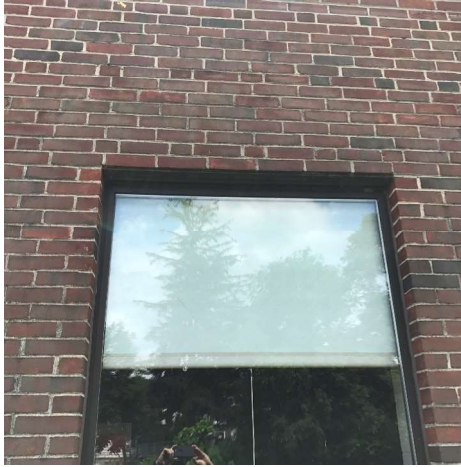
Figure 16—Non Low-E coated window glazing

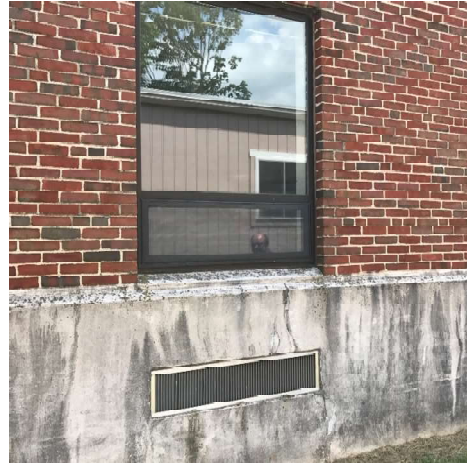
Figure 17—Non thermally broken windows

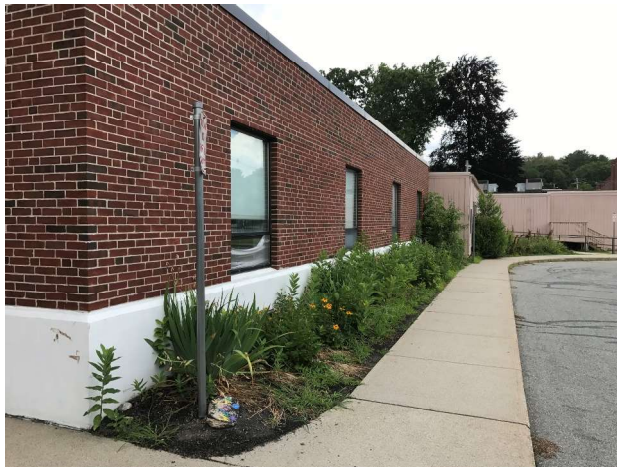
Figure 18—Non thermally broken windows

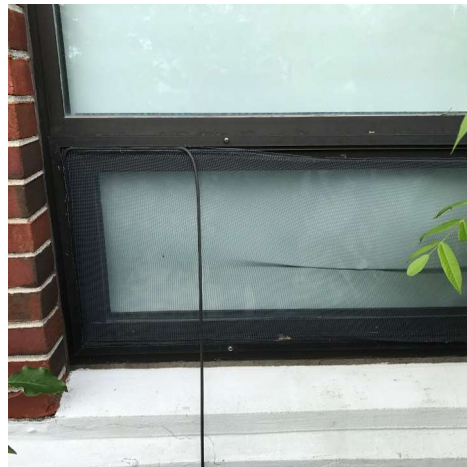
Figure 19—Loose screening and splines

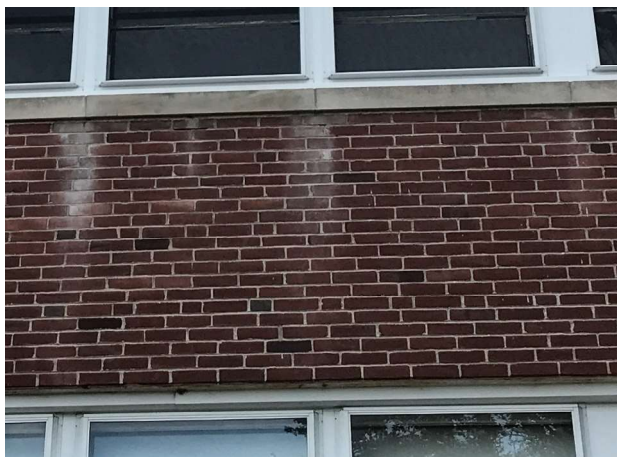
Figure 20—Failing sealant stains on brick

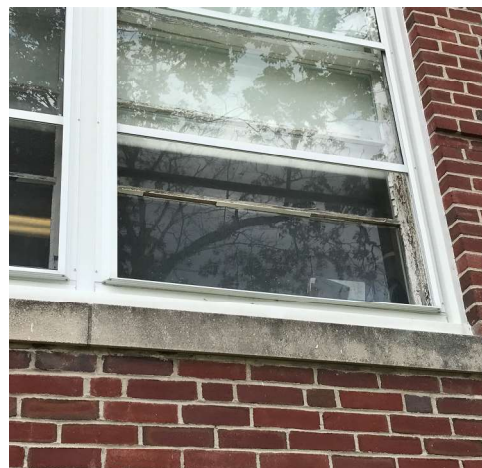
Figure 21—Deteriorating wood windows '52 bldg.

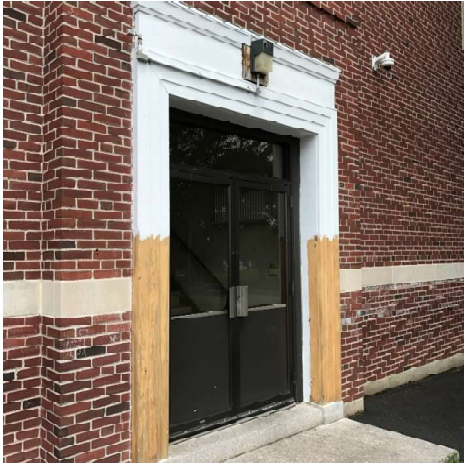
Figure 22—Storefront door at '52 building

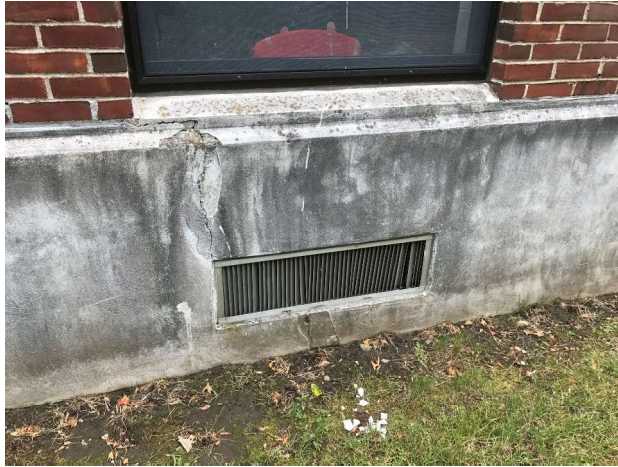
Figure 27—Damage at '83 addition.

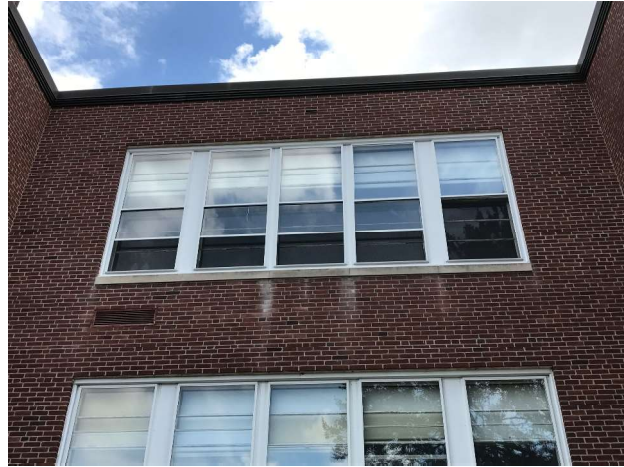
Figure 28—Degraded paint on louvers @ '52 building

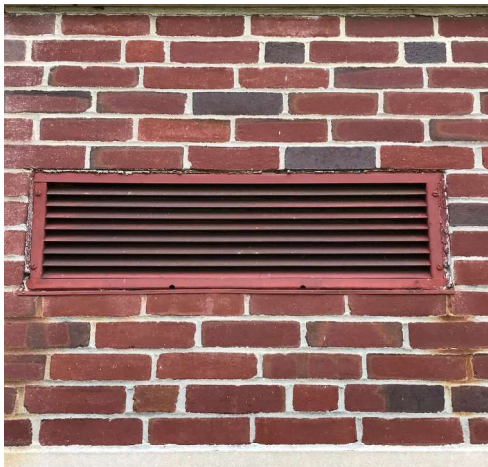
Figure 29—Degraded caulking around lower typical

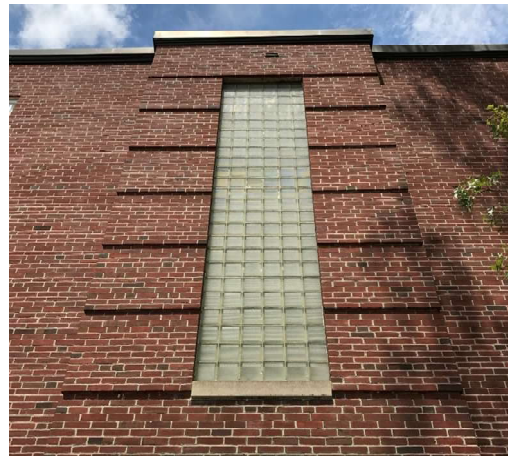
Figure 30—Glass Block Fenestration

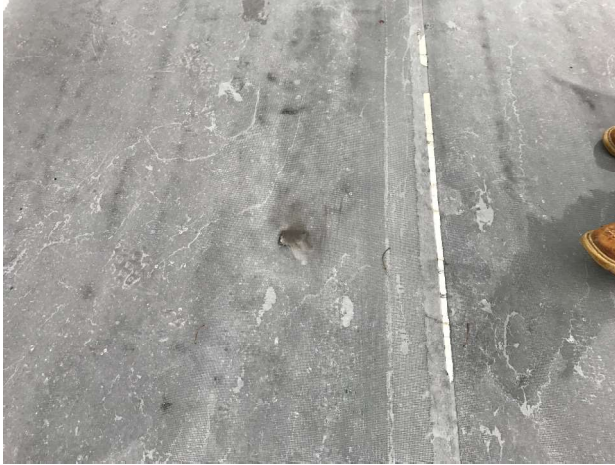
Figure 31– Visible scrim layer on '52 building roof

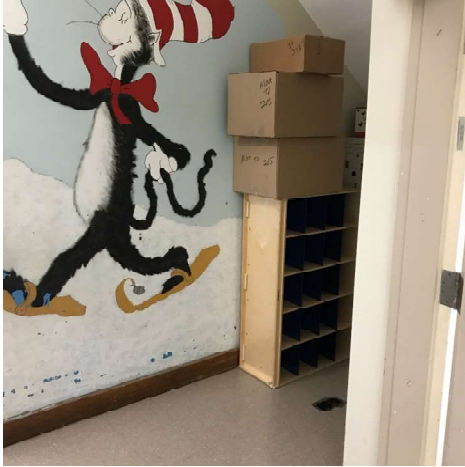
Figure 37—Delaminated & damaged VCT

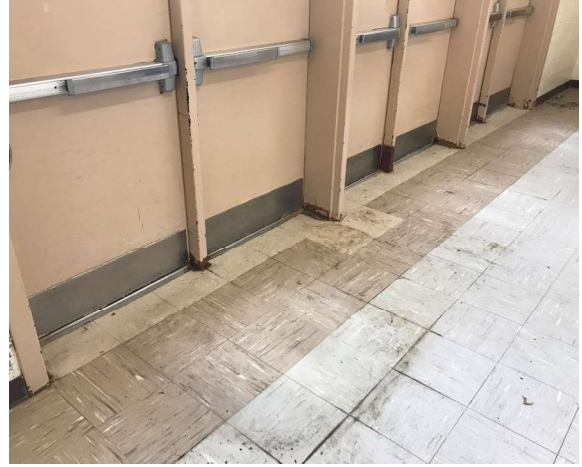
Figure 38—Stained & delaminated tile at '83 bldg.

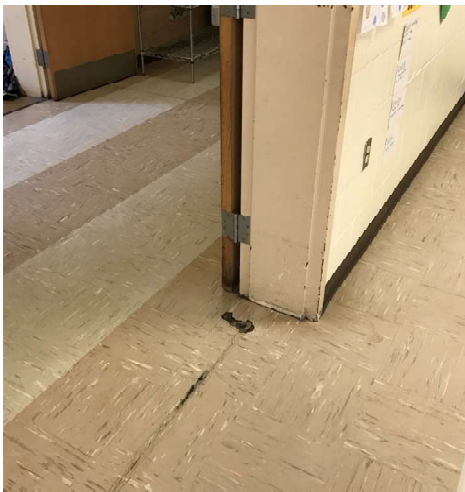
Figure 39—Worn down VCT tile at door '83 bldg.

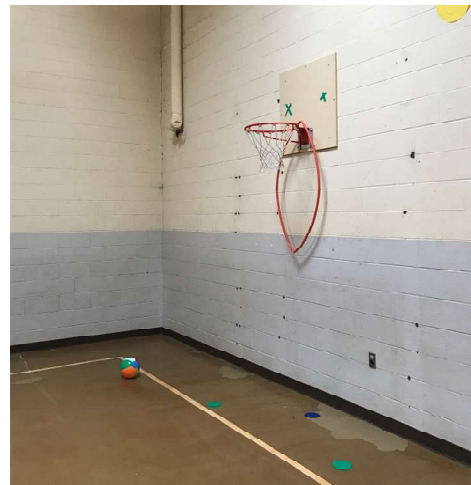
Figure 40—Worn down paint on Gymnasium floor

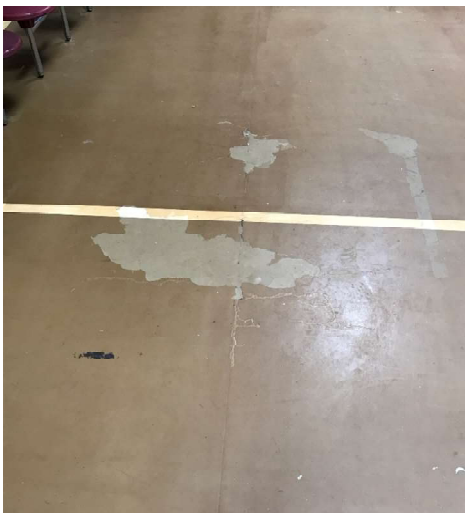
Figure 41—Worn down paint on Gymnasium floor

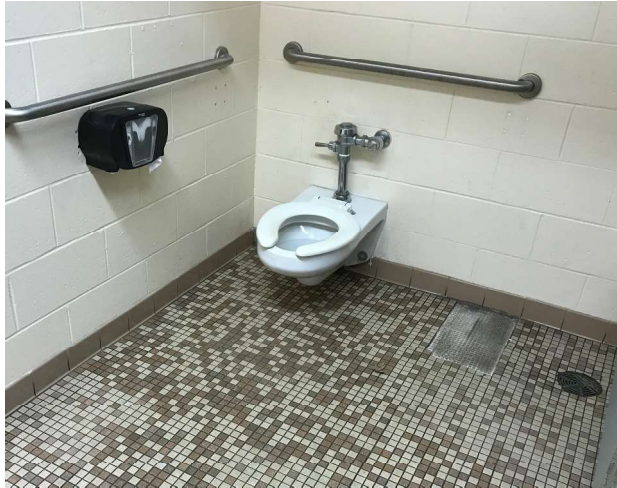
Figure 42— Area of missing mosaic tile

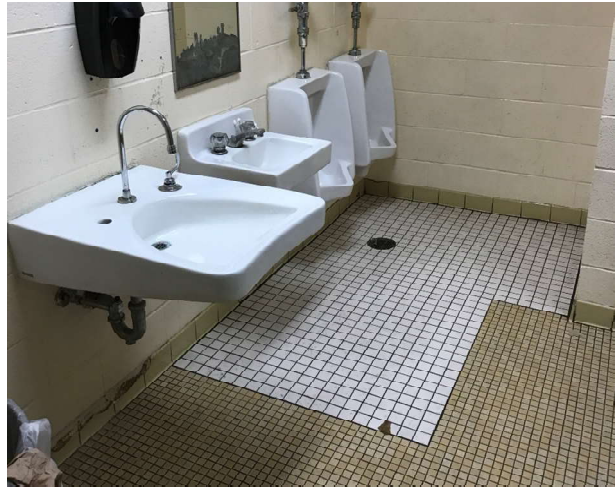
Figure 43—Large area of mismatched tile

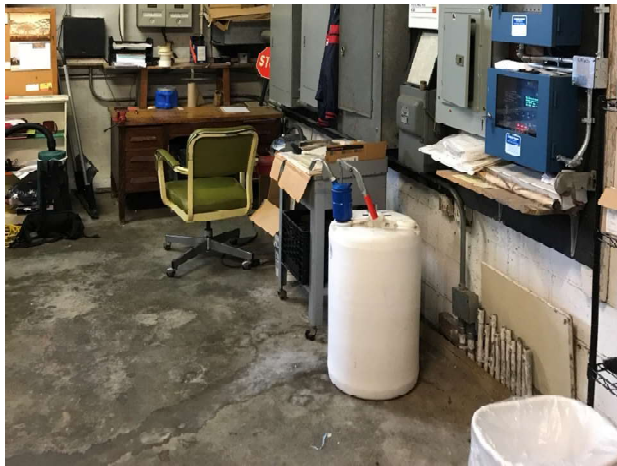
Figure 44—Concrete floor sealer worn

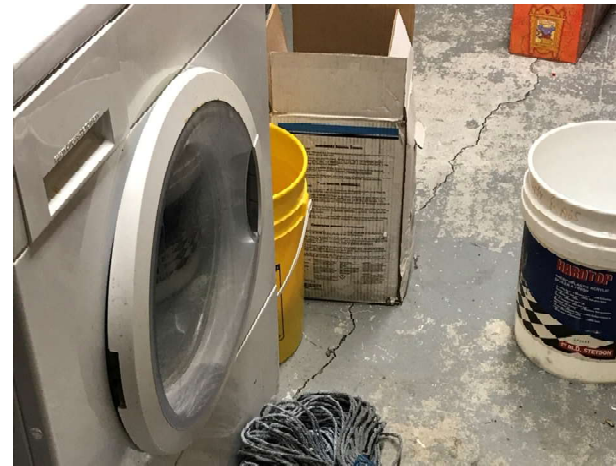
Figure 45—Sealed concrete floor worn away typical

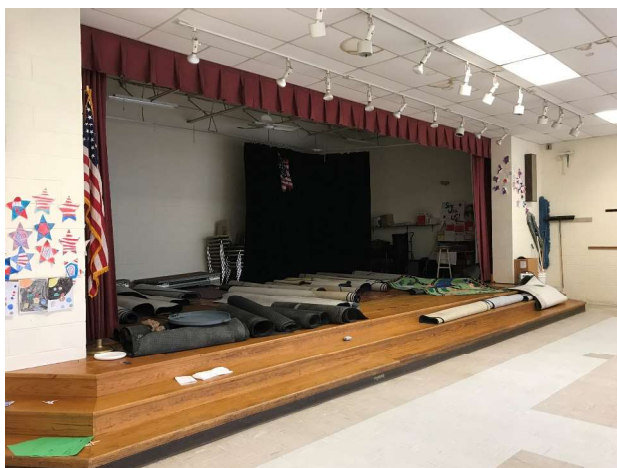
Figure 46—scuffed and gouged stage floor

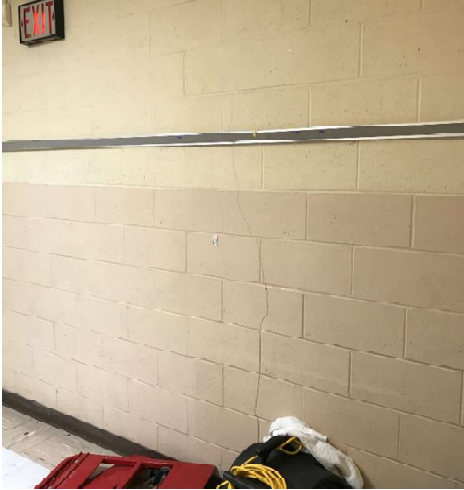
Figure 48—Crack in corridor of '83 addition

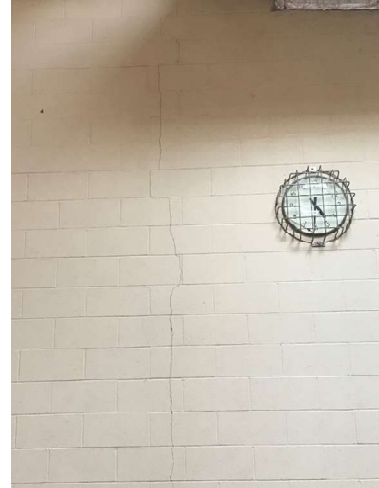
Figure 49—Crack in Gymnasium wall

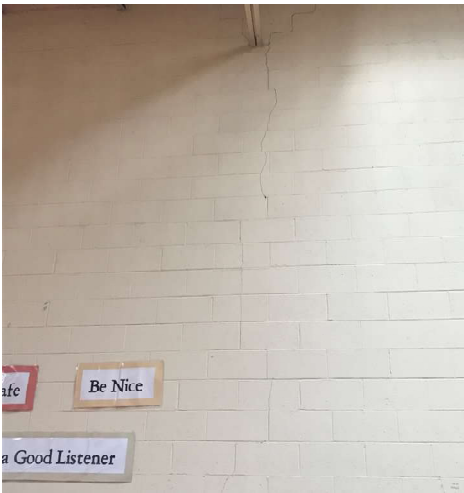
Figure 50—Crack in Gymnasium wall

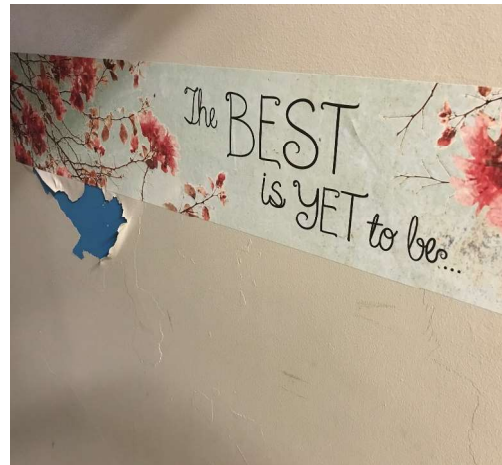
Figure 51—Paint peeling of plaster and lath wall

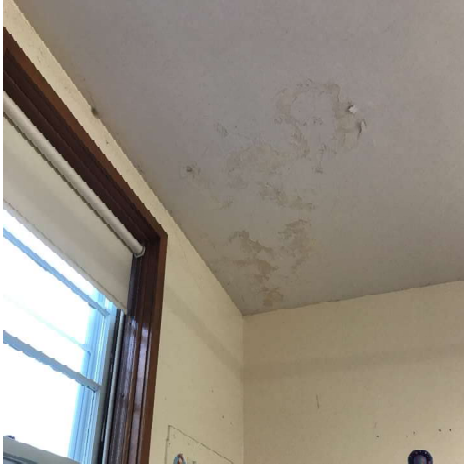
*Figure 54—Flaking ceiling paint & water damage*

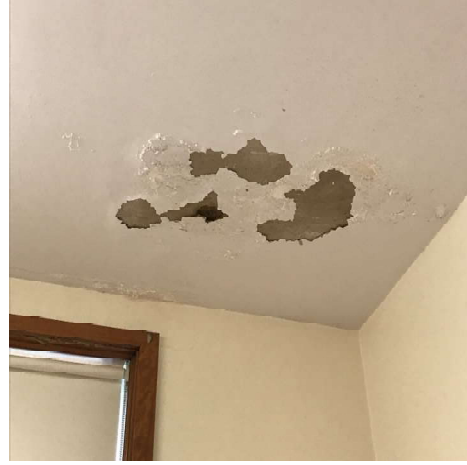
*Figure 55—Flaking ceiling paint & water damage*

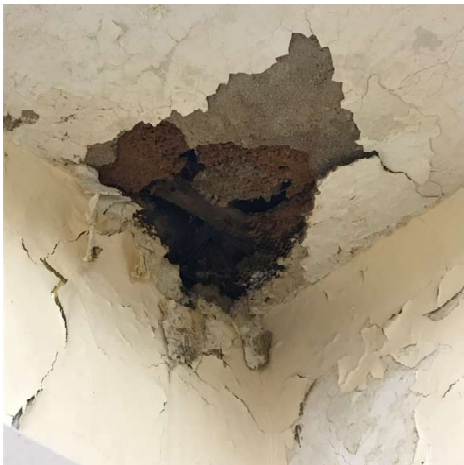
*Figure 56—Water damaged ceiling 1st floor.*

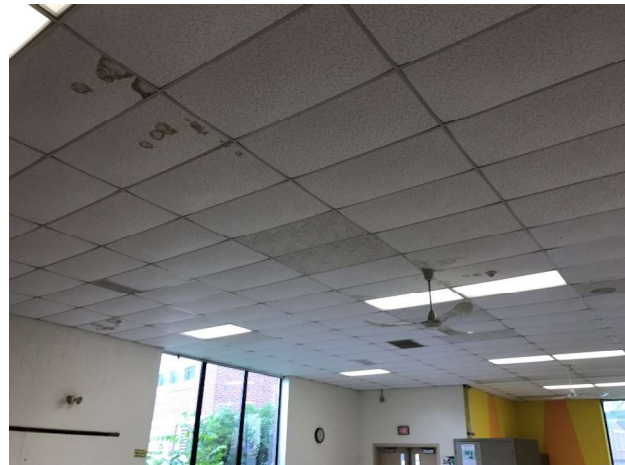
*Figure 57—Sagging & stained ceiling panels.*

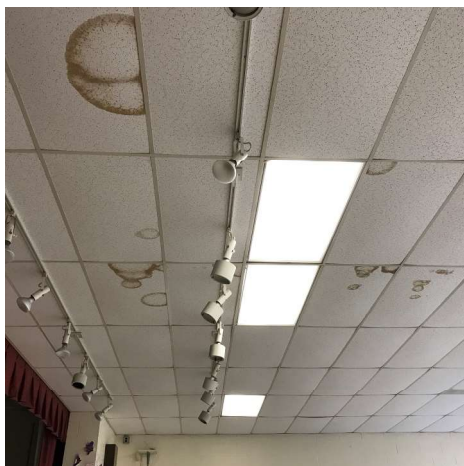
*Figure 58—Stained ceiling panels in Cafetorium*

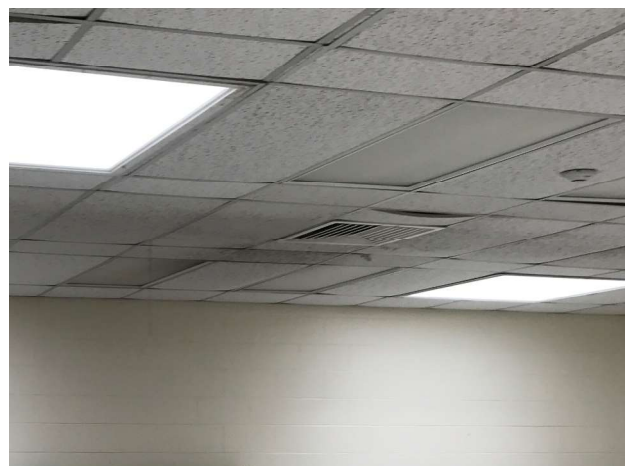
*Figure 59—Soiled ceiling panels at return grilles*

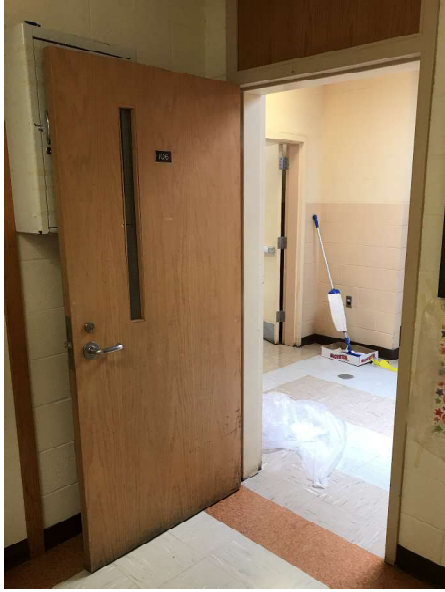
Figure 60—Typical natural finish wood door

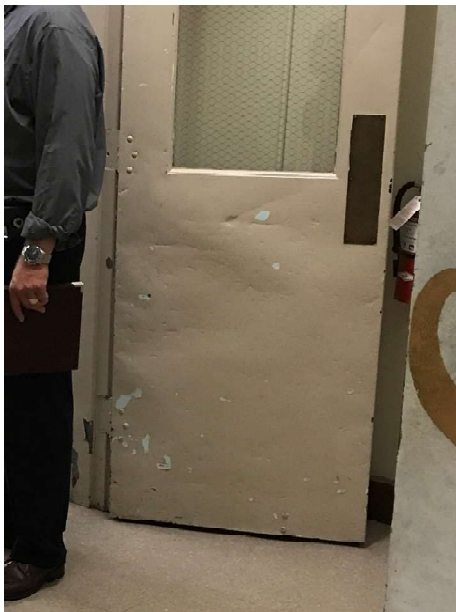
Figure 62—Damaged face of HM door

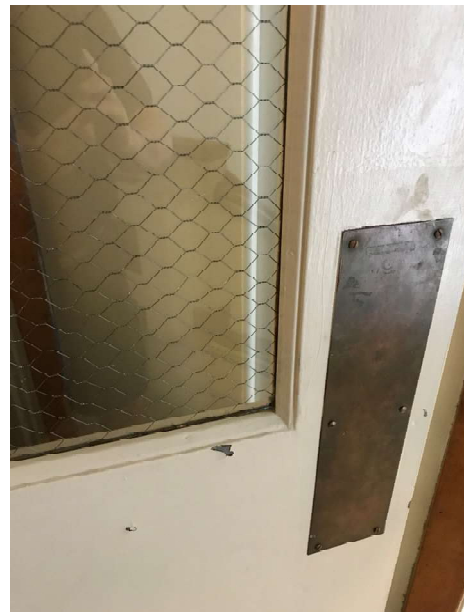
Figure 63—Wired glass vision panel

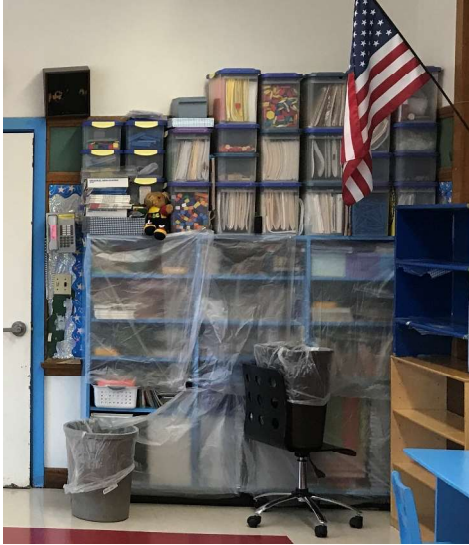
Figure 64—High piled classroom storage

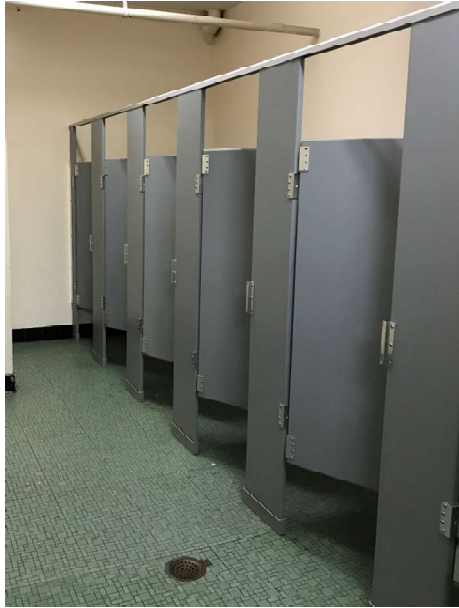
Figure 69—Toilet Partitions

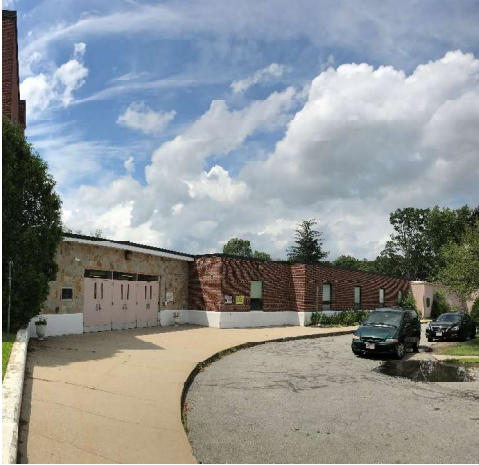
*Figure 1—Non-accessible entrance no curb cut ramp*

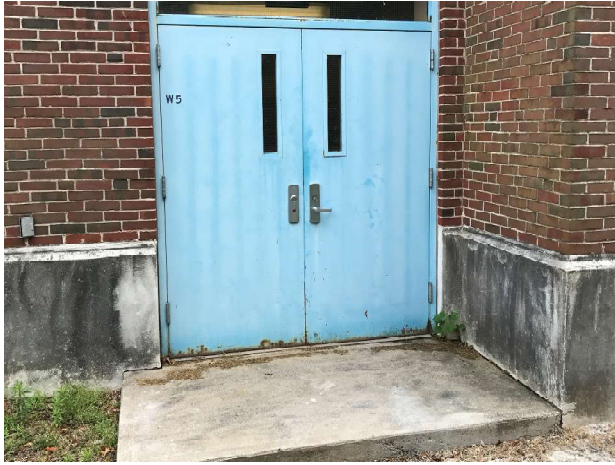
Figure 6—Exit stair discharge door with step

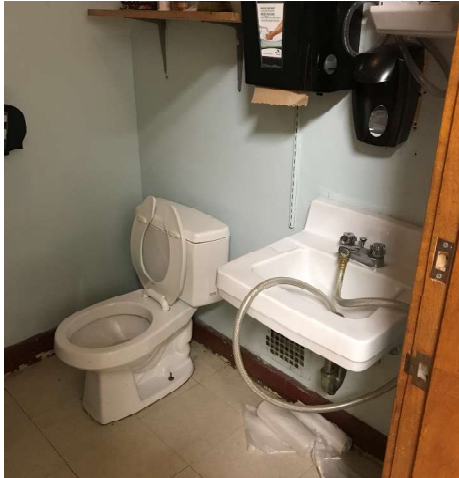
Figure 10—Non accessible toilet room.

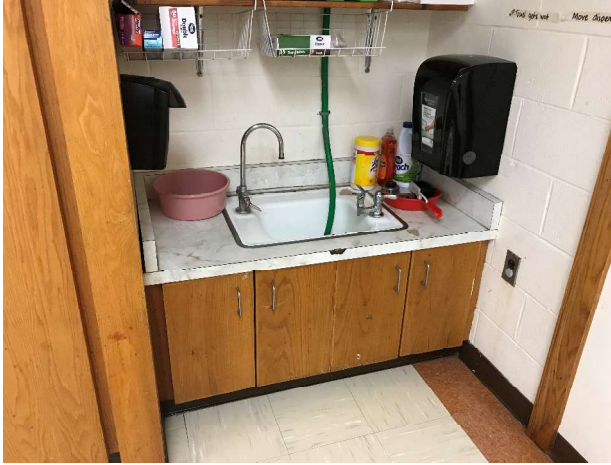
Figure 16—Typical non-accessible sink in classroom

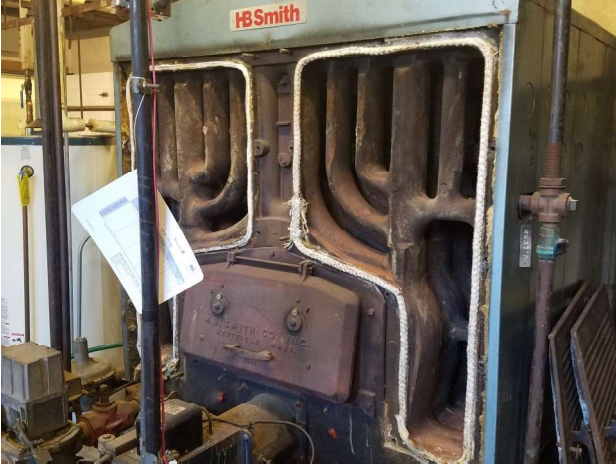
Insulation associated with the Heating Plant breeching system may contain asbestos.	Test and abate all insulation as required for removal of toxins within the educational environment.
Abandoned fuel-oil system may be a cause for pollution concerns beneath the ground.	Remove/ test fuel-oil system as required to alleviate all pollution concerns.
Damaged and missing hot water and steam piping insulation within boiler room and likely throughout building.	Add and replace with new insulation as required for complete system coverage.

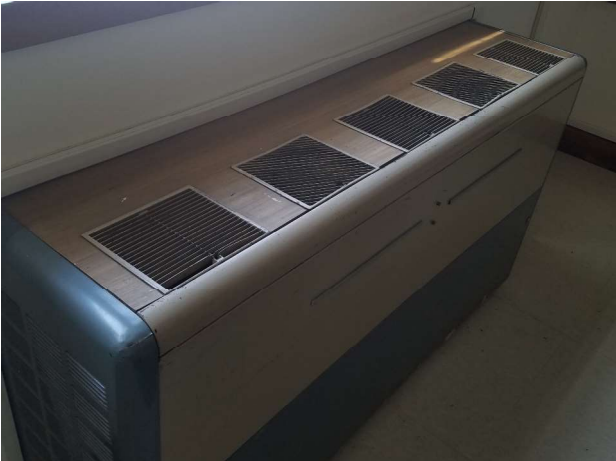
<i>Specific Issues</i>	<i>Recommendations</i>
Existing systems do not utilize demand control ventilation to limit the amount of Outdoor Air introduced based on space CO2 levels for energy conservation and current code compliance.	Replace existing air-handling and control systems with current technologies for compliance with the current building code and general energy efficiency.
No supplemental hot water heating units are installed for maintenance of unoccupied heating space temperature set-points to avoid running the unit ventilators when unnecessary.	Provide supplemental hot water heating terminal units within the space as the primary occupied and unoccupied heating source.

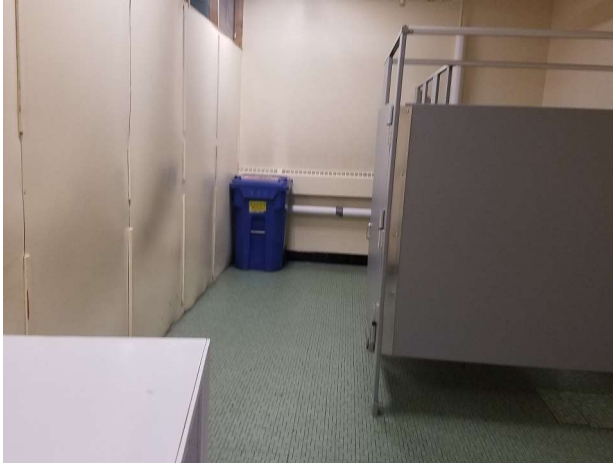
<i>Specific Issues</i>	<i>Recommendations</i>
None.	None.

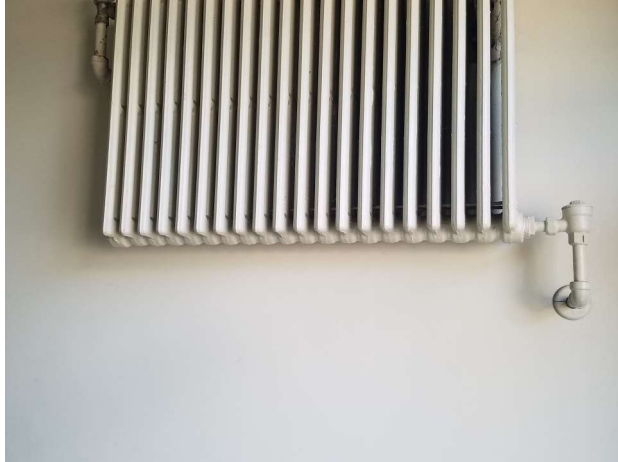
<i>Specific Issues</i>	<i>Recommendations</i>
Pneumatic Control System air leaks were noted in various spaces throughout the building and at the boiler room control panel.	Replace control system entirely with Direct Digital Control System.

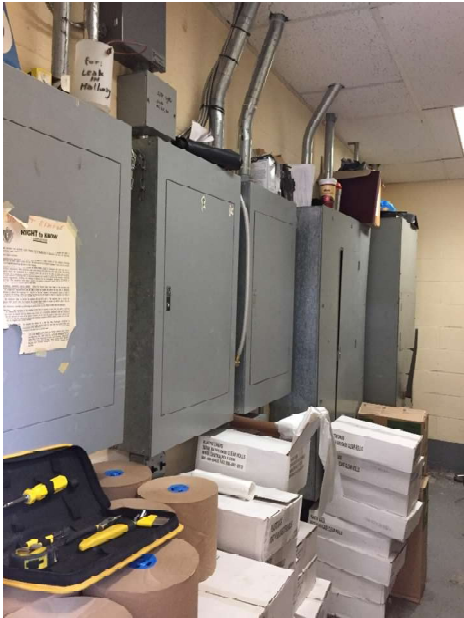
<i>Specific Issues</i>	<i>Recommendations</i>
Battery units and exit sign condition vary and require maintenance on each unit. There is no generator at the facility.	Provide a new emergency stand-by generator and a normal/emergency distribution system that will serve emergency lighting, life safety loads, and optional stand-by loads. The existing battery units can be eliminated and maintenance will be limited to the generator and transfer equipment only.

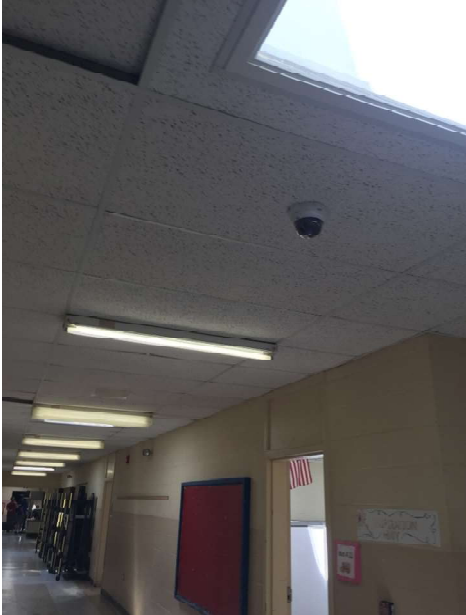
Lighting fixtures are not energy efficient.	Replace existing lighting throughout the building with LED fixtures and provide an automated lighting control system with occupancy sensors and daylight dimming sensors to reduce energy usage and comply with the latest energy code.
---	---

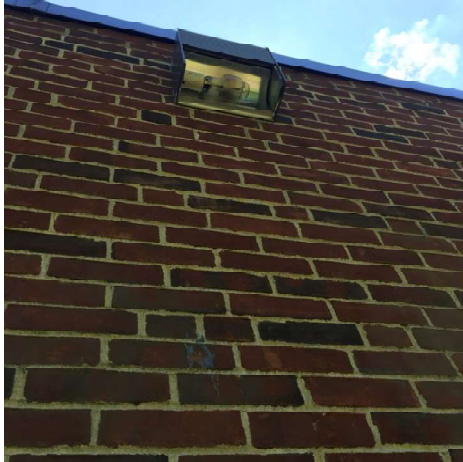
<i>Specific Issues</i>	<i>Recommendations</i>
Fire alarm system is non-addressable and in poor condition. Voice evacuation is required in E-use group.	The fire alarm system should be replaced.

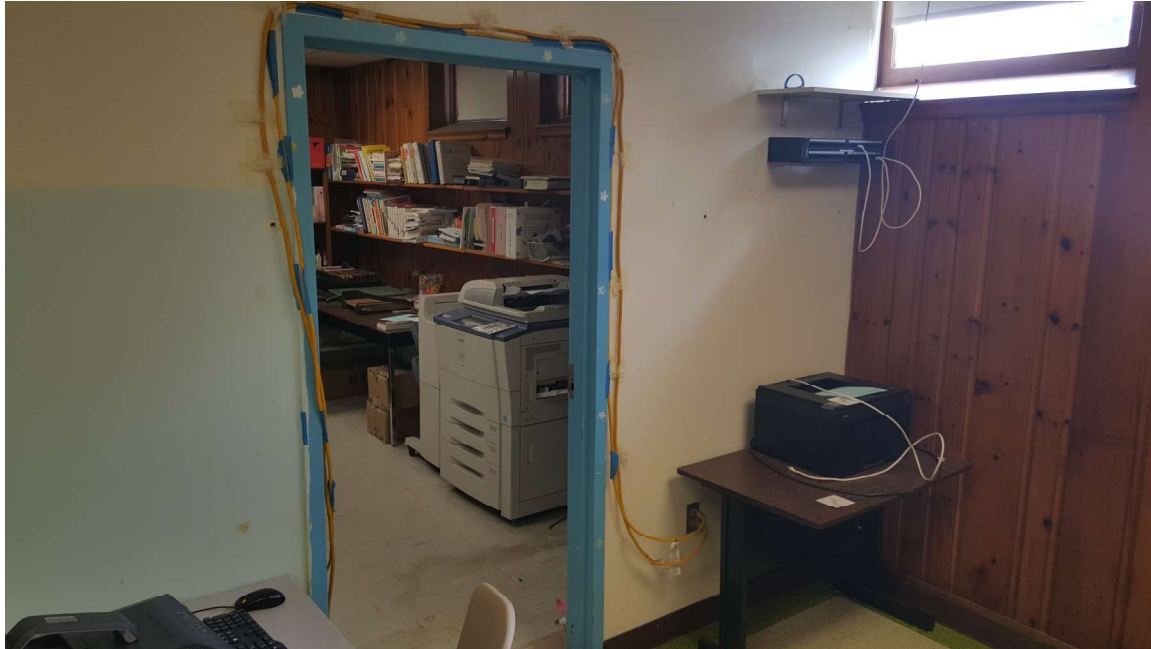
Figure 1-IDF showing insufficient power distribution for equipment

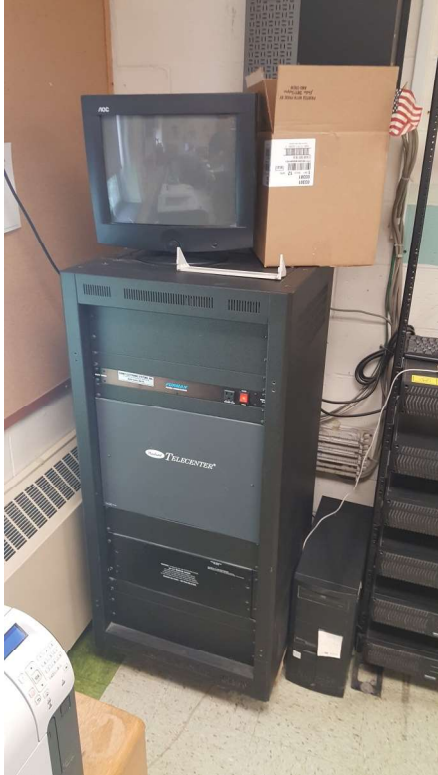
Figure 4 - Public Address System

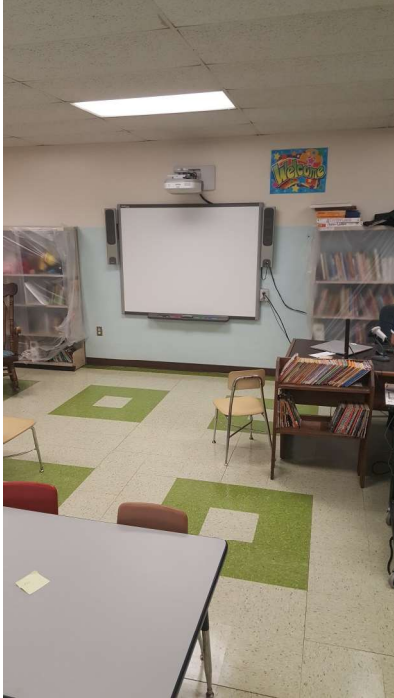
Figure 8- Classroom Projection

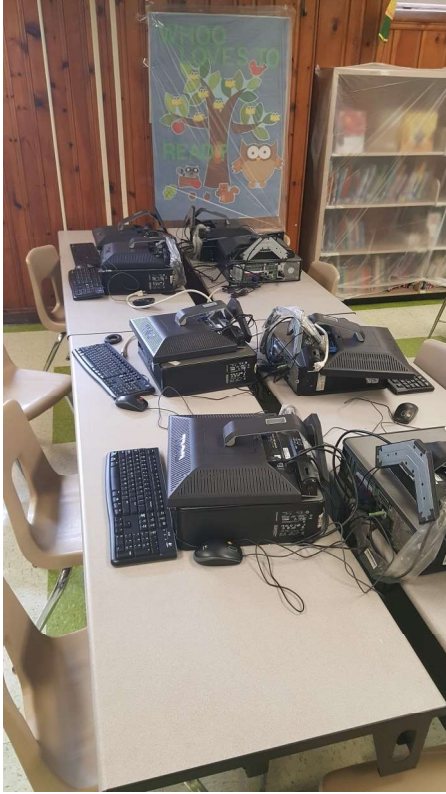
*Figure 14—Computer Lab*

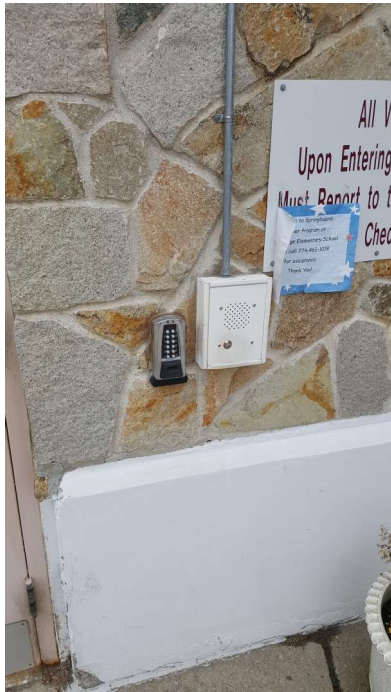
*Figure 17 - Access Control*

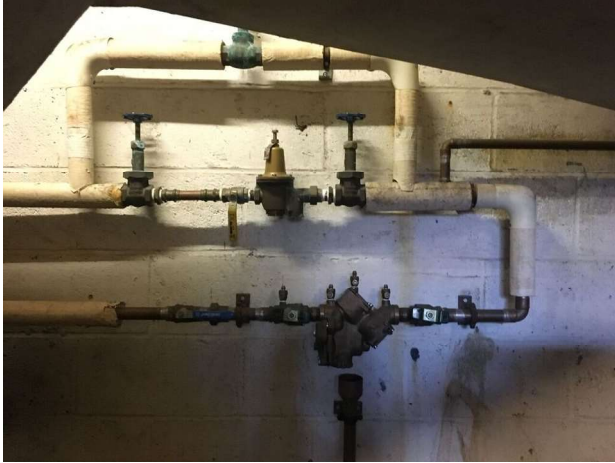
Figure 5— Backflow preventer and PRV (HVAC)

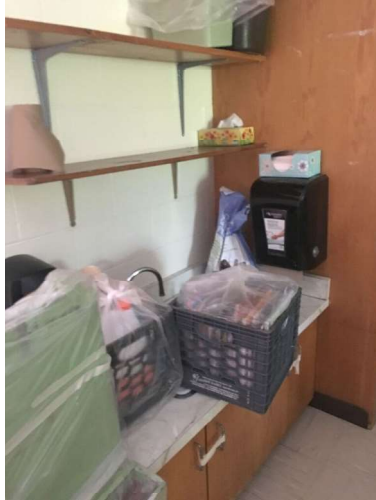
Figure 9 — Classroom sink

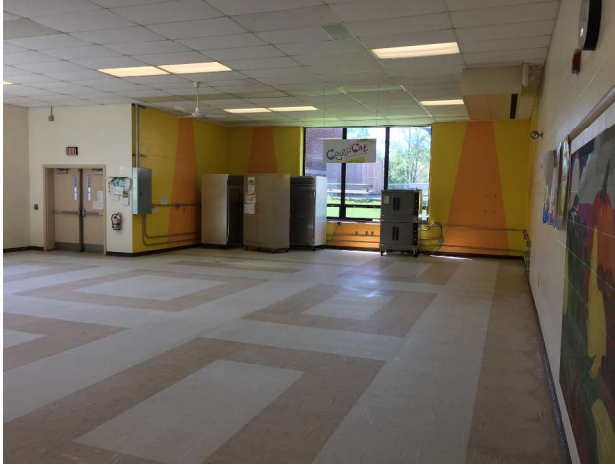
Figure 1—The kitchen space at the rear
