AWARD NOMINATION Rehabilitation & Restoration Category

**Northbridge Memorial Town Hall
Whitinsville, MA
February 14, 2014**

Northbridge Memorial Town Hall Statement of Achievement

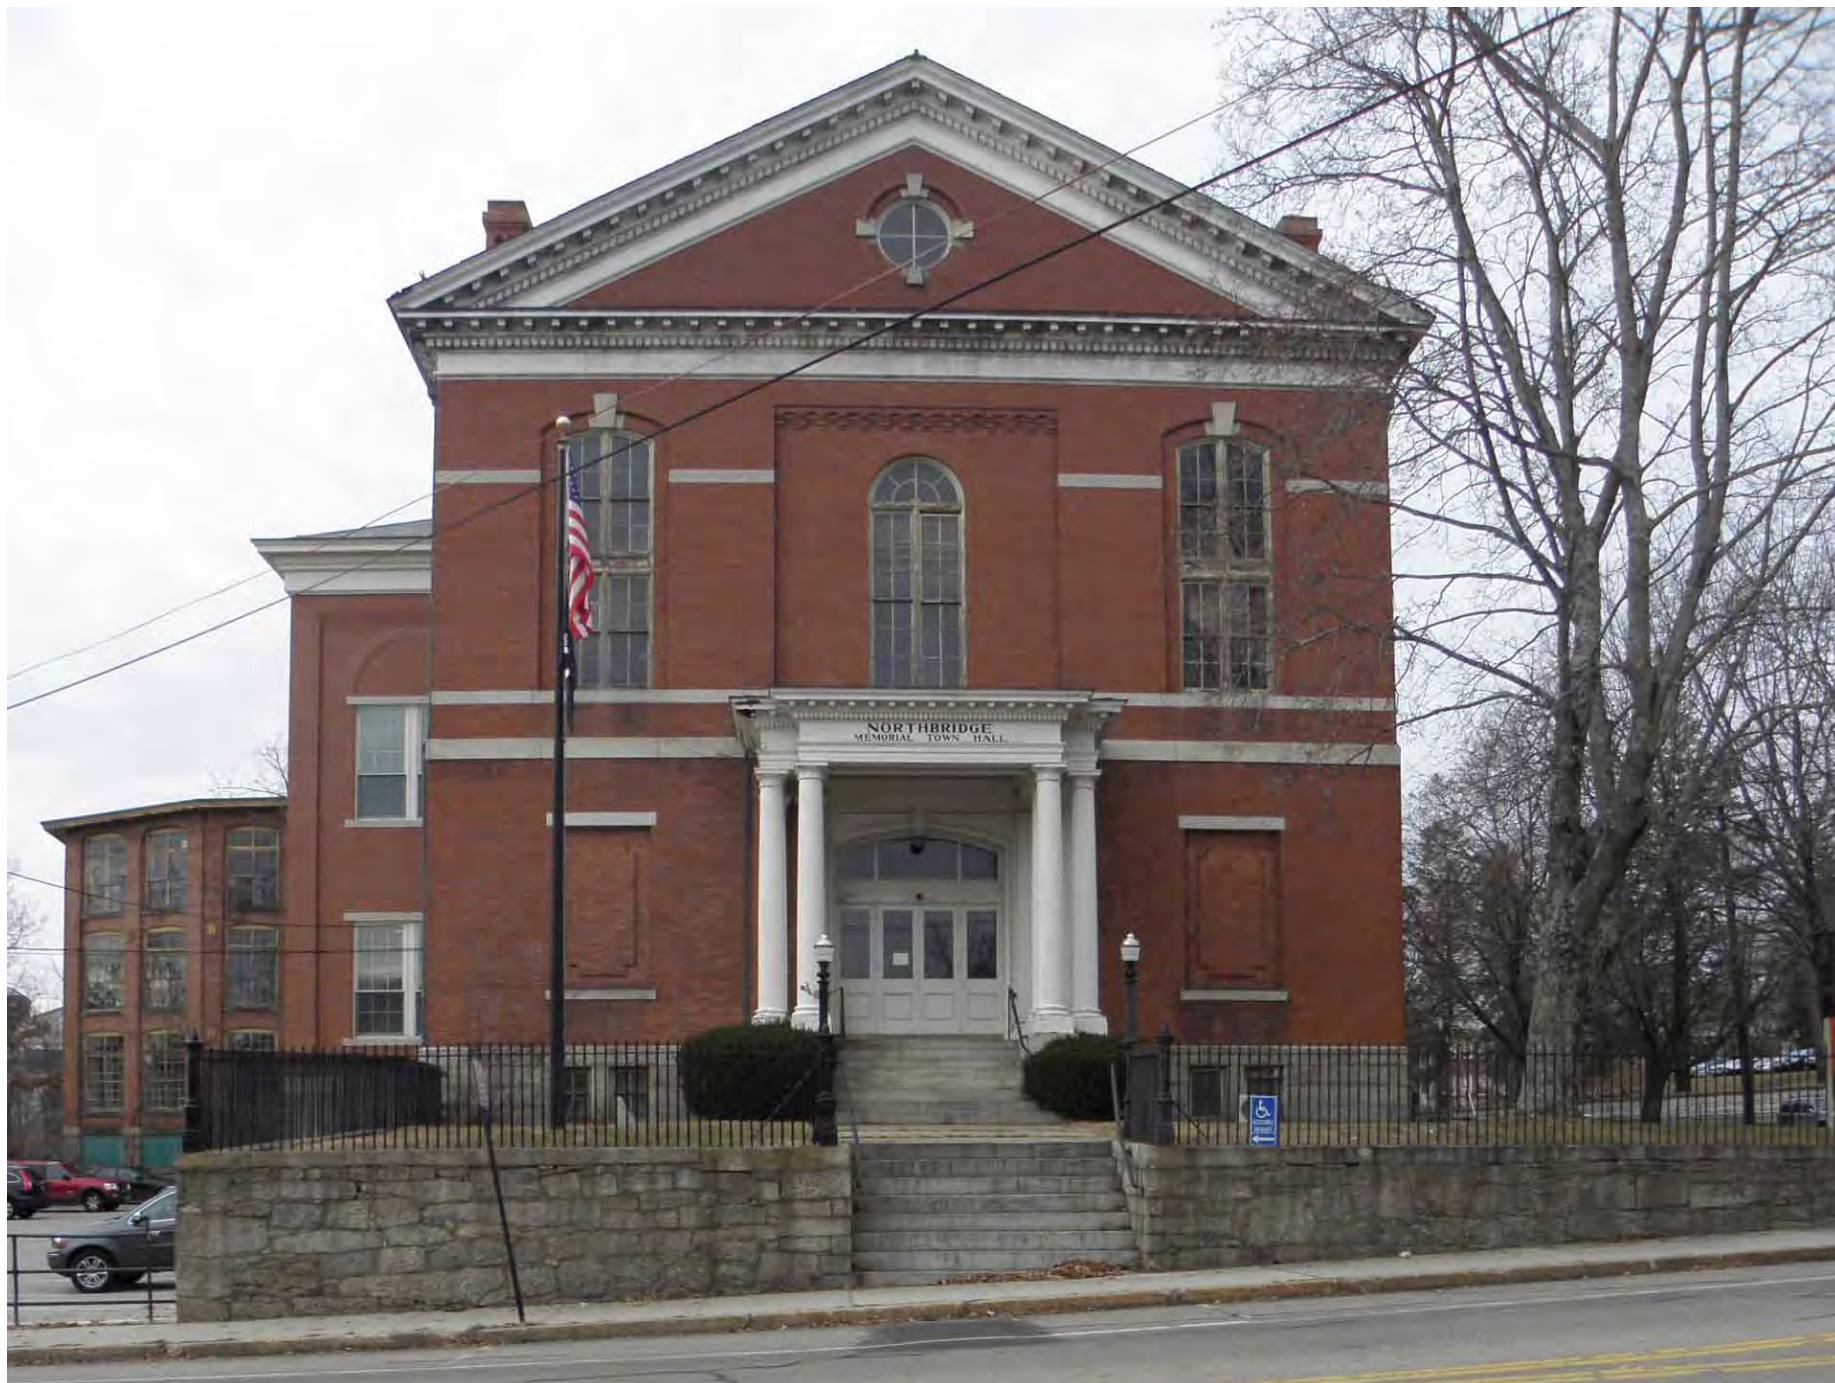
2. 2012 Photograph of East Elevation of Northbridge Town Hall before restoration

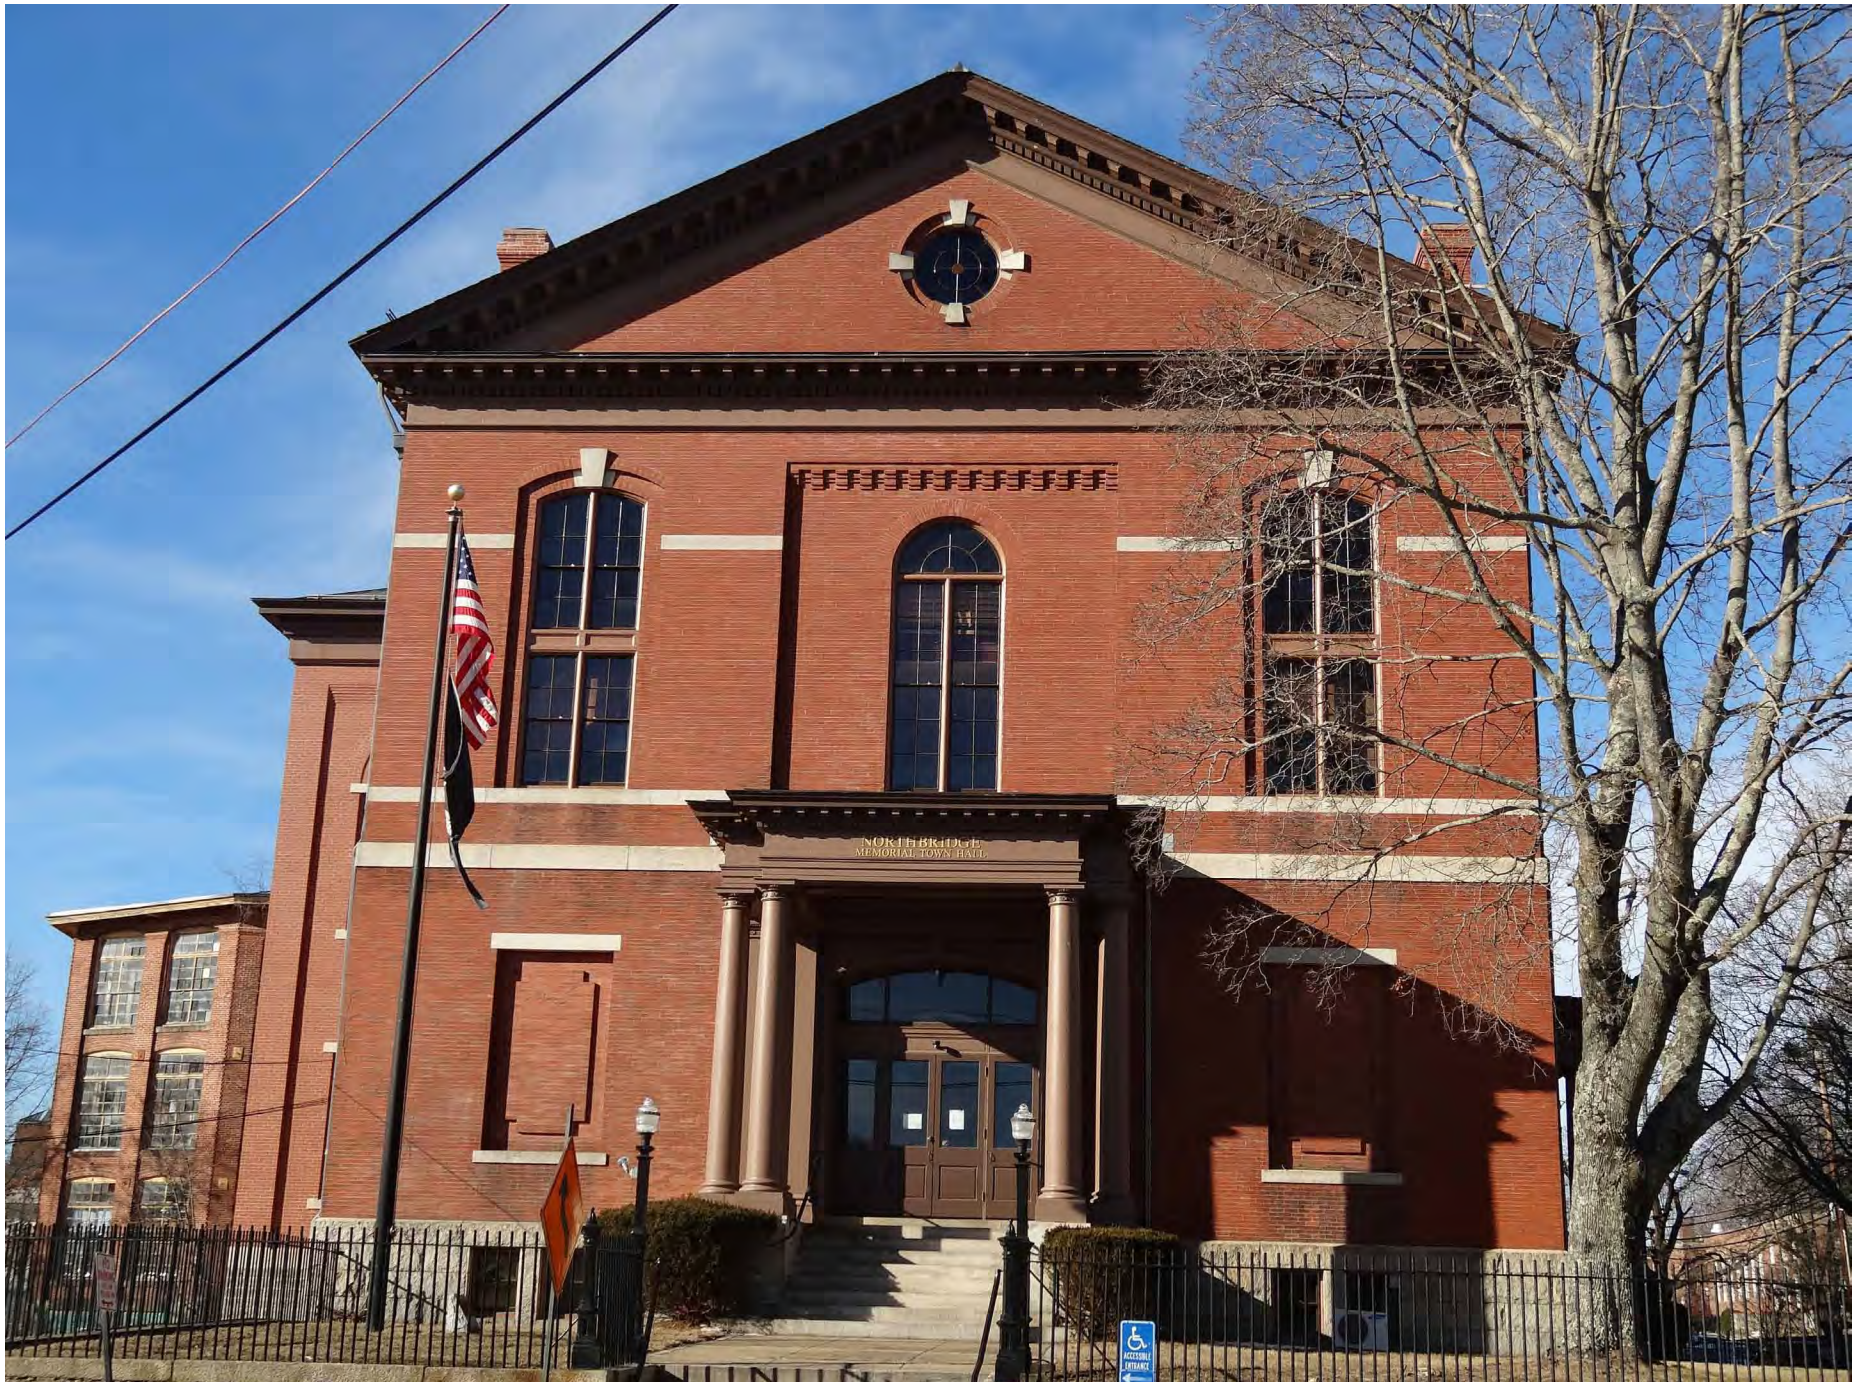
3. 2013 restored East Elevation showing historic two-tone dark brown paint scheme and restored original windows, doors and woodwork.

For more than one hundred years, all of the trim had been painted a series of whites and off-whites. These color schemes created a very different appearance than the original paint schedule, which was two slightly different shades of brown. After receiving support from the Northbridge Historical Commission, this dramatic change in appearance was approved by the Town of Northbridge. The original historic paint scheme has been well received by the citizens of Northbridge.

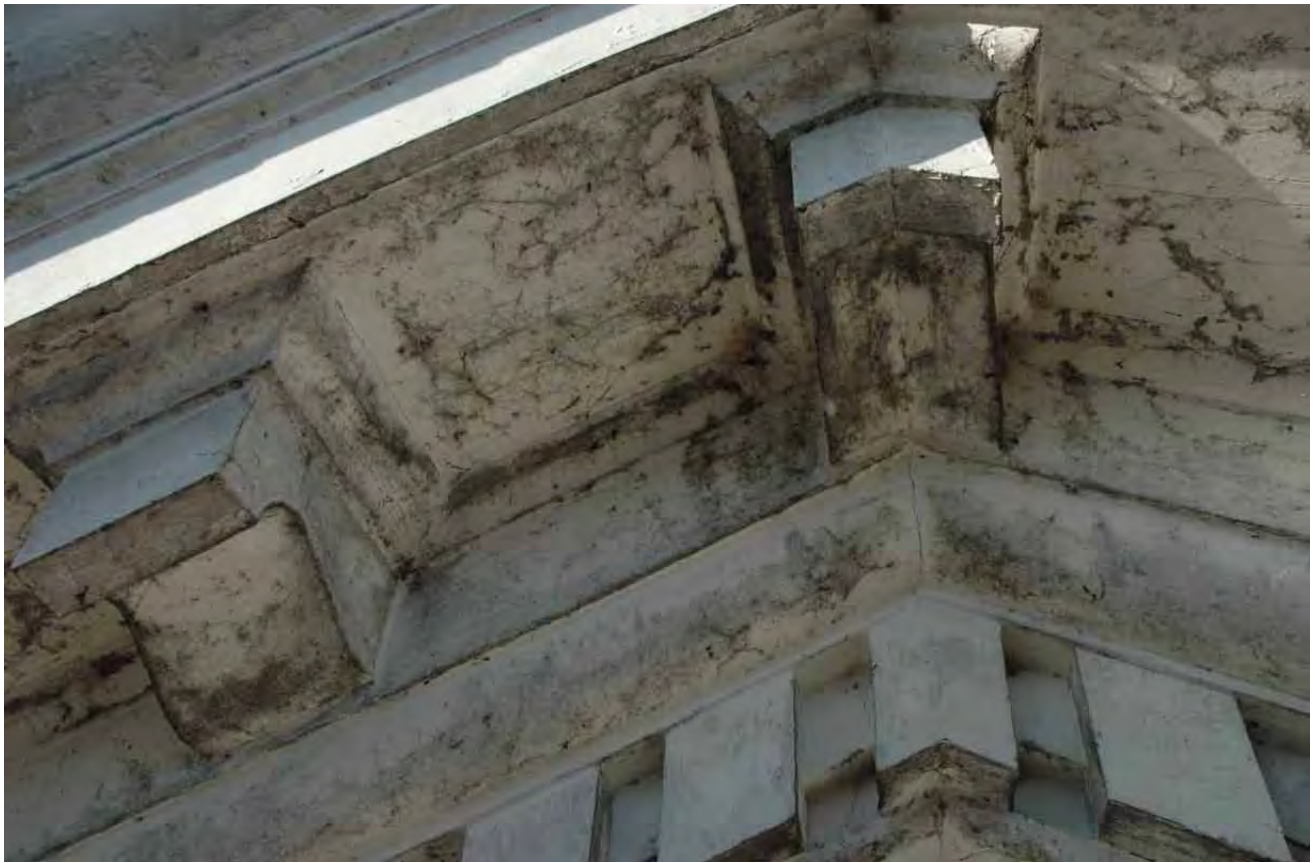
4. Deteriorated slope cornice with mold. This mold was prevalent throughout all cornices.

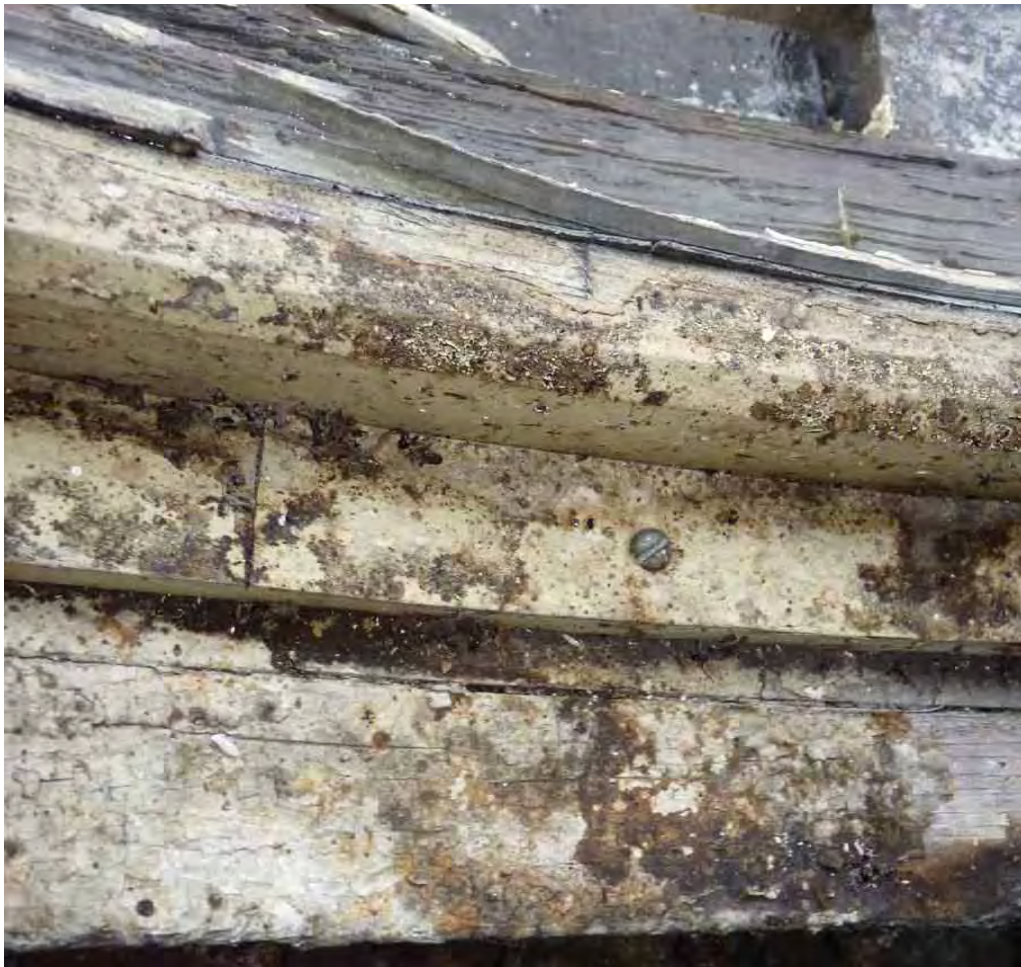
5. Deteriorated Interior of Circular Window Sill

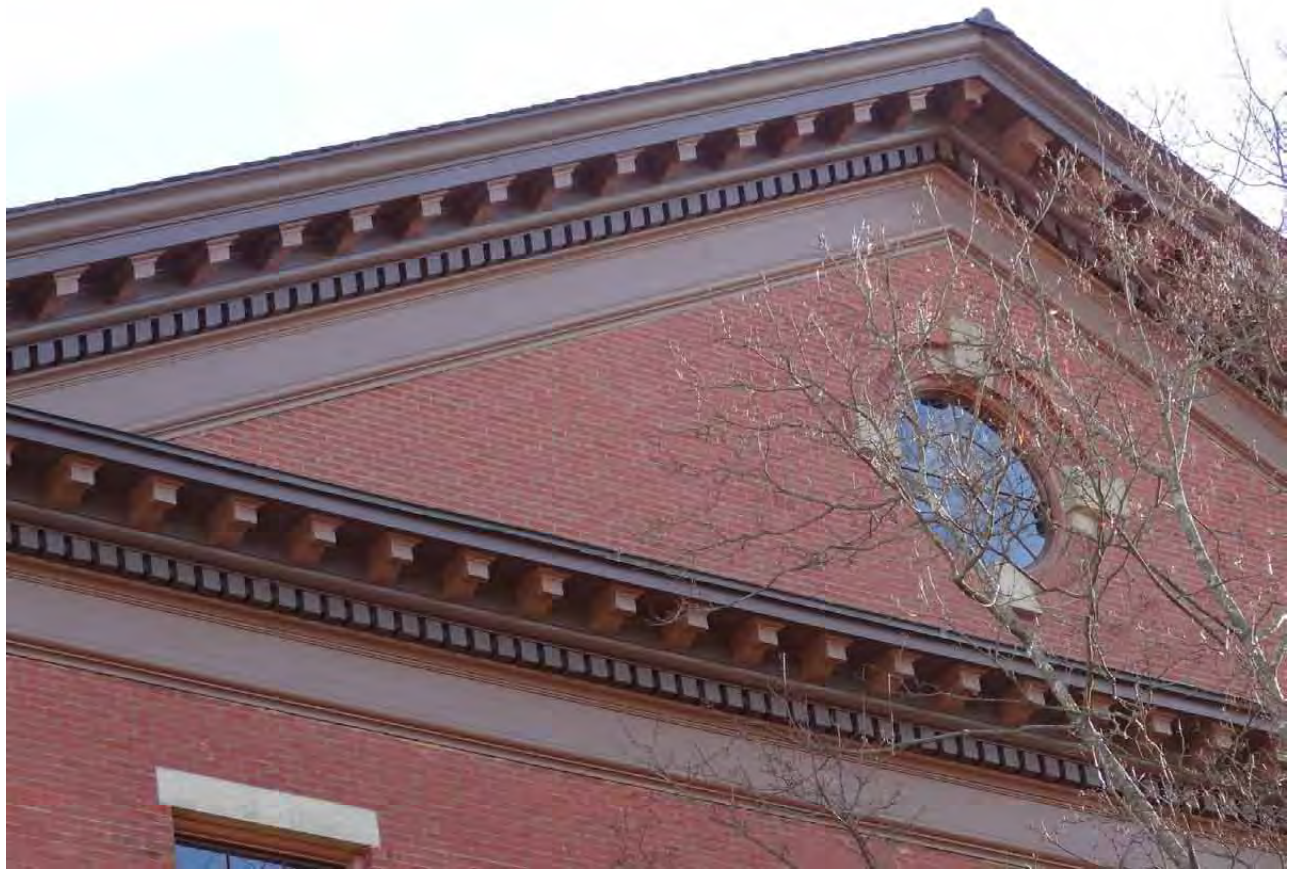
6. Restored East Gable End showing restored woodwork and original paint scheme.

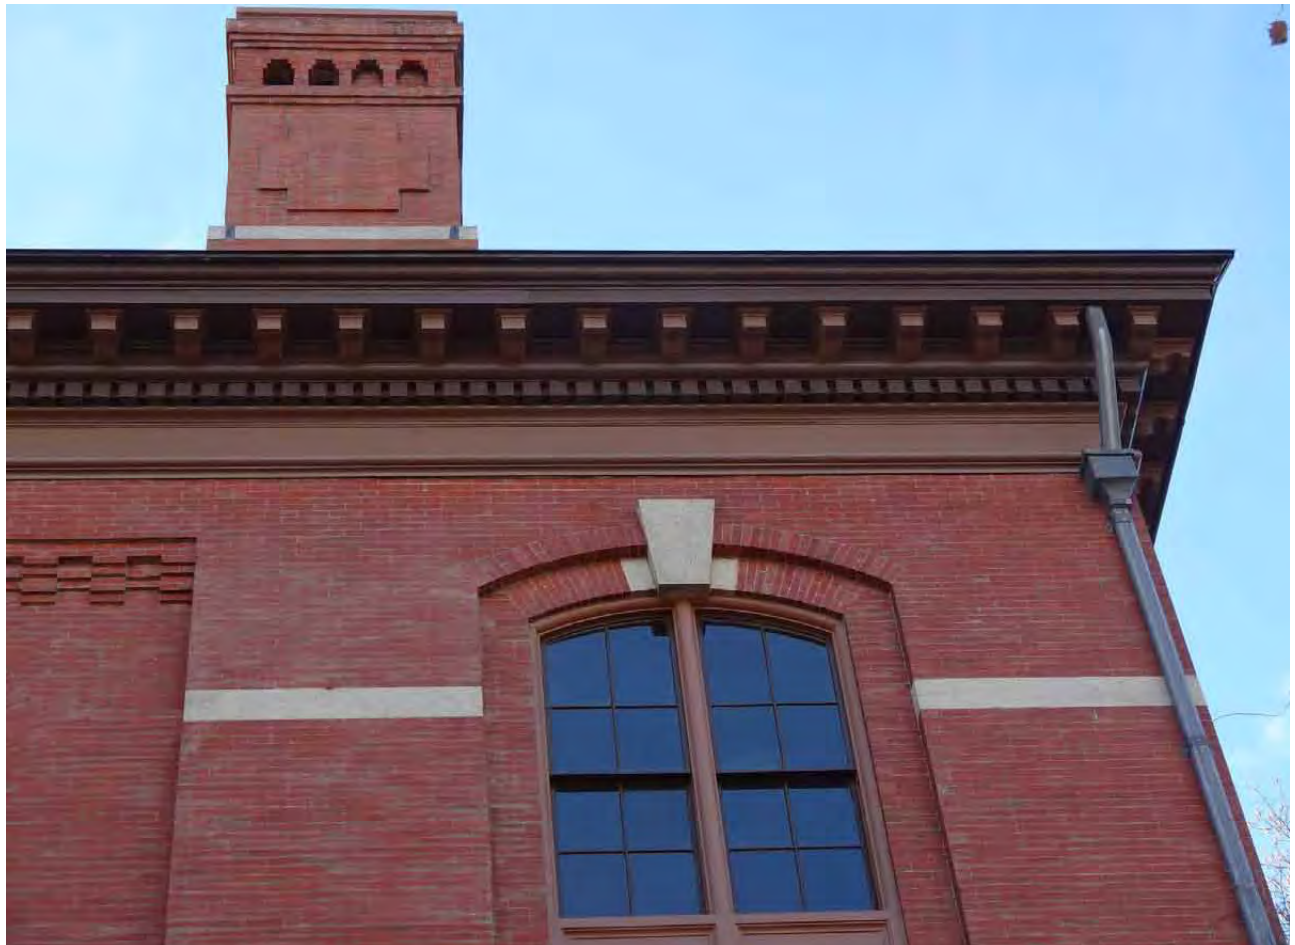
7. Restored Horizontal Cornice and Windows

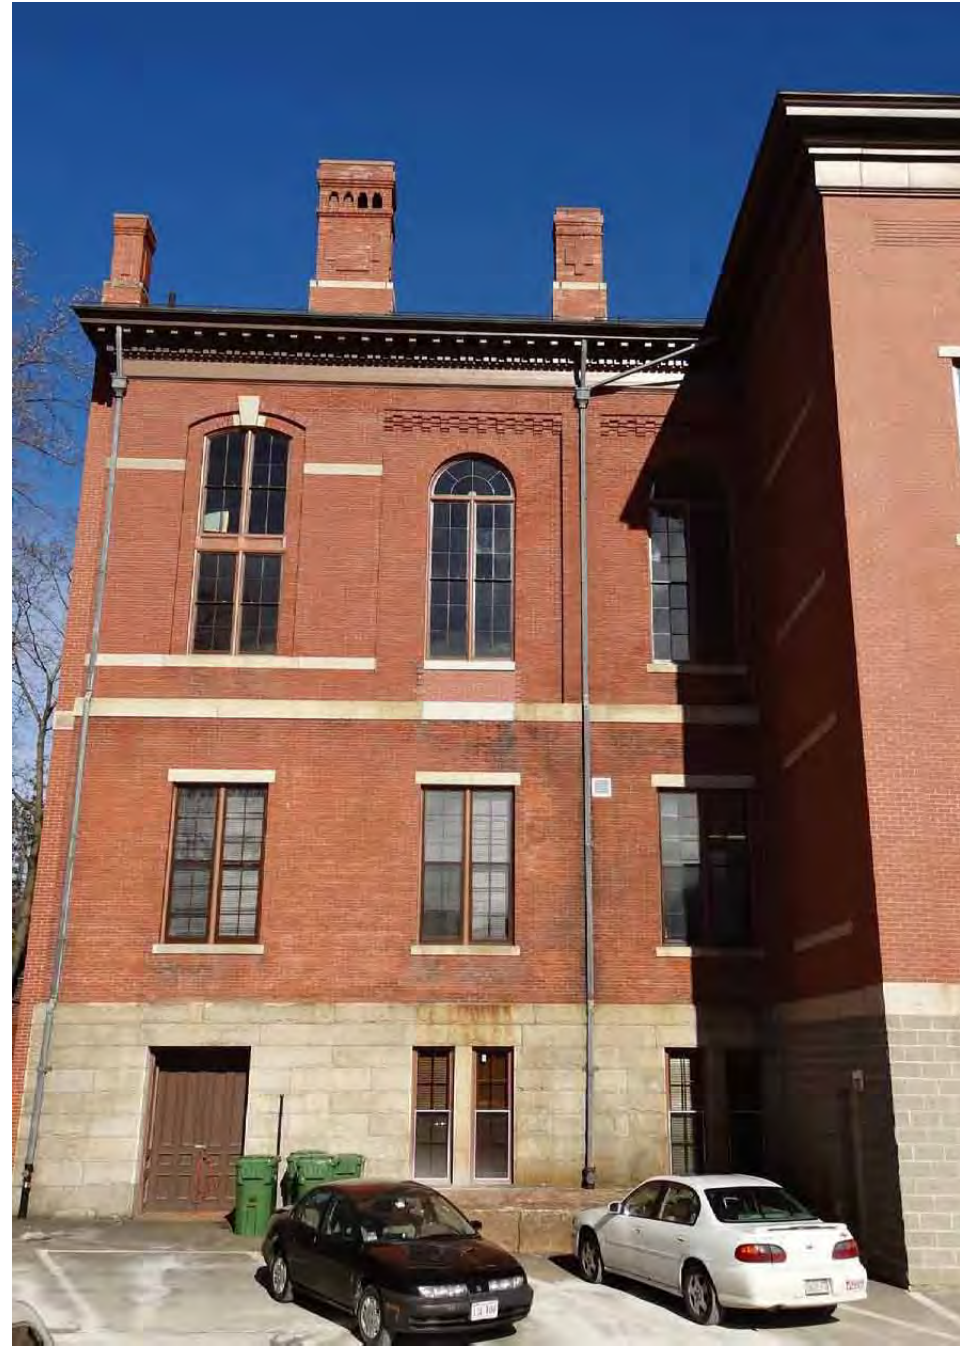
9. Southwest Elevation with Fire Escape Removed and Original Paint Color on Restored Windows and Doors

In the early Twentieth Century, building codes and an increased concern for fire safety prompted the addition of many fire escapes to public buildings, especially those with second floor auditoriums. These utilitarian fire escapes usually detracted from the appearance of the historic buildings. Not only was Northbridge's fire escape unattractive, it was deteriorated and no longer needed since an enclosed stair and elevator addition was constructed in 1998. This fire escape was removed and the original auditorium window replicated.

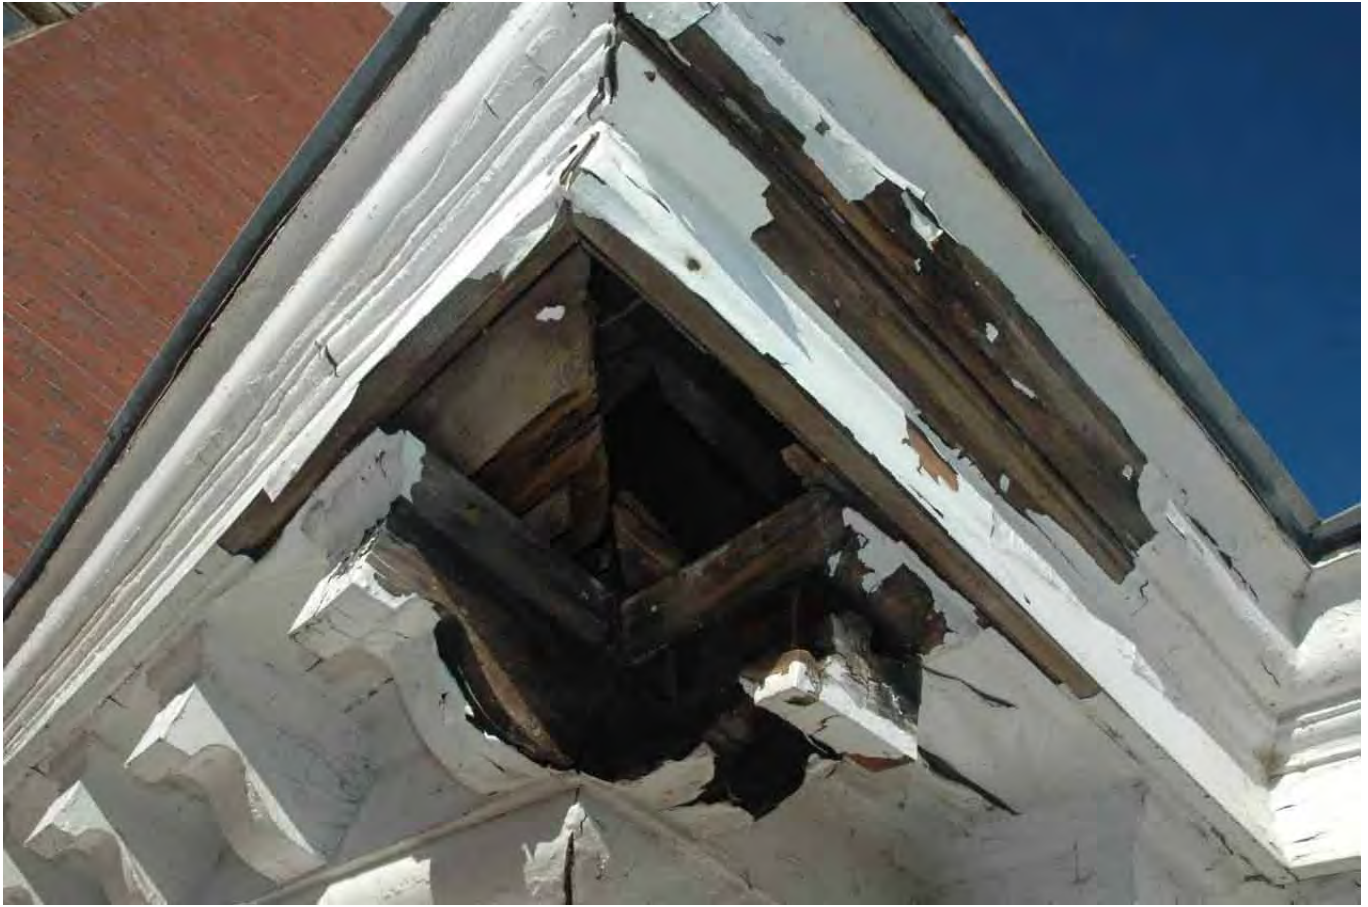
10. Rotted East Portico Gable.

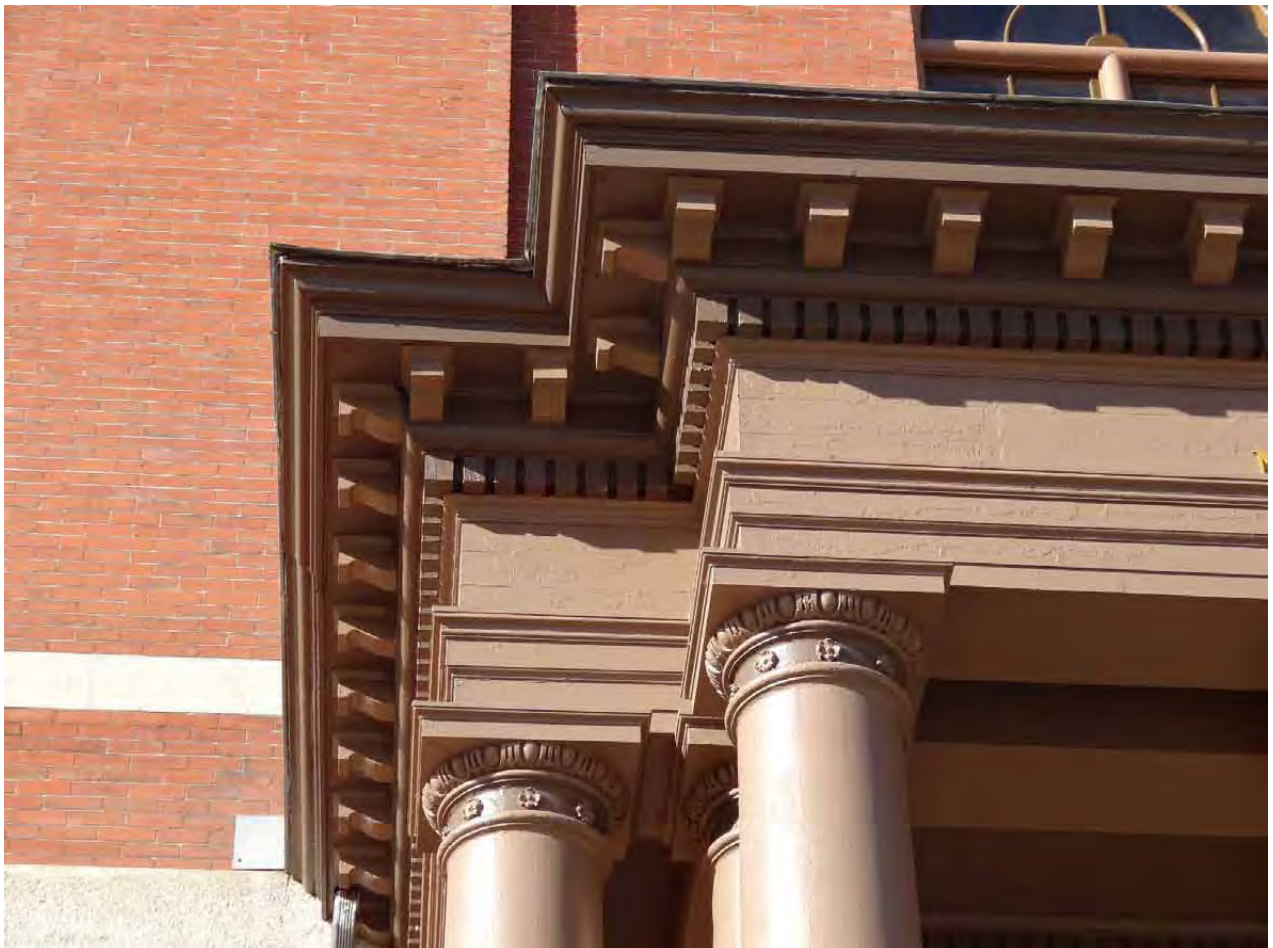
11. Restored East Portico Cornice and Columns

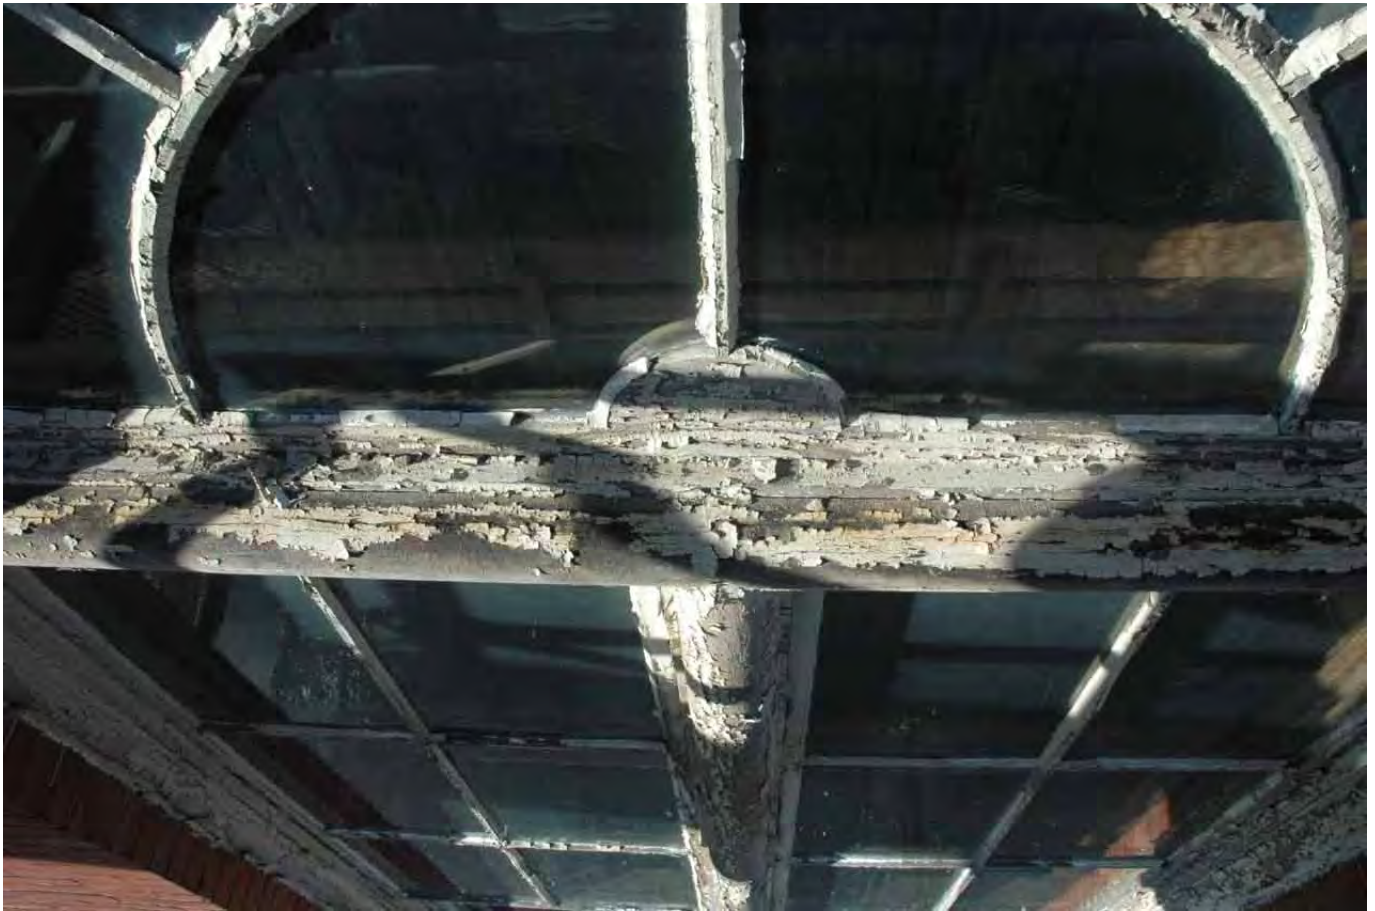
12. 2012 photograph of typical window with failed glazing putty and sealants at window perimeters and failed paint.

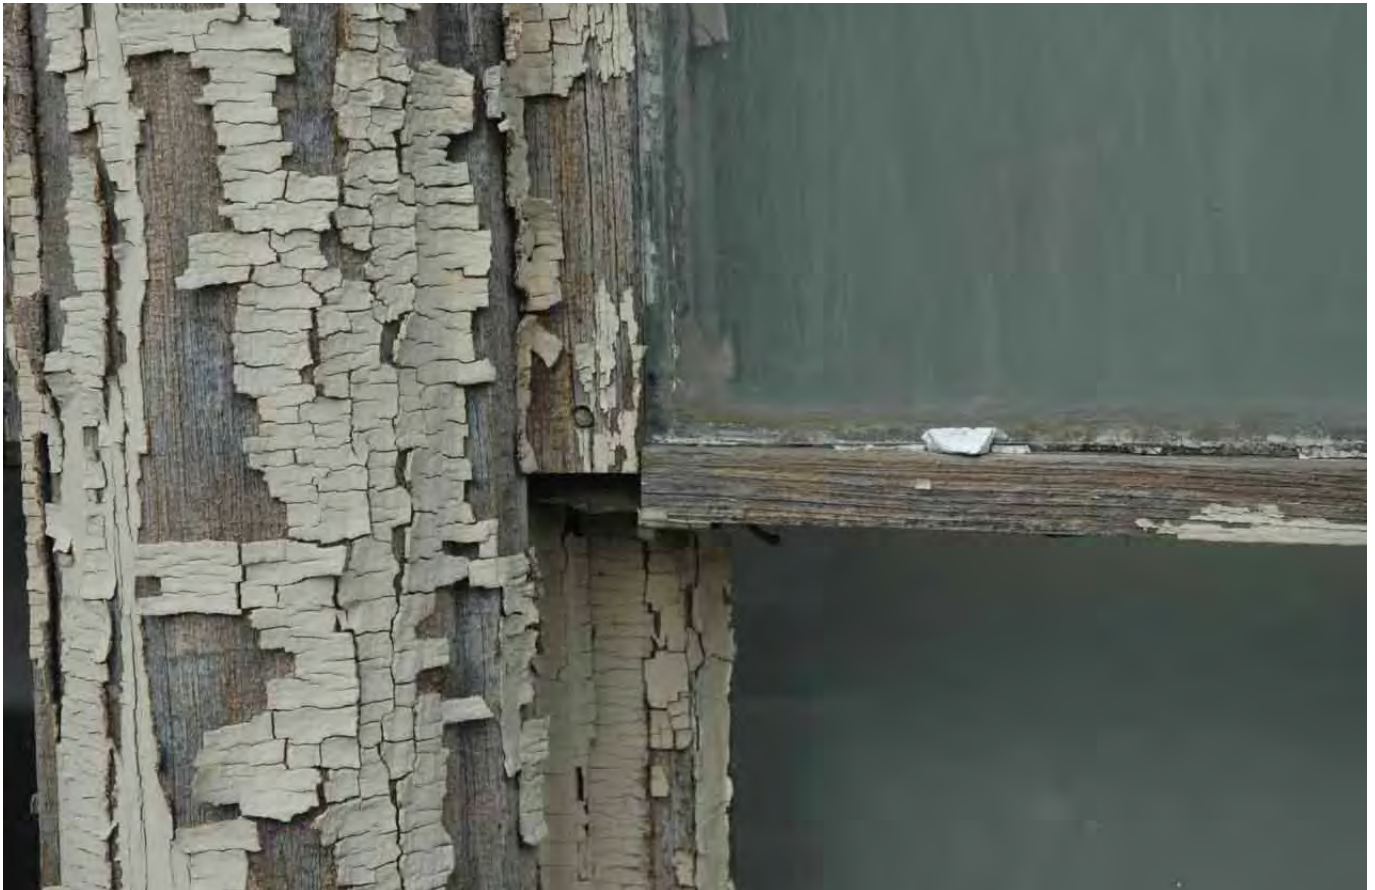
13. Closeup of Failed Meeting Rail

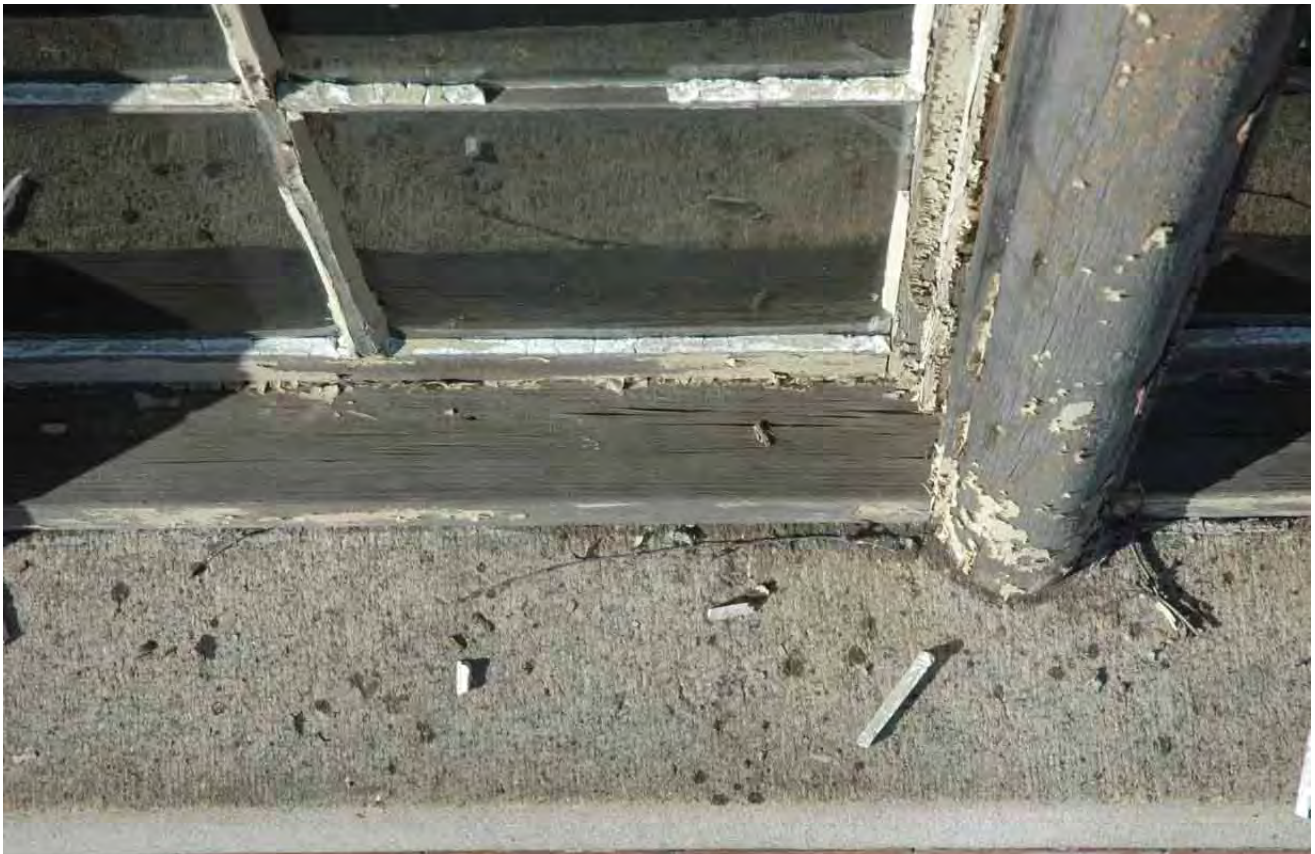
14. Severely Weathered Window Sill and Half-Round Mullion.

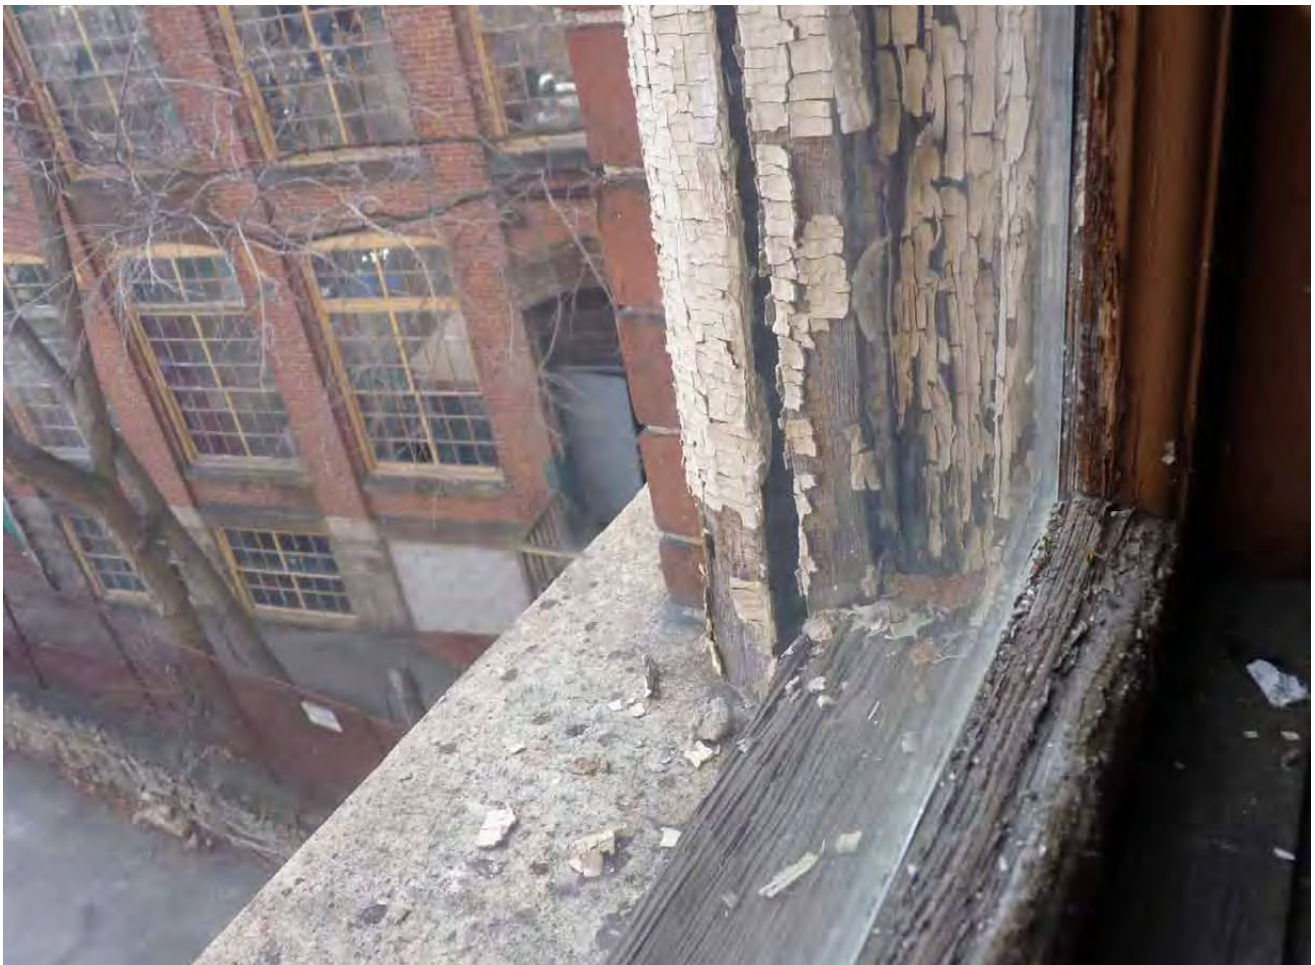
15. Sills on the south side of the building were much more deteriorated than the sills on the north side. Damaged sill surfaces were consolidated and patched with epoxy materials.

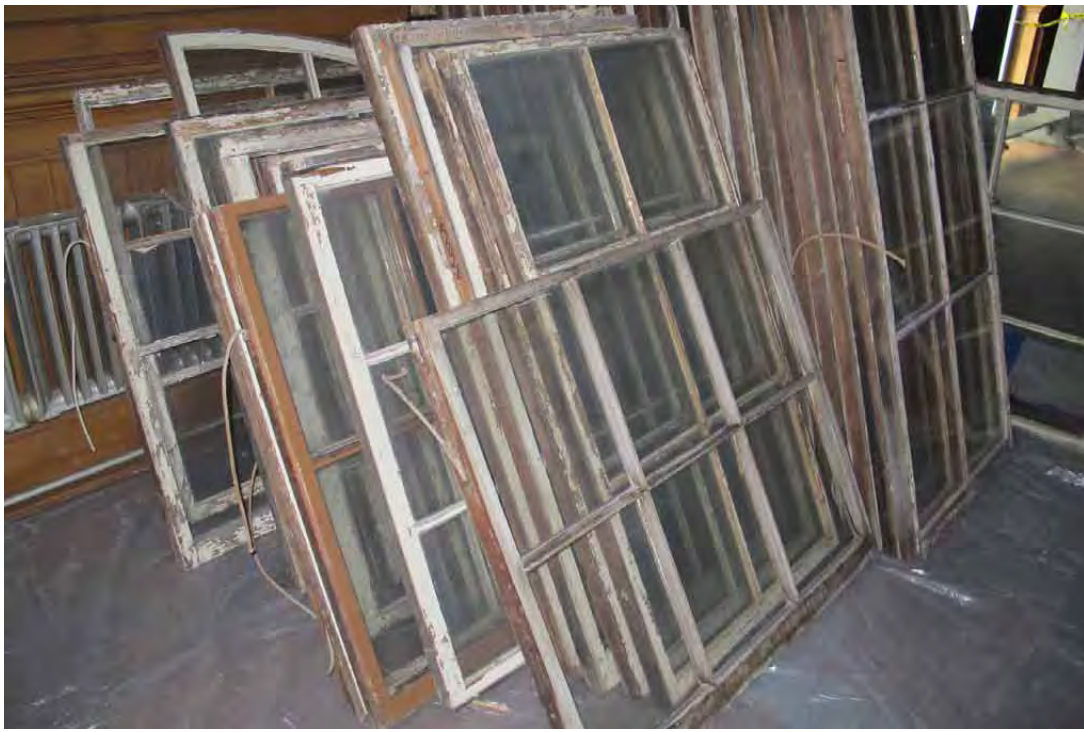
16. Once removed, window sashes were individually numbered to make sure they were reinstalled in the correct opening. Before being removed from the site, all glazing putty and glass was removed during an abatement process. Approximately two-thirds of all original glass was removed without breakage, and saved for reinstallation. W.W. Millworks performed the restoration of the windows in its shop.

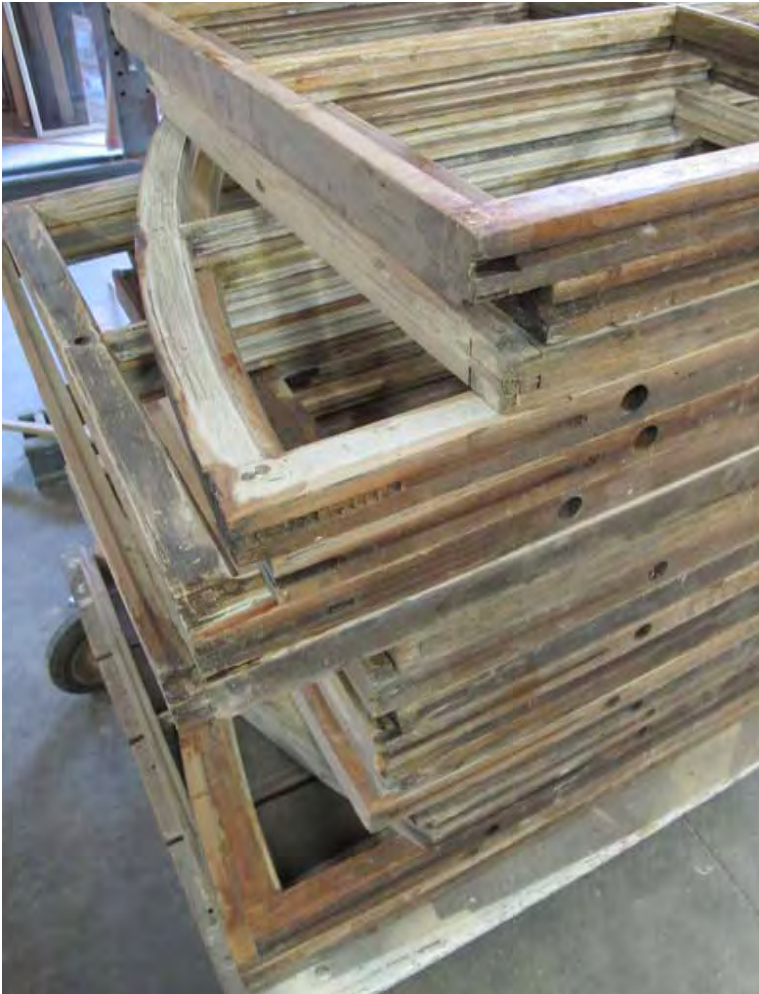
17. These window sashes have had loose connections mechanically repaired, and deteriorated wood areas repaired with epoxy wood consolidants and patching compounds.

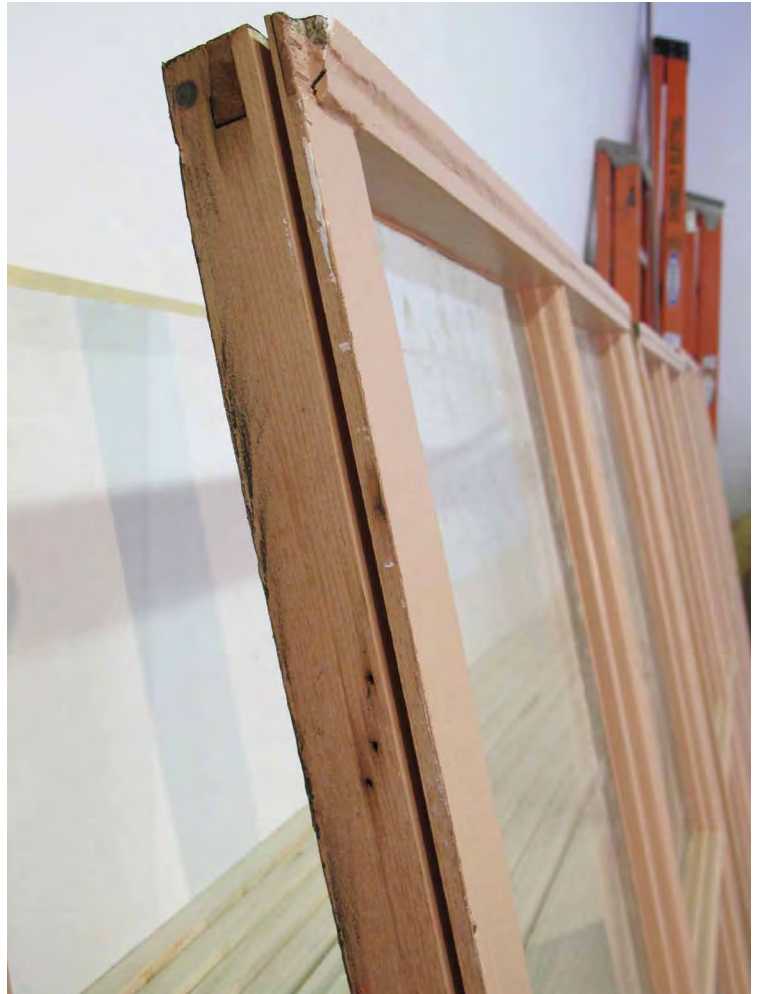
18. As part of the restoration work, kerfs were cut into the stiles of each sash to receive new metal weatherstripping.

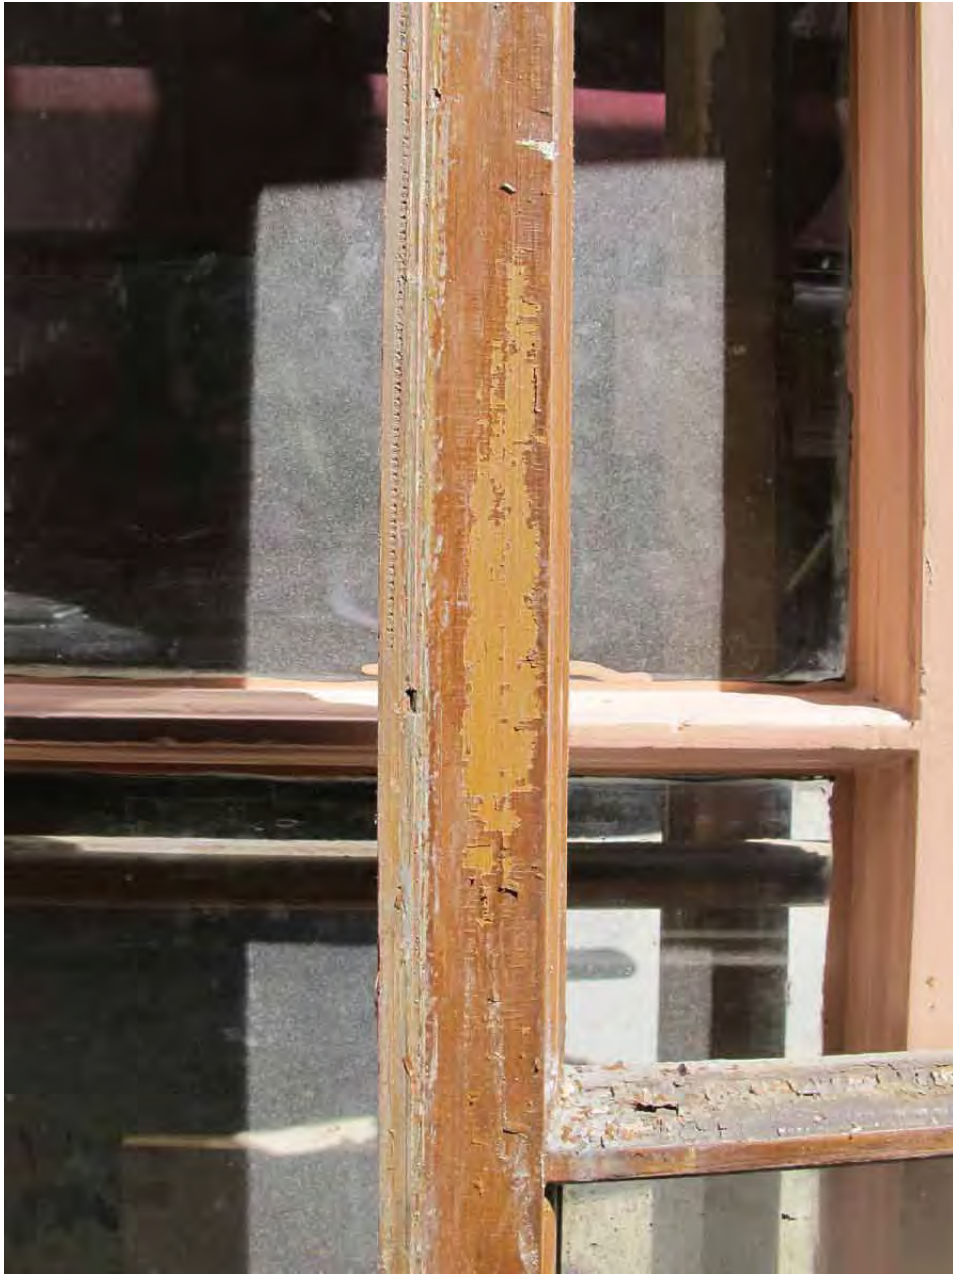
19. A number of different window sashes were inspected to confirm their original paint color.
