AWARD NOMINATION Rehabilitation & Restoration Category

**Northbridge Memorial Town Hall
Whitinsville, MA
February 14, 2014**

Northbridge Memorial Town Hall Statement of Achievement

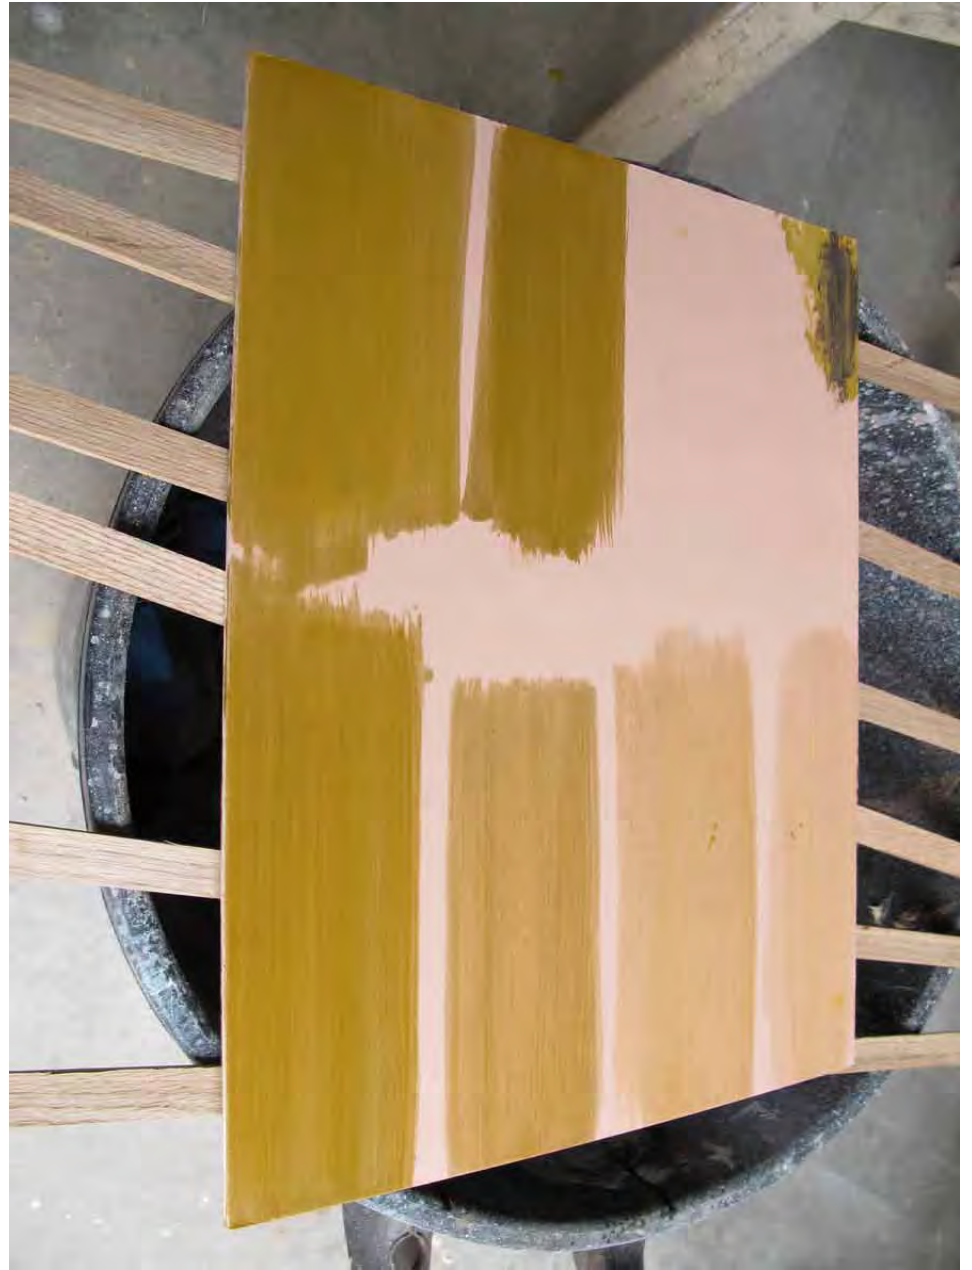
20. A number of different paint colors and pigmented stains were explored to get the closest match.

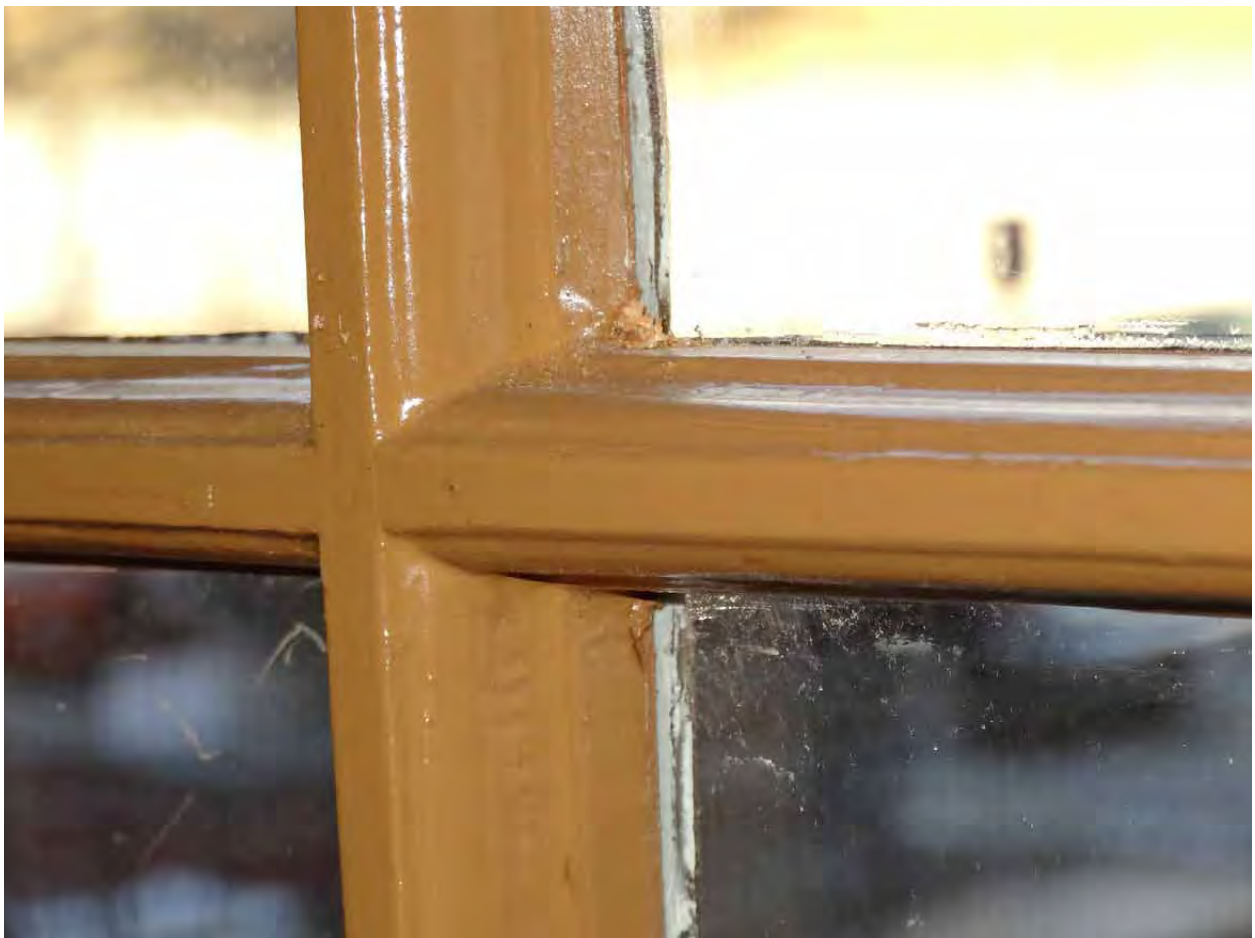
22. Restored Window Muntin

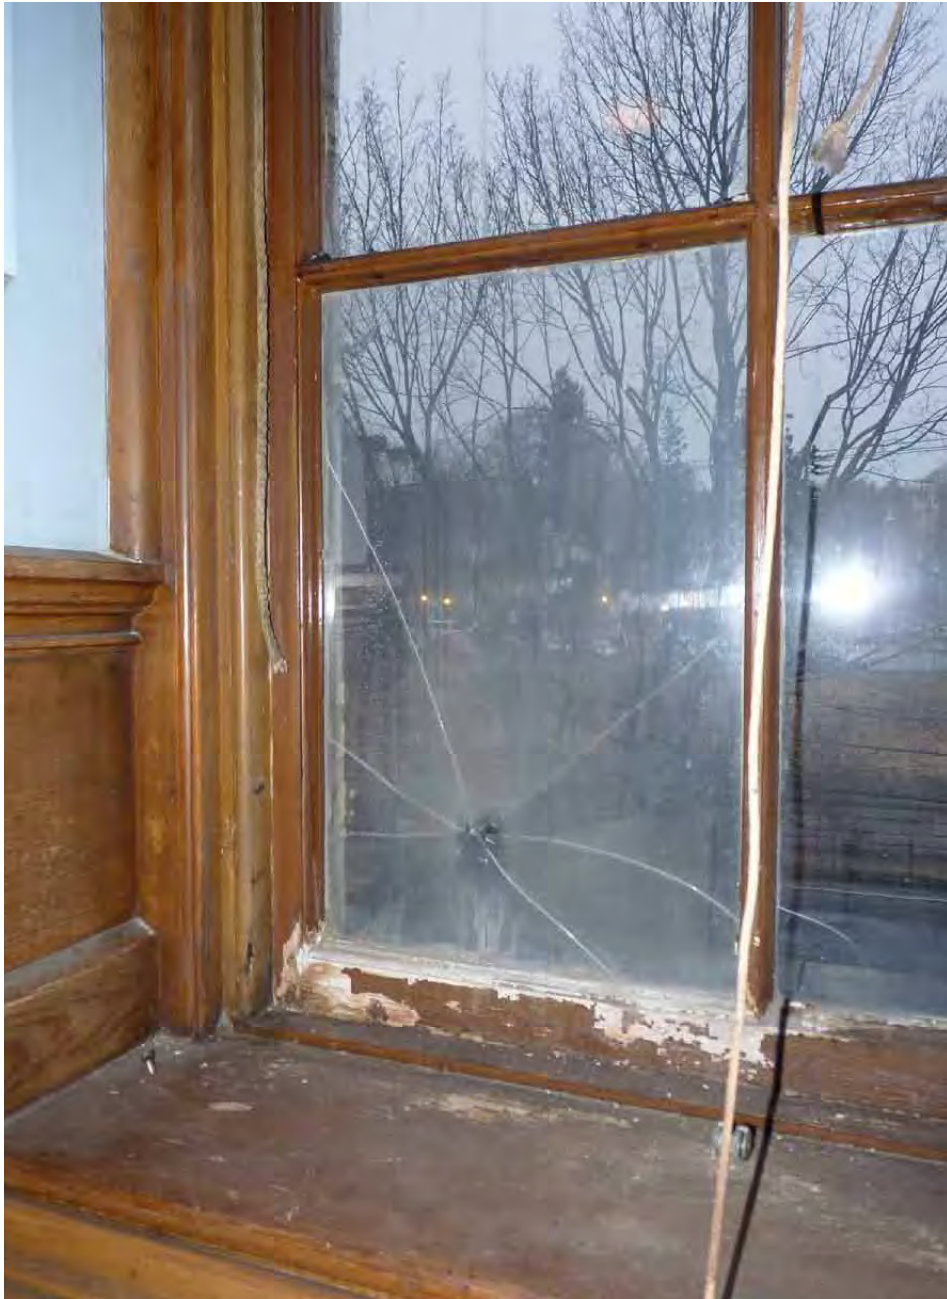
23. Typical First Floor Window (Interior): Window finish is water damaged due to missing glazing putty, sash cords are broken, and there is glass breakage.

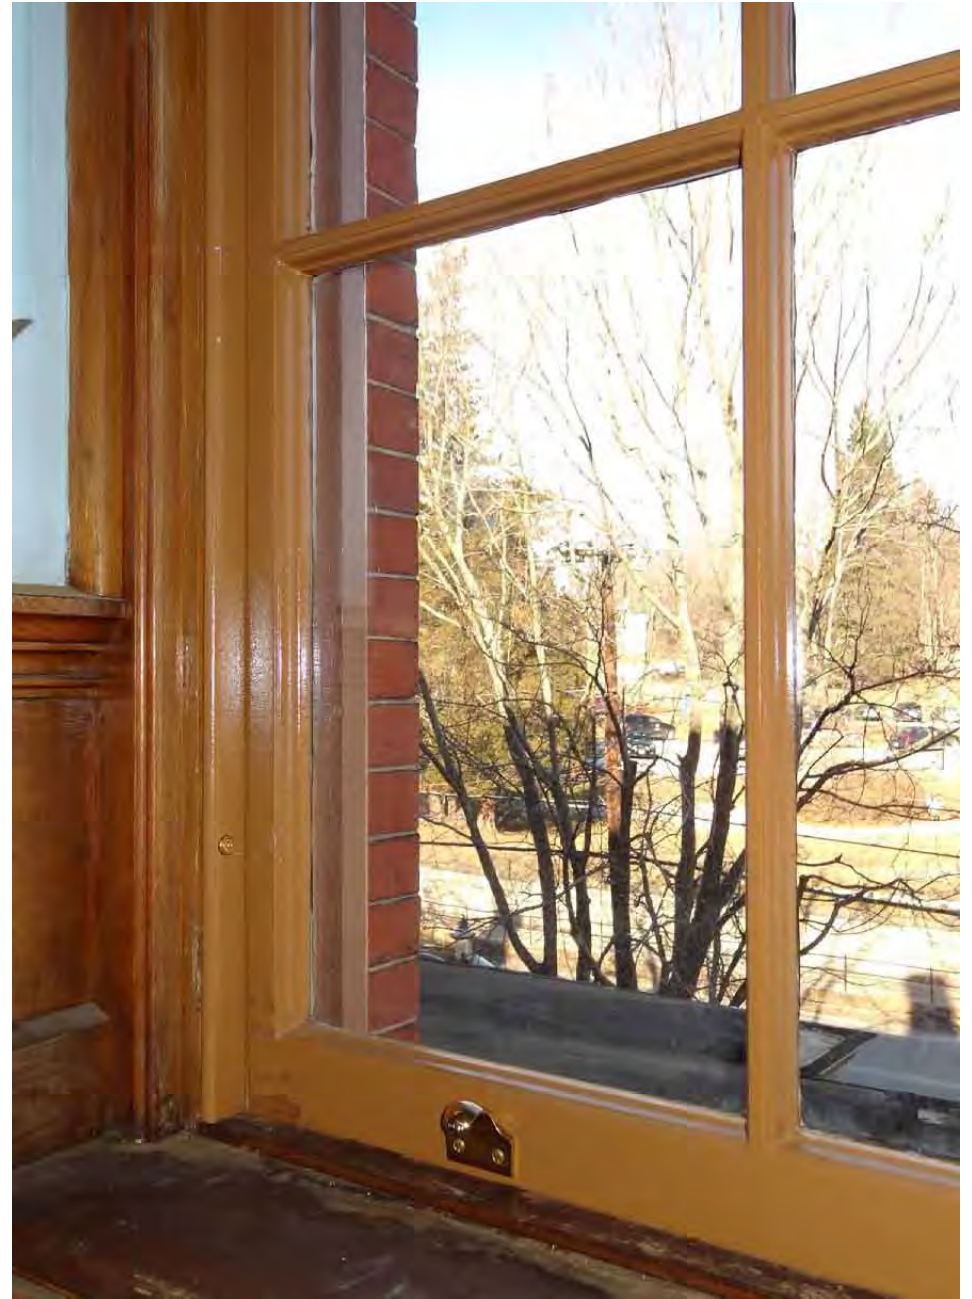
24. Typical Restored Window Interior with interior sash finish matching unweathered original finish.

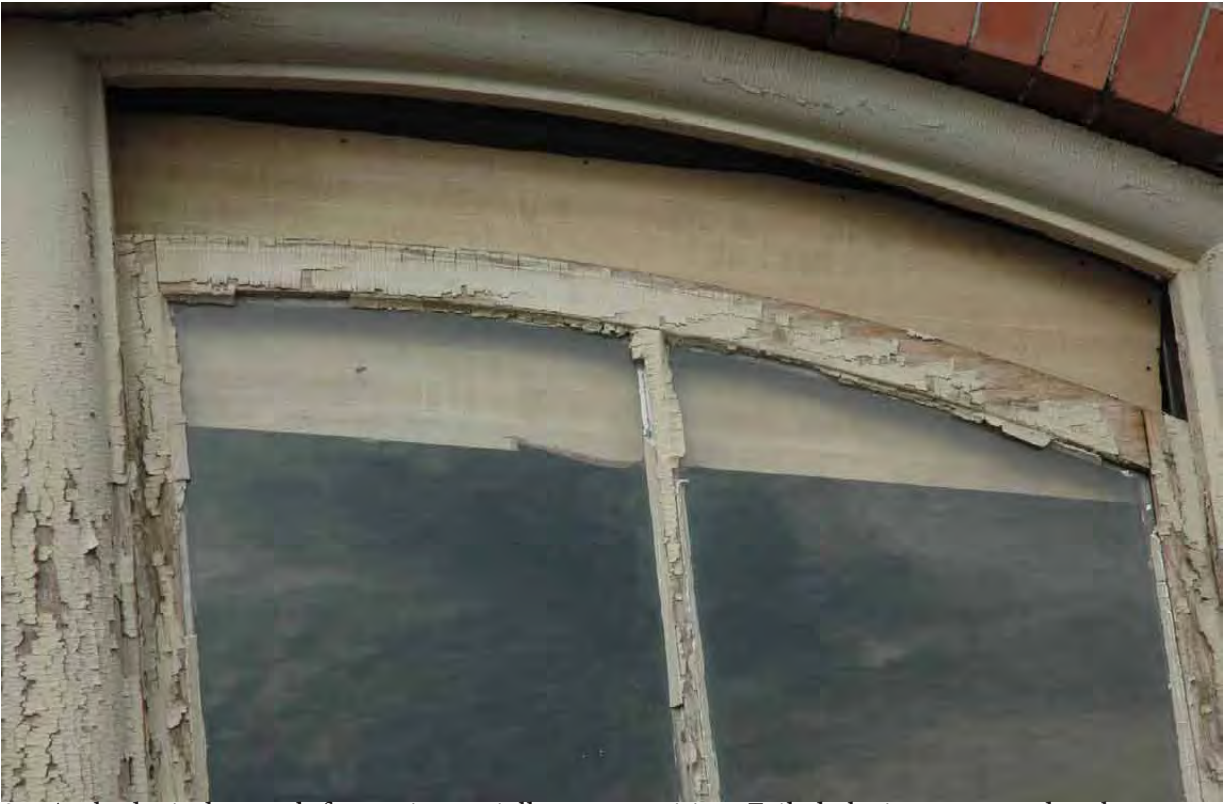
25. Arched window sash frozen in partially open position. Failed glazing putty and sealants at window perimeters also contributed to water and air infiltration.

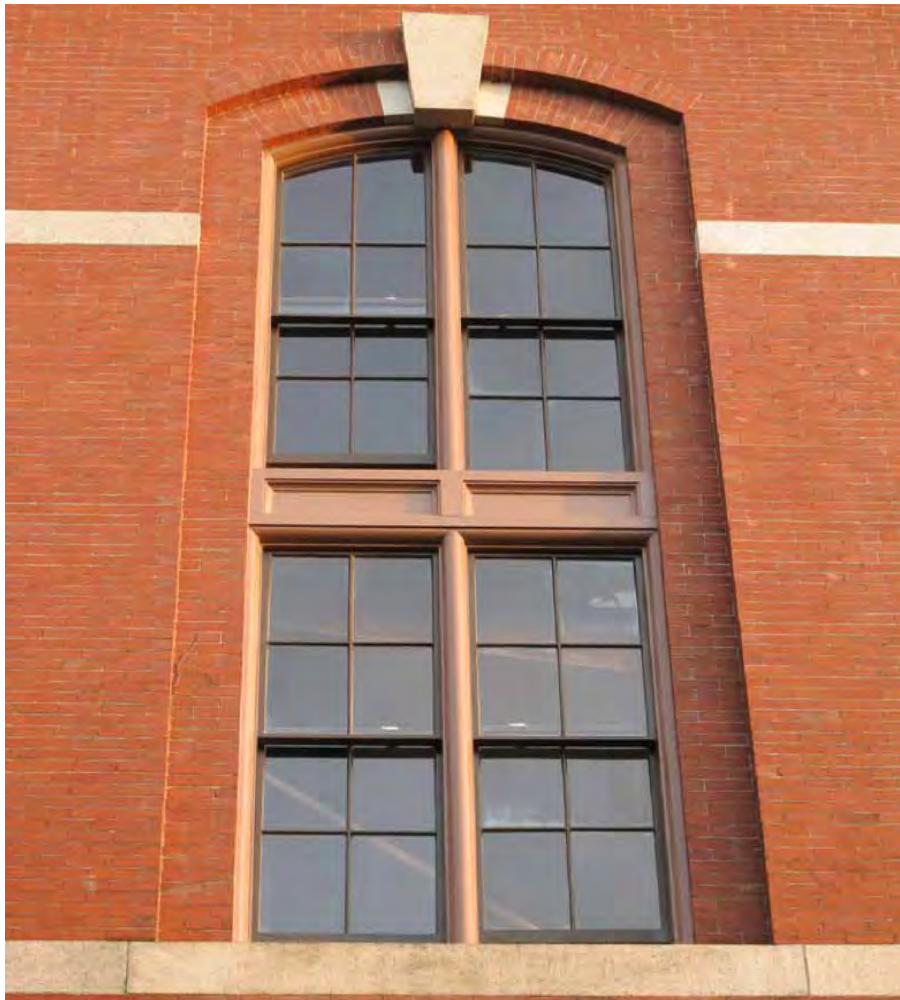
26. Restored Arched Window Assembly showing two-tone original paint scheme.

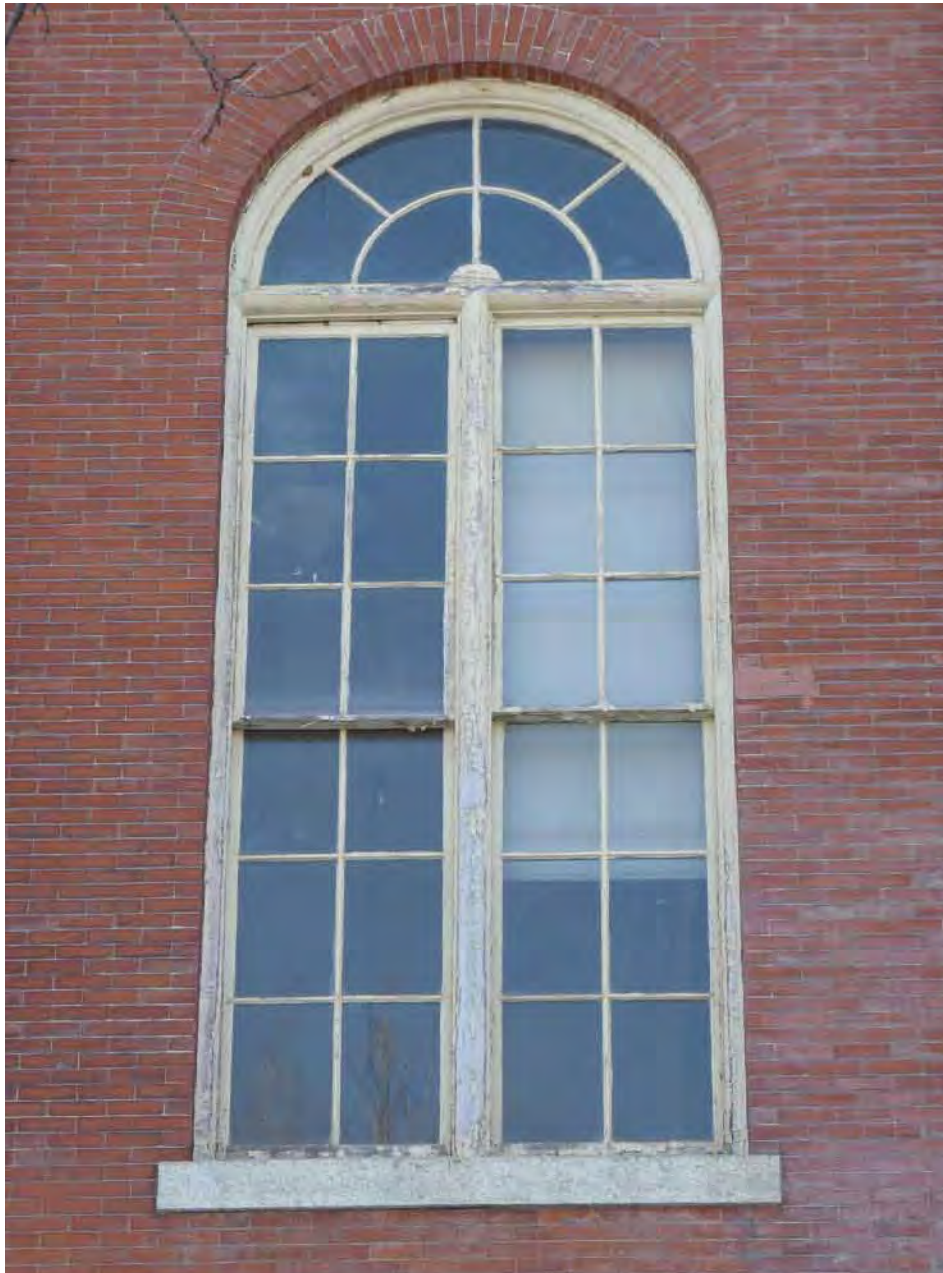
27. Pre-restoration round top window assembly showing severely weathered mullions, window sashes, sub-transom, frame and overlight.

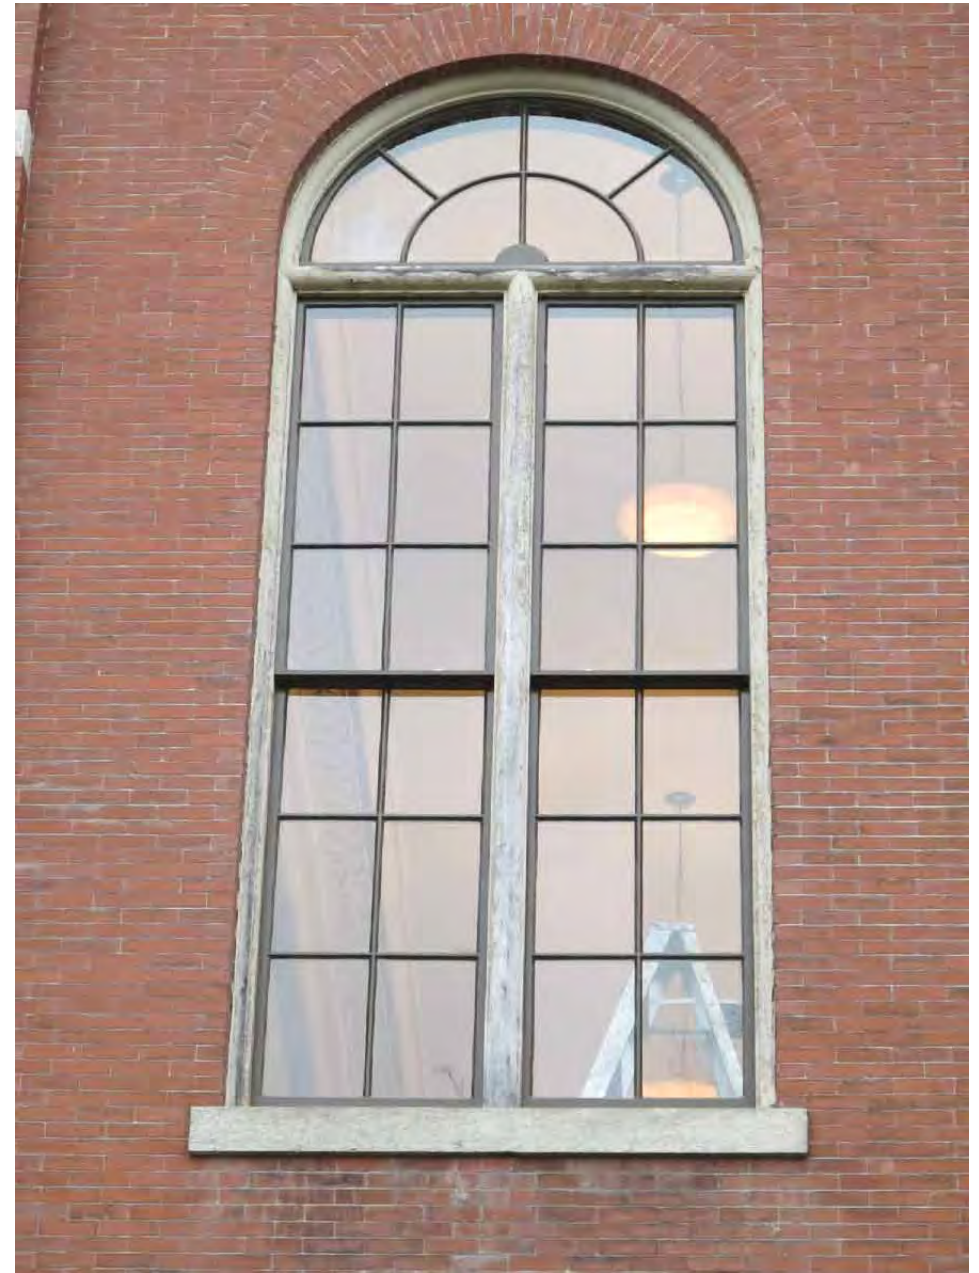
28. A window sash mock-up was installed for review by MK&A, the Town, and MHC, before authorizing a full-scale production effort at the woodwork shop and installation of completed units.

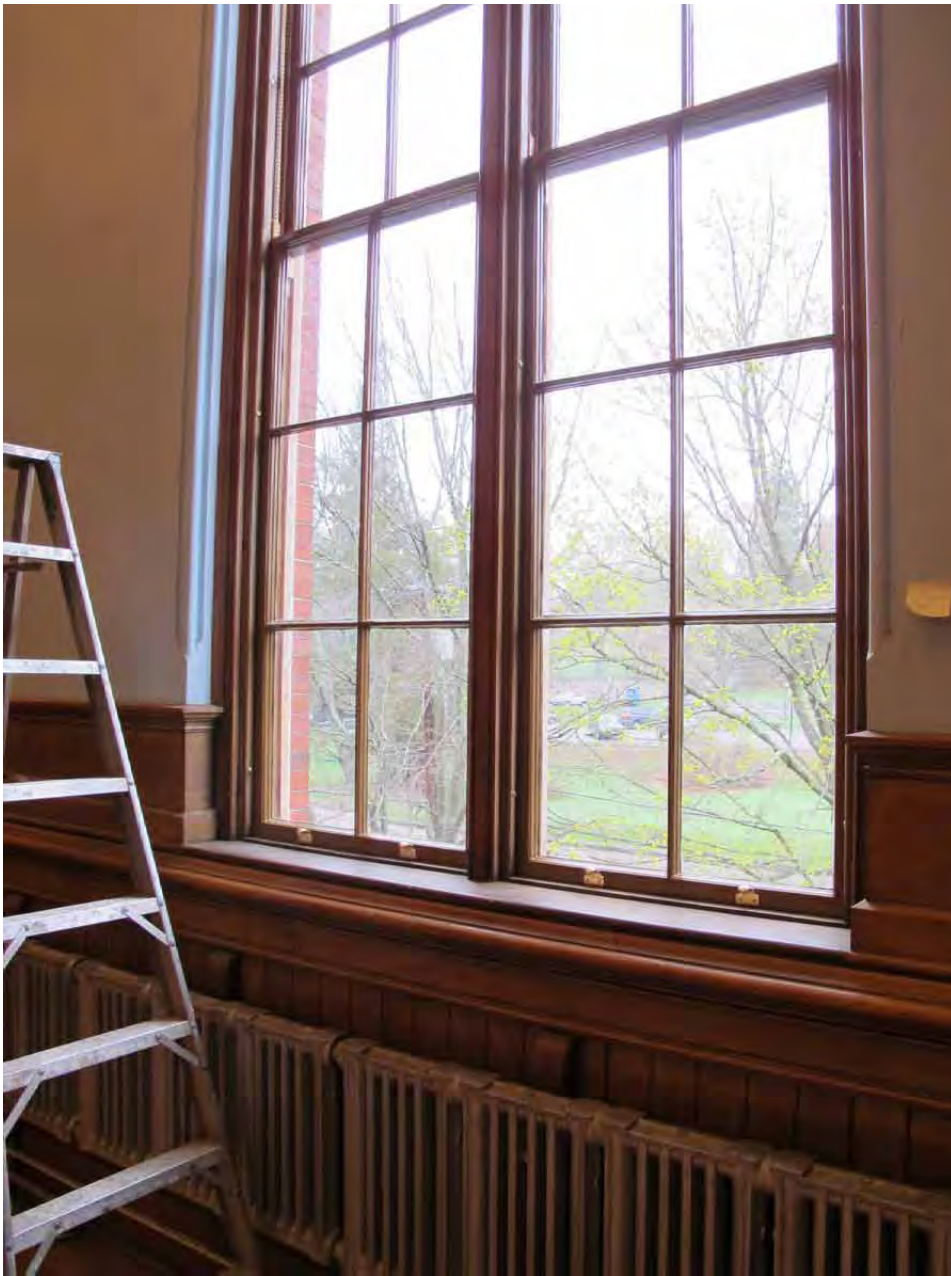
29. The interior of the mock-up was reviewed for paint colors, sash locks and sash lifts, sash chains and pulleys, weatherstripping, glazing appearance, and ease of operation.

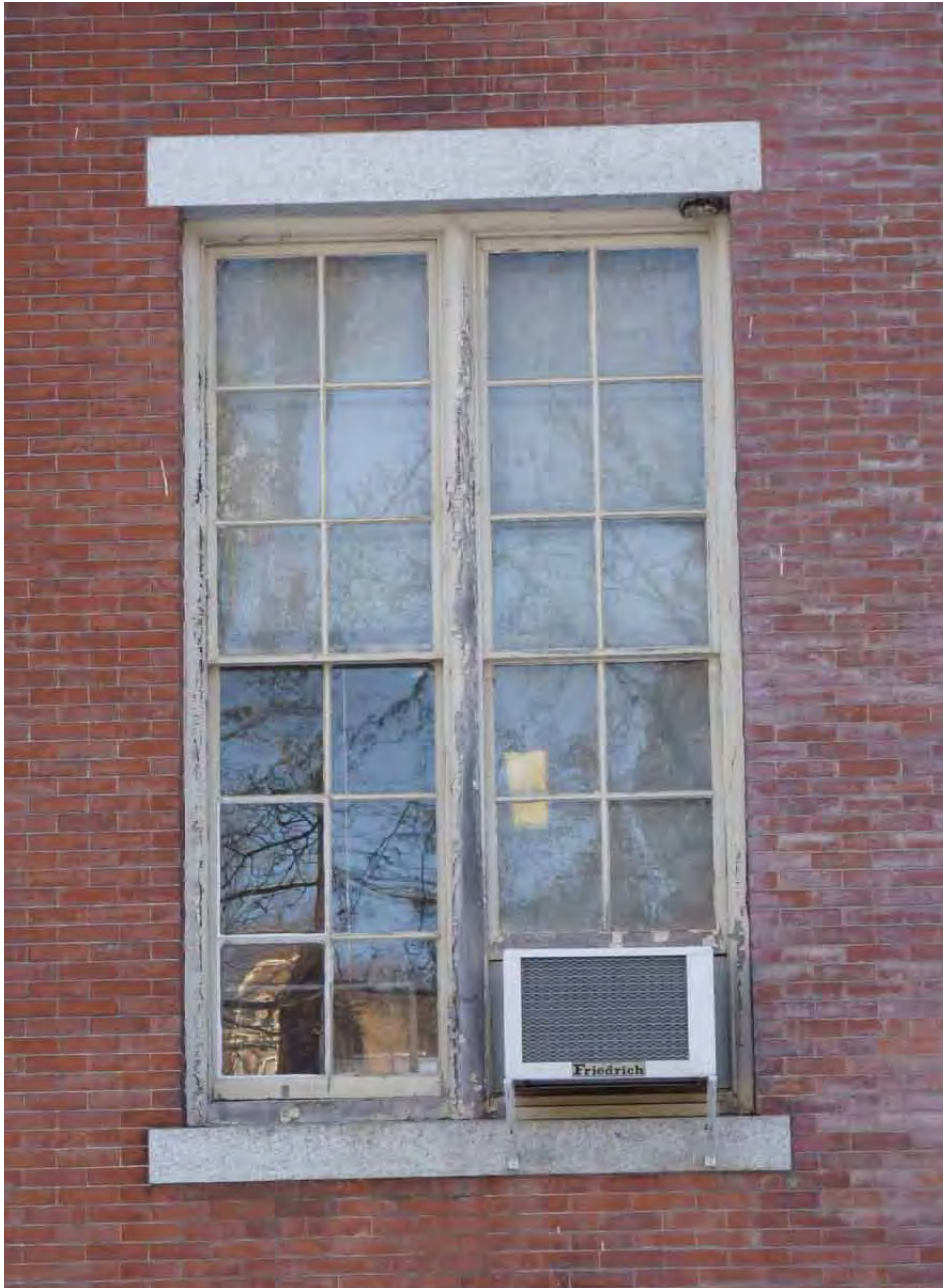
31. Pre-restoration window with window sashes, mullions, sills and frame all severely weathered.

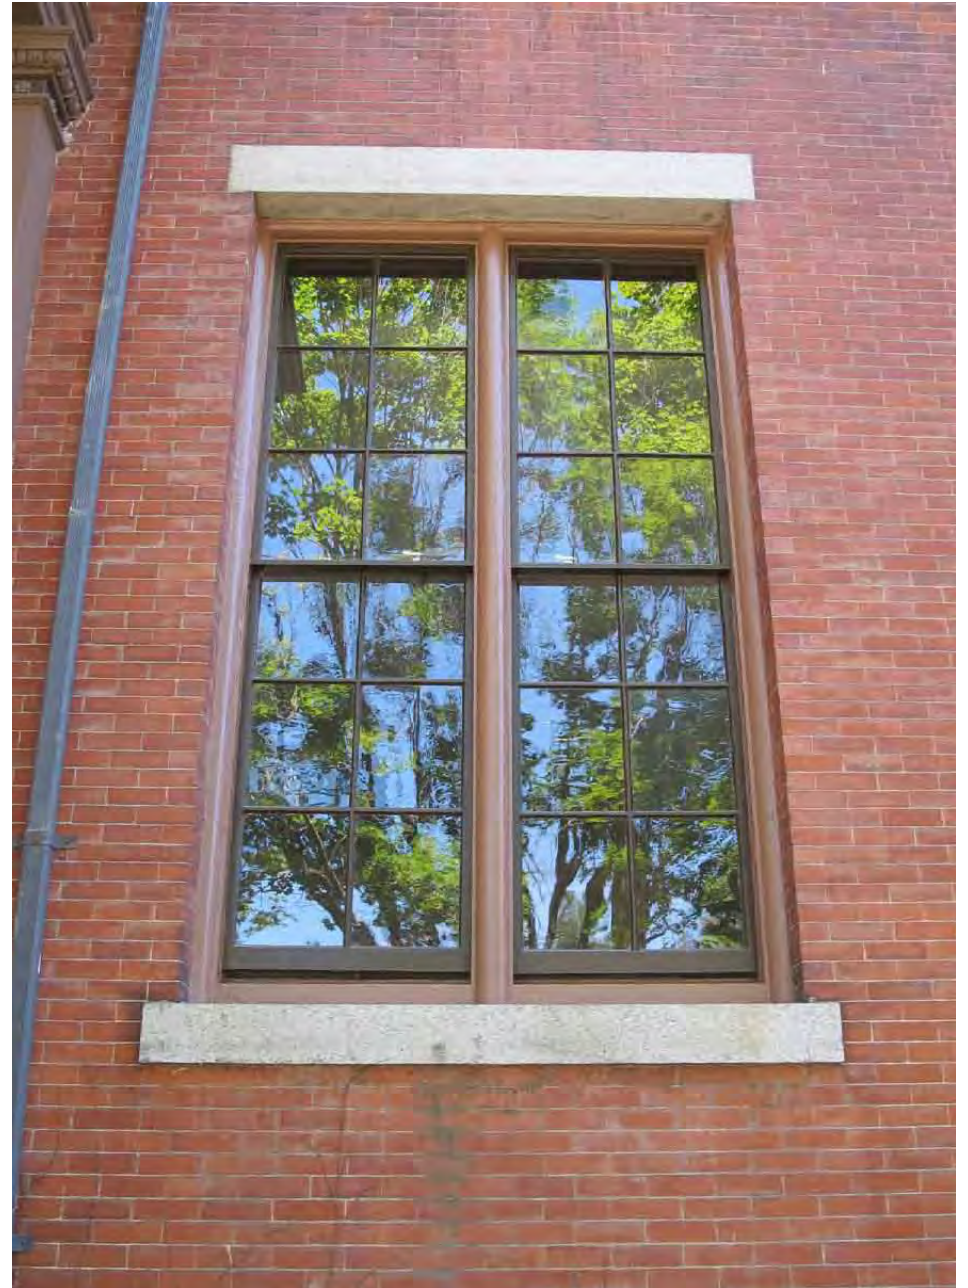
32. Restored window: The operation of the restored window sashes is relatively easy, considering that the sash weights only exist at the masonry opening side of each window, and not within the central vertical mullion. The narrow proportions of the new windows probably make this possible.

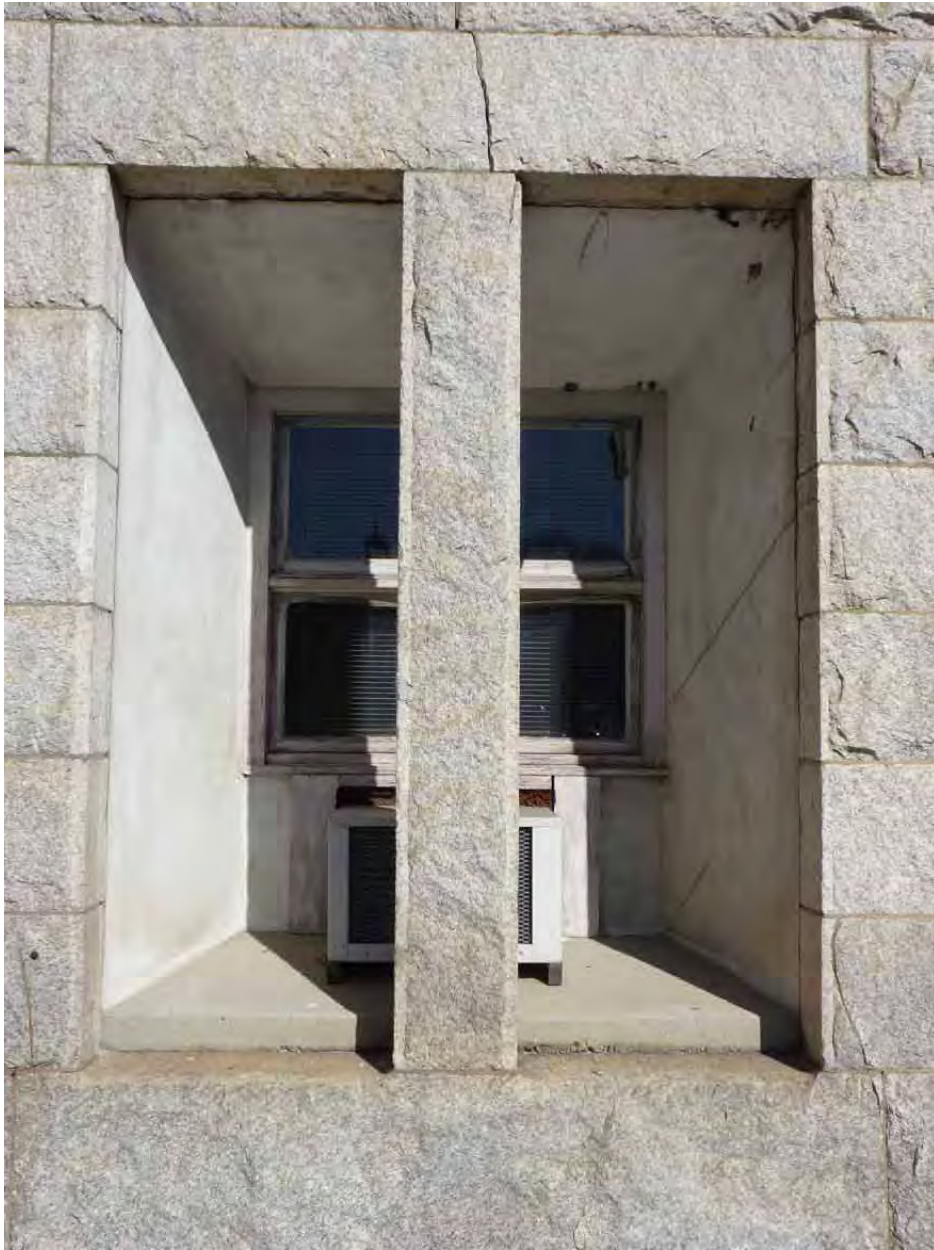
33. Ground Floor Replacement Window and Air Conditioning

The south side of the Ground Floor is at grade and originally had very narrow paired four-over-four double hung windows. At some time when the Ground Floor was renovated these windows were replaced with a single one-over-one recessed double hung window. These windows were located behind an 8" wide granite mullion and created a very awkward appearance. Removing the one-over-one recessed window and replicating the paired four-over-four double hung windows helped to eliminate one of the more unfortunate changes that had occurred to the Northbridge Town Hall.

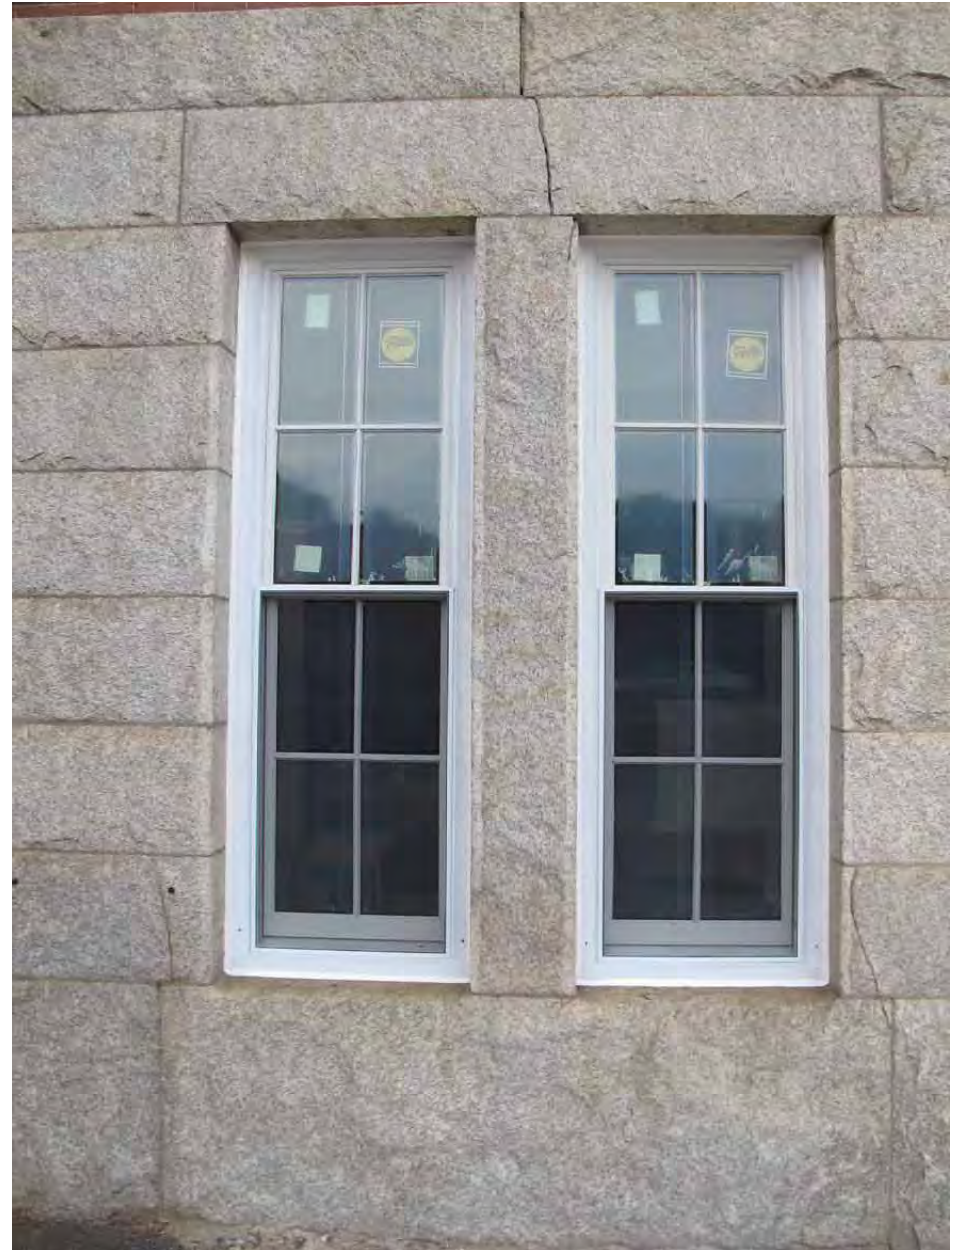
34. Construction Photo Showing Replica Historic Windows Prior to Field Painting

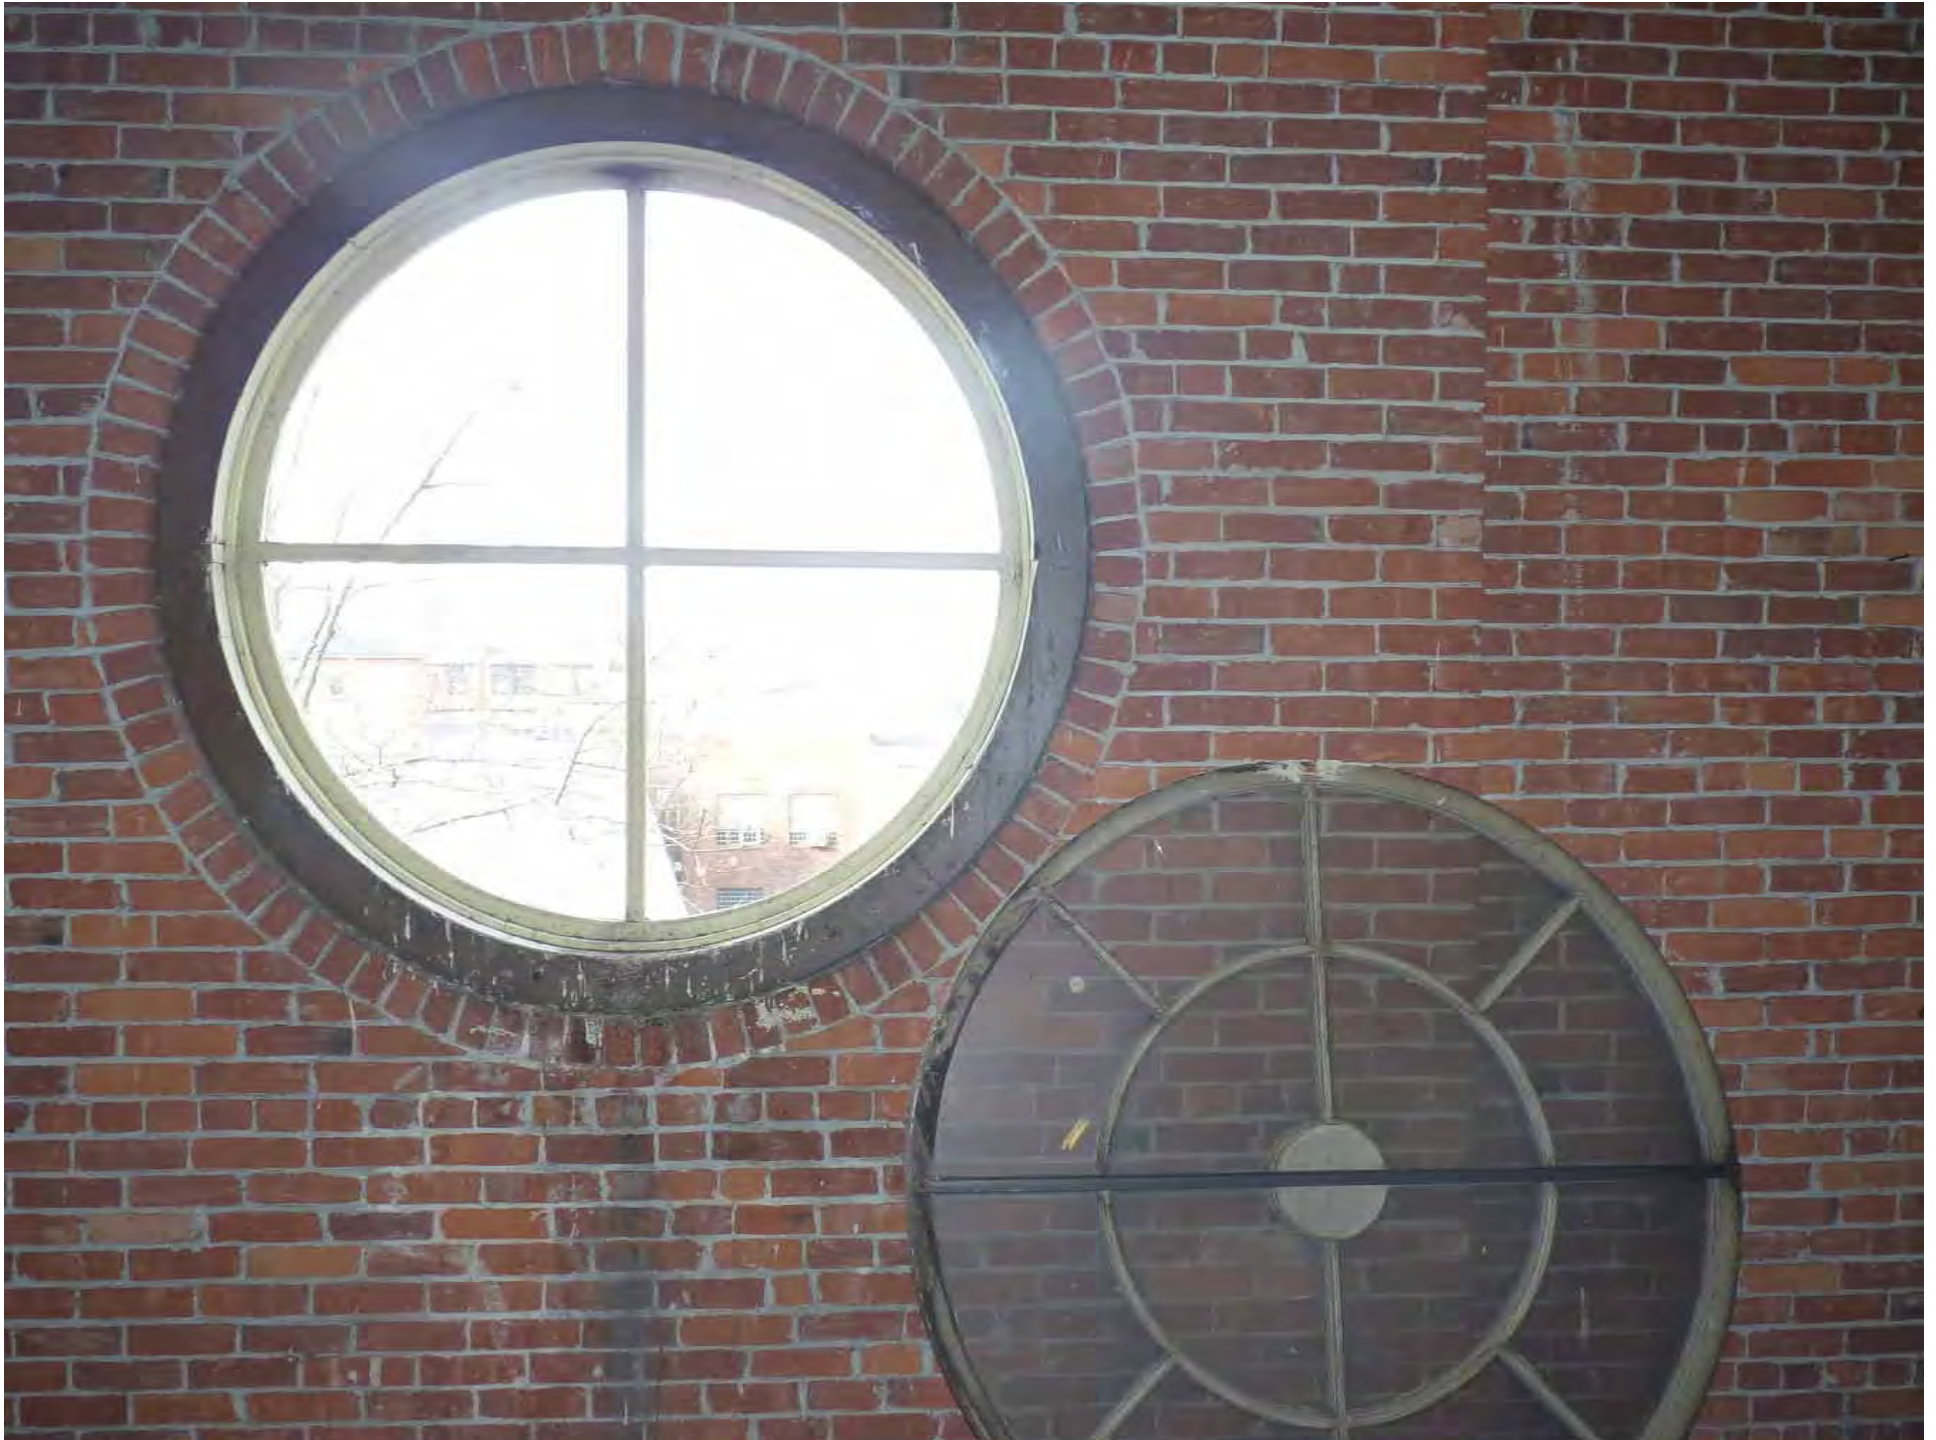
35. 20th Century Replacement Attic Sash with Original Severely Deteriorated Window Sash to Right, which was found in Attic.

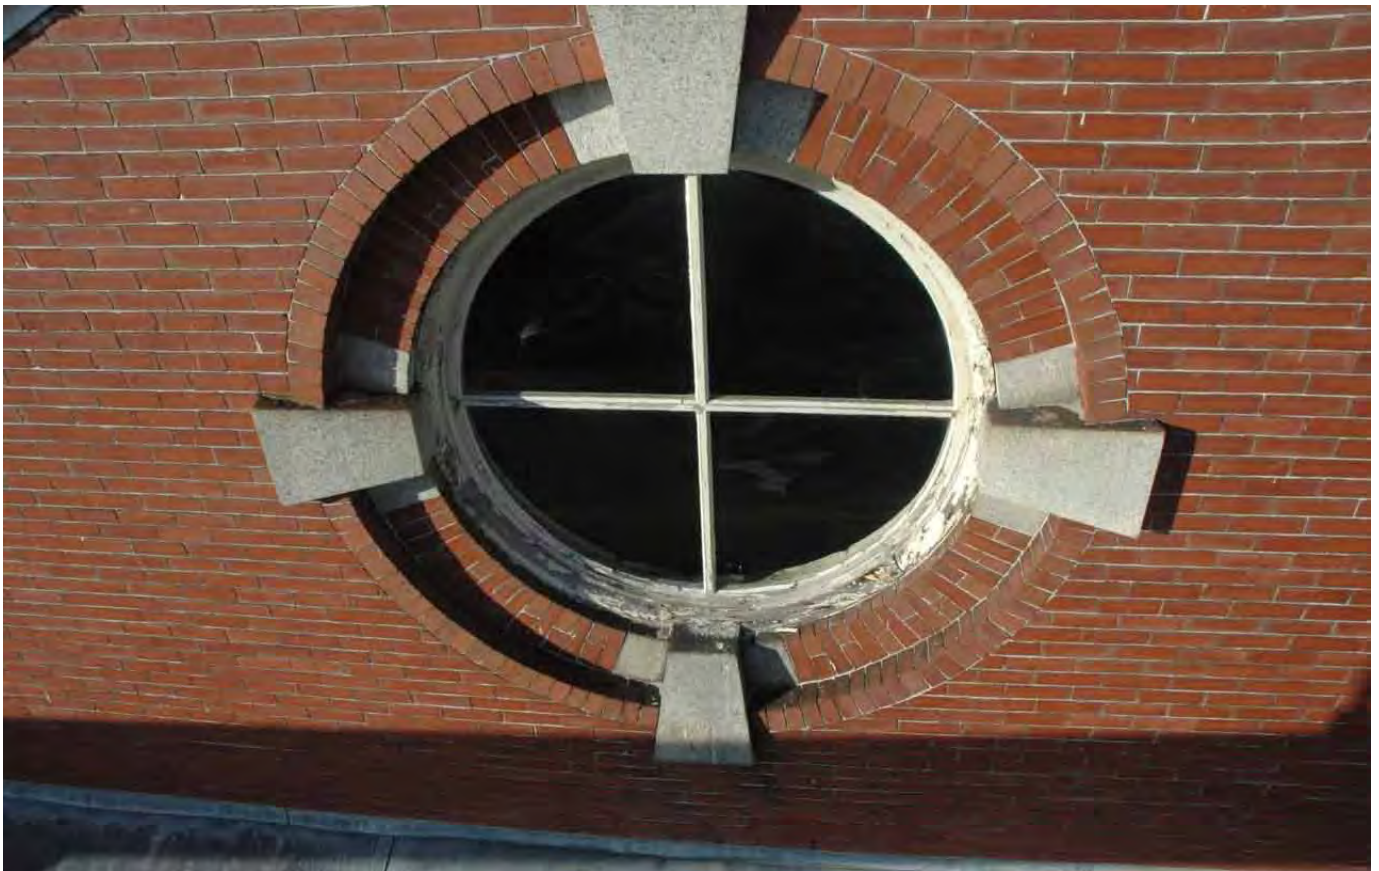
36. 20th Century Replacement Attic Sash Showing Severe Deterioration.

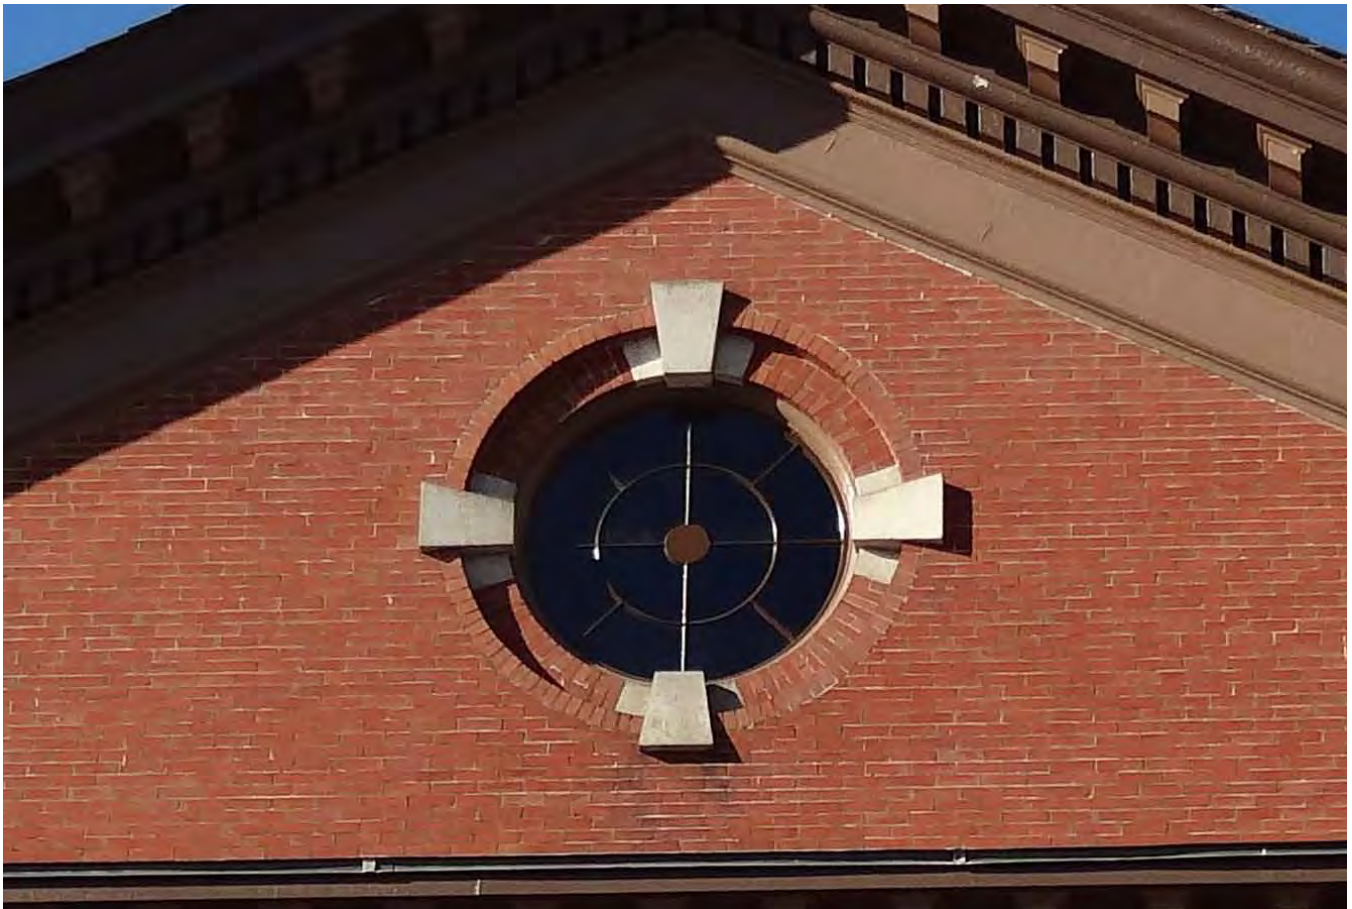
37. The original eastern round window had previously been replaced with a simplified new design. After restoration, this window was relocated to the more protected west end of the attic. The newly constructed round window was placed at the east end, which has more exposure to the elements.
