AWARD NOMINATION Rehabilitation & Restoration Category

**Northbridge Memorial Town Hall
Whitinsville, MA
February 14, 2014**

Northbridge Memorial Town Hall Statement of Achievement

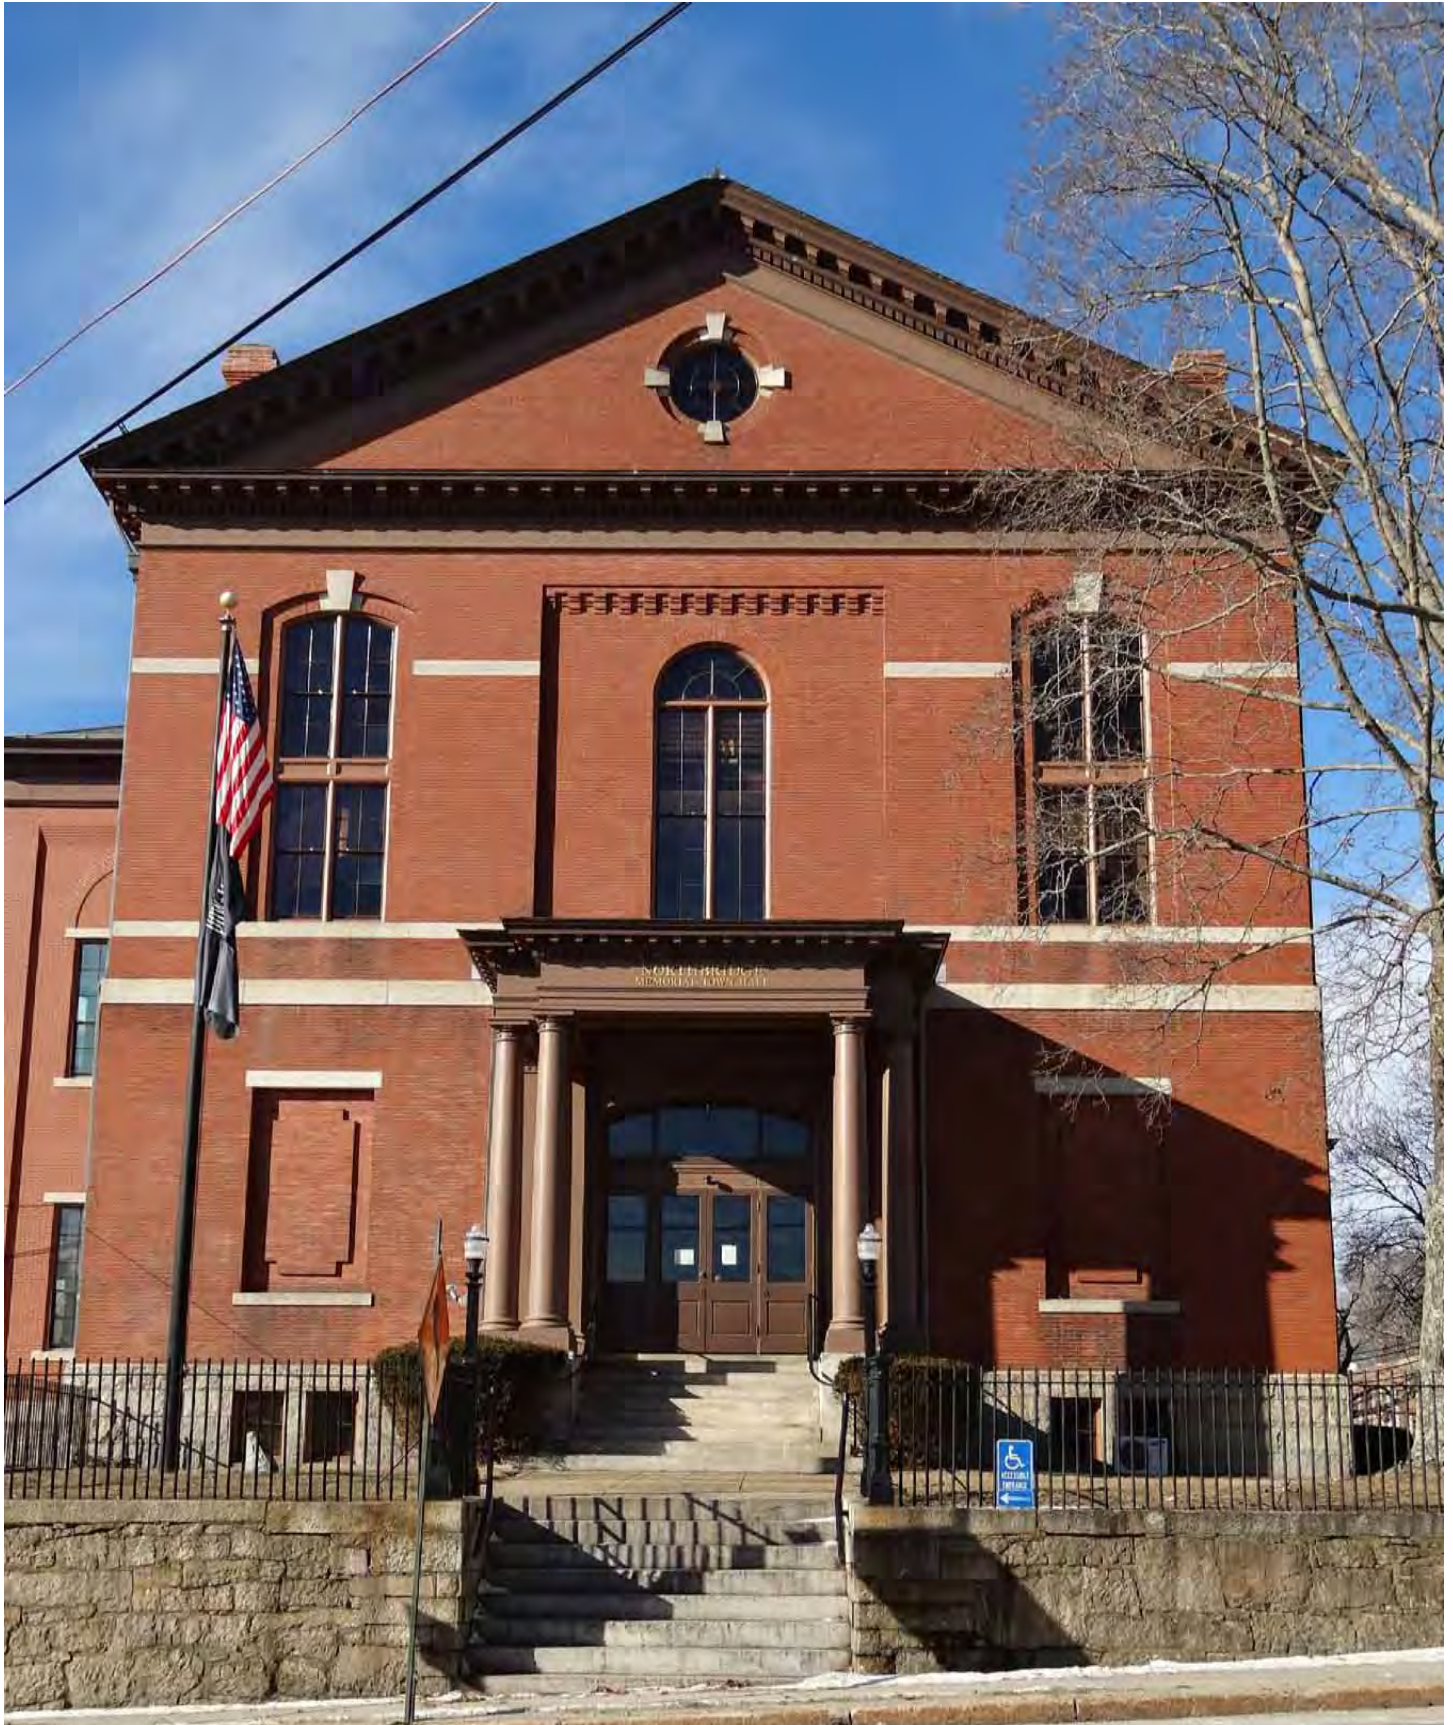
38. Restored East Elevation returning the Northbridge Memorial Town Hall to its original elegant appearance.
