# Northbridge Slum & Blight Inventory

## Rockdale Target Area

Report compiled by the Pioneer Valley  
Planning Commission for the Town of  
Northbridge

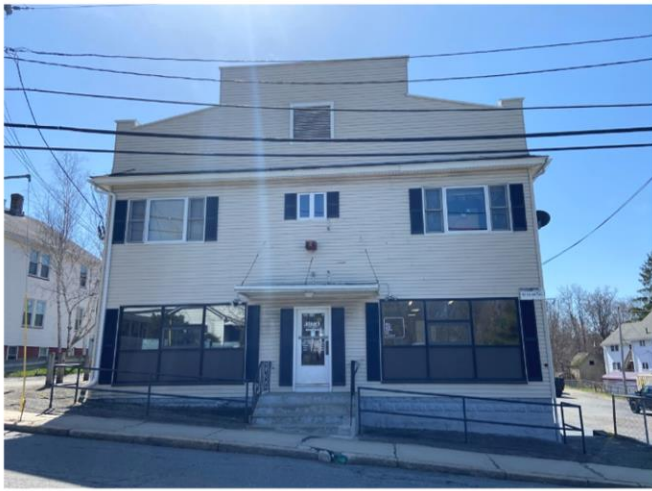
**Figure 2:** A mixed use structure at 22 Beanes Lane

Condition: Fair

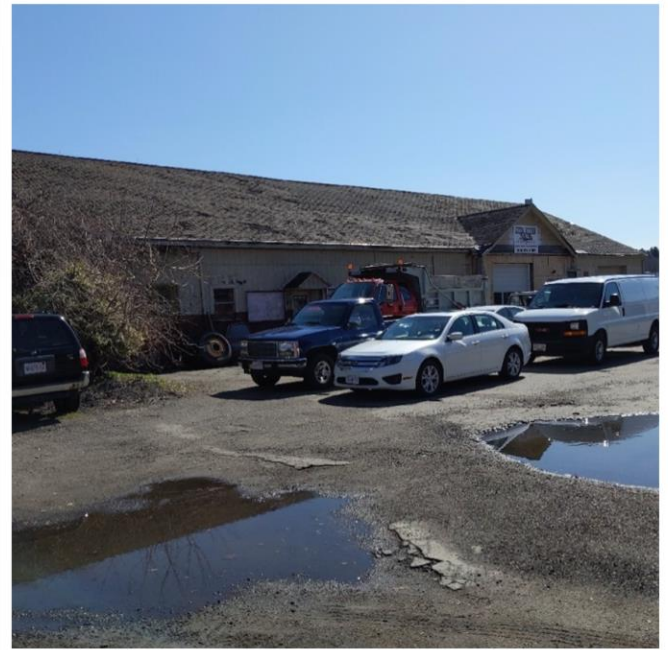
**Figure 3:** A commercial structure at 2184 Providence Rd

Condition: Poor

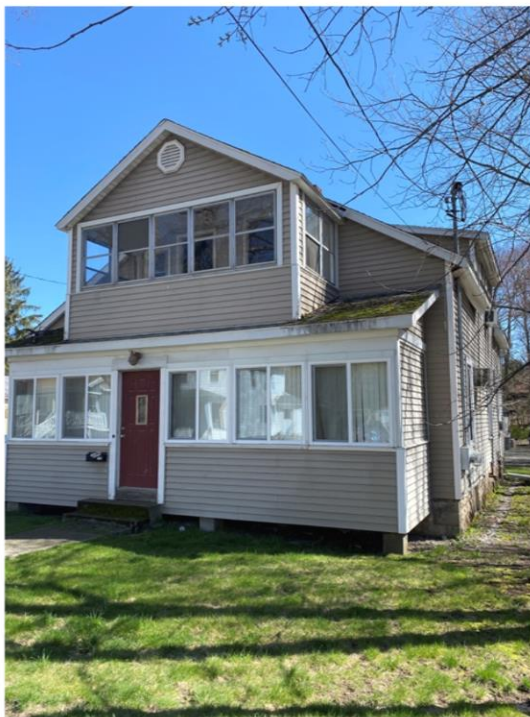
**Figure 4:** A residential structure at 2184 Providence Rd

Condition: Fair

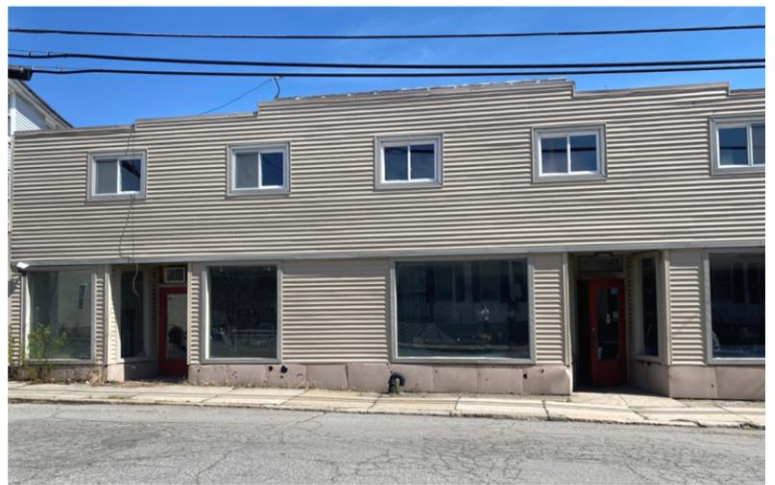
**Figure 5:** A commercial structure at 95 Church Ave

Condition: Poor

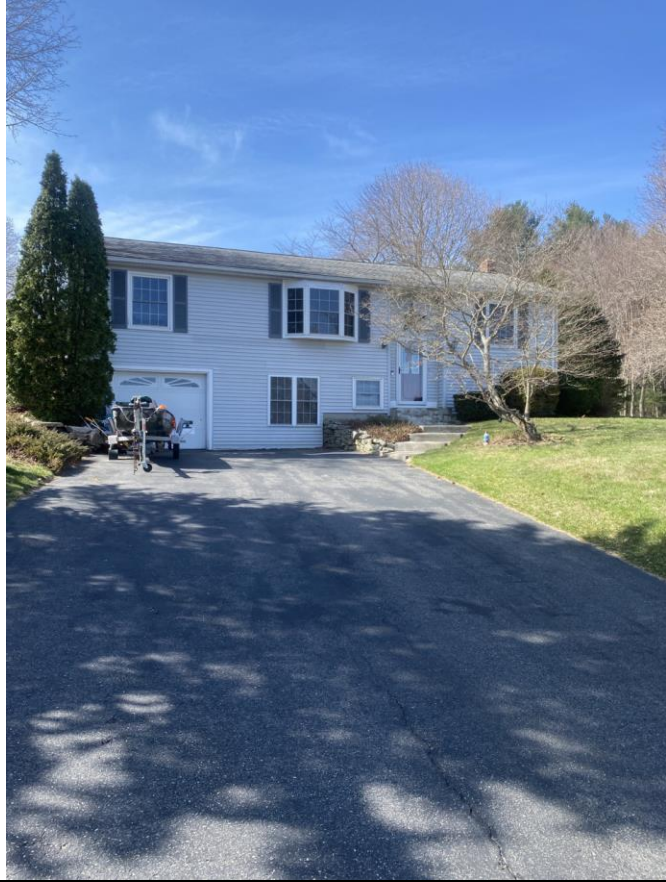
<u>Component</u>	<u>Condition</u>
Roofing	Good – asphalt shingles
Windows and Doors	Fair - older
Exterior Walls	Good
Porch/Stairs/Deck	Fair – moss growth and stains
Foundation	Good
Storefront & Signage	
Parking Lots	
Other:	
Overall Property Rating: (Excellent / Good / Fair / Poor) briefly state why. Good

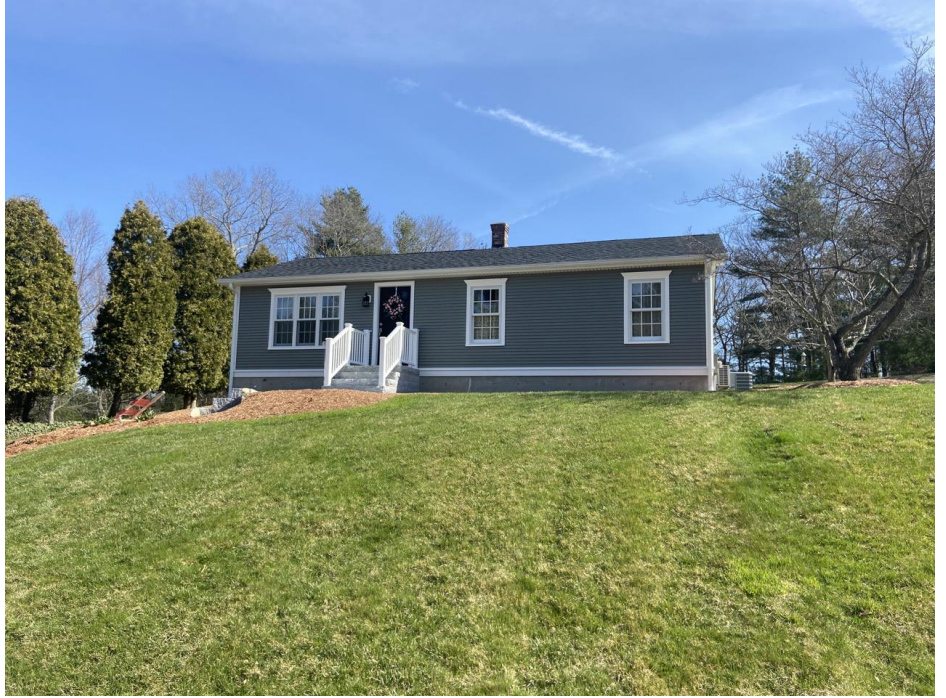
- ☐ Physical Deterioration of Building  
☐ Abandoned Property  
☐ Chronic High Occupancy Turnover  
☐ Chronic High Vacancy Rate  
☐ Significant Decline in Property Value  
☐ Abnormally Low Property Value  
☐ Known or Suspected Environmental Contamination  
☐ Other (please explain)  
*x The property is not contributing to slum and blight*

<u>Component</u>	<u>Condition</u>
------------------	------------------

Foundation	Excellent
------------	-----------

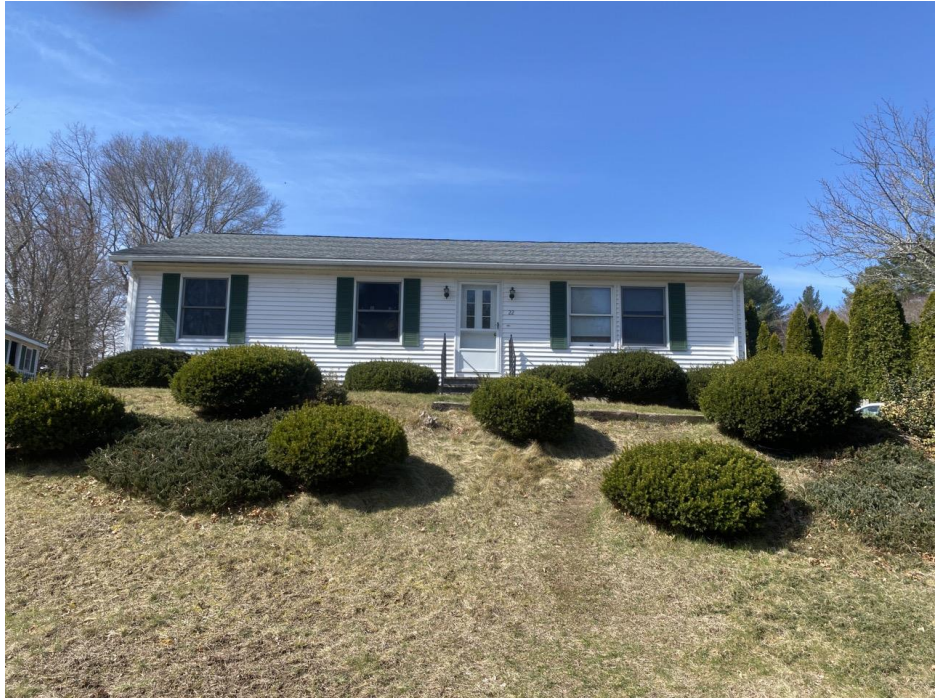
- ☐ Physical Deterioration of Building  
☐ Abandoned Property  
☐ Chronic High Occupancy Turnover  
☐ Chronic High Vacancy Rate  
☐ Significant Decline in Property Value  
☐ Abnormally Low Property Value  
☐ Known or Suspected Environmental Contamination  
☐ Other (please explain)  
*x The property is not contributing to slum and blight*

Foundation                Good

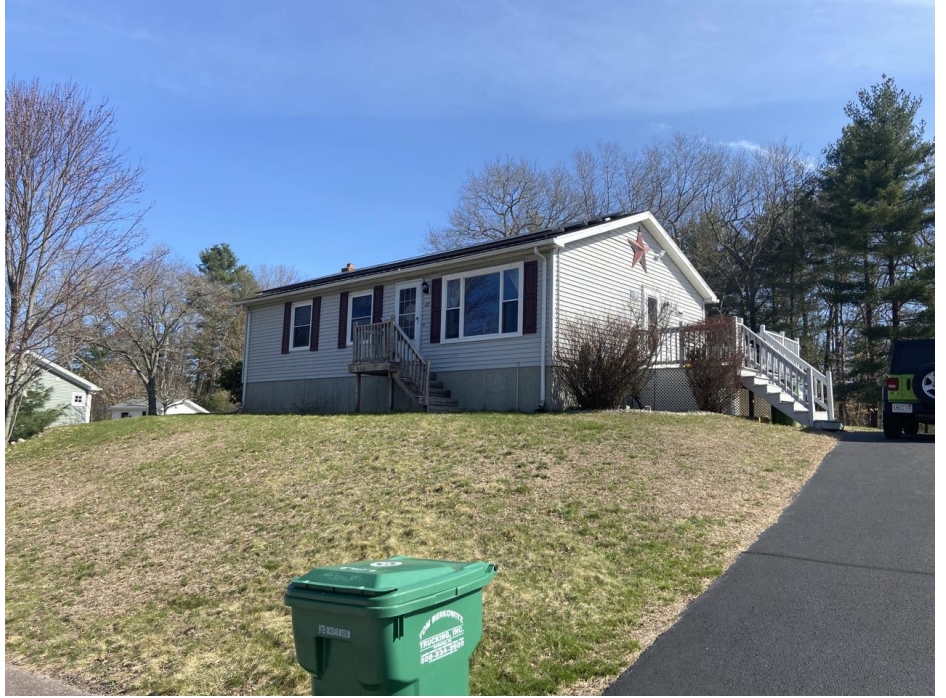
- ☐ Physical Deterioration of Building  
☐ Abandoned Property  
☐ Chronic High Occupancy Turnover  
☐ Chronic High Vacancy Rate  
☐ Significant Decline in Property Value  
☐ Abnormally Low Property Value  
☐ Known or Suspected Environmental Contamination  
☐ Other (please explain)  
*x The property is not contributing to slum and blight*

Foundation                      Good

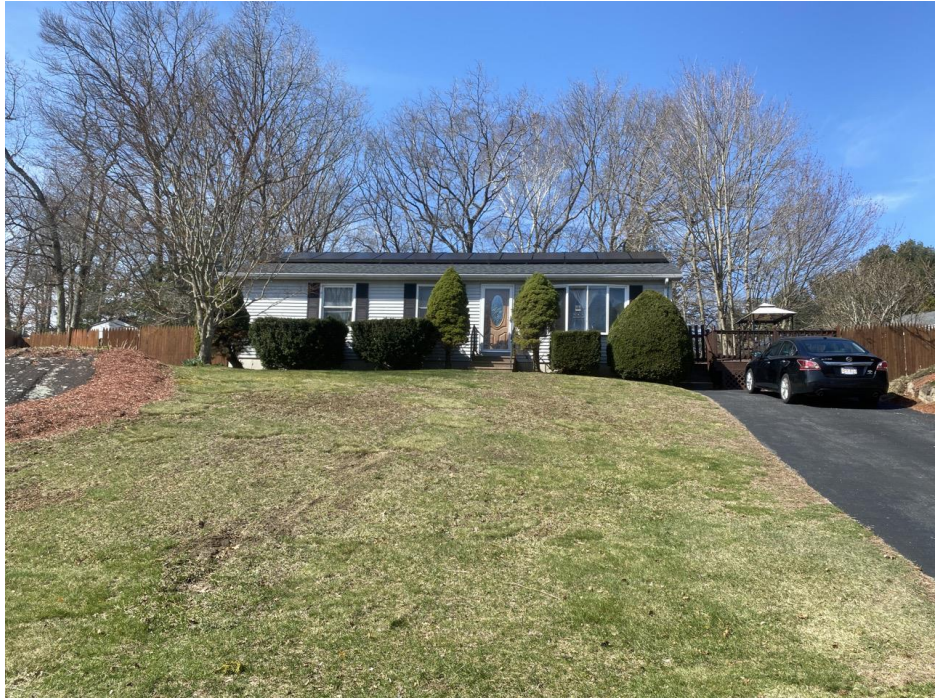
- ☐ Physical Deterioration of Building  
☐ Abandoned Property  
☐ Chronic High Occupancy Turnover  
☐ Chronic High Vacancy Rate  
☐ Significant Decline in Property Value  
☐ Abnormally Low Property Value  
☐ Known or Suspected Environmental Contamination  
☐ Other (please explain)  
*x The property is not contributing to slum and blight*

Foundation                Unknown

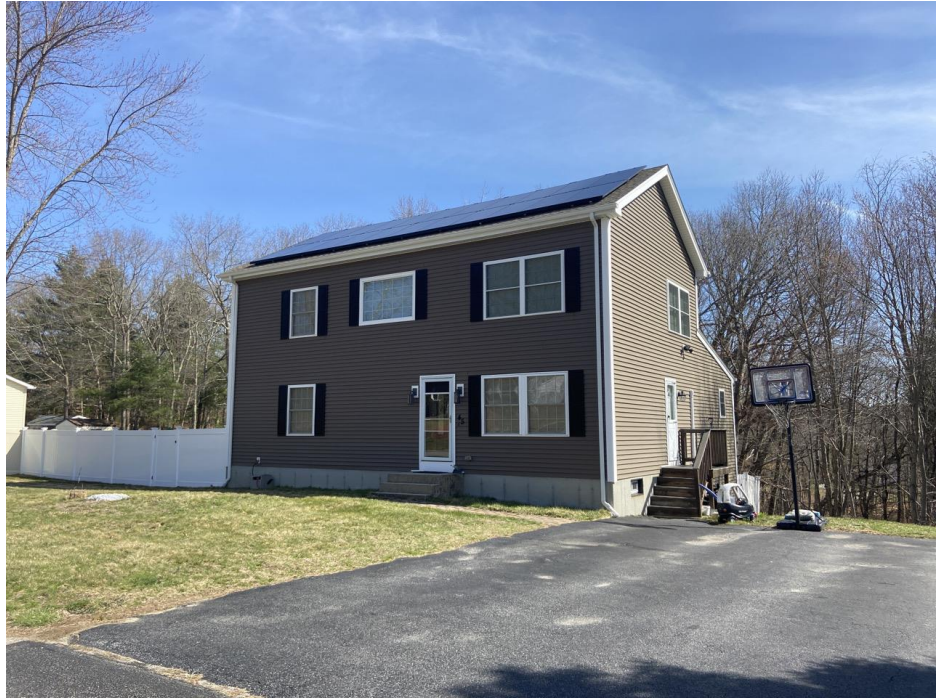
- ☐ Physical Deterioration of Building  
☐ Abandoned Property  
☐ Chronic High Occupancy Turnover  
☐ Chronic High Vacancy Rate  
☐ Significant Decline in Property Value  
☐ Abnormally Low Property Value  
☐ Known or Suspected Environmental Contamination  
☐ Other (please explain)  
☒ *The property is not contributing to slum and blight*

Foundation	Excellent
------------	-----------

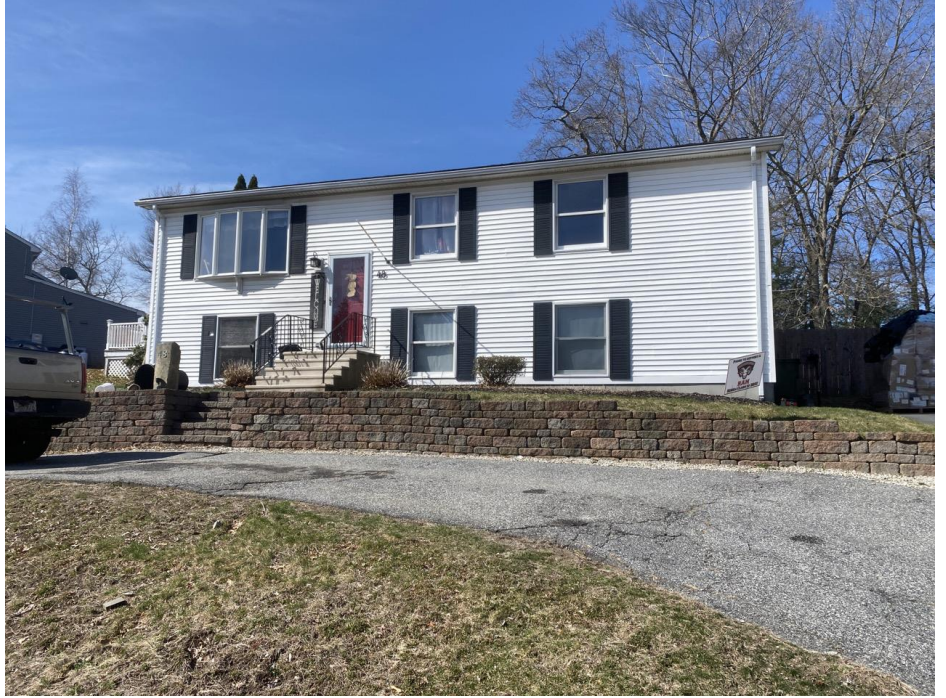
- ☐ Physical Deterioration of Building  
☐ Abandoned Property  
☐ Chronic High Occupancy Turnover  
☐ Chronic High Vacancy Rate  
☐ Significant Decline in Property Value  
☐ Abnormally Low Property Value  
☐ Known or Suspected Environmental Contamination  
☐ Other (please explain)  
*x The property is not contributing to slum and blight*

Roofing	Unknown
Windows and Doors	Good
Exterior Walls	Good – vinyl siding
Porch/Stairs/Deck	Excellent
Foundation	Good
Storefront & Signage	
Parking Lots	
Other:

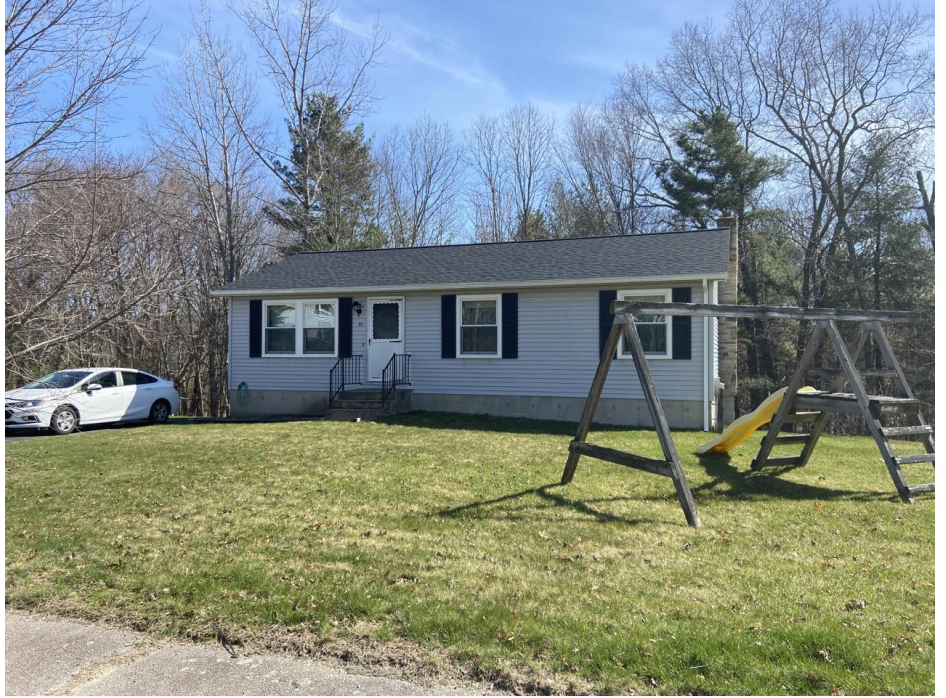
- ☐ Physical Deterioration of Building  
☐ Abandoned Property  
☐ Chronic High Occupancy Turnover  
☐ Chronic High Vacancy Rate  
☐ Significant Decline in Property Value  
☐ Abnormally Low Property Value  
☐ Known or Suspected Environmental Contamination  
☐ Other (please explain)  
☒ *The property is not contributing to slum and blight*

Foundation                      Good

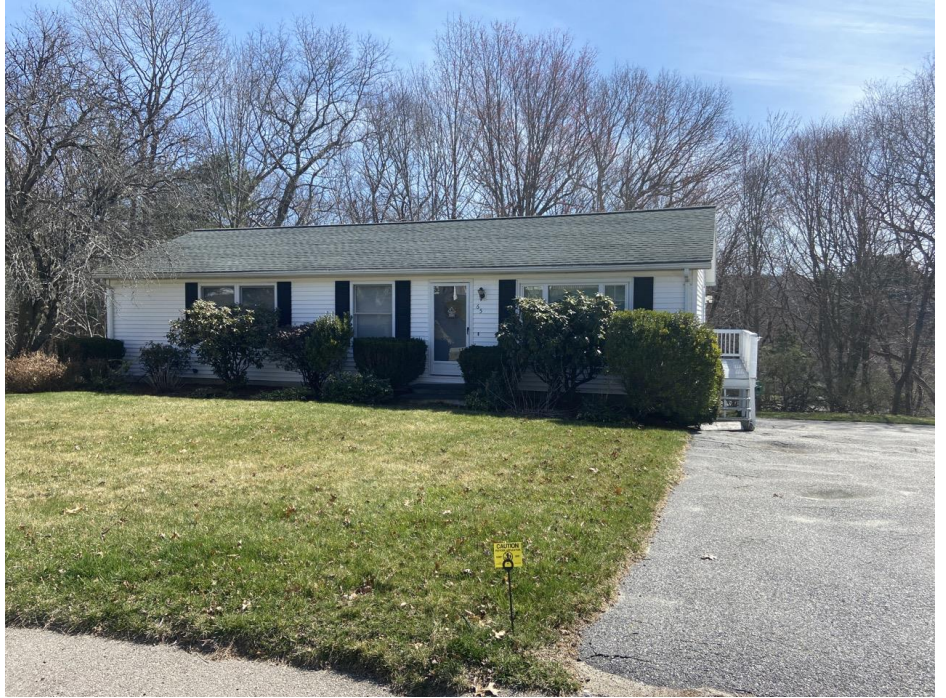
- ☐ Physical Deterioration of Building  
☐ Abandoned Property  
☐ Chronic High Occupancy Turnover  
☐ Chronic High Vacancy Rate  
☐ Significant Decline in Property Value  
☐ Abnormally Low Property Value  
☐ Known or Suspected Environmental Contamination  
☐ Other (please explain)  
*x The property is not contributing to slum and blight*

Foundation	Good
------------	------

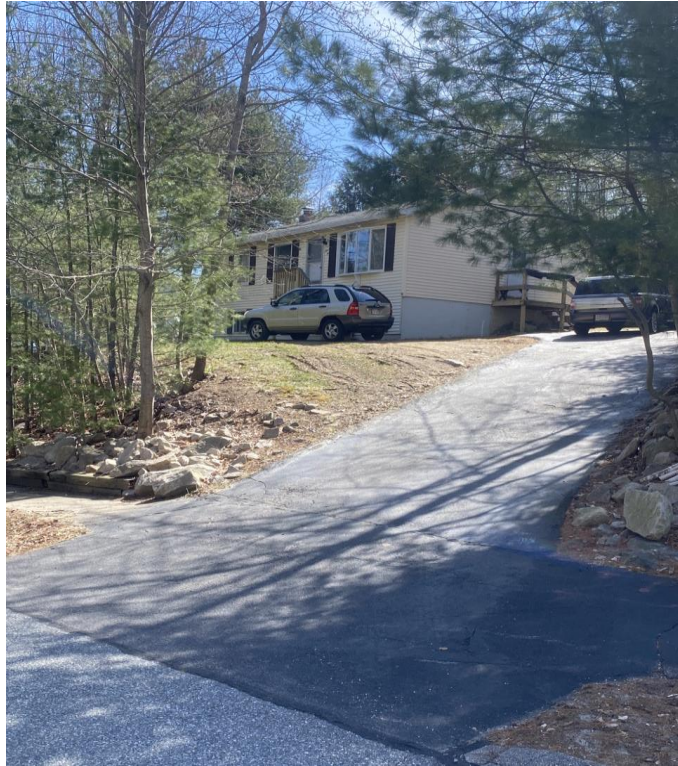
<u>Component</u>	<u>Condition</u>
Roofing	Unknown
Windows and Doors	Good
Exterior Walls	Good – vinyl siding
Porch/Stairs/Deck	Good
Foundation	Excellent
Storefront & Signage	
Parking Lots	
Other:

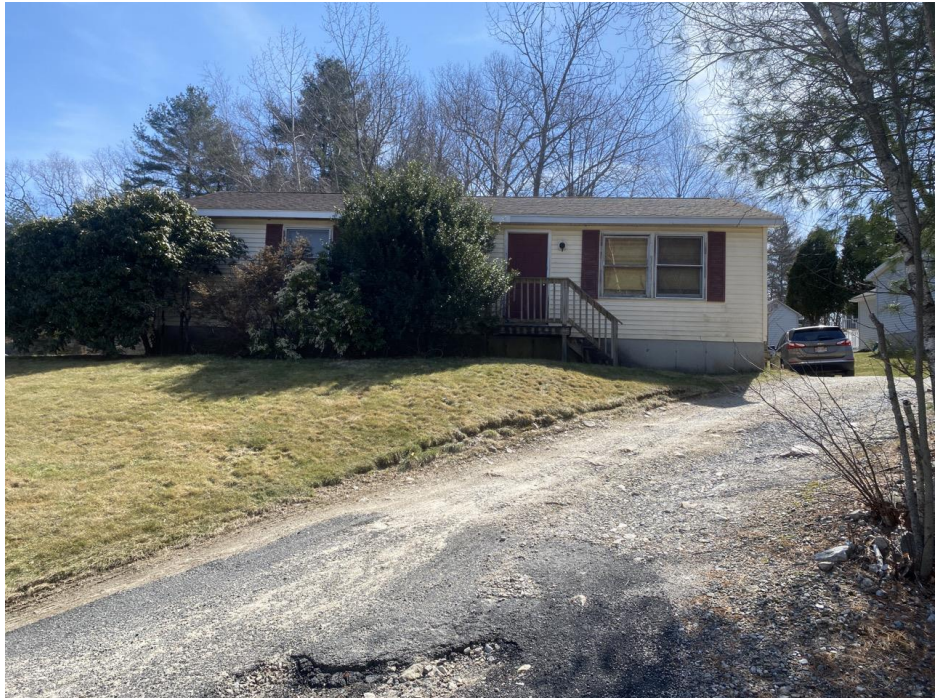
☒ Physical Deterioration of Building

<u>Component</u>	<u>Condition</u>
Roofing	Good – asphalt shingles
Windows and Doors	Poor – very old with deteriorating trim
Exterior Walls	Fair – stains
Porch/Stairs/Deck	Good
Foundation	Good
Storefront & Signage	
Parking Lots	
Other:	
Overall Property Rating: (Excellent / Good / Fair / Poor) briefly state why. Fair

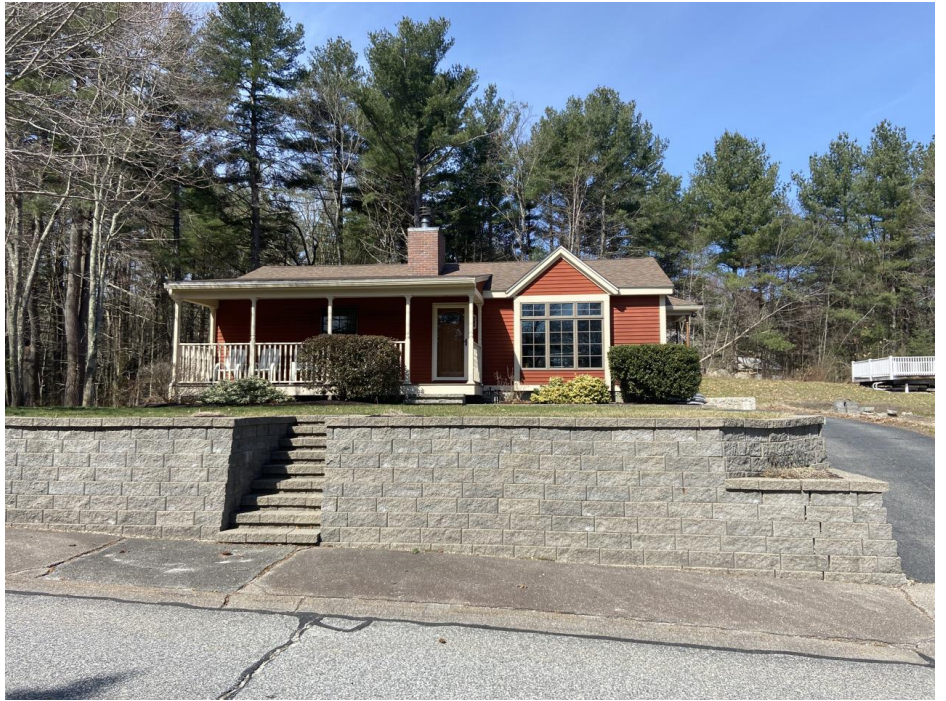
*x The property is not contributing to slum and blight*

### **Component**                      **Condition**

Foundation                      Excellent

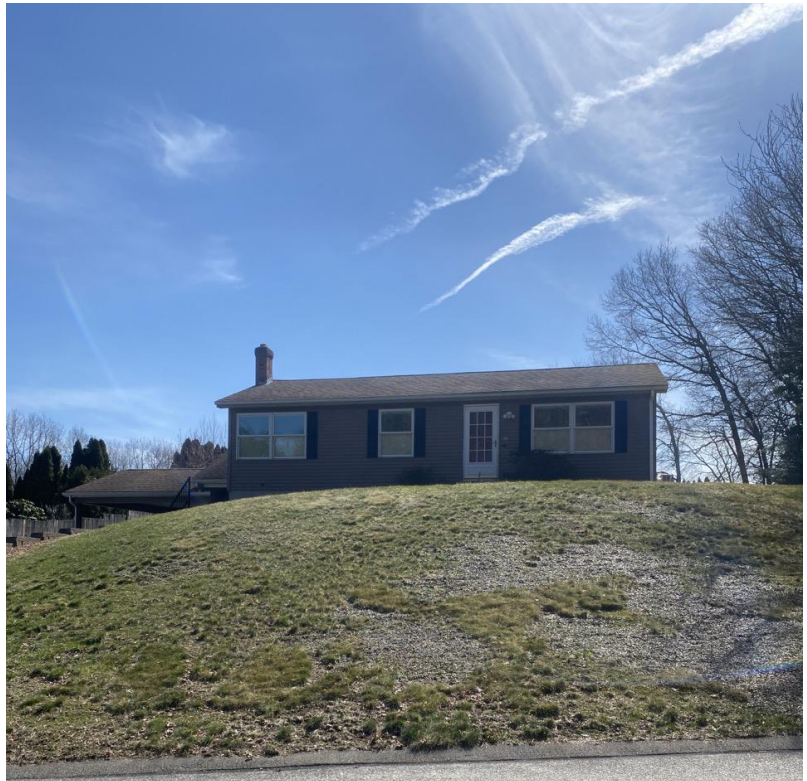
x *The property is not contributing to slum and blight*

Foundation Good

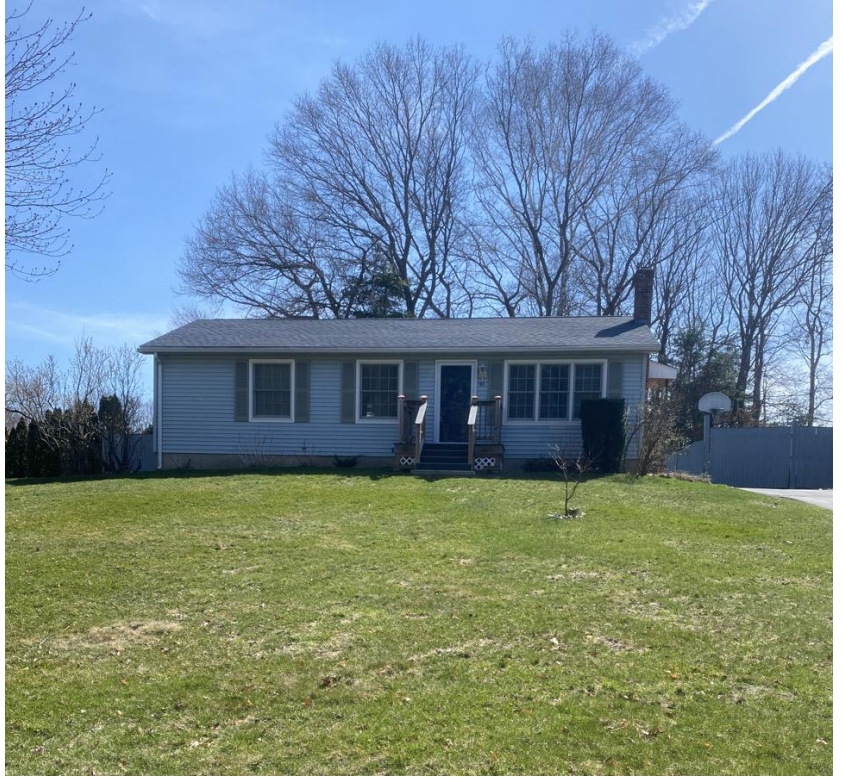
- ☐ Physical Deterioration of Building  
☐ Abandoned Property  
☐ Chronic High Occupancy Turnover  
☐ Chronic High Vacancy Rate  
☐ Significant Decline in Property Value  
☐ Abnormally Low Property Value  
☐ Known or Suspected Environmental Contamination  
☐ Other (please explain)  
☒ *The property is not contributing to slum and blight*

Foundation               Good

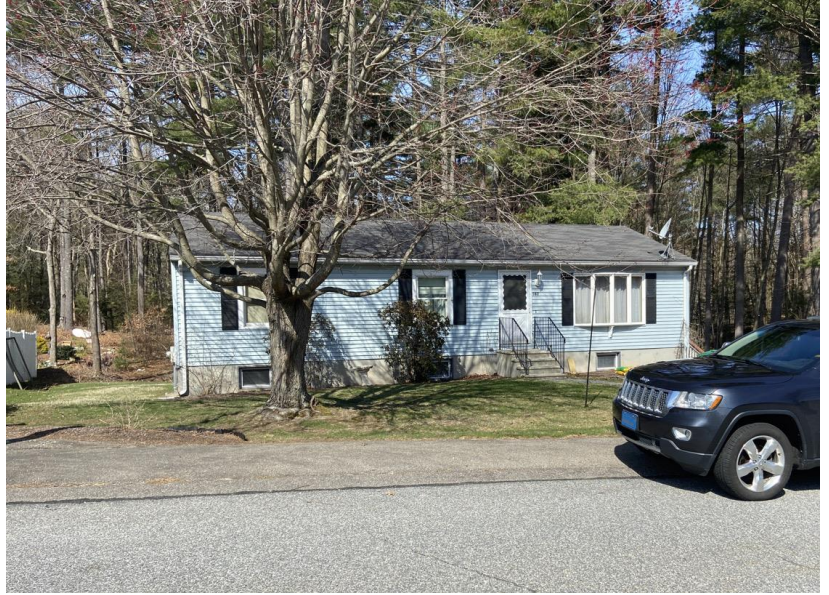
- ☐ Physical Deterioration of Building  
☐ Abandoned Property  
☐ Chronic High Occupancy Turnover  
☐ Chronic High Vacancy Rate  
☐ Significant Decline in Property Value  
☐ Abnormally Low Property Value  
☐ Known or Suspected Environmental Contamination  
☐ Other (please explain)  
*x The property is not contributing to slum and blight*

Roofing	Good
Windows and Doors	Good
Exterior Walls	Fair – minor moss growth
Porch/Stairs/Deck	Good
Foundation	Good
Storefront & Signage	
Parking Lots	
Other:

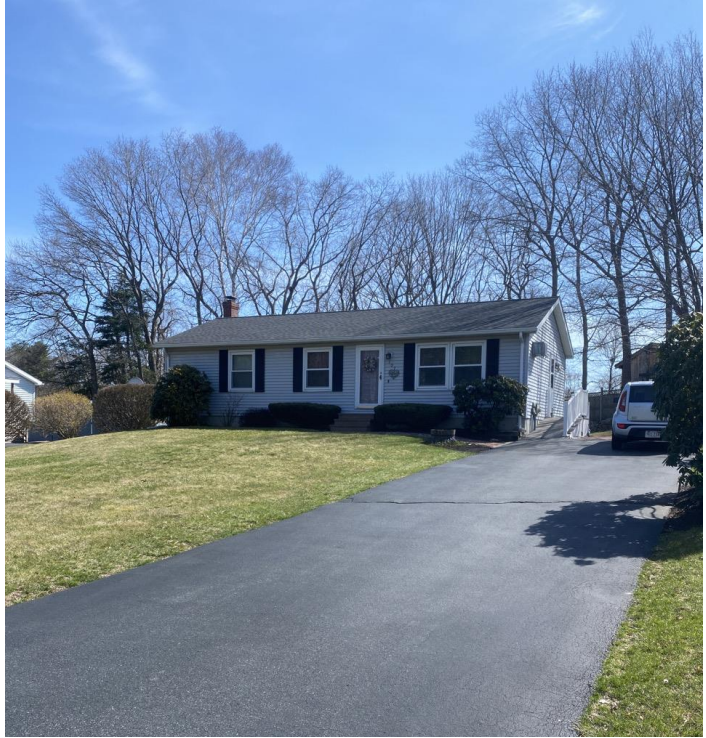
*x The property is not contributing to slum and blight*

Foundation                Good

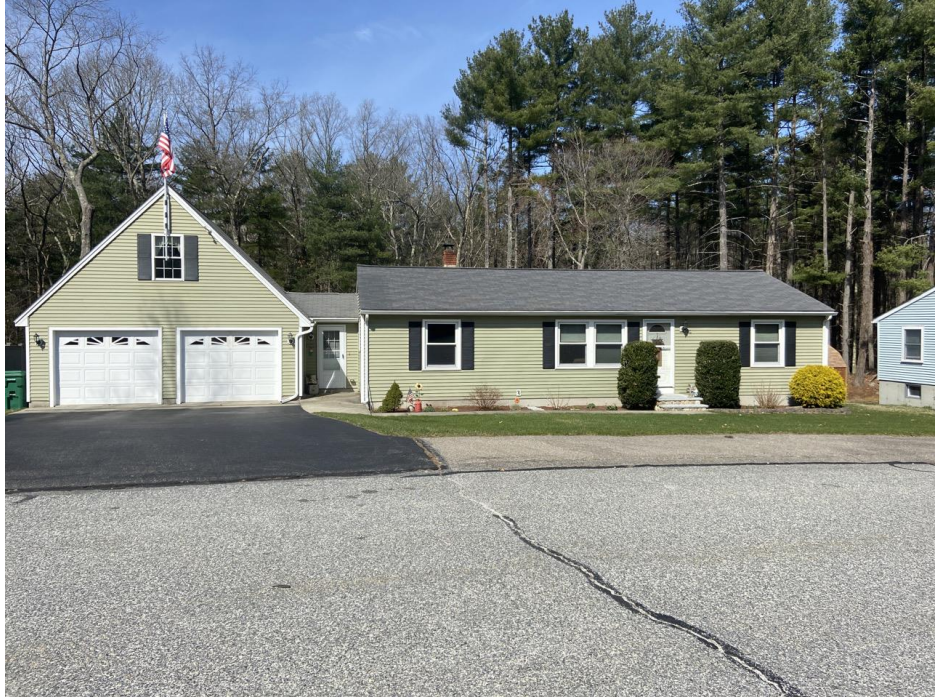
- ☐ Physical Deterioration of Building  
☐ Abandoned Property  
☐ Chronic High Occupancy Turnover  
☐ Chronic High Vacancy Rate  
☐ Significant Decline in Property Value  
☐ Abnormally Low Property Value  
☐ Known or Suspected Environmental Contamination  
☐ Other (please explain)  
*x The property is not contributing to slum and blight*

Foundation                        Excellent

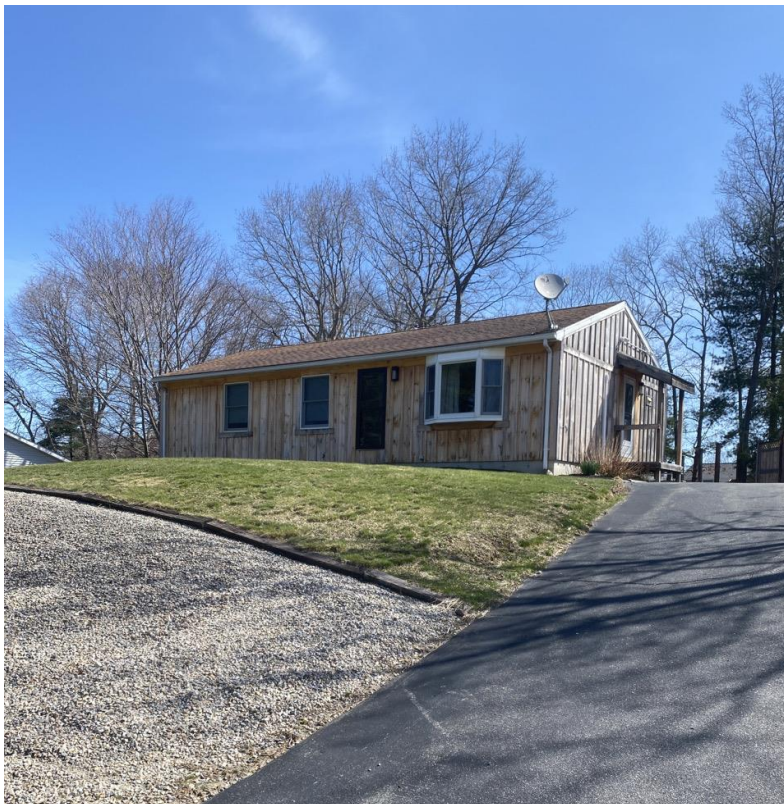
x The property is not contributing to slum and blight

Foundation                Good

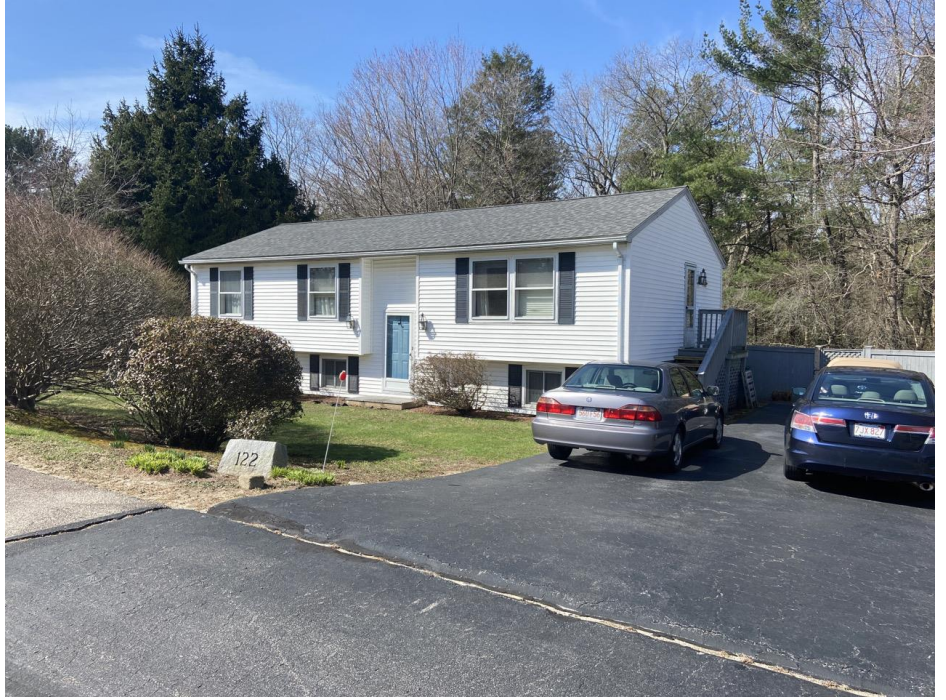
- ☐ Physical Deterioration of Building  
☐ Abandoned Property  
☐ Chronic High Occupancy Turnover  
☐ Chronic High Vacancy Rate  
☐ Significant Decline in Property Value  
☐ Abnormally Low Property Value  
☐ Known or Suspected Environmental Contamination  
☐ Other (please explain)  
*x The property is not contributing to slum and blight*

Foundation                      Good

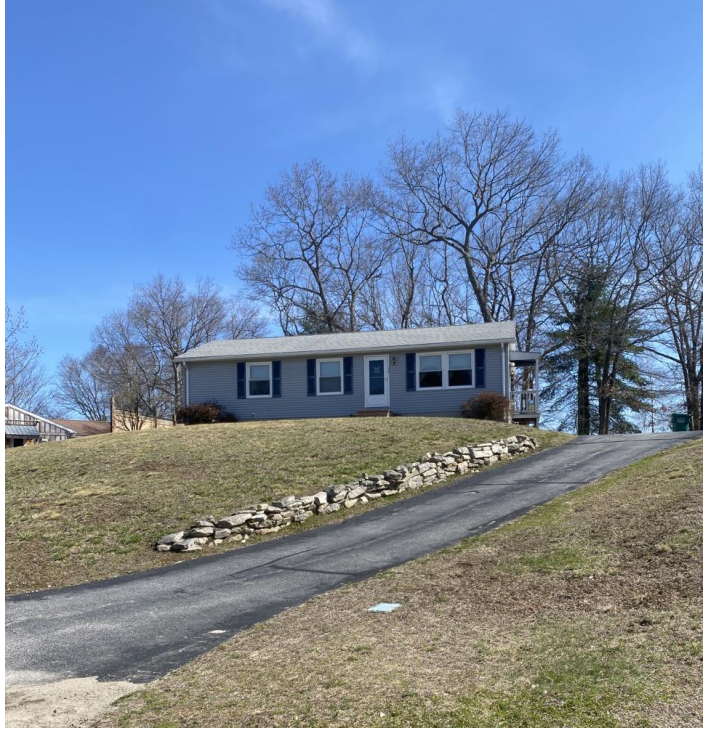
x *The property is not contributing to slum and blight*

Foundation	Good
------------	------

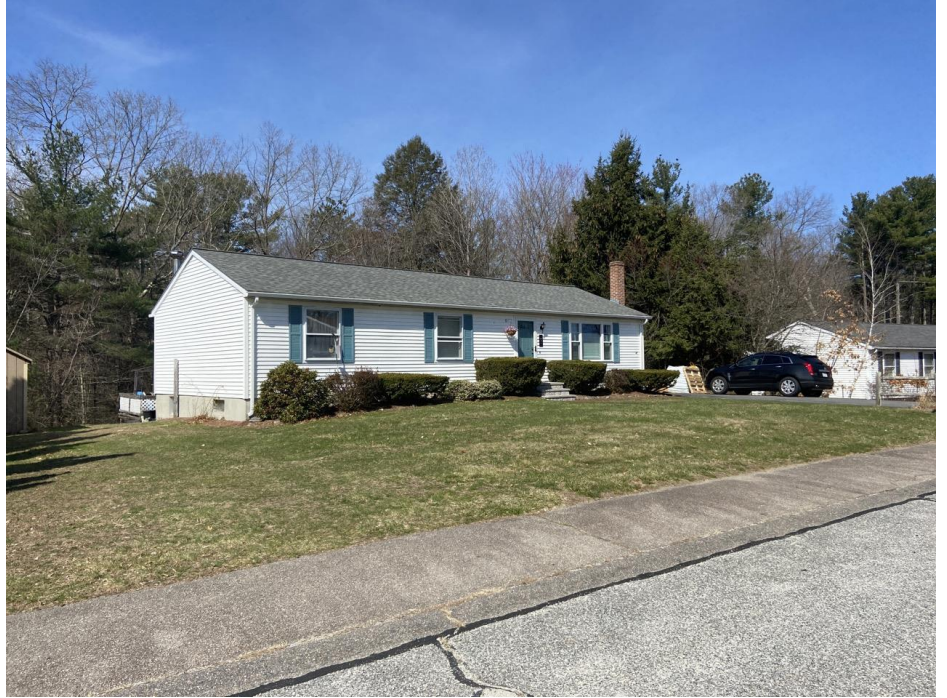
- ☐ Physical Deterioration of Building  
☐ Abandoned Property  
☐ Chronic High Occupancy Turnover  
☐ Chronic High Vacancy Rate  
☐ Significant Decline in Property Value  
☐ Abnormally Low Property Value  
☐ Known or Suspected Environmental Contamination  
☐ Other (please explain)  
*x The property is not contributing to slum and blight*

Foundation                      Good

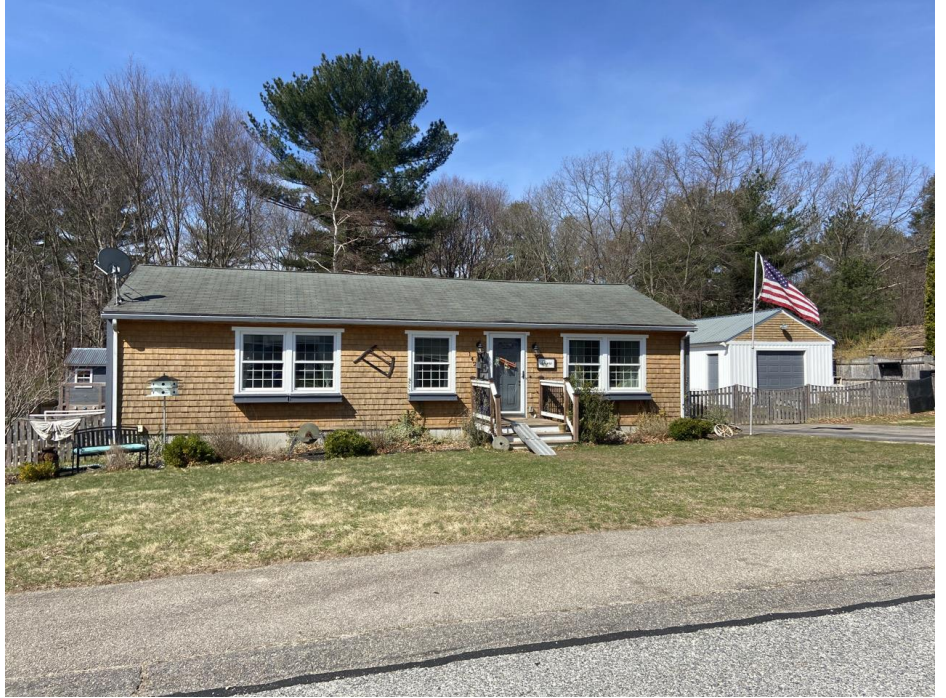
- ☐ Physical Deterioration of Building  
☐ Abandoned Property  
☐ Chronic High Occupancy Turnover  
☐ Chronic High Vacancy Rate  
☐ Significant Decline in Property Value  
☐ Abnormally Low Property Value  
☐ Known or Suspected Environmental Contamination  
☐ Other (please explain)  
*x The property is not contributing to slum and blight*

Roofing	Good
Windows and Doors	Excellent
Exterior Walls	Fair
Porch/Stairs/Deck	Fair – chipped/faded paint
Foundation	Good
Storefront & Signage	
Parking Lots	
Other:

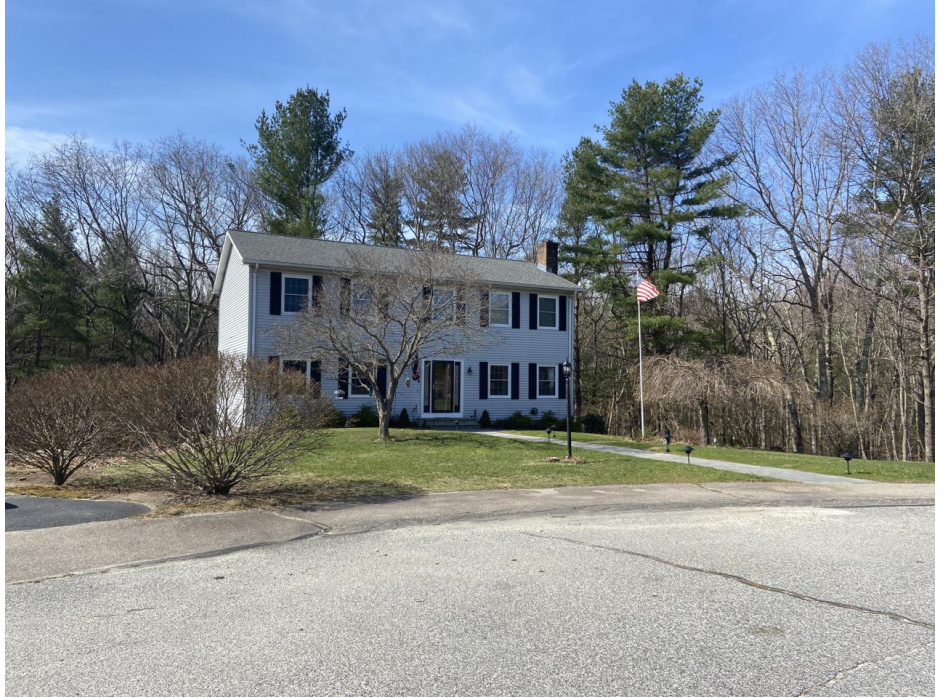
- ☐ Physical Deterioration of Building  
☐ Abandoned Property  
☐ Chronic High Occupancy Turnover  
☐ Chronic High Vacancy Rate  
☐ Significant Decline in Property Value  
☐ Abnormally Low Property Value  
☐ Known or Suspected Environmental Contamination  
☐ Other (please explain)  
x *The property is not contributing to slum and blight*

Foundation                      Excellent

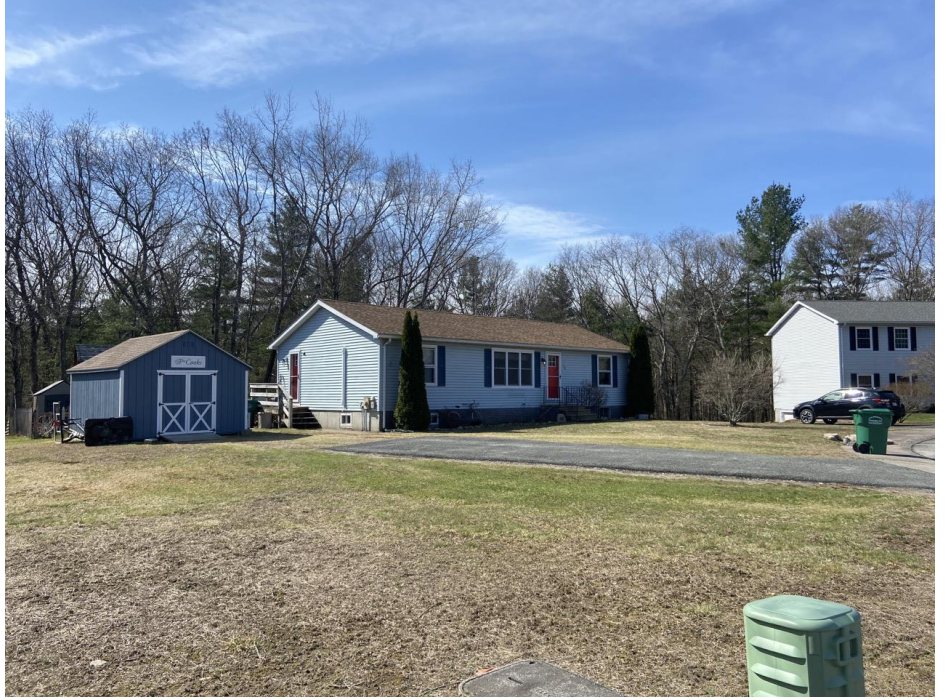
- ☐ Physical Deterioration of Building  
☐ Abandoned Property  
☐ Chronic High Occupancy Turnover  
☐ Chronic High Vacancy Rate  
☐ Significant Decline in Property Value  
☐ Abnormally Low Property Value  
☐ Known or Suspected Environmental Contamination  
☐ Other (please explain)  
*x The property is not contributing to slum and blight*

<u>Component</u>	<u>Condition</u>
Roofing	Excellent
Windows and Doors	Excellent
Exterior Walls	Fair – faded
Porch/Stairs/Deck	Good
Foundation	Good
Storefront & Signage	
Parking Lots	
Other:

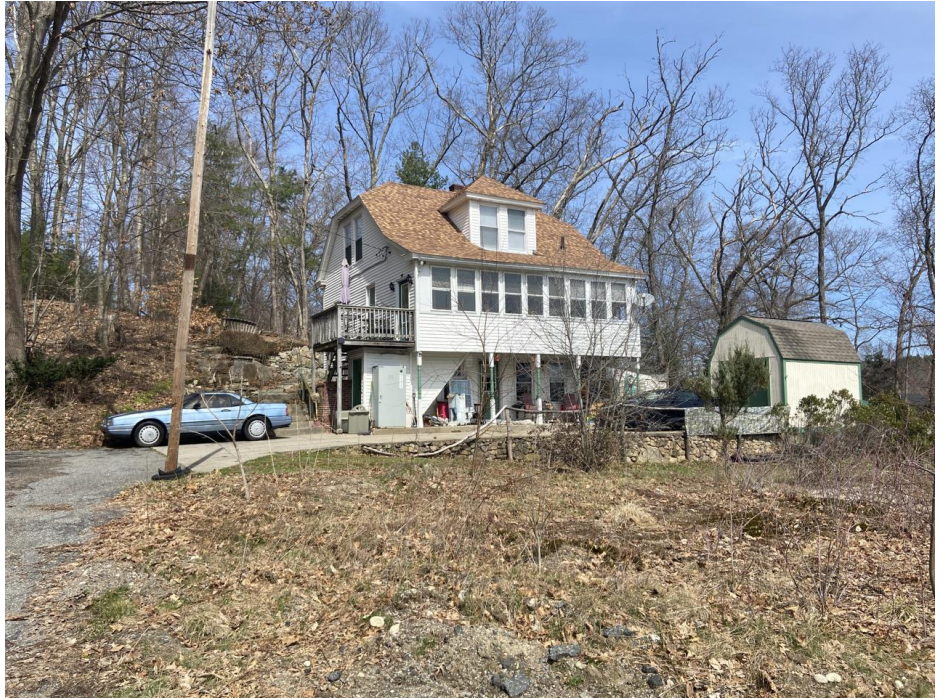
- ☐ Physical Deterioration of Building  
☐ Abandoned Property  
☐ Chronic High Occupancy Turnover  
☐ Chronic High Vacancy Rate  
☐ Significant Decline in Property Value  
☐ Abnormally Low Property Value  
☐ Known or Suspected Environmental Contamination  
☐ Other (please explain)  
☐ *The property is not contributing to slum and blight*

Foundation	Good
------------	------

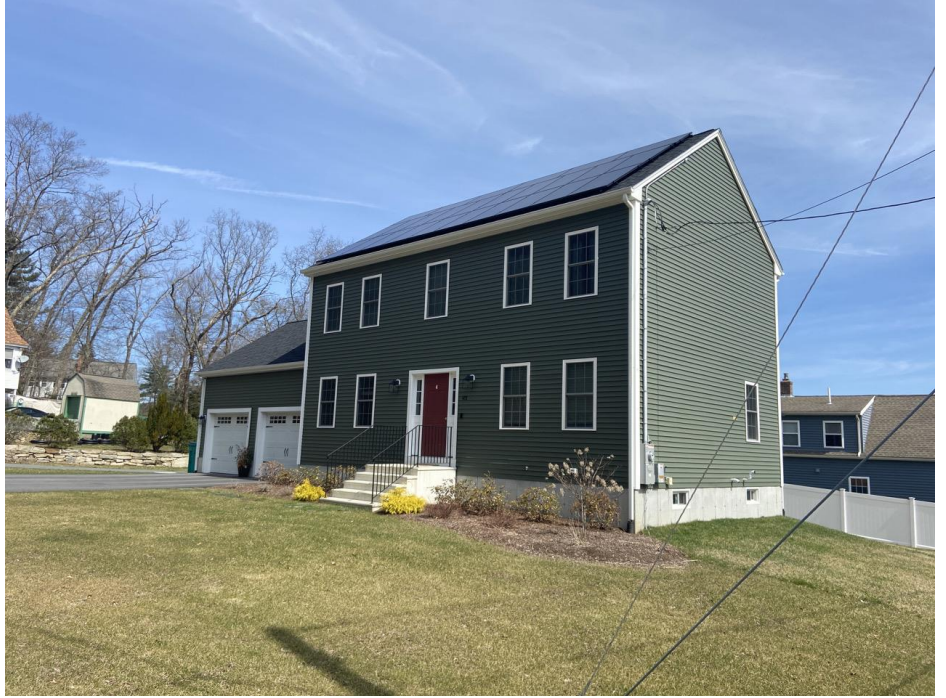
- ☐ Physical Deterioration of Building  
☐ Abandoned Property  
☐ Chronic High Occupancy Turnover  
☐ Chronic High Vacancy Rate  
☐ Significant Decline in Property Value  
☐ Abnormally Low Property Value  
☐ Known or Suspected Environmental Contamination  
☐ Other (please explain)  
x *The property is not contributing to slum and blight*

Foundation                      Excellent

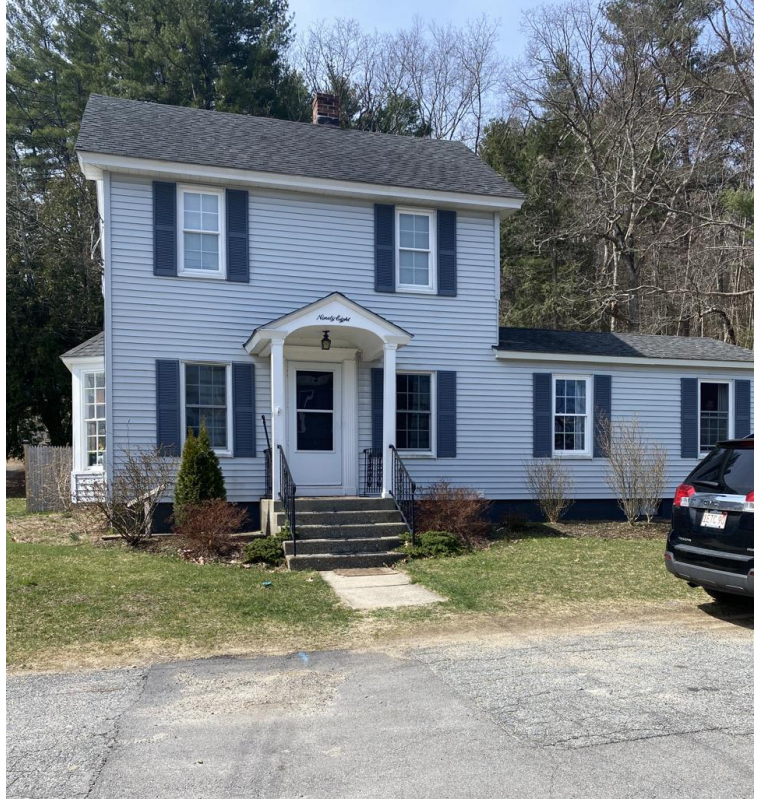
- ☐ Physical Deterioration of Building  
☐ Abandoned Property  
☐ Chronic High Occupancy Turnover  
☐ Chronic High Vacancy Rate  
☐ Significant Decline in Property Value  
☐ Abnormally Low Property Value  
☐ Known or Suspected Environmental Contamination  
☐ Other (please explain)  
*x The property is not contributing to slum and blight*

Foundation                      Good

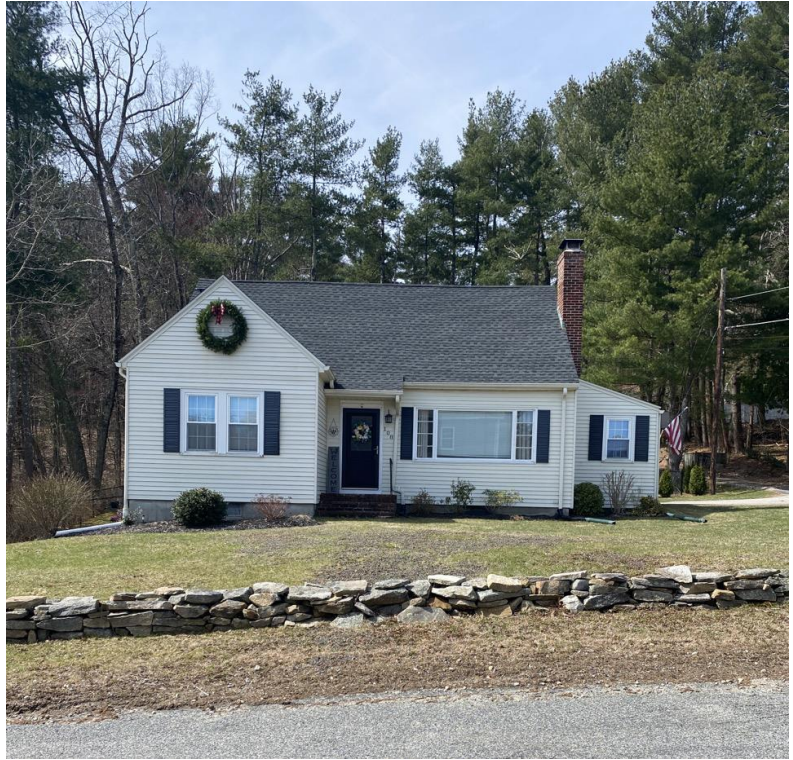
- ☐ Physical Deterioration of Building  
☐ Abandoned Property  
☐ Chronic High Occupancy Turnover  
☐ Chronic High Vacancy Rate  
☐ Significant Decline in Property Value  
☐ Abnormally Low Property Value  
☐ Known or Suspected Environmental Contamination  
☐ Other (please explain)  
☒ *The property is not contributing to slum and blight*

Foundation                Good

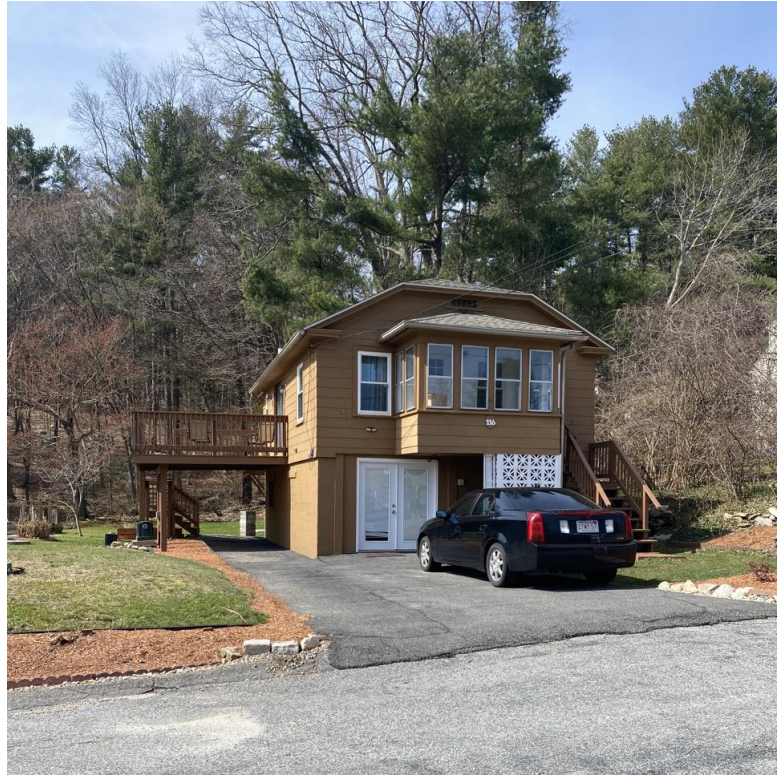
- ☐ Physical Deterioration of Building  
☐ Abandoned Property  
☐ Chronic High Occupancy Turnover  
☐ Chronic High Vacancy Rate  
☐ Significant Decline in Property Value  
☐ Abnormally Low Property Value  
☐ Known or Suspected Environmental Contamination  
☐ Other (please explain)  
*x The property is not contributing to slum and blight*

Foundation                        Good
