# Northbridge Slum & Blight Inventory

## Rockdale Target Area

Report compiled by the Pioneer Valley  
Planning Commission for the Town of  
Northbridge

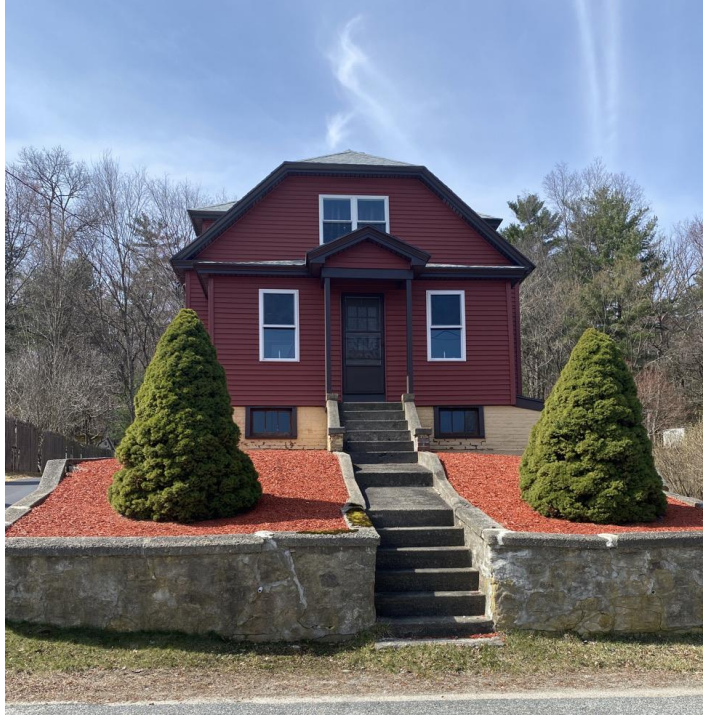
- ☐ Physical Deterioration of Building  
☐ Abandoned Property  
☐ Chronic High Occupancy Turnover  
☐ Chronic High Vacancy Rate  
☐ Significant Decline in Property Value  
☐ Abnormally Low Property Value  
☐ Known or Suspected Environmental Contamination  
☐ Other (please explain)  
x *The property is not contributing to slum and blight*

Foundation

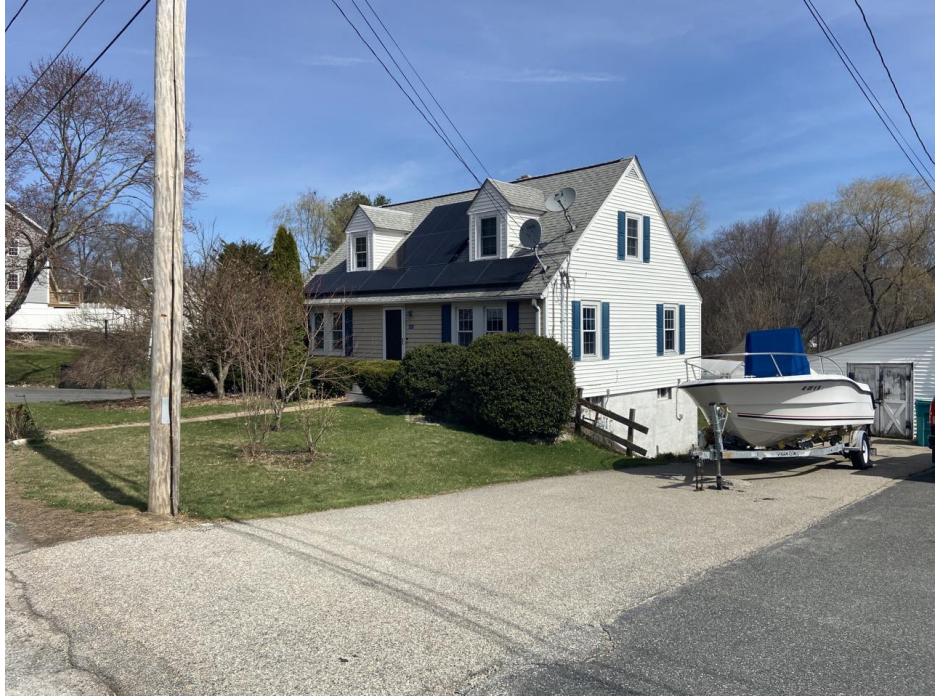
- ☐ Physical Deterioration of Building  
☐ Abandoned Property  
☐ Chronic High Occupancy Turnover  
☐ Chronic High Vacancy Rate  
☐ Significant Decline in Property Value  
☐ Abnormally Low Property Value  
☐ Known or Suspected Environmental Contamination  
☐ Other (please explain)  
*x The property is not contributing to slum and blight*

<u>Component</u>	<u>Condition</u>
Roofing	Excellent
Windows and Doors	Excellent
Exterior Walls	Excellent
Porch/Stairs/Deck	Good
Foundation	Good
Storefront & Signage	
Parking Lots	
Other:	
Overall Property Rating: (Excellent / Good / Fair / Poor) briefly state why.	Good

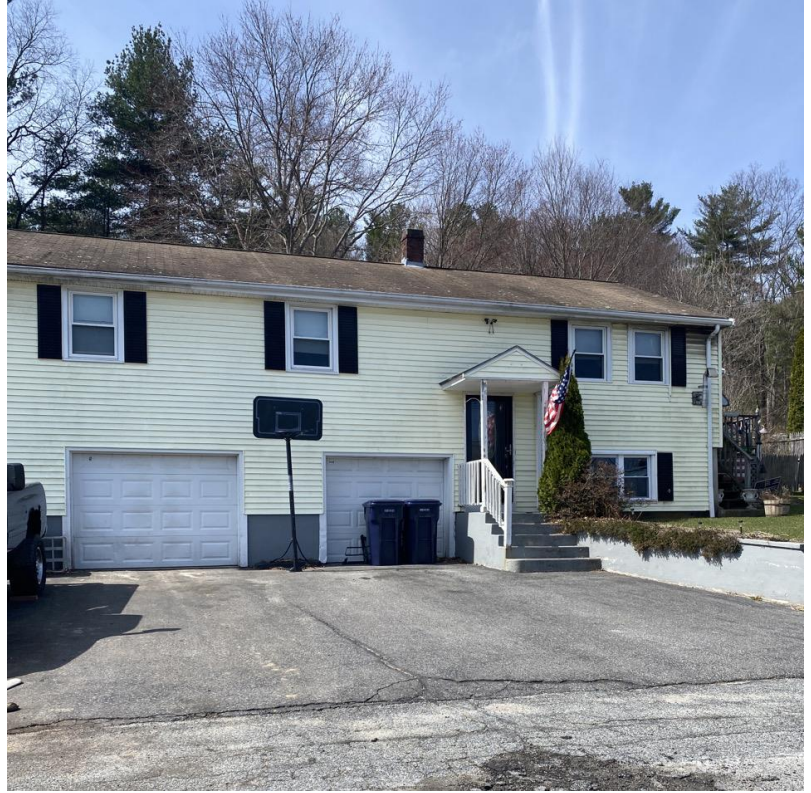
☒ Physical Deterioration of Building

Roofing                      Poor – stains with moss growth

Exterior Walls            Fair - stains

Foundation               Good

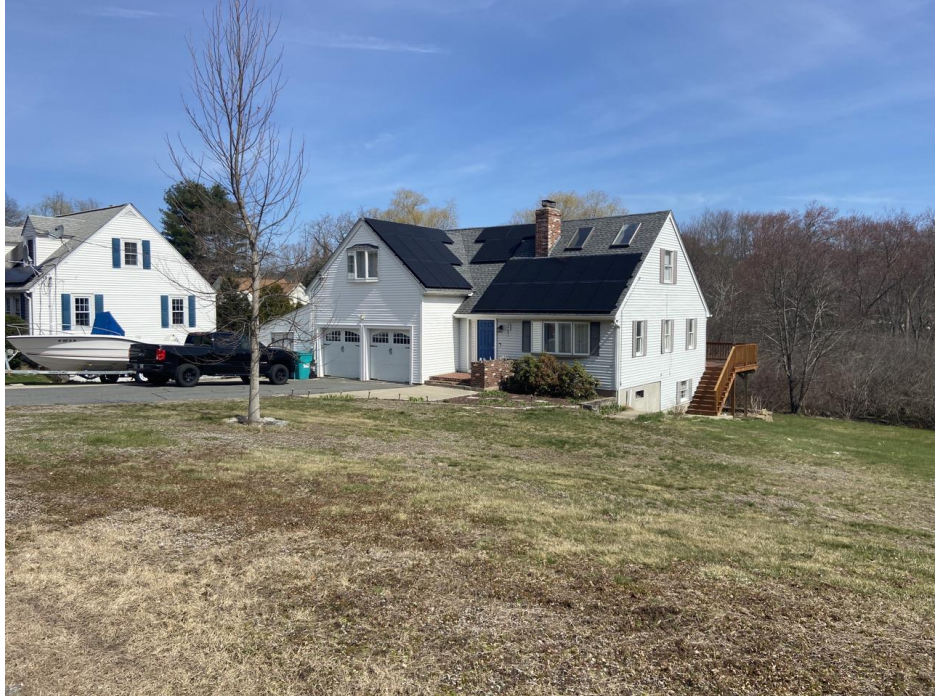
- ☐ Physical Deterioration of Building  
☐ Abandoned Property  
☐ Chronic High Occupancy Turnover  
☐ Chronic High Vacancy Rate  
☐ Significant Decline in Property Value  
☐ Abnormally Low Property Value  
☐ Known or Suspected Environmental Contamination  
☐ Other (please explain)  
*x The property is not contributing to slum and blight*

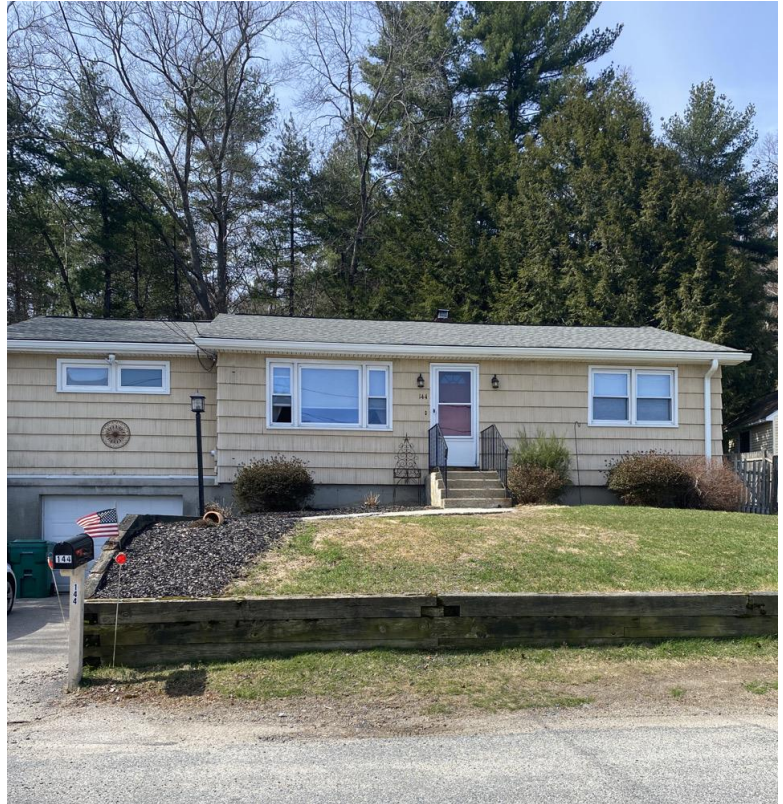
*x The property is not contributing to slum and blight*

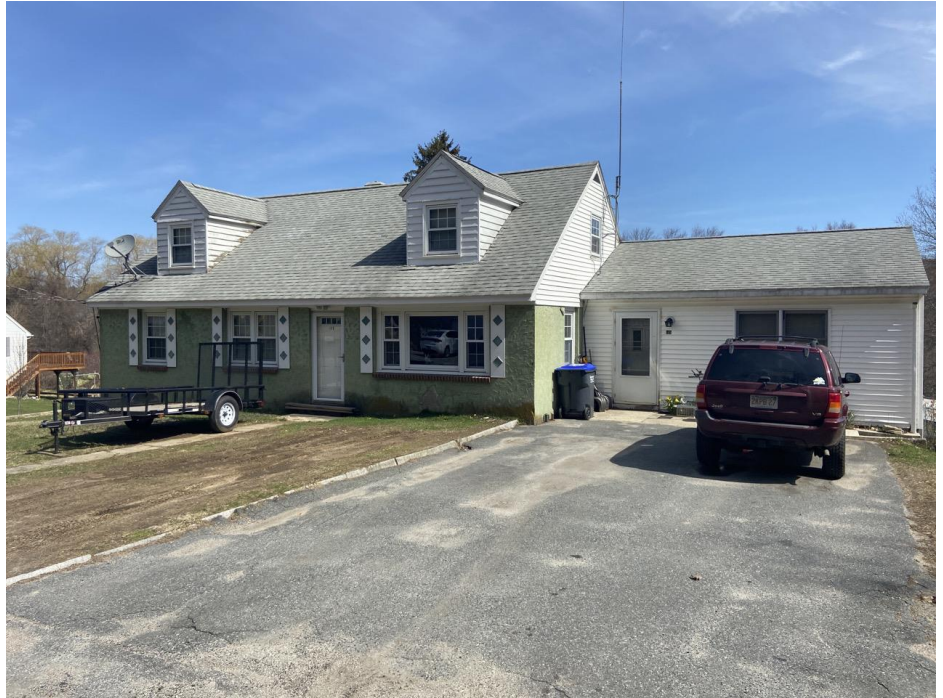
☒ Physical Deterioration of Building

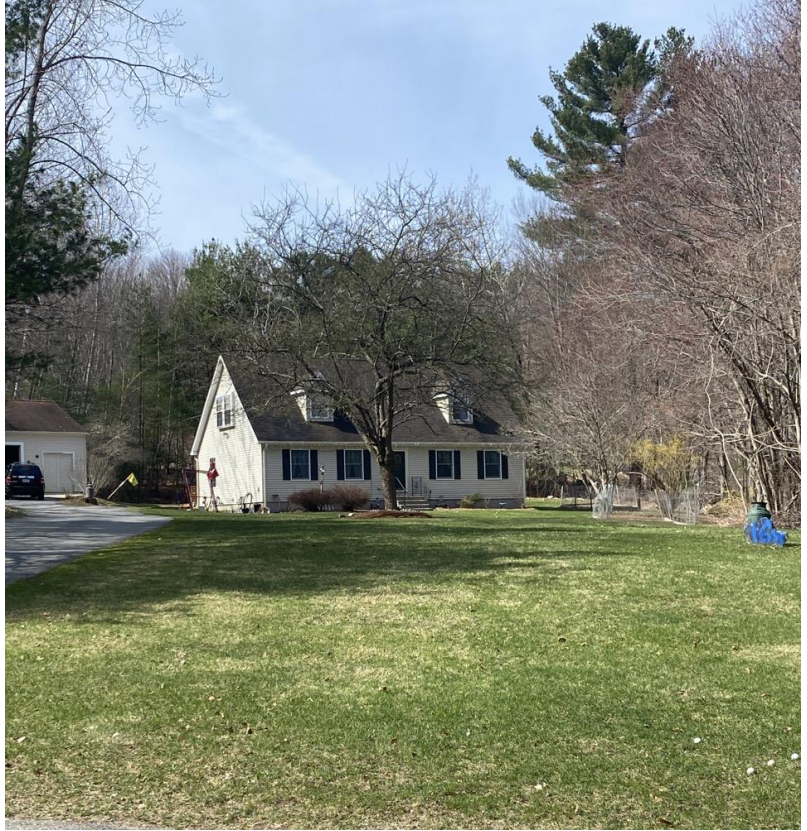
*x The property is not contributing to slum and blight*

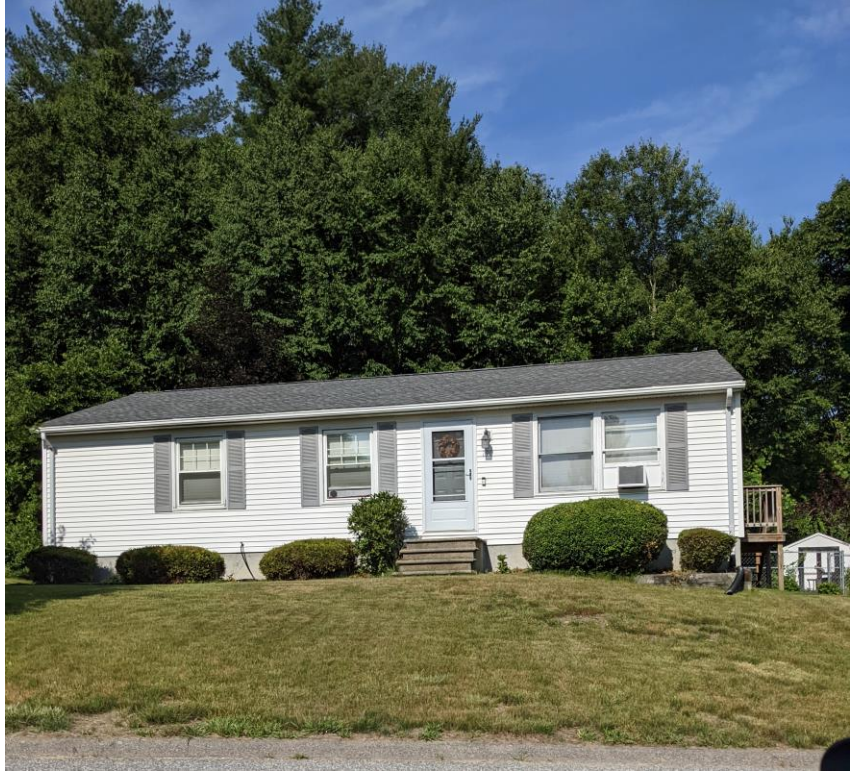
- ☐ Physical Deterioration of Building  
☐ Abandoned Property  
☐ Chronic High Occupancy Turnover  
☐ Chronic High Vacancy Rate  
☐ Significant Decline in Property Value  
☐ Abnormally Low Property Value  
☐ Known or Suspected Environmental Contamination  
☐ Other (please explain)  
☒ *The property is not contributing to slum and blight*

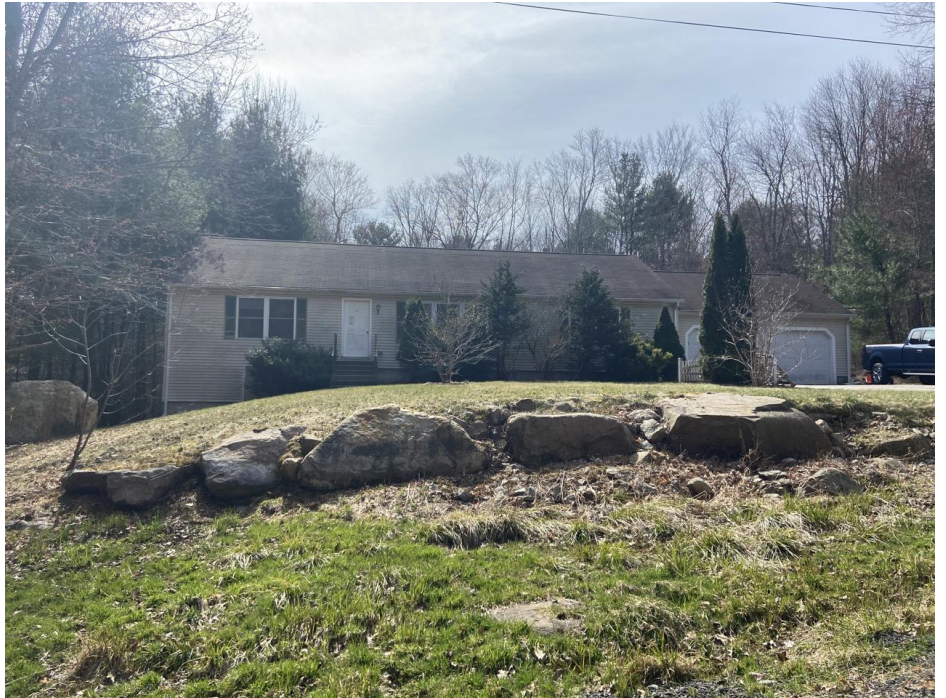
x Physical Deterioration of Building

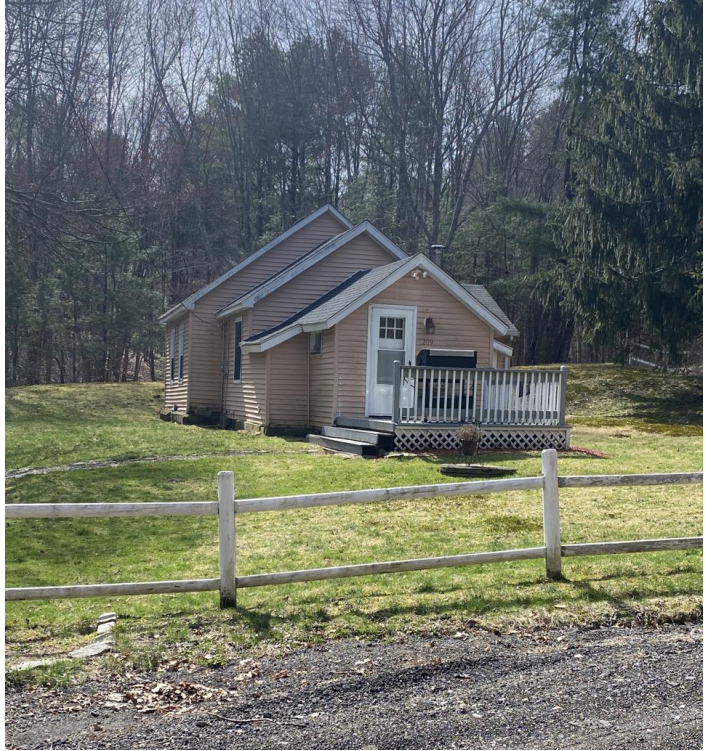
x Physical Deterioration of Building

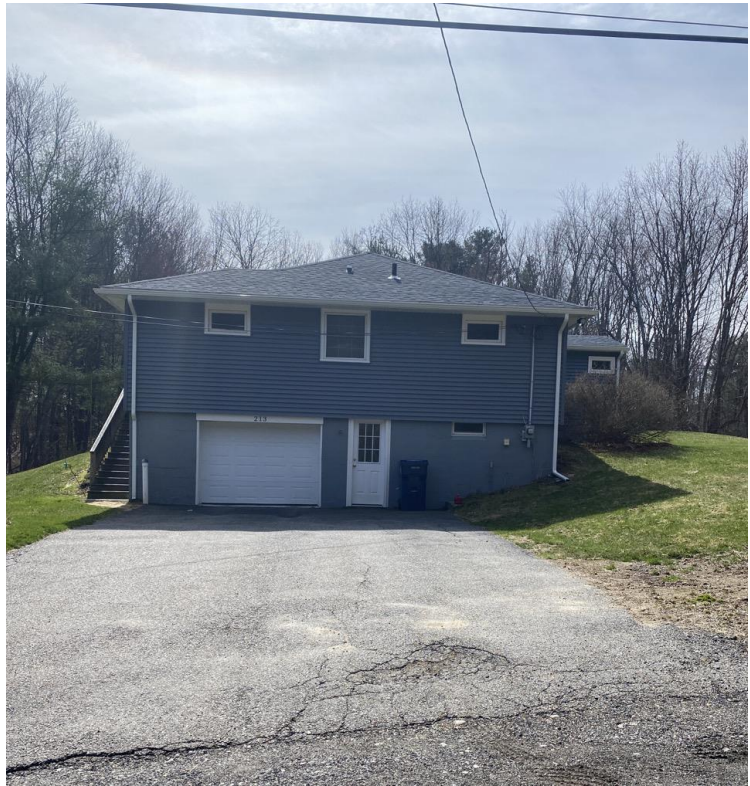
x *The property is not contributing to slum and blight*

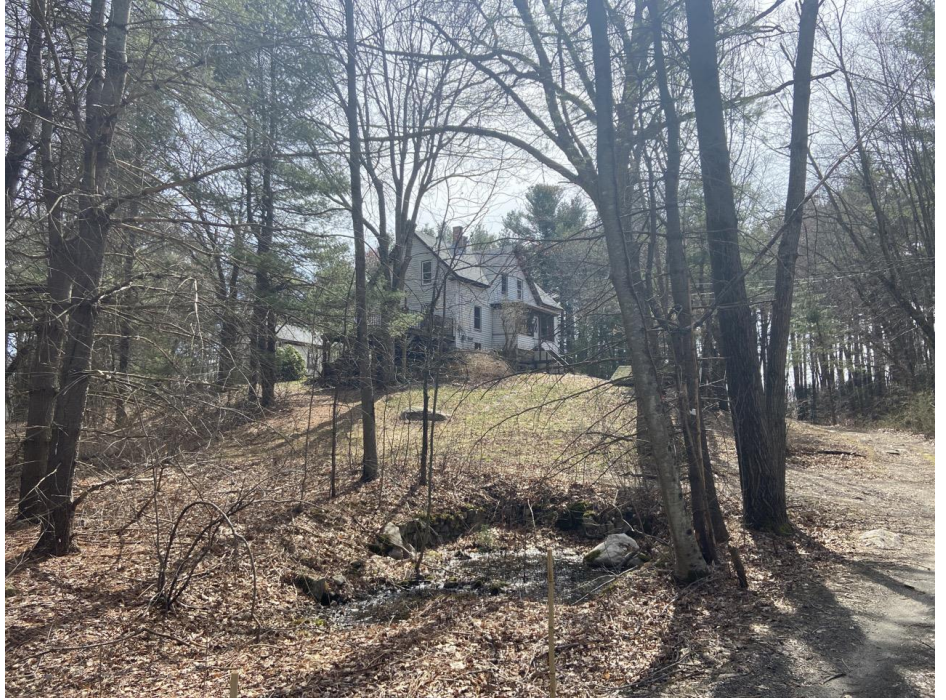
☒ Physical Deterioration of Building

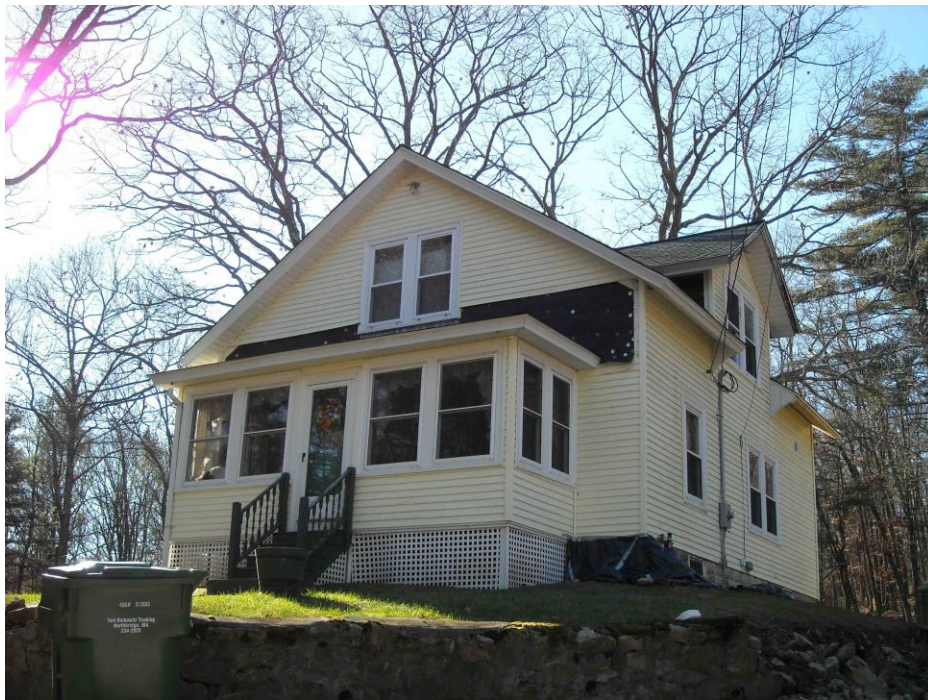
☒ Physical Deterioration of Building

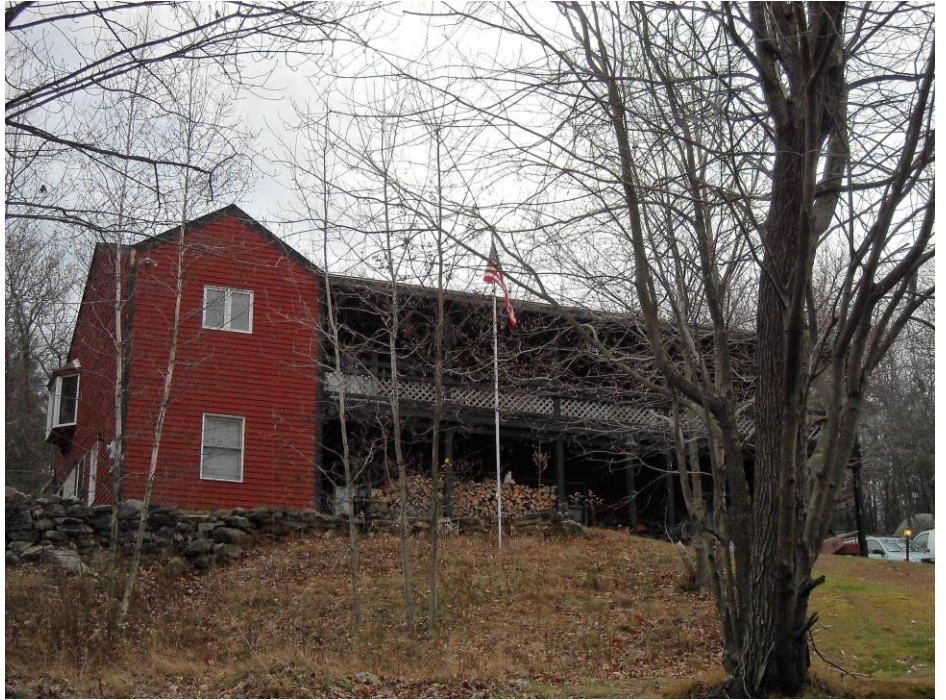
x The property is not contributing to slum and blight

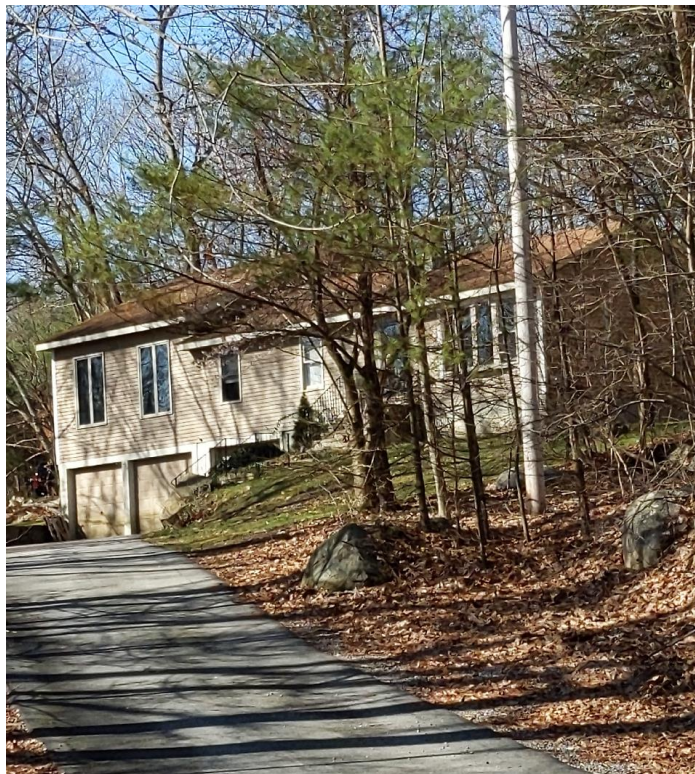
☒ The property is not contributing to slum and blight

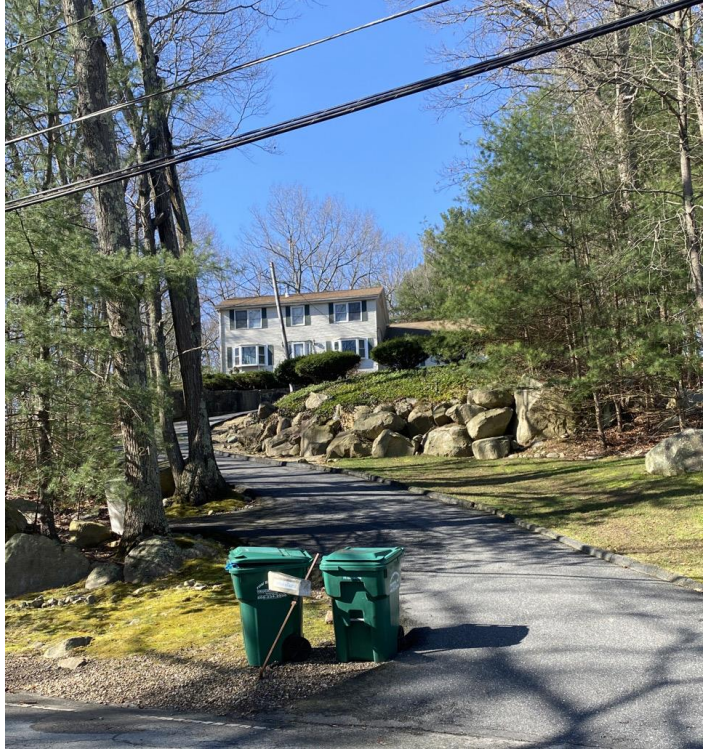
x The property is not contributing to slum and blight

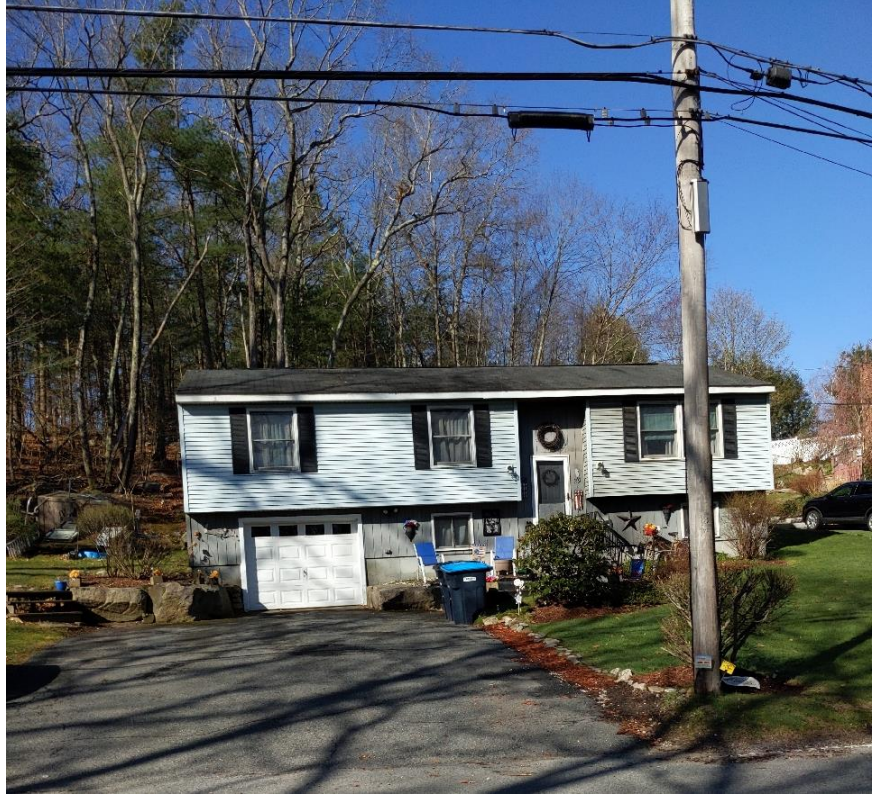
x Physical Deterioration of Building

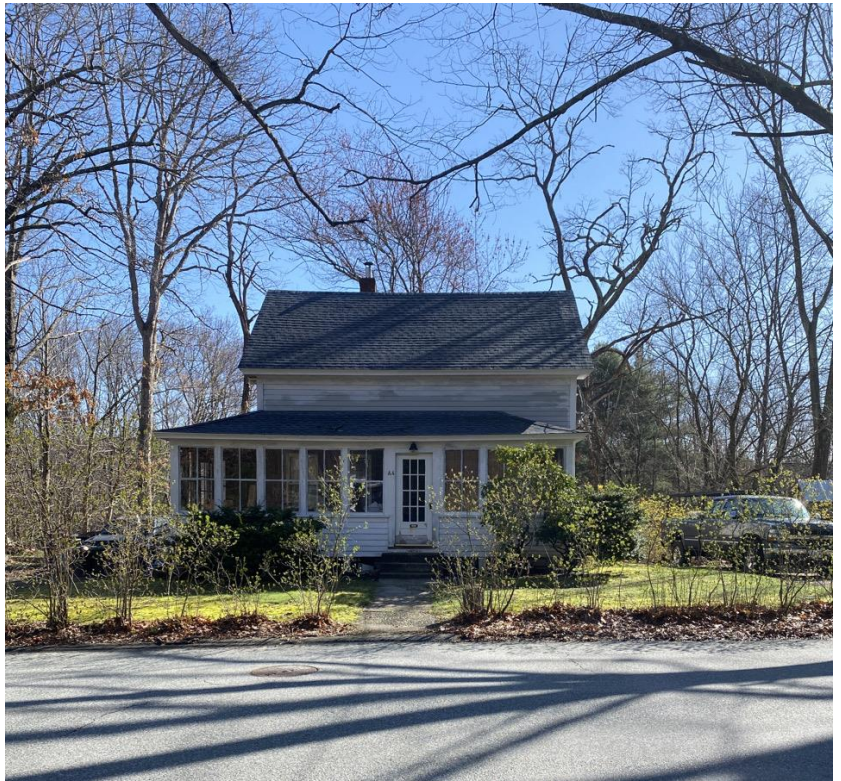
x Physical Deterioration of Building

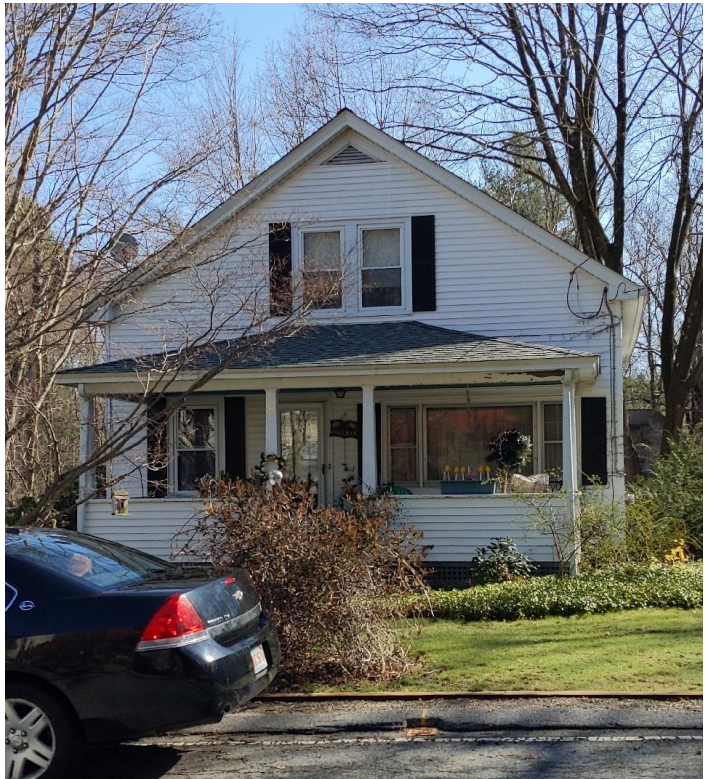
x Physical Deterioration of Building

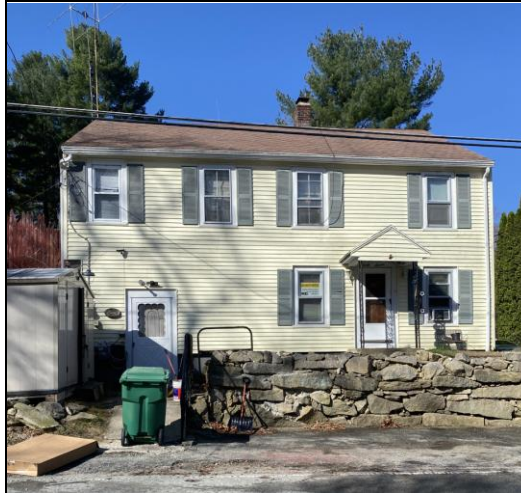
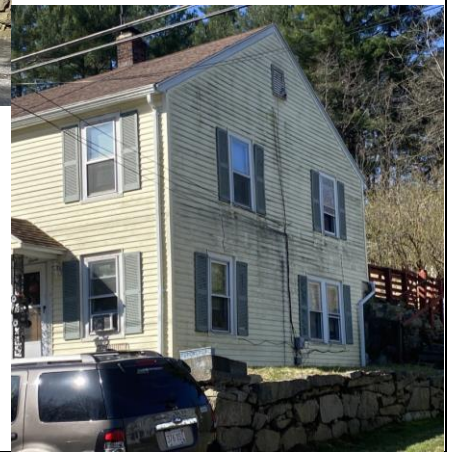
x Physical Deterioration of Building

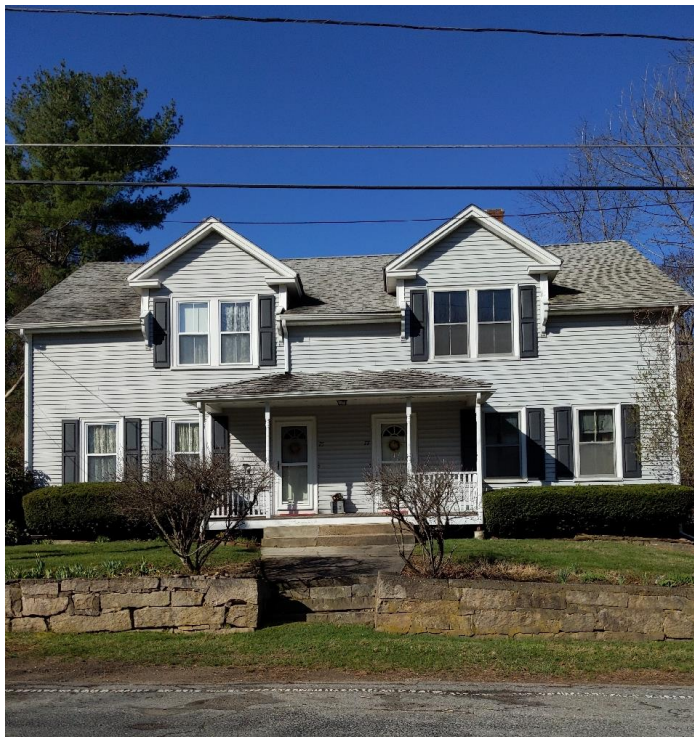
x *The property is not contributing to slum and blight*

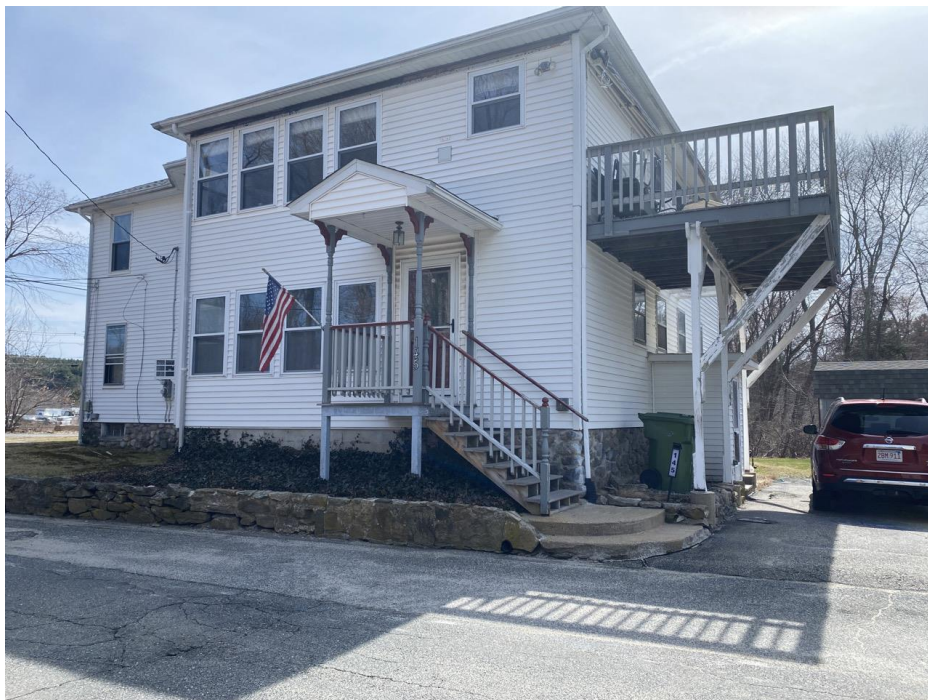
x Physical Deterioration of Building

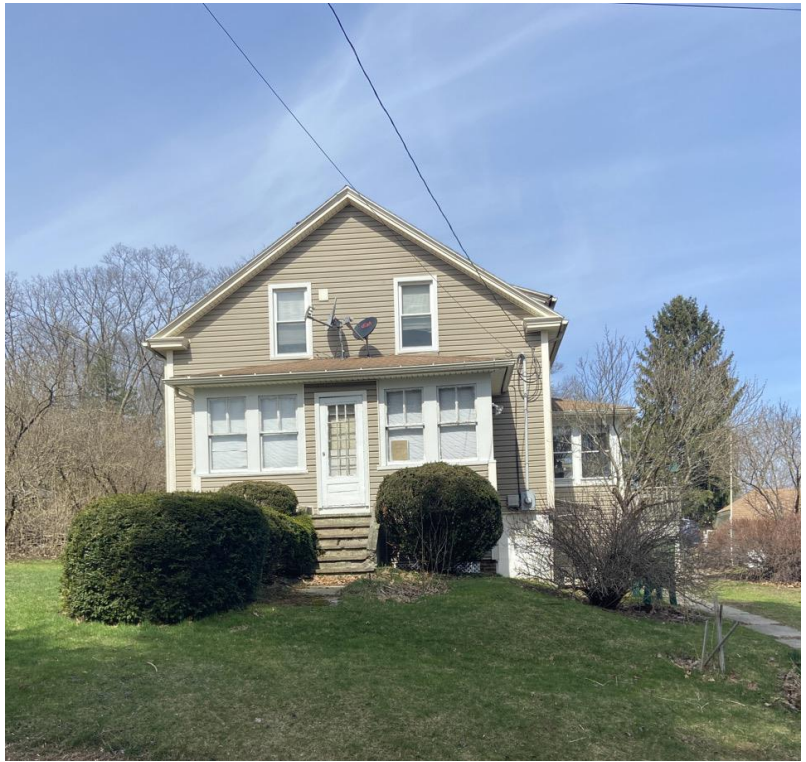
Roofing Fair – significant staining

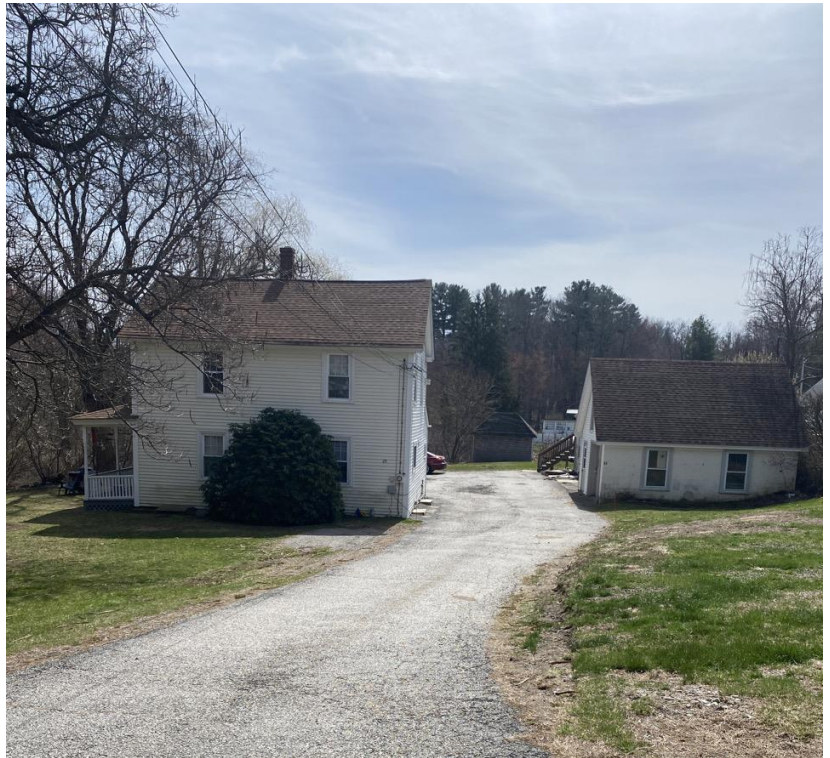
Roofing	Good
Windows and Doors	Good
Exterior Walls	Fair – stains and moss growth
Porch/Stairs/Deck	Unknown
Foundation	Unknown
Storefront & Signage	
Parking Lots	
Other:

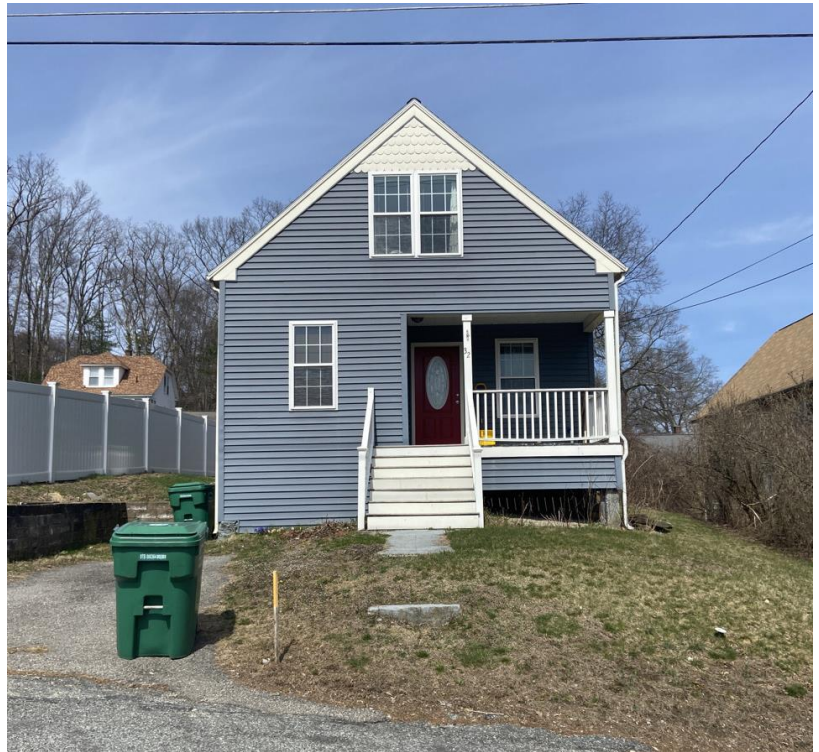
<u>Component</u>	<u>Condition</u>
Roofing	Excellent
Windows and Doors	Excellent
Exterior Walls	Excellent
Porch/Stairs/Deck	Excellent
Foundation	Good
Storefront & Signage	
Parking Lots	
Other:	
Overall Property Rating: (Excellent / Good / Fair / Poor) briefly state why. Excellent

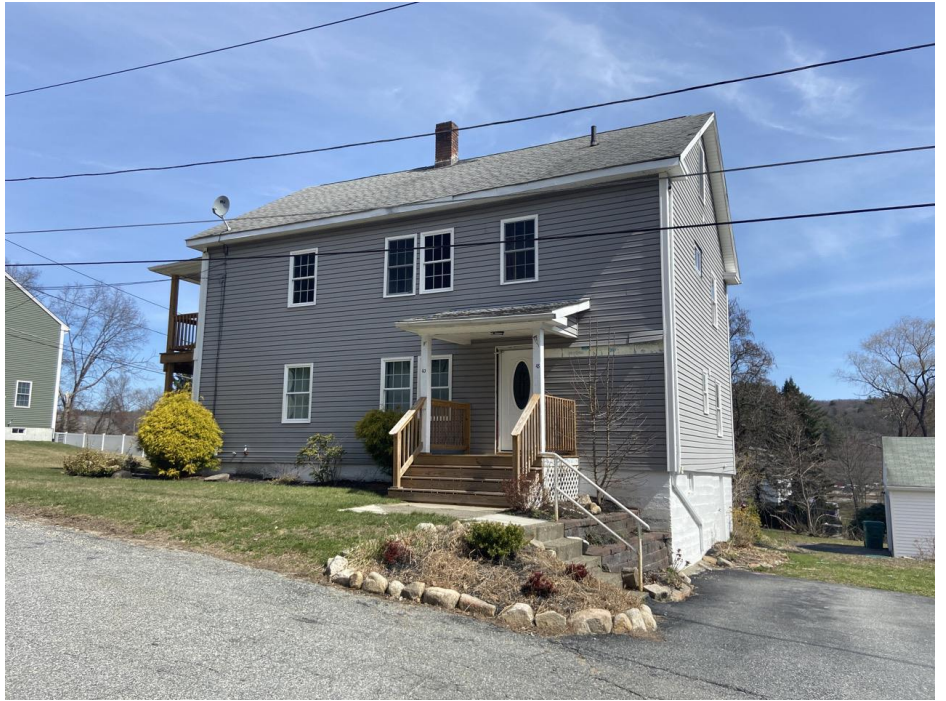
Roofing	Good
Windows and Doors	Good
Exterior Walls	Fair – missing siding, damaged trim
Porch/Stairs/Deck	Excellent
Foundation	Good
Storefront & Signage	
Parking Lots	
Other:

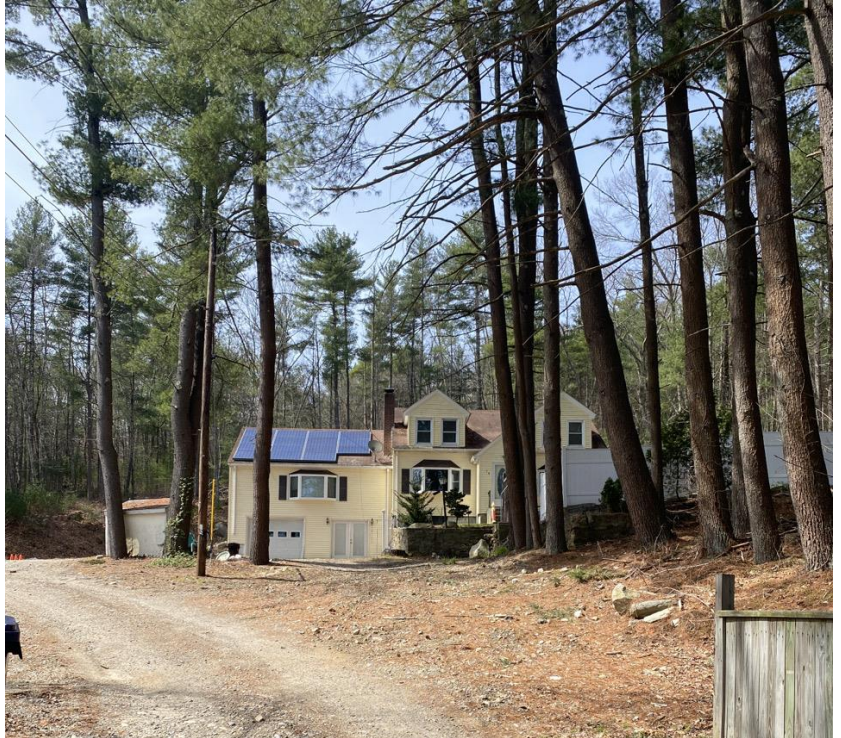
Roofing Fair – moss growth and stains

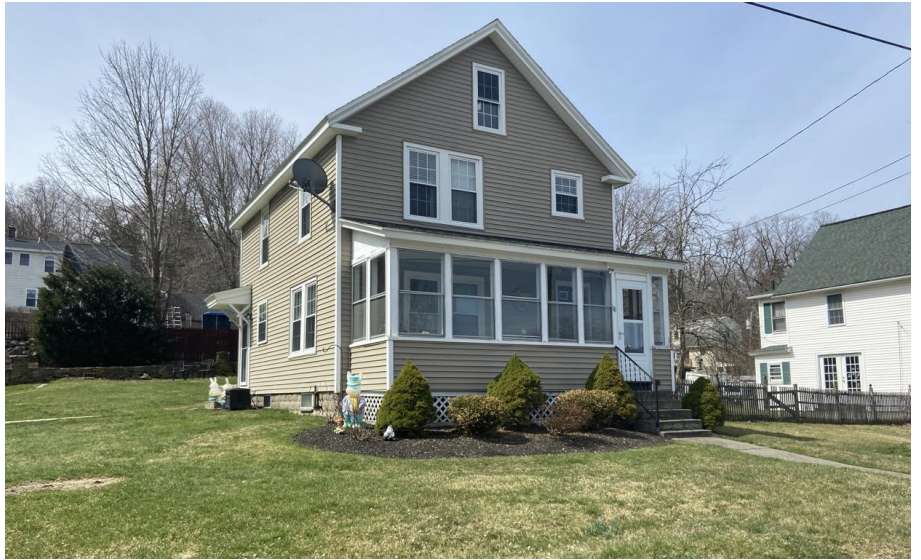
Roofing	Good
Windows and Doors	Fair – older style windows
Exterior Walls	Good
Porch/Stairs/Deck	Good
Foundation	Good
Storefront & Signage	
Parking Lots	
Other:

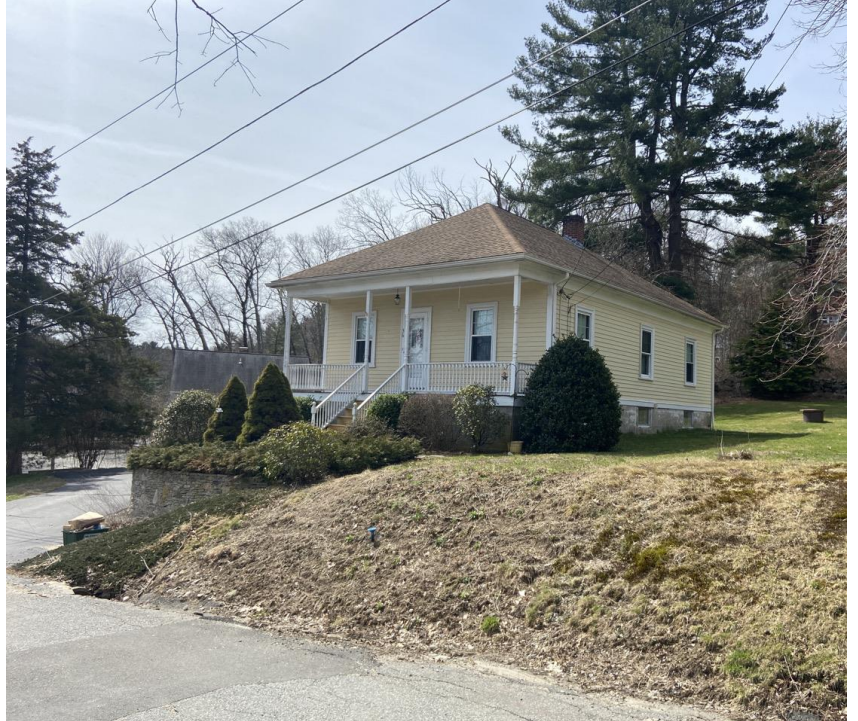
<u>Component</u>	<u>Condition</u>
Roofing	Good
Windows and Doors	Good
Exterior Walls	Good
Porch/Stairs/Deck	Good
Foundation	Fair – faded paint
Storefront & Signage	
Parking Lots	
Other:	
Overall Property Rating: (Excellent / Good / Fair / Poor) briefly state why. Good

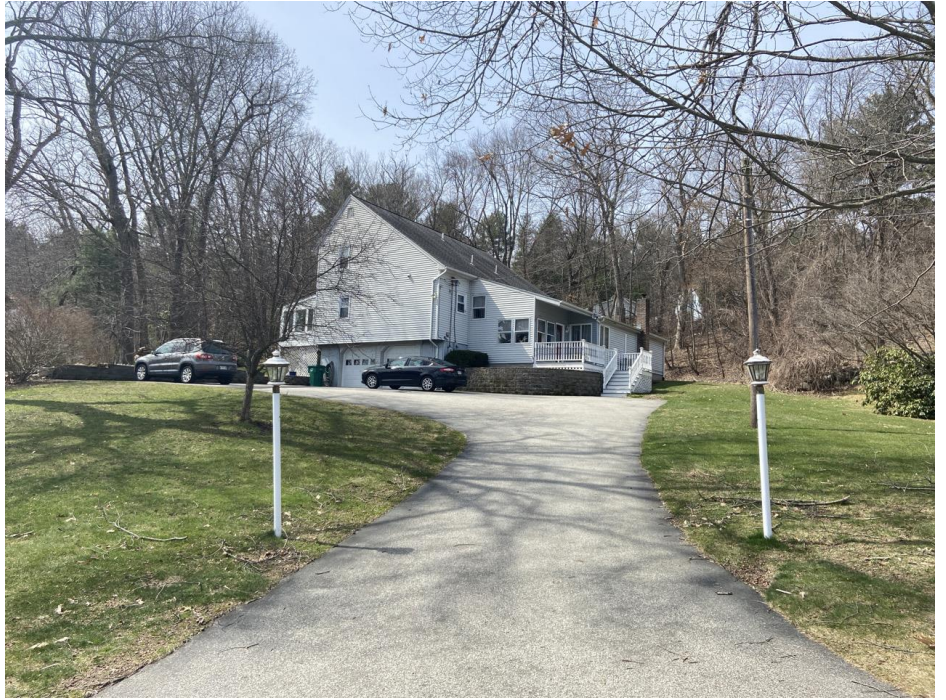
Roofing Fair – minor staining

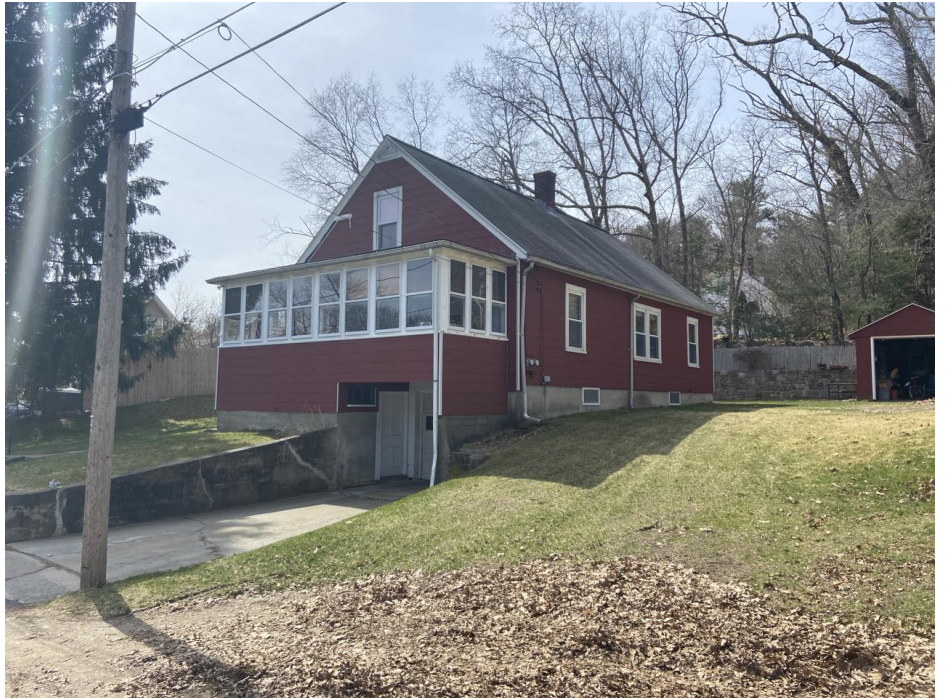
Roofing	Fair – stains
Windows and Doors	Fair – old
Exterior Walls	Fair – chipped paint
Porch/Stairs/Deck	Good
Foundation	Good
Storefront & Signage	
Parking Lots	
Other:

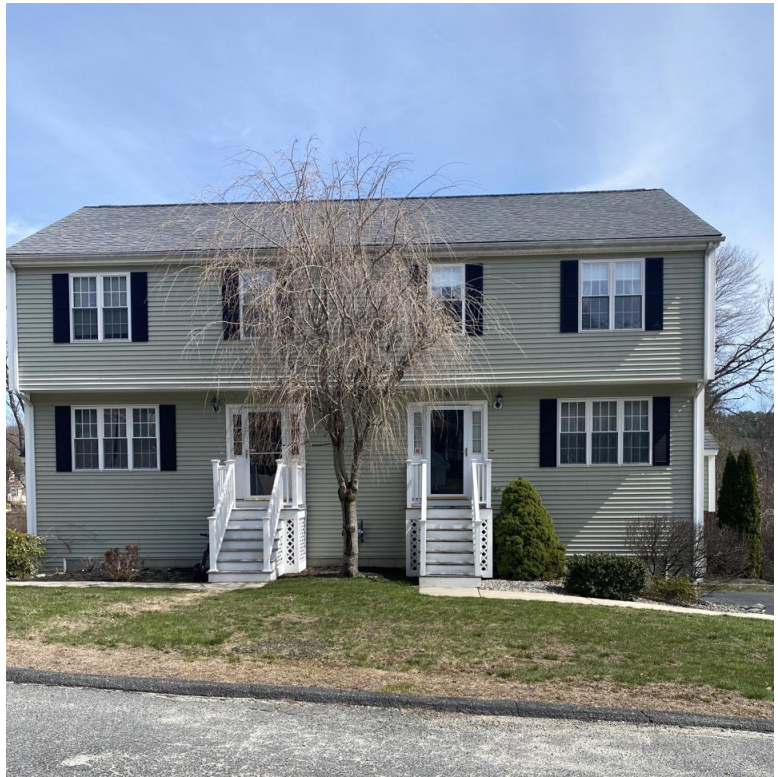
Roofing	Good
Windows and Doors	Good
Exterior Walls	Excellent
Porch/Stairs/Deck	Good
Foundation	Good
Storefront & Signage	
Parking Lots	
Other:

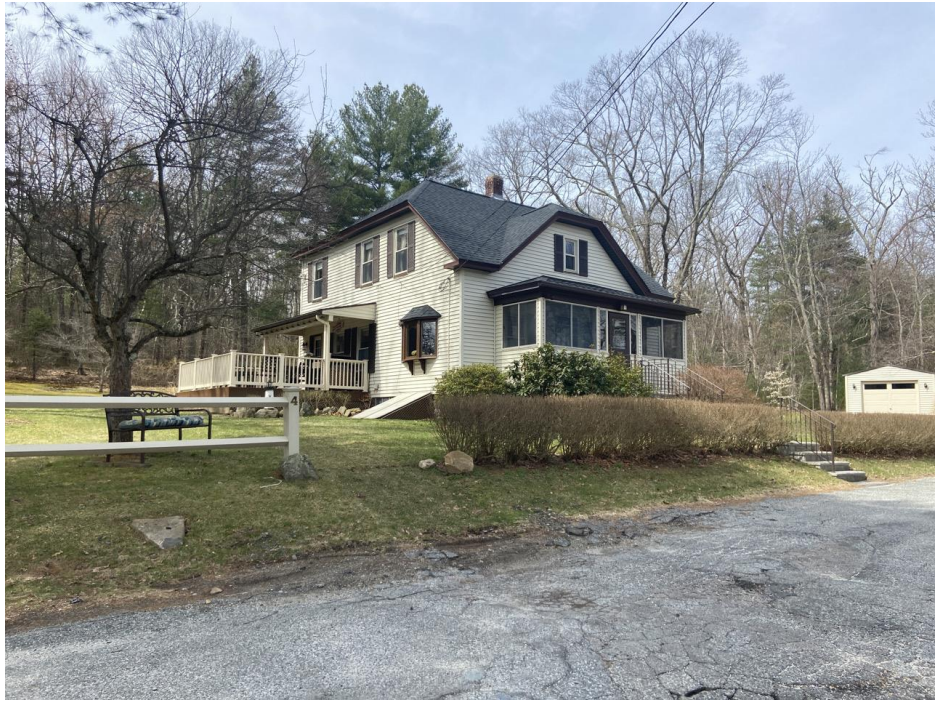
Roofing	Good
Windows and Doors	Fair – older
Exterior Walls	Good
Porch/Stairs/Deck	Good
Foundation	Good
Storefront & Signage	
Parking Lots	
Other:

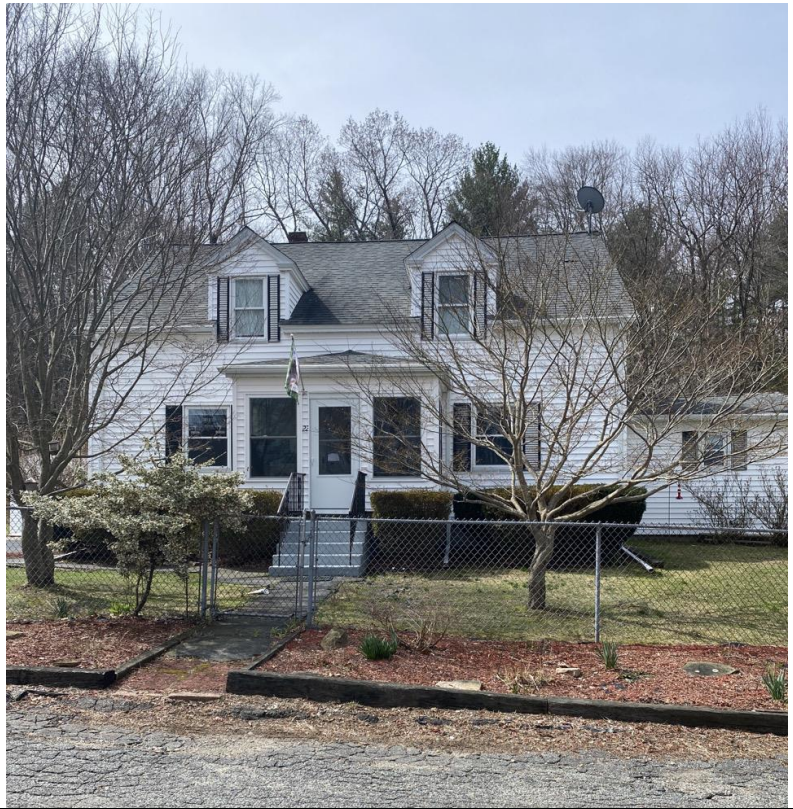
Roofing Fair – lifting shingles with stains

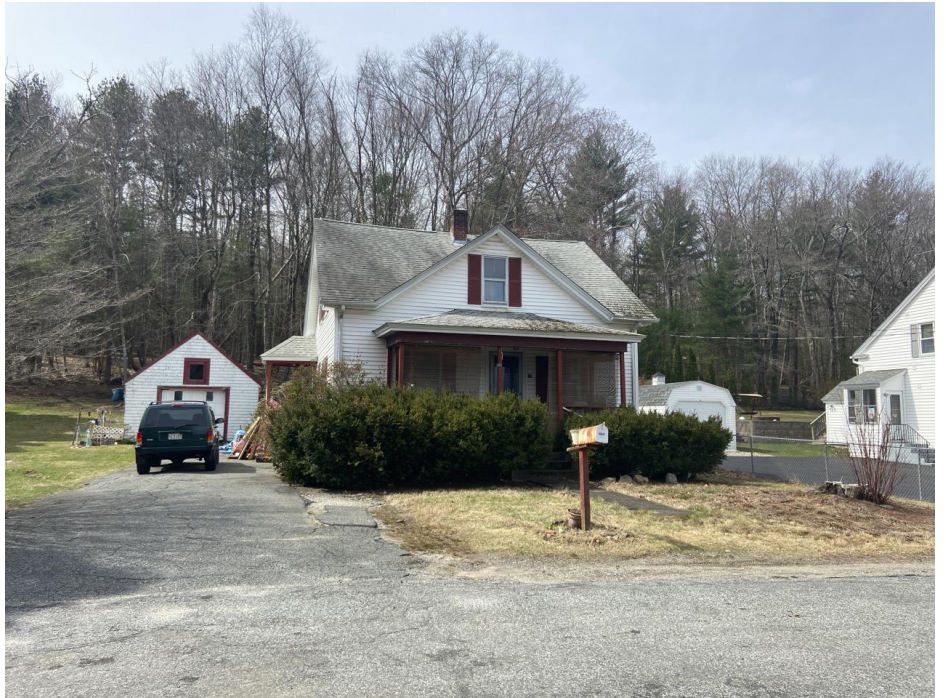
Roofing                      Poor – significant staining/ mold and moss growth

Exterior Walls            Fair – area of damaged siding

Porch/Stairs/Deck       Fair – damaged wood/chipped paint
