# Northbridge Slum & Blight Inventory

## Rockdale Target Area

Report compiled by the Pioneer Valley  
Planning Commission for the Town of  
Northbridge

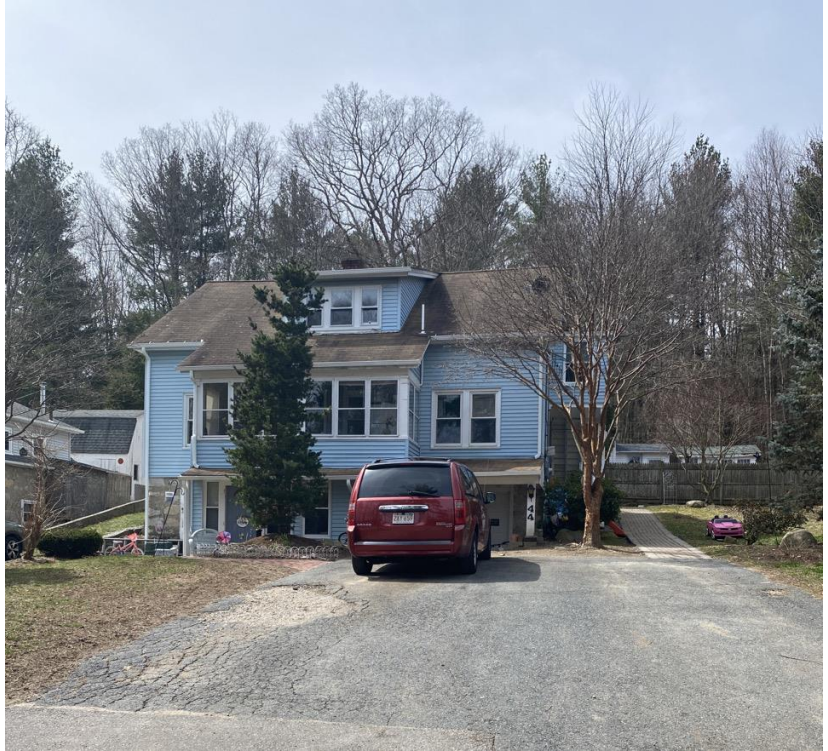
Roofing Poor – moss growth with stains

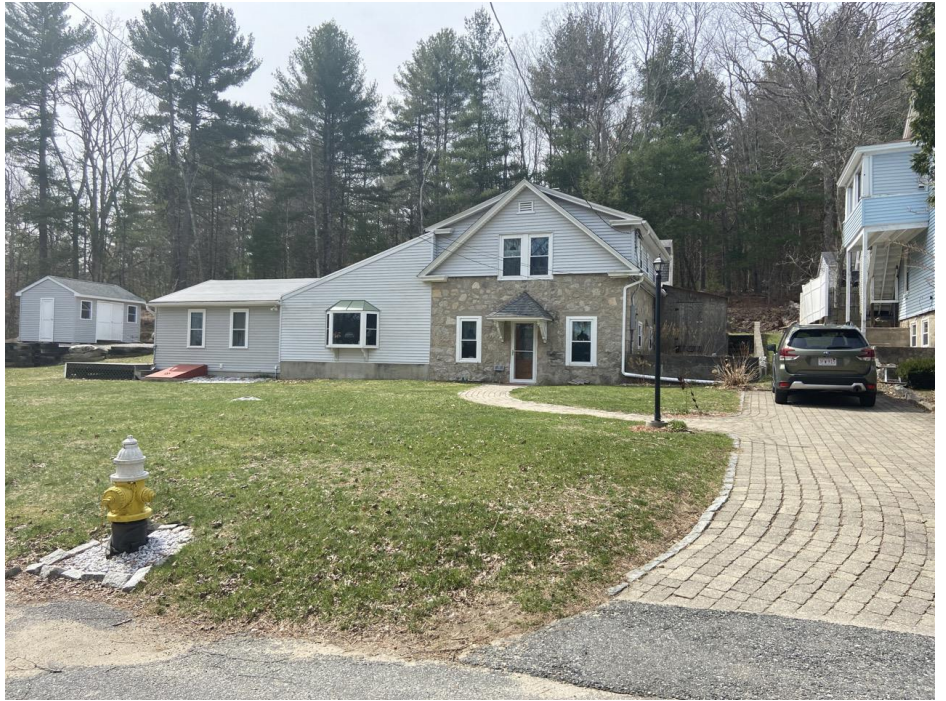
<u>Component</u>	<u>Condition</u>
Roofing	Good
Windows and Doors	Good
Exterior Walls	Good
Porch/Stairs/Deck	Fair – no railings
Foundation	Good
Storefront & Signage	
Parking Lots	
Other:	
Overall Property Rating: (Excellent / Good / Fair / Poor) briefly state why. Good

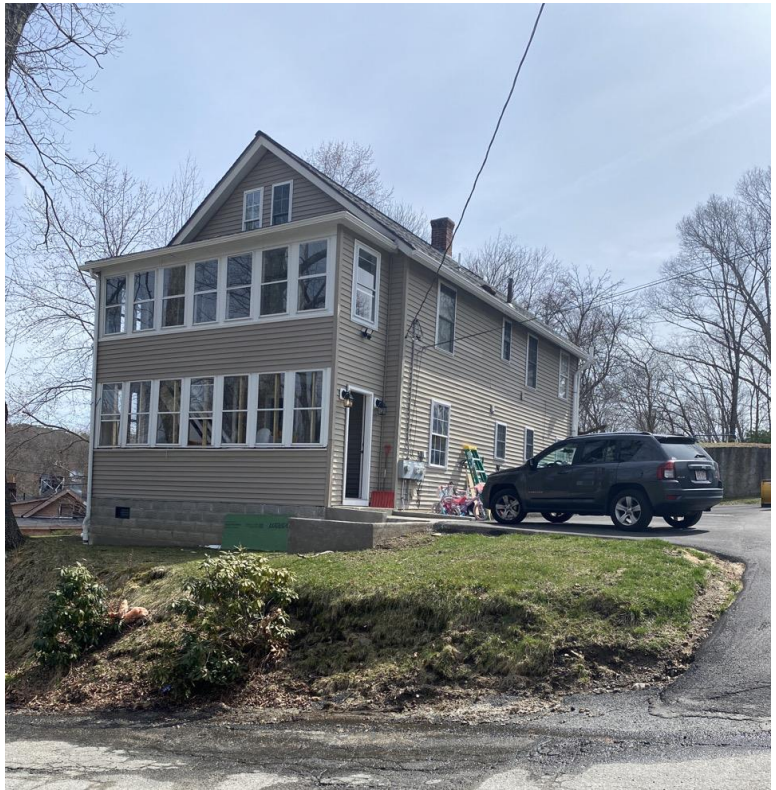
Roofing	Good – minor stains
Windows and Doors	Fair – missing/broken trim
Exterior Walls	Good
Porch/Stairs/Deck	Good
Foundation	Good
Storefront & Signage	
Parking Lots	
Other:

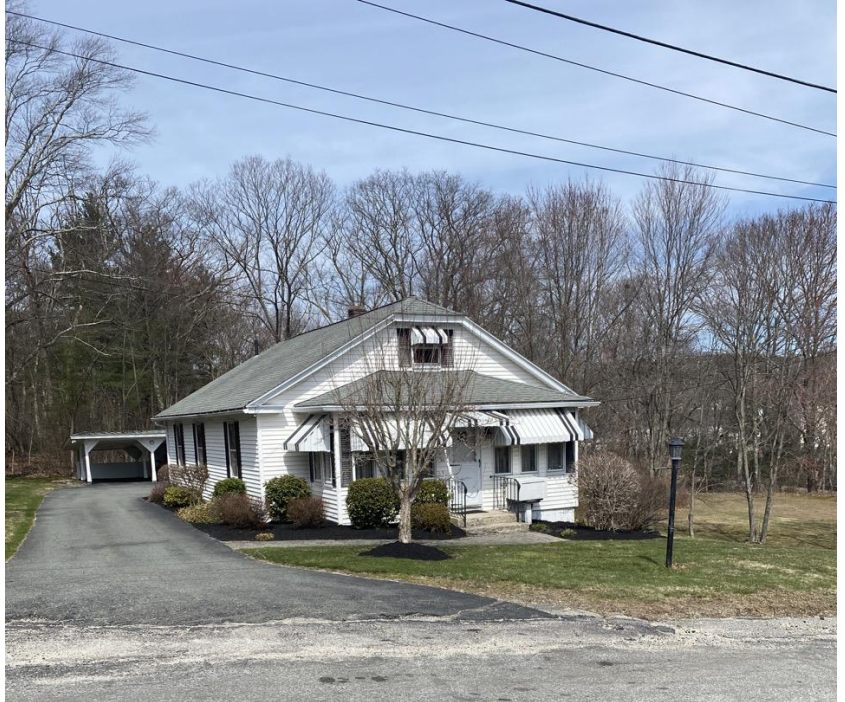
Roofing	Good
Windows and Doors	Good
Exterior Walls	Good
Porch/Stairs/Deck	Good – granite stairs
Foundation	Good
Storefront & Signage	
Parking Lots	
Other:

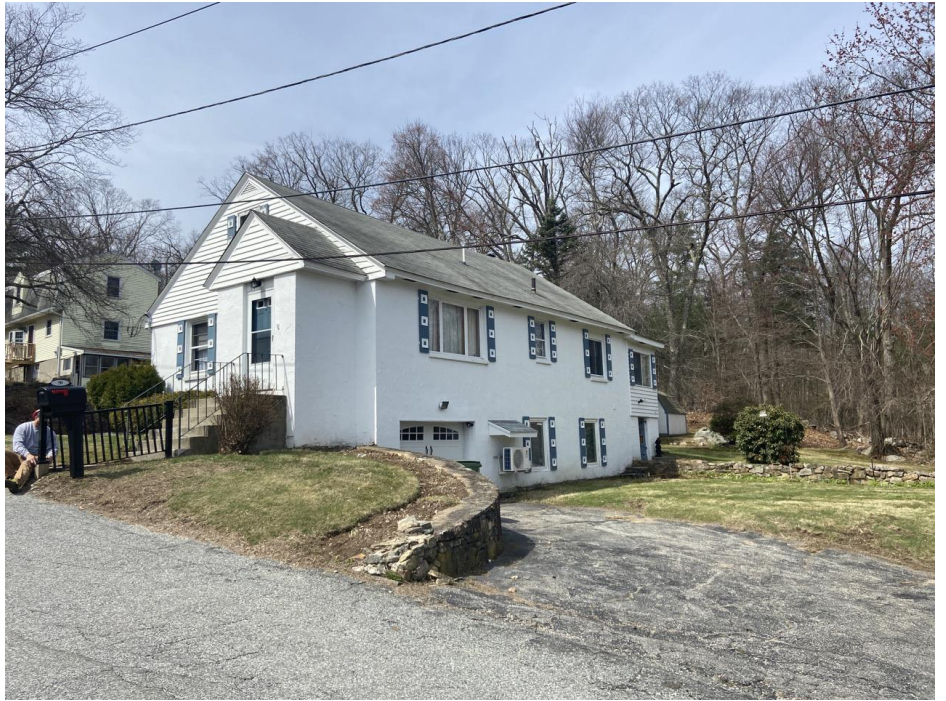
<u>Component</u>	<u>Condition</u>
Roofing	Fair - stains
Windows and Doors	Good
Exterior Walls	Good
Porch/Stairs/Deck	Good
Foundation	Good
Storefront & Signage

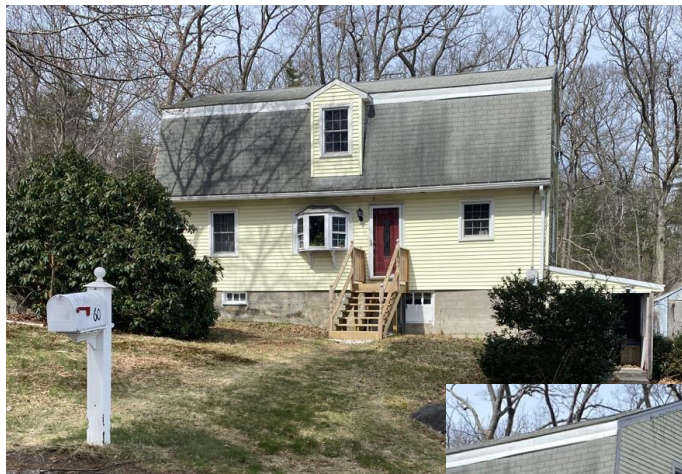
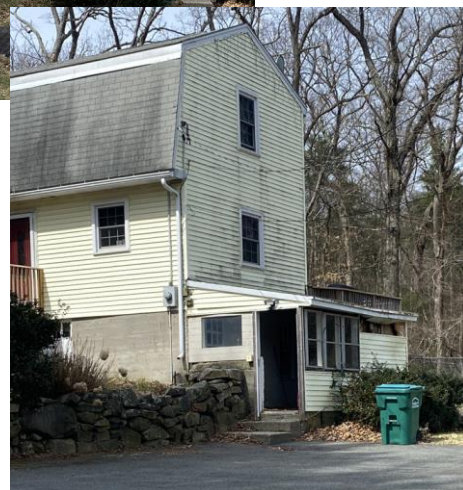
Roofing	Fair – stains
Windows and Doors	Fair – old
Exterior Walls	Fair – stains
Porch/Stairs/Deck	Poor – missing siding on porch with hole in the side, stairs are in good condition
Foundation	Good
Storefront & Signage	
Parking Lots	
Other:

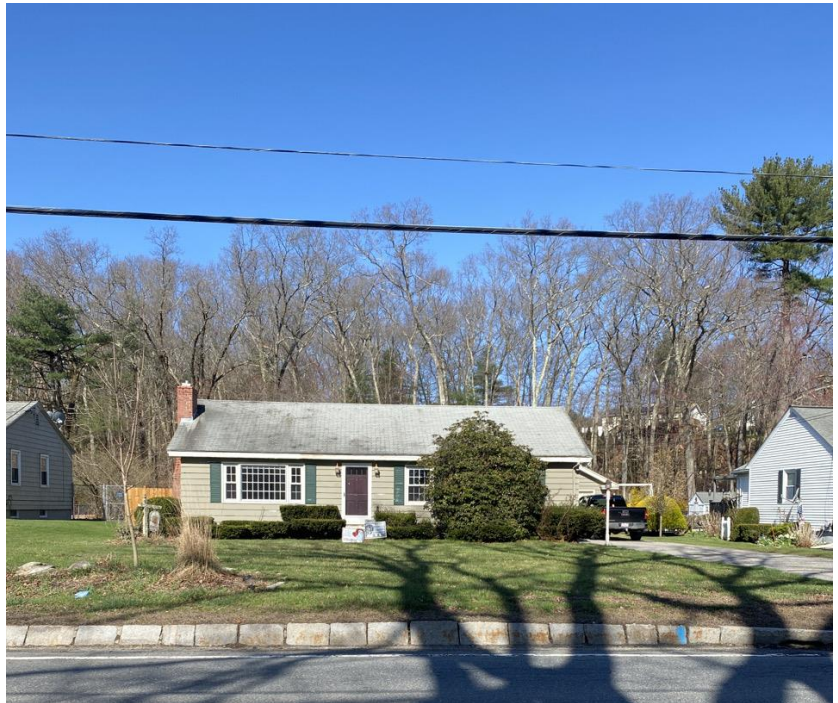
Roofing	Fair – stains
Windows and Doors	Fair – old
Exterior Walls	Fair – chipped paint
Porch/Stairs/Deck	Unknown
Foundation	Unknown

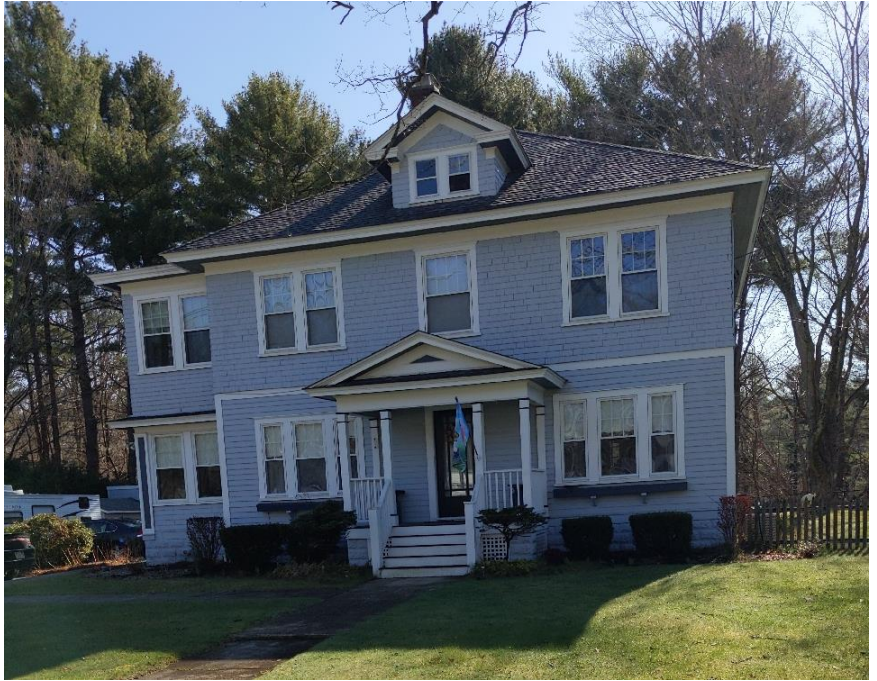
Roofing	Good – asphalt shingles
Windows and Doors	Good – newer
Exterior Walls	Fair – older wood siding, some chipping
Porch/Stairs/Deck	Good
Foundation	Good
Storefront & Signage	
Parking Lots	
Other:

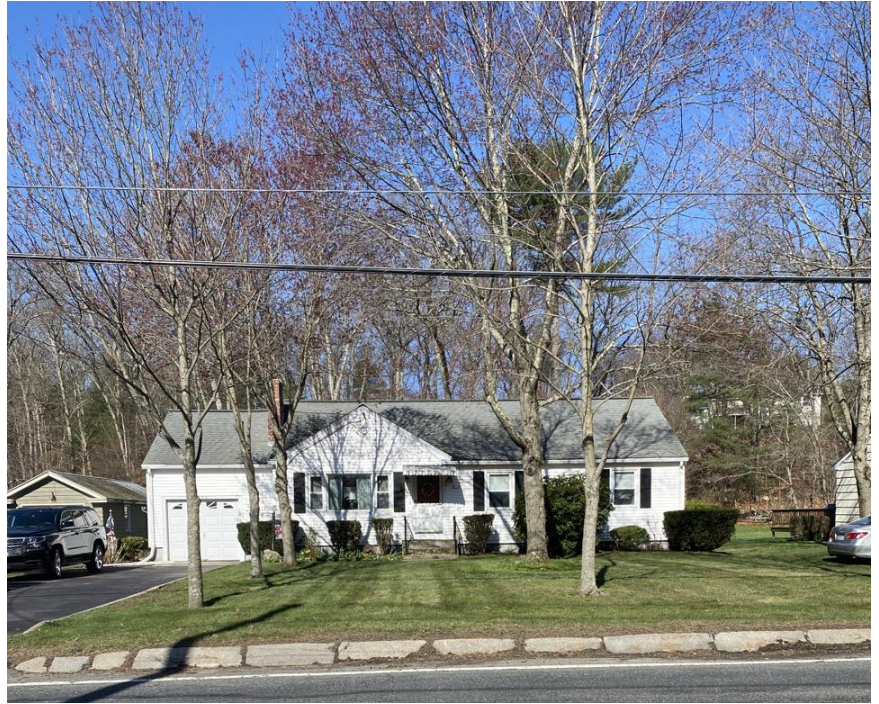
Roofing	Good
Windows and Doors	Good
Exterior Walls	Good
Porch/Stairs/Deck	Good – minor moss growth
Foundation	Good
Storefront & Signage	
Parking Lots	
Other:

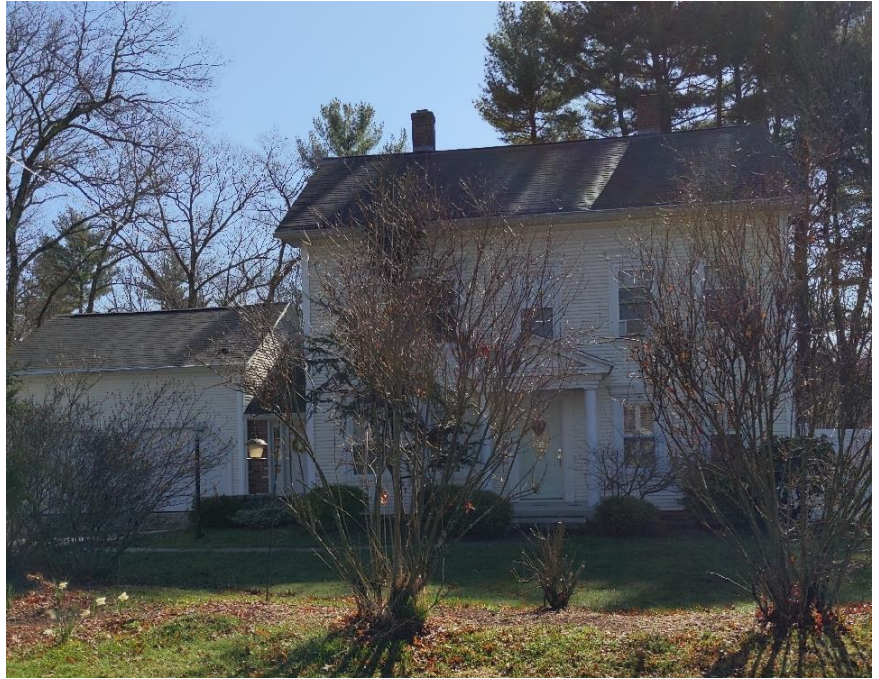
Roofing	Good
Windows and Doors	Fair – some staining on door
Exterior Walls	Good
Porch/Stairs/Deck	Fair – some moss growth
Foundation	Good
Storefront & Signage	
Parking Lots	
Other:

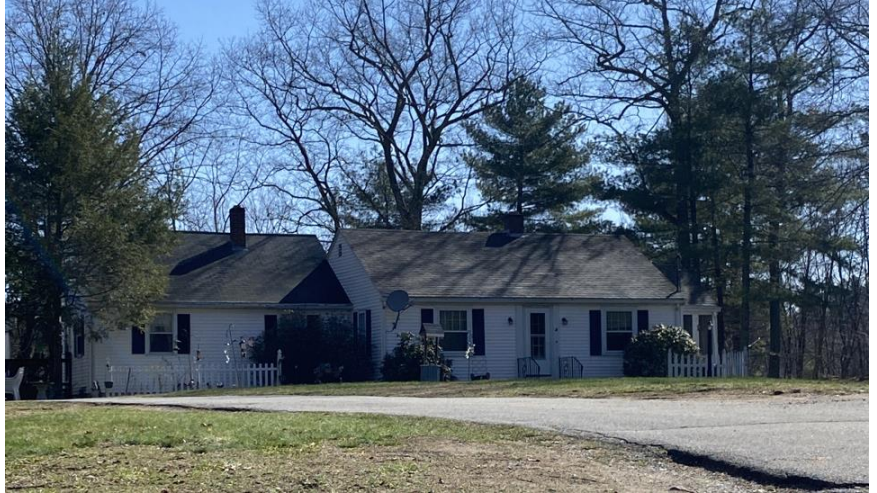
Roofing	Good
Windows and Doors	Good
Exterior Walls	Good
Porch/Stairs/Deck	Unknown
Foundation	Unknown

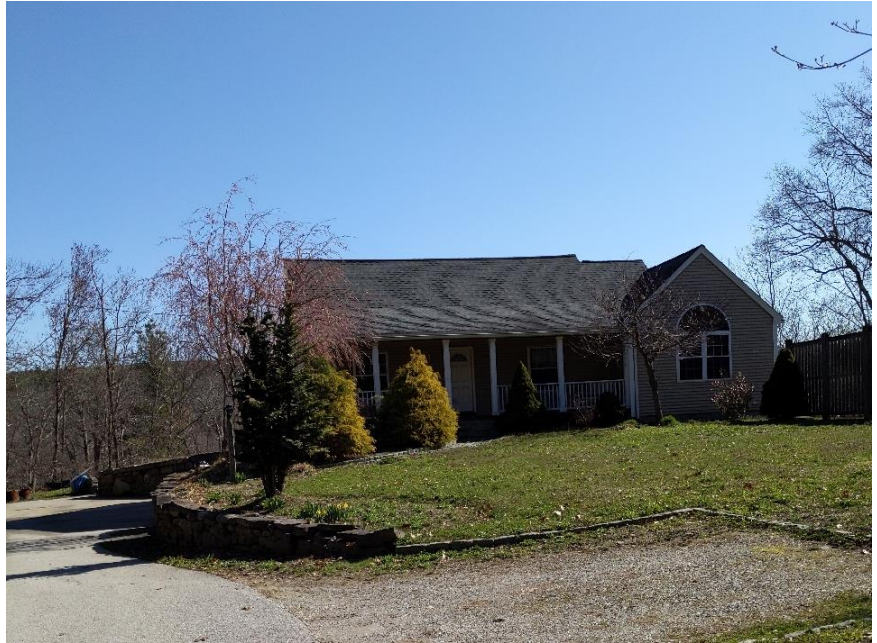
Roofing	Good
Windows and Doors	Fair – windows are newer, door is stained
Exterior Walls	Good
Porch/Stairs/Deck	Good – stone stairs
Foundation	Good
Storefront & Signage	
Parking Lots	
Other:

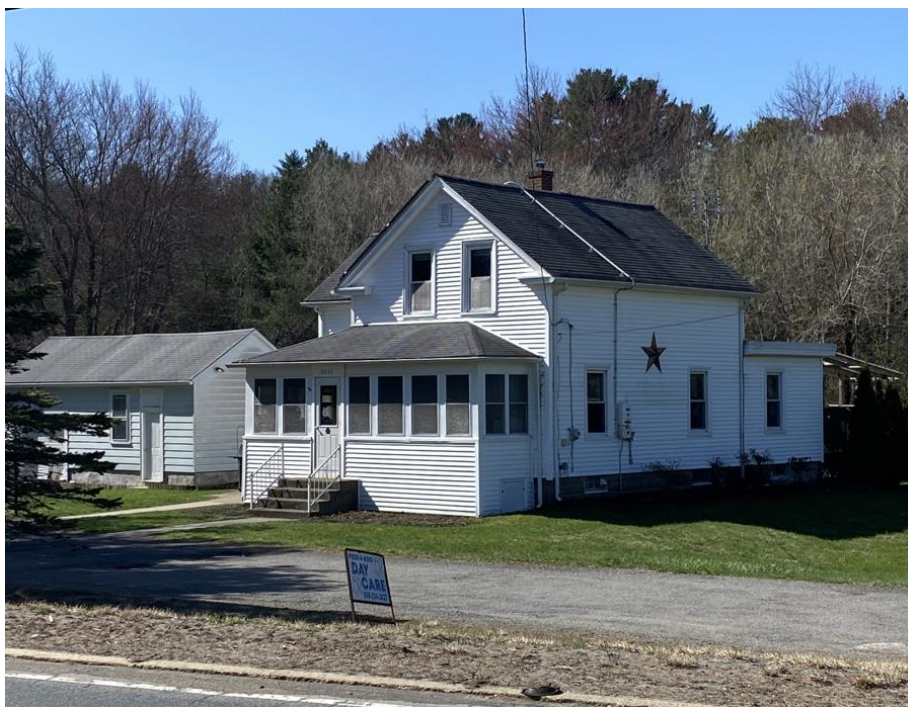
Roofing	Good – minor stains
Windows and Doors	Fair – old
Exterior Walls	Fair – vinyl siding is stained
Porch/Stairs/Deck	Good
Foundation	Good
Storefront & Signage	
Parking Lots	
Other:

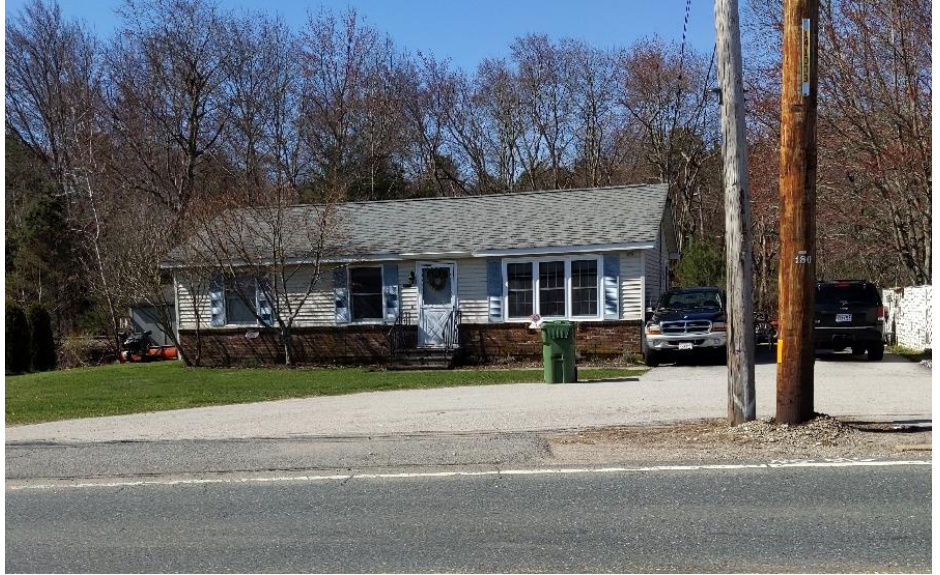
Roofing	Good
Windows and Doors	Good
Exterior Walls	Good
Porch/Stairs/Deck	Good
Foundation	Fair – brick is stained, minor moss growth

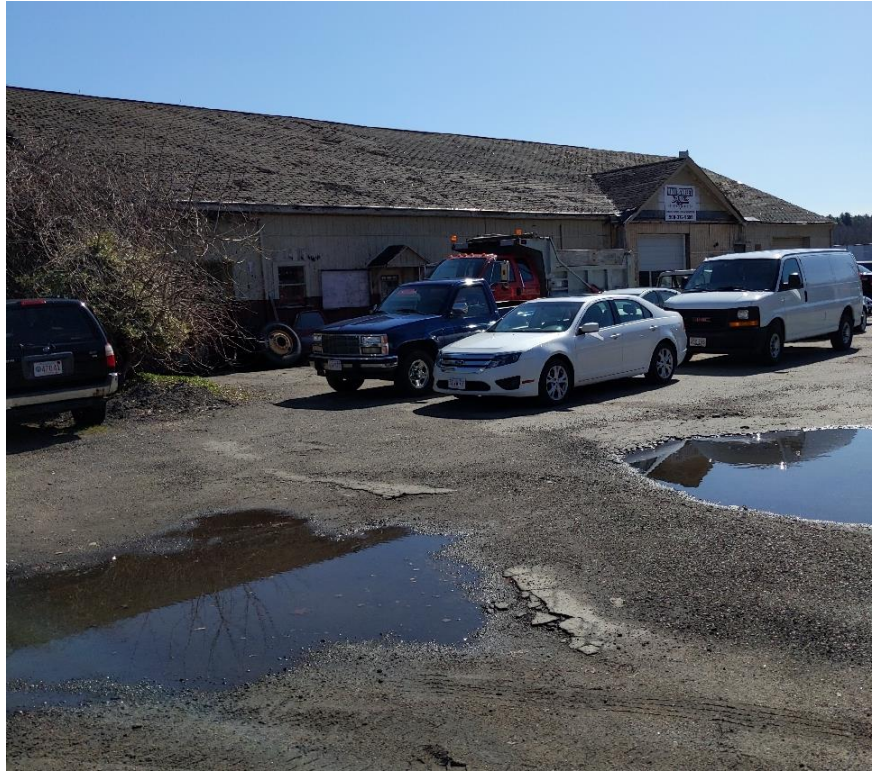
<u>Component</u>	<u>Condition</u>
Roofing	Poor – shingles are falling apart
Windows and Doors	Fair – some newer doors
Exterior Walls	Poor – overgrown ivy, siding is rotting in some spots, chipped paint
Porch/Stairs/Deck	N/a
Foundation	Unknown
Storefront & Signage	Fair
Parking Lots	Poor – missing pavement, potholes
Other:	
Overall Property Rating: (Excellent / Good / Fair / Poor) briefly state why. Poor

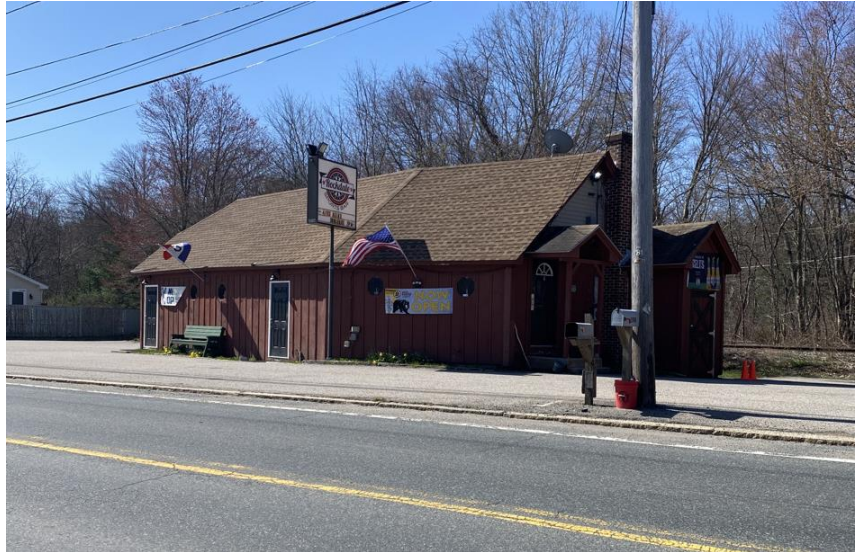
<u>Component</u>	<u>Condition</u>
Roofing	Good
Windows and Doors	Good
Exterior Walls	Good
Porch/Stairs/Deck	Good
Foundation	Good
Storefront & Signage	Good
Parking Lots	Fair – no paint
Other:

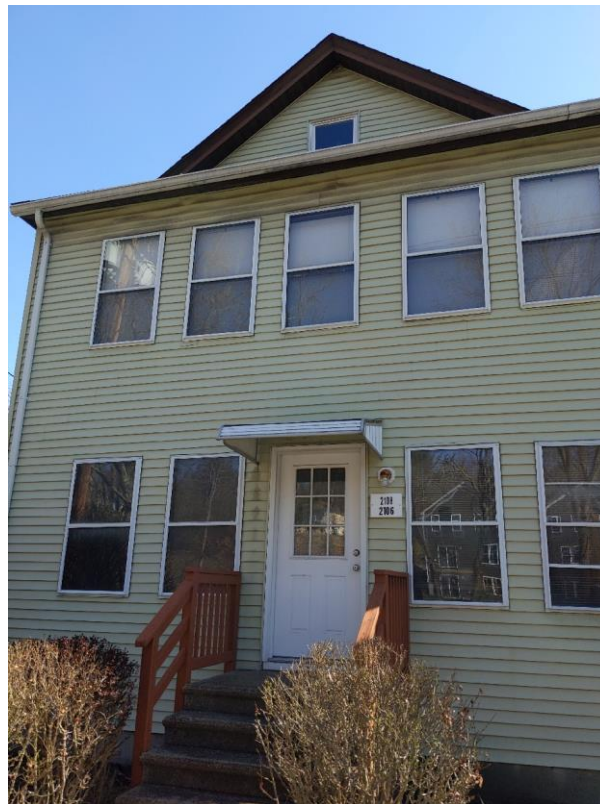
<u>Component</u>	<u>Condition</u>
Roofing	Good
Windows and Doors	Fair – old
Exterior Walls	Fair – warped and stained in some spots
Porch/Stairs/Deck	Good
Foundation	Good
Storefront & Signage	
Parking Lots	
Other:	
Overall Property Rating: (Excellent / Good / Fair / Poor) briefly state why. Fair

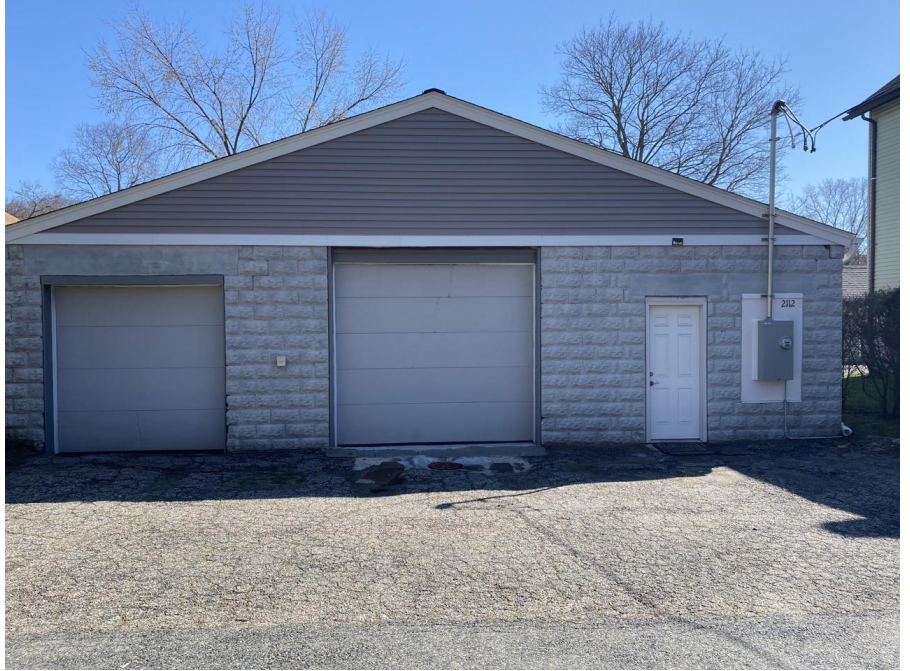
Roofing	Good
Windows and Doors	Good
Exterior Walls	Good
Porch/Stairs/Deck	n/a
Foundation	Good
Storefront & Signage	Poor – none
Parking Lots	Poor – uneven with cracks

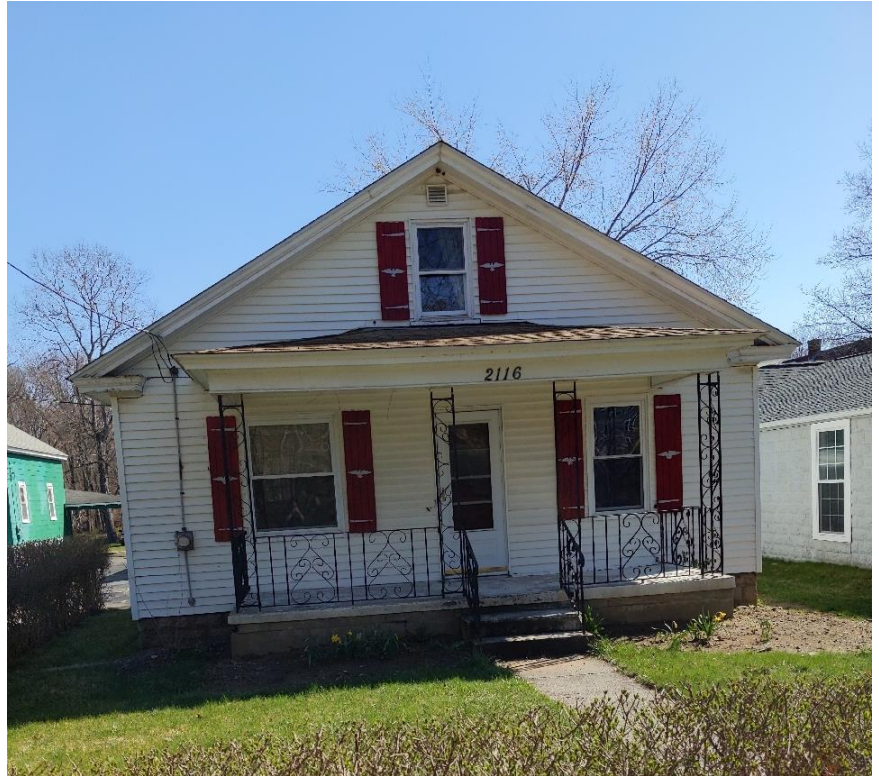
<u>Component</u>	<u>Condition</u>
Roofing	Fair
Windows and Doors	Fair – old
Exterior Walls	Fair – old, some rotting around windows
Porch/Stairs/Deck	Fair – stained and corners are chipped
Foundation	Good
Storefront & Signage	
Parking Lots	
Other:	
Overall Property Rating: (Excellent / Good / Fair / Poor) briefly state why. Fair

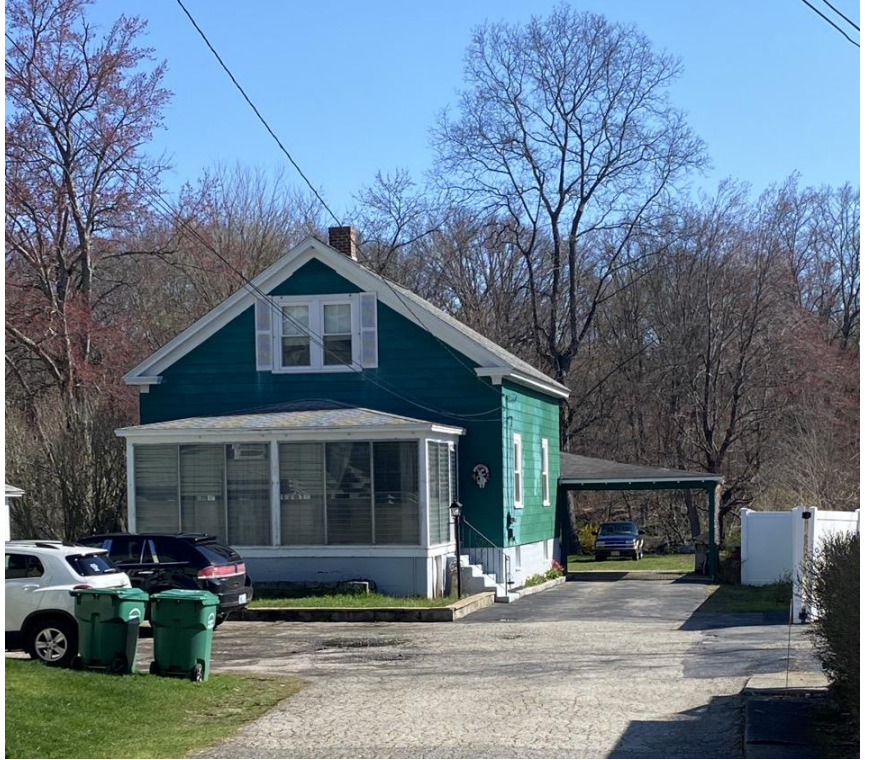
Foundation

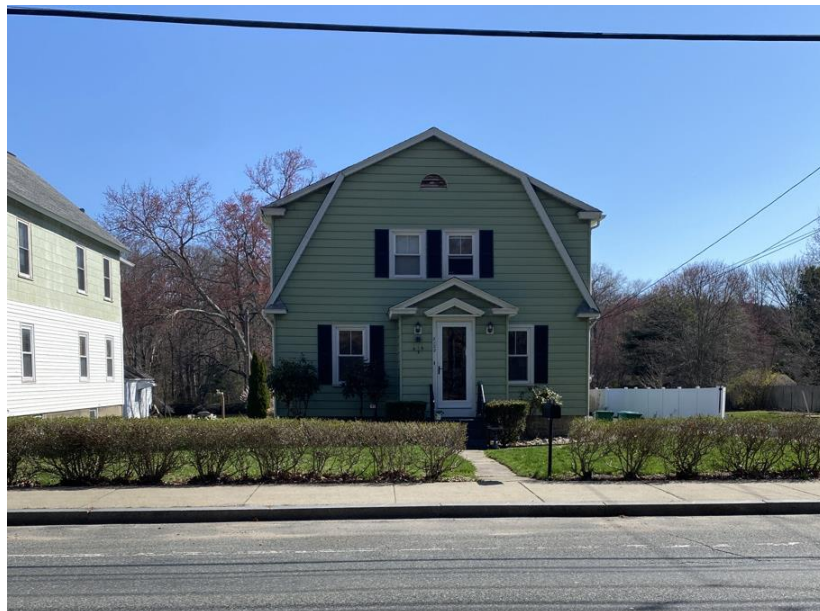
Address: 2122 Providence Rd  
 Zoning or Land Use: R-3  
 Commercial/Residential: Residential  
 Stories: 2  
 General Construction: 1920  
 Storefront Construction:  
 Building Age: 102  
 Vacant: yes ☐ no ☒ other:  
 Assessed Value: 207,100  
 Other Relevant Data:

<u>Component</u>	<u>Condition</u>
Roofing	Unknown
Windows and Doors	Fair – old
Exterior Walls	Good – aluminum
Porch/Stairs/Deck	Good
Foundation	Good
Storefront & Signage	
Parking Lots	
Other:	
Overall Property Rating: (Excellent / Good / Fair / Poor) briefly state why. Good

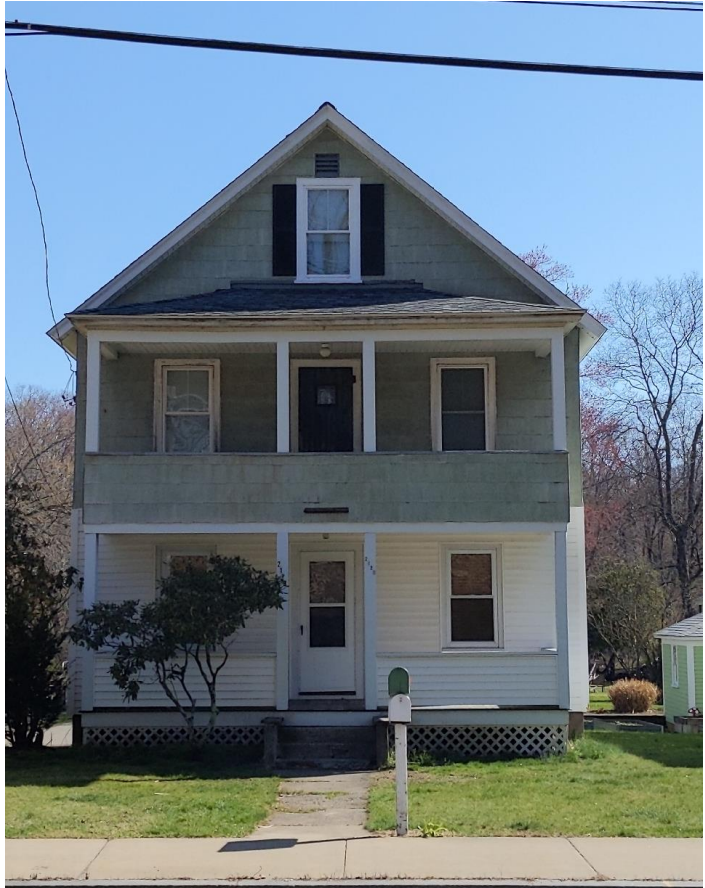
<u>Component</u>	<u>Condition</u>
Roofing	Good – asphalt shingles
Windows and Doors	Fair – downstairs windows are good, upstairs windows are old
Exterior Walls	Fair – first floor vinyl with some chips, second floor aluminum with stains and worn out
Porch/Stairs/Deck	Fair – old and stained, porch is crooked
Foundation	Good
Storefront & Signage	
Parking Lots	
Other:	
Overall Property Rating: (Excellent / Good / Fair / Poor) briefly state why. Fair

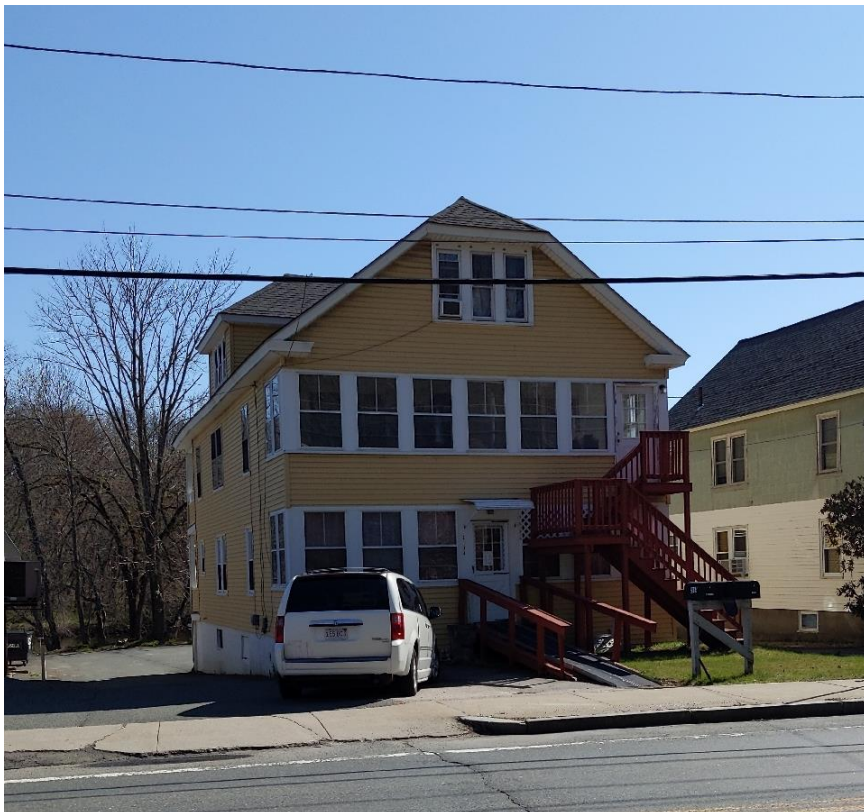
<u>Component</u>	<u>Condition</u>
Roofing	Good
Windows and Doors	Fair – old
Exterior Walls	Good
Porch/Stairs/Deck	Fair – crooked
Foundation	Fair - stained
Storefront & Signage	
Parking Lots	
Other:	
Overall Property Rating: (Excellent / Good / Fair / Poor) briefly state why. Fair

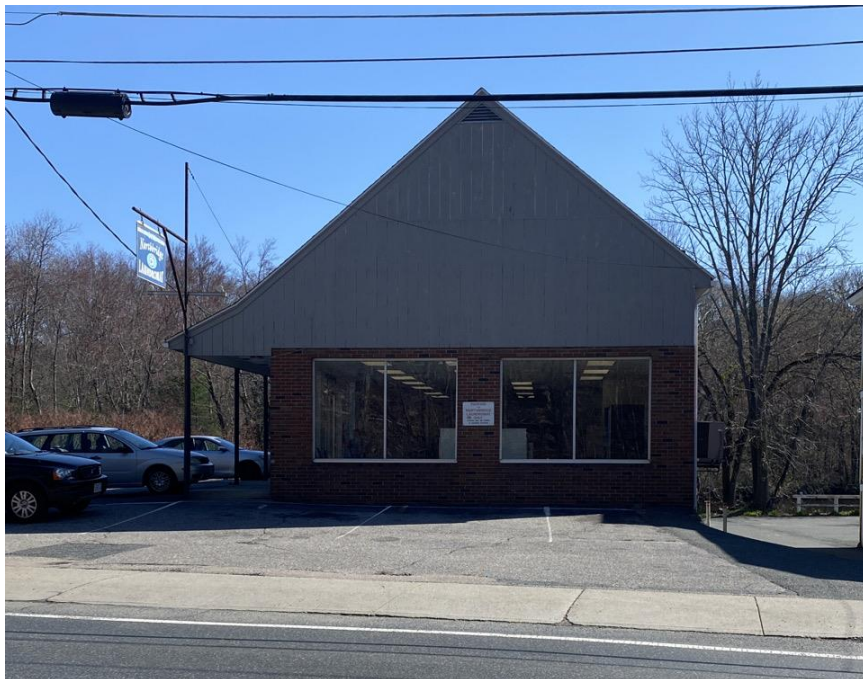
Foundation Good

Parking Lots Fair - cracks

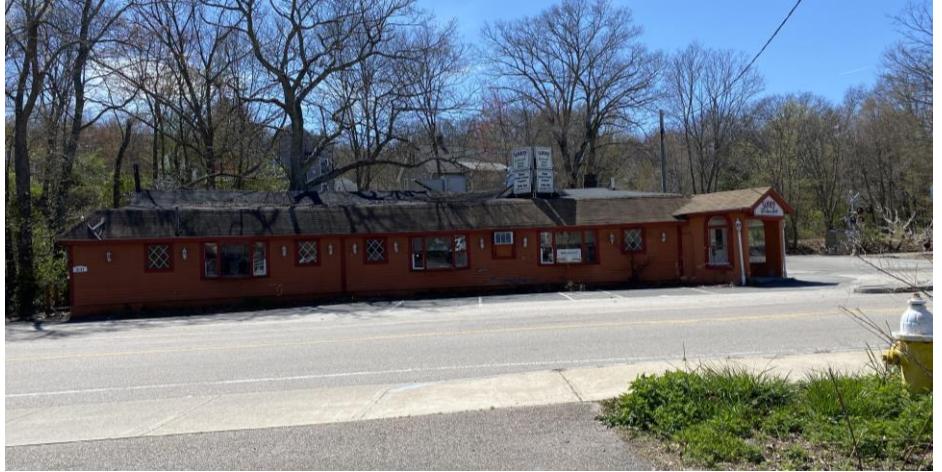
Address: 2147 Providence Rd  
Zoning or Land Use: B-1  
Commercial/Residential: Commercial  
Stories: 1  
General Construction: 1930  
Storefront Construction:  
Building Age: 92  
Vacant: yes x no ☐ other:  
Assessed Value: 263,900  
Other Relevant Data: Sammy's  
Restaurant

Exterior Walls Poor – broken siding

Foundation Unknown

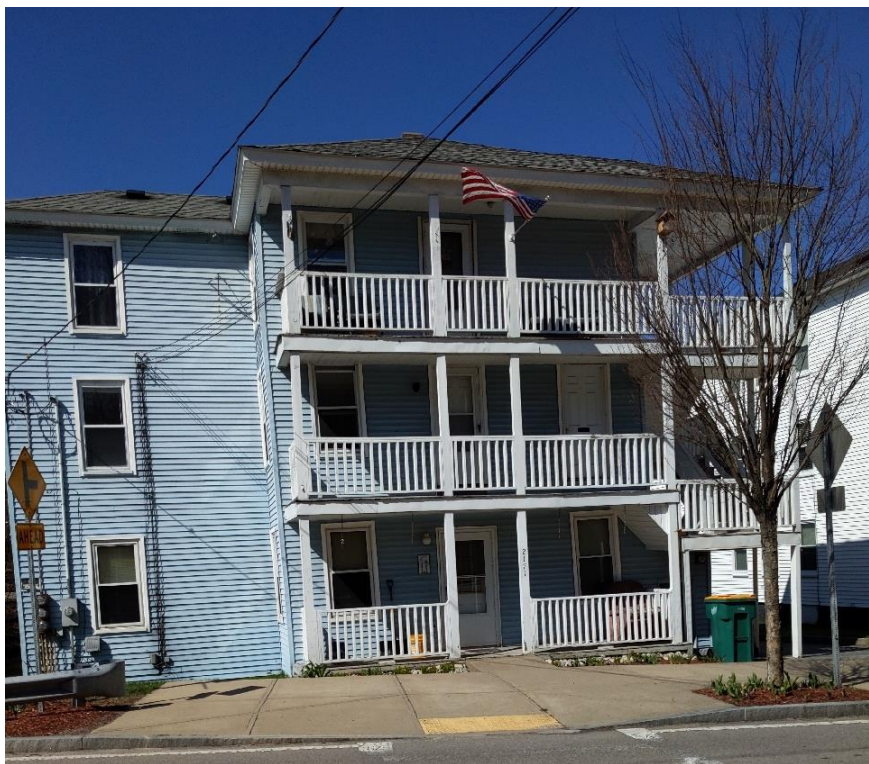
Roofing	Fair – some warping
Windows and Doors	Good
Exterior Walls	Good
Porch/Stairs/Deck	Fair – wood paint is chipped; some siding is warped; wood is worn out
Foundation	Good
Storefront & Signage	
Parking Lots	
Other:

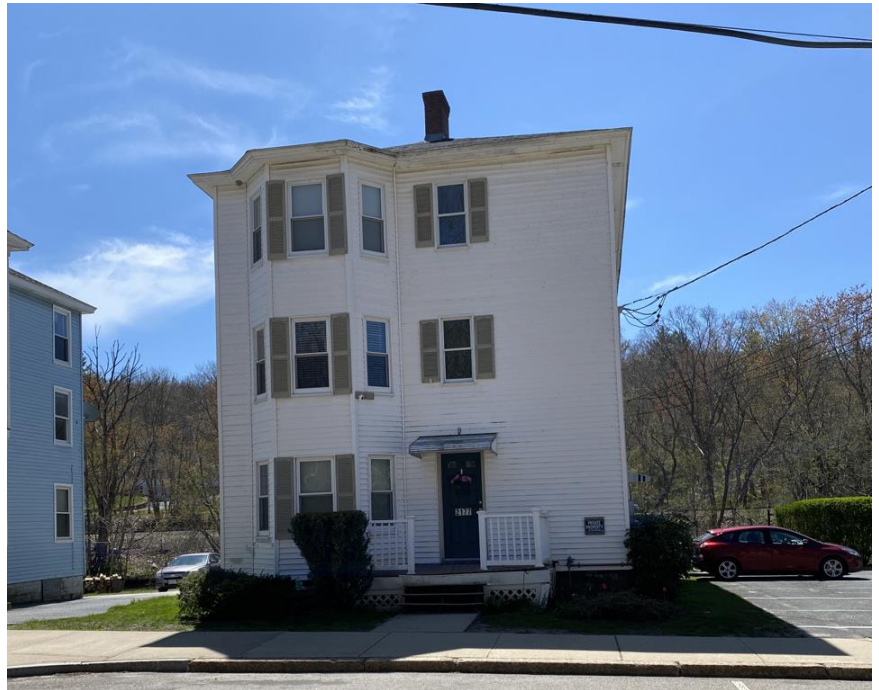
<u>Component</u>	<u>Condition</u>
Roofing	Unknown
Windows and Doors	Fair – old
Exterior Walls	Poor – chipped siding with broken trim
Porch/Stairs/Deck	Poor – uneven and bowed
Foundation	Fair
Storefront & Signage	
Parking Lots	
Other:	
Overall Property Rating: (Excellent / Good / Fair / Poor) briefly state why. Poor

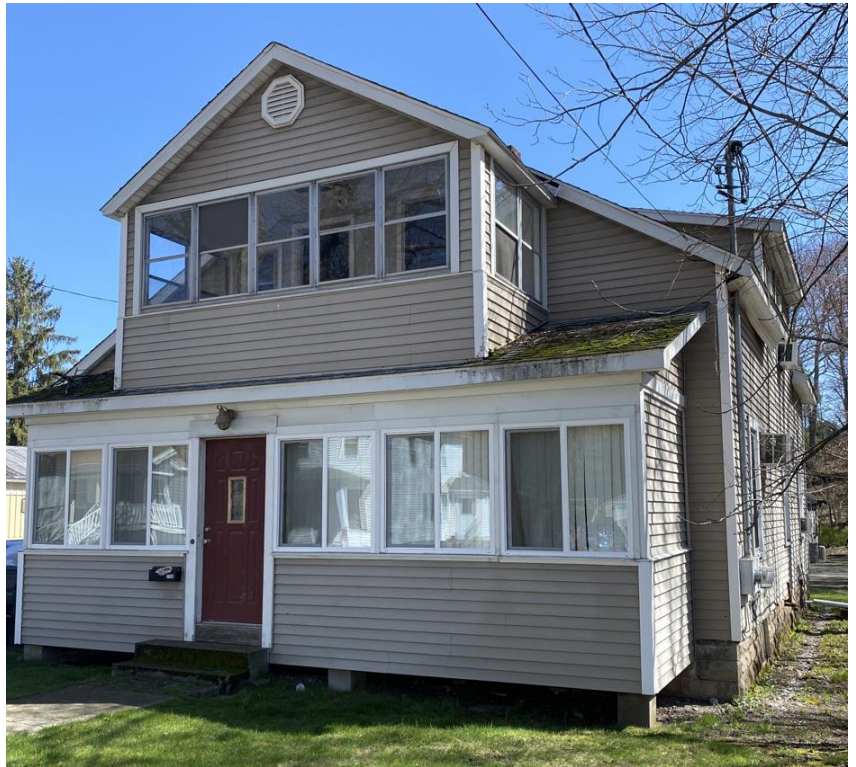
Exterior Walls Fair – stains

Foundation Fair – moss growth

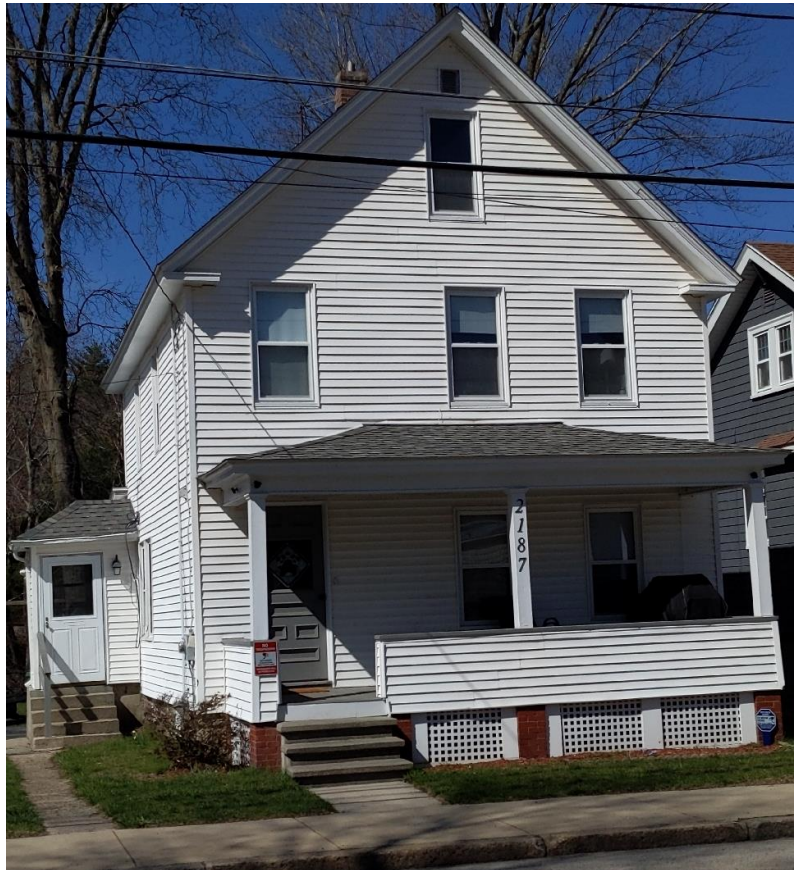
<u>Component</u>	<u>Condition</u>
Roofing	Excellent
Windows and Doors	Good
Exterior Walls	Good
Porch/Stairs/Deck	Good
Foundation	Fair – old with few cracks
Storefront & Signage	
Parking Lots

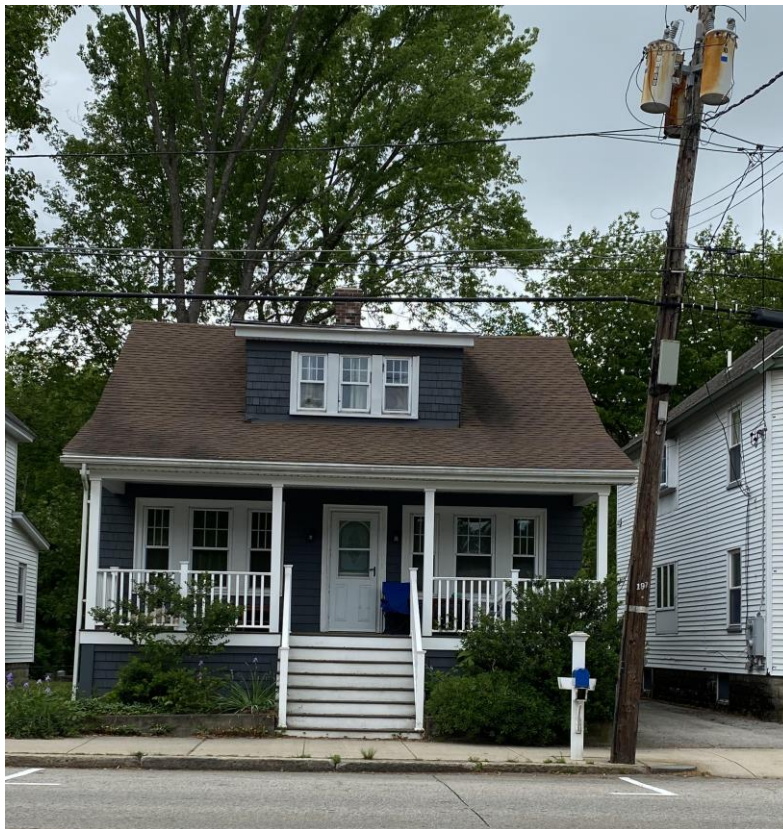
Roofing	Good
Windows and Doors	Good
Exterior Walls	Excellent
Porch/Stairs/Deck	Good
Foundation	Good

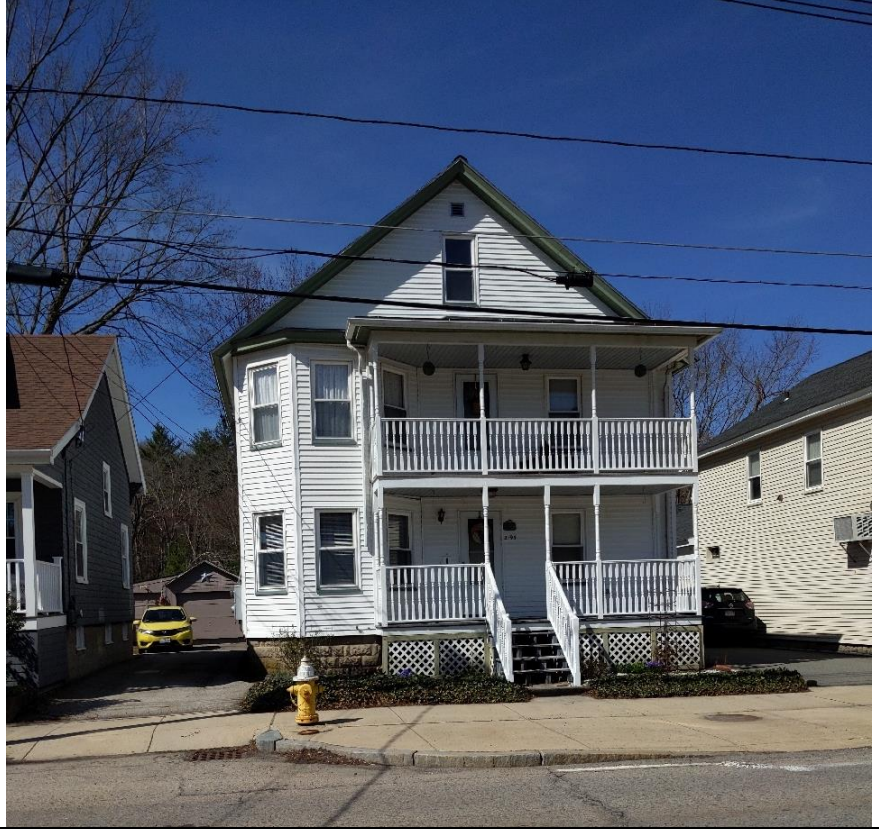
Roofing	Good
Windows and Doors	Fair – old
Exterior Walls	Fair – siding on side is chipping
Porch/Stairs/Deck	Fair – worn out paint
Foundation	Fair - stains
Storefront & Signage	
Parking Lots	
Other:

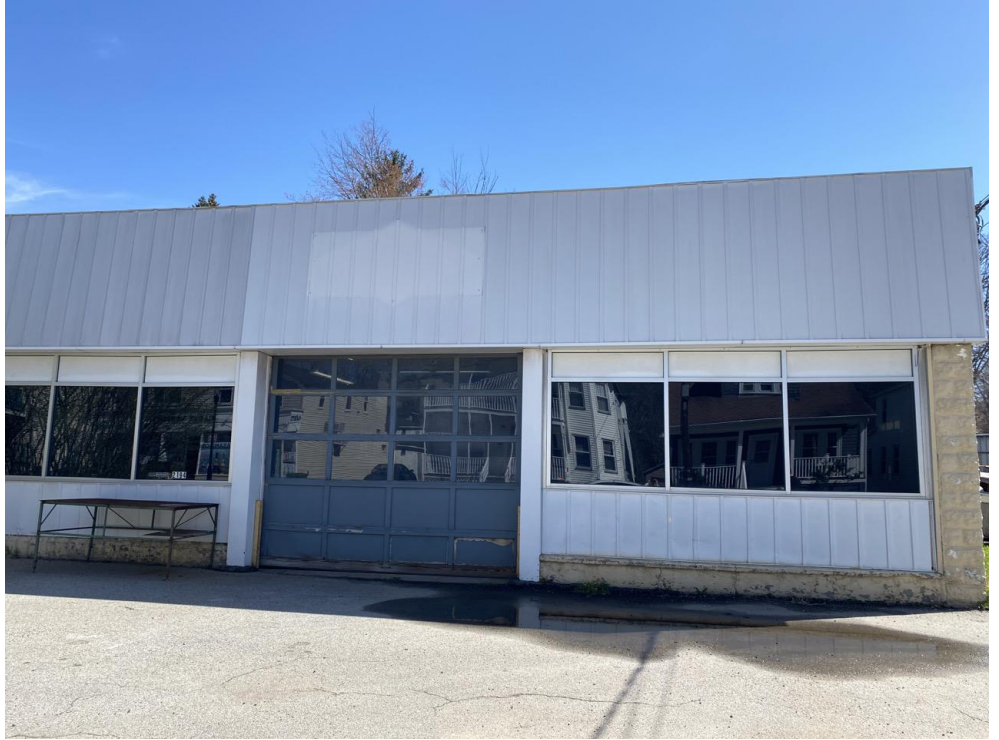
Poor – cracks, uneven, minor flooding

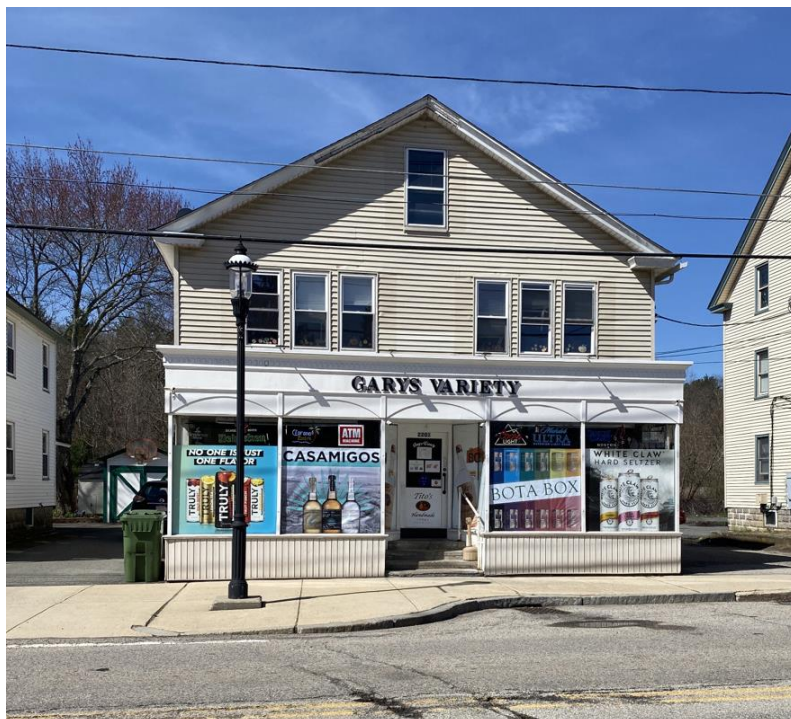
<u>Component</u>	<u>Condition</u>
Roofing	Good
Windows and Doors	Fair – old
Exterior Walls	Fair – faded siding
Porch/Stairs/Deck	Fair – chipped stairs
Foundation	Good
Storefront & Signage	Fair – excessive signage
Parking Lots	n/a

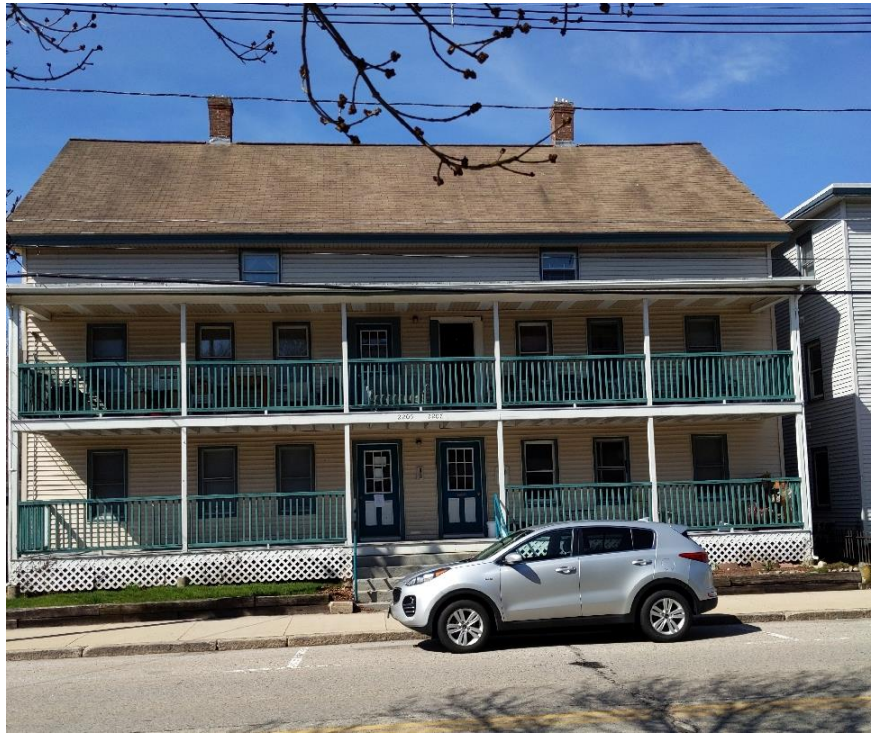
Roofing	Good
Windows and Doors	Fair – old, some stains
Exterior Walls	Fair – stained
Porch/Stairs/Deck	Fair – chipped paint on railings
Foundation	Good
Storefront & Signage	
Parking Lots	
Other:
