# Northbridge Slum & Blight Inventory

## Rockdale Target Area

Report compiled by the Pioneer Valley  
Planning Commission for the Town of  
Northbridge

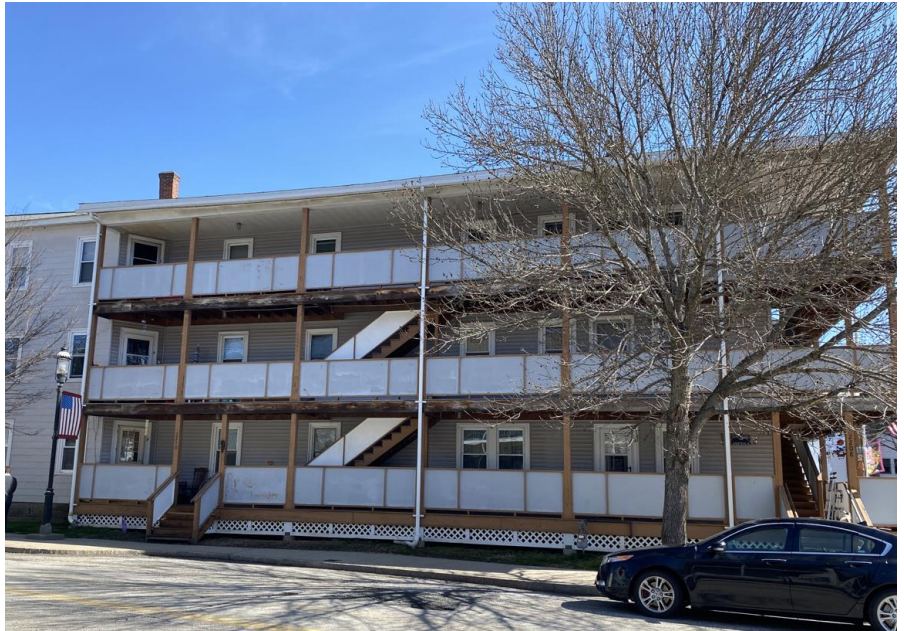
<u>Component</u>	<u>Condition</u>
Roofing	Unknown
Windows and Doors	Fair – old
Exterior Walls	Fair – aluminum chipped with stains
Porch/Stairs/Deck	Fair
Foundation	Good
Storefront & Signage	
Parking Lots	Poor – dirt
Other:	
Overall Property Rating: (Excellent / Good / Fair / Poor) briefly state why. Fair

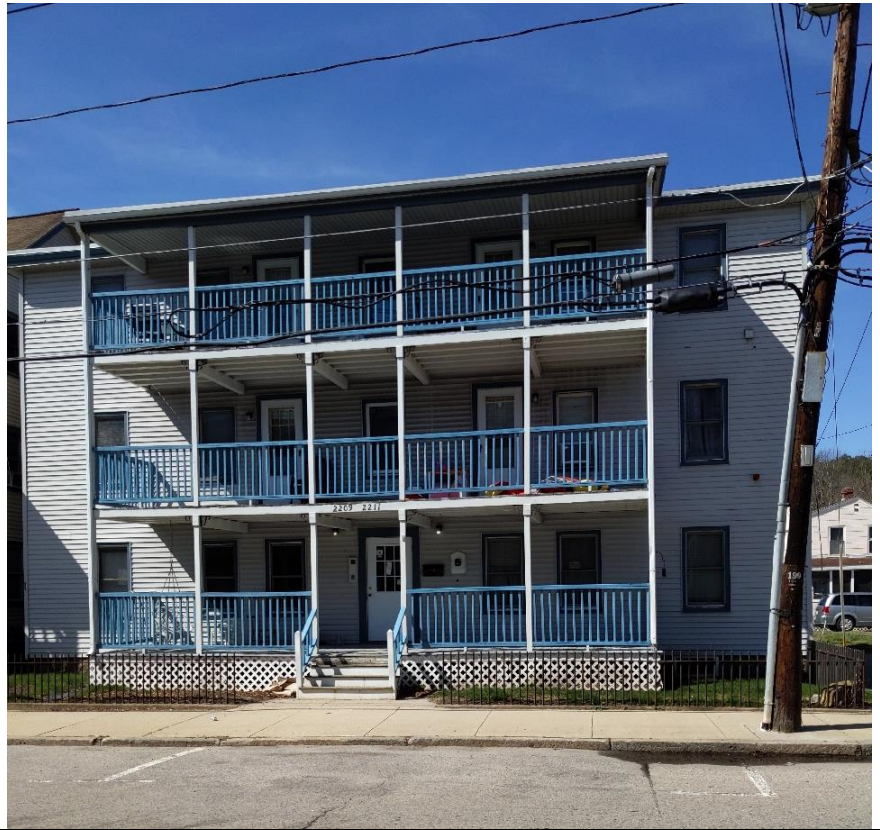
Fair – stained and chipped

Fair - stained

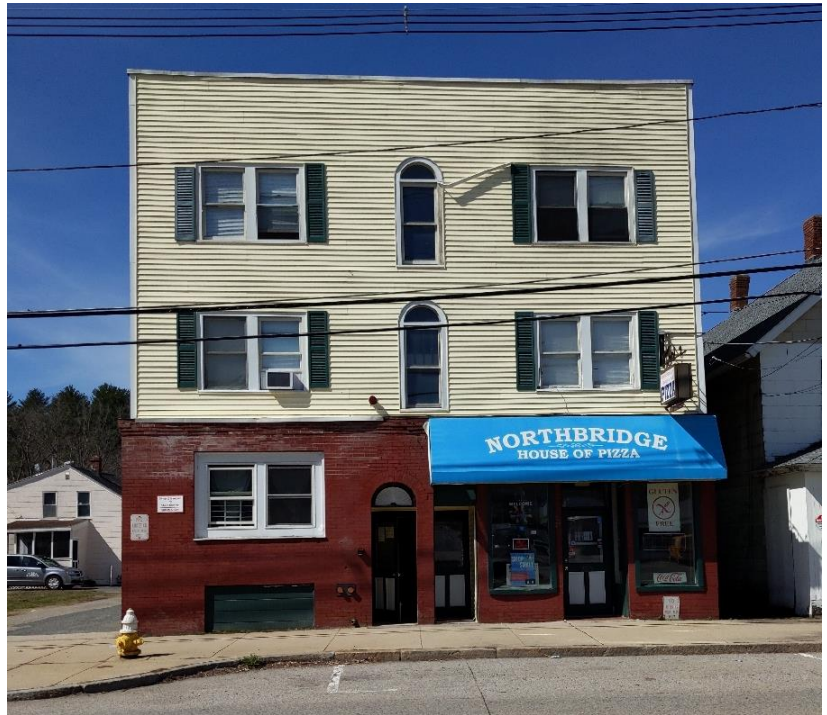
<u>Component</u>	<u>Condition</u>
Roofing	Unknown
Windows and Doors	Fair – trim is falling off
Exterior Walls	Poor – trim is falling off
Porch/Stairs/Deck	n/a
Foundation	Fair
Storefront & Signage	Good
Parking Lots	Fair – big potholes
Other:

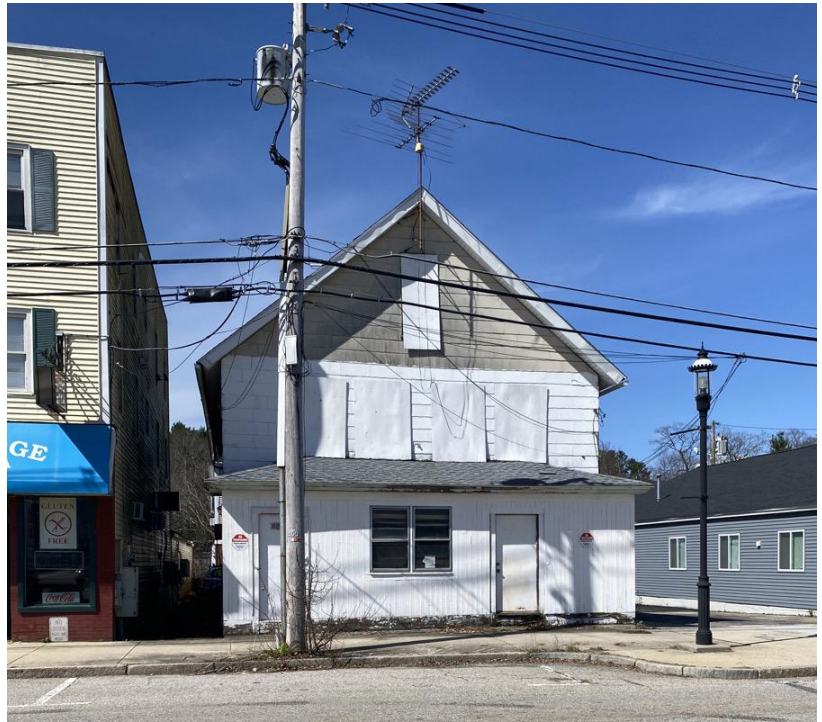
Roofing Poor – missing shingles

Foundation Unknown

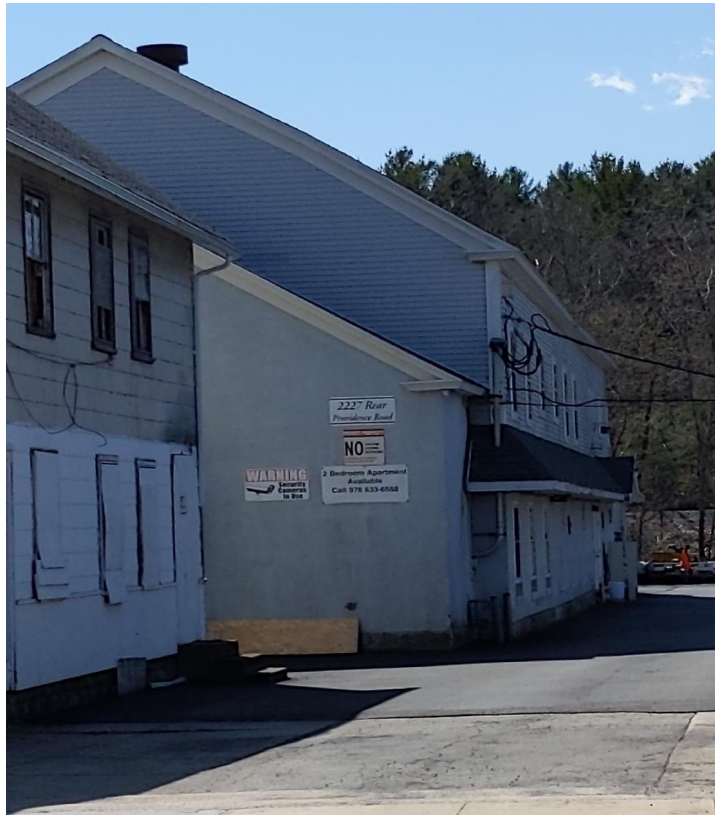
Roofing	Good
Windows and Doors	Good
Exterior Walls	Fair – stucco is stained
Porch/Stairs/Deck	Good
Foundation	Good
Storefront & Signage	
Parking Lots	
Other:

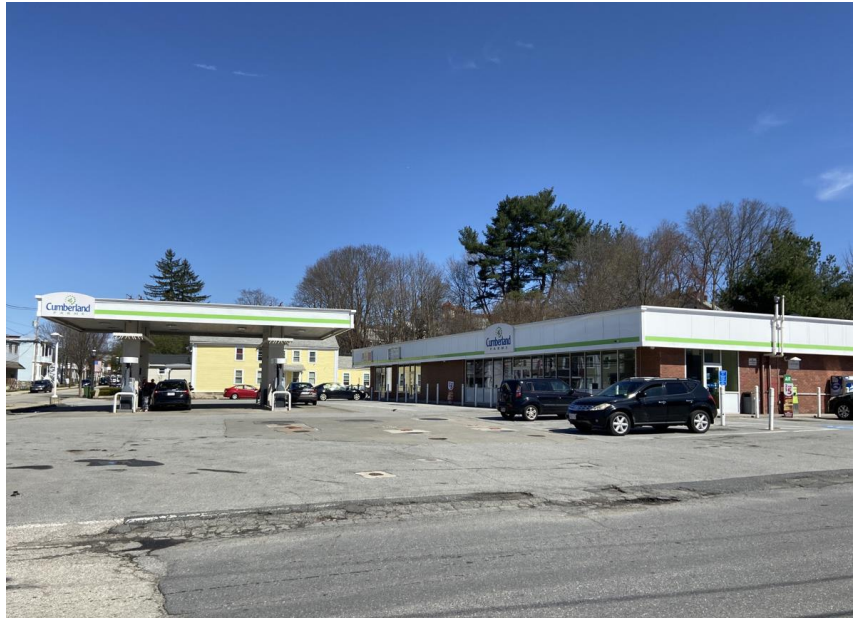
Roofing	Unknown
Windows and Doors	Good
Exterior Walls	Good
Porch/Stairs/Deck	Good
Foundation	Good
Storefront & Signage	Fair – one sign missing cover

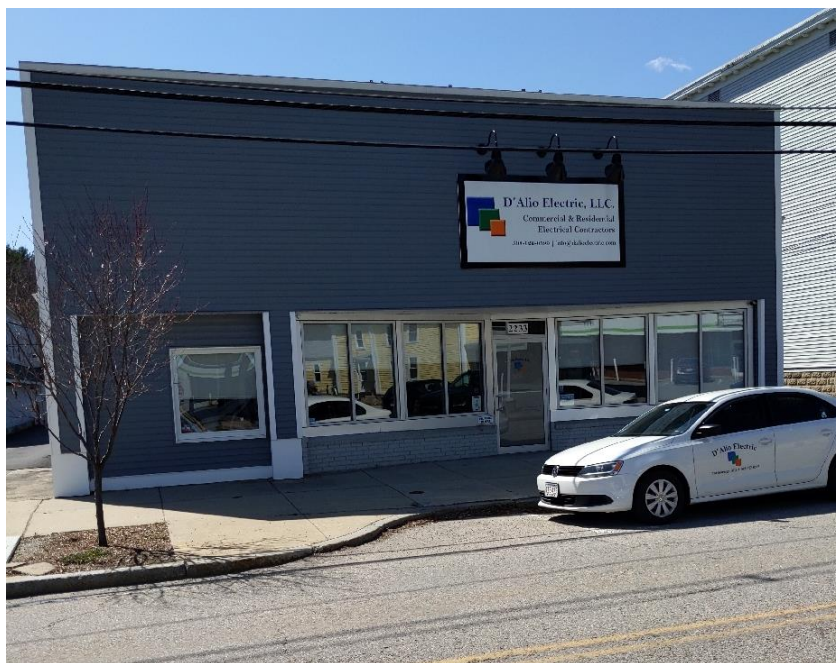
<u>Component</u>	<u>Condition</u>
Roofing	Good
Windows and Doors	Good
Exterior Walls	Excellent
Porch/Stairs/Deck	Good
Foundation	Good
Storefront & Signage	Good
Parking Lots	Good – newly paved

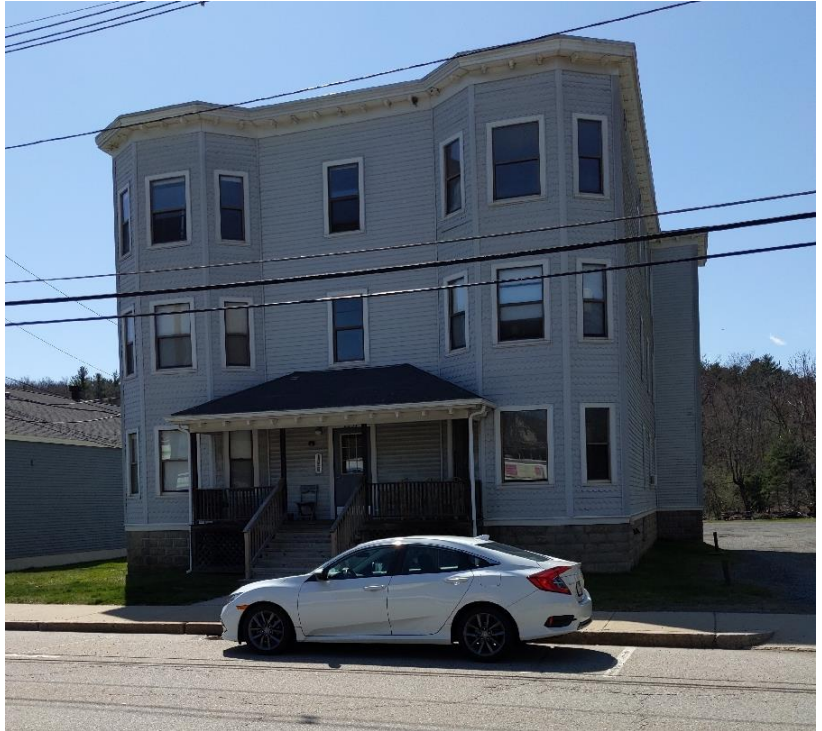
Roofing Fair – flat roof, but some signs of wear around trim

Windows and Doors Fair – door is stained, older windows

Porch/Stairs/Deck Fair – minor stains/weathering

Foundation Fair – some staining and moss growth

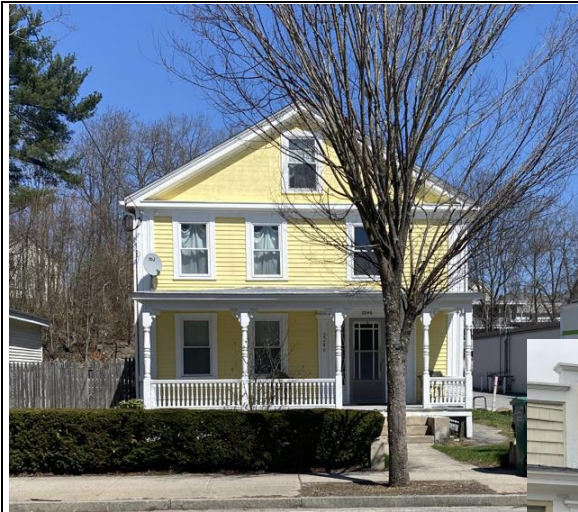
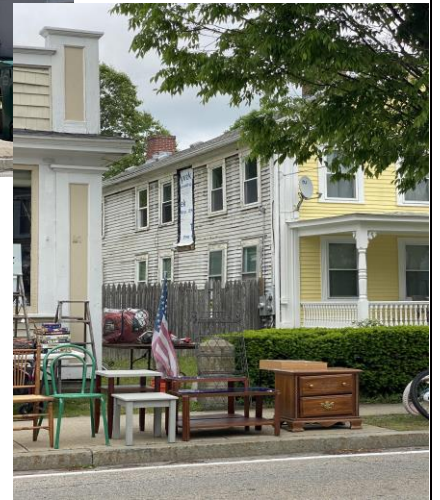
<u>Component</u>	<u>Condition</u>
Roofing	Fair
Windows and Doors	Fair – old, one is boarded up on side
Exterior Walls	Poor – side is missing all paint
Porch/Stairs/Deck	Good
Foundation	Good
Storefront & Signage	
Parking Lots	
Other:	
Overall Property Rating: (Excellent / Good / Fair / Poor) briefly state why. Fair

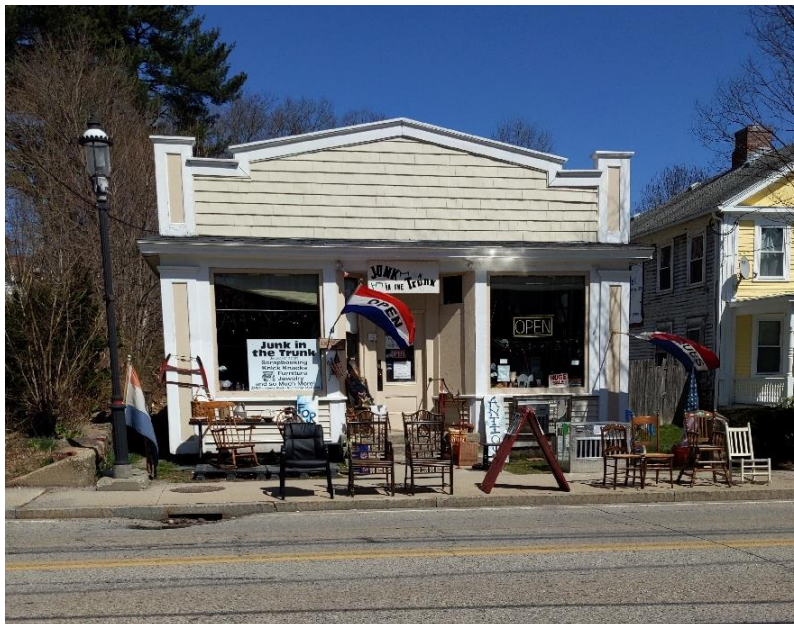
<u>Component</u>	<u>Condition</u>
Roofing	Good
Windows and Doors	Fair – paint is chipping around trim
Exterior Walls	Fair – wood siding, stained around side, some chipped paint
Porch/Stairs/Deck	Fair – some stains and signs of wear
Foundation	Good
Storefront & Signage	Fair - small
Parking Lots	
Other:	
Overall Property Rating: (Excellent / Good / Fair / Poor) briefly state why. Fair

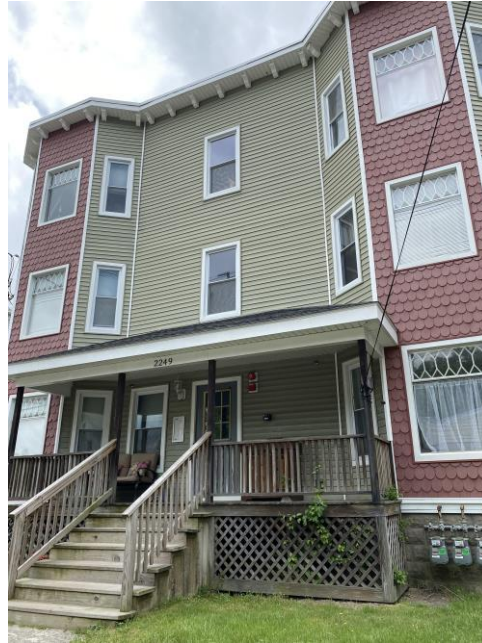
Roofing	Unknown – flat roof
Windows and Doors	Good – newer
Exterior Walls	Good
Porch/Stairs/Deck	Fair – wood on porch is weathered
Foundation	Good
Storefront & Signage	
Parking Lots	
Other:

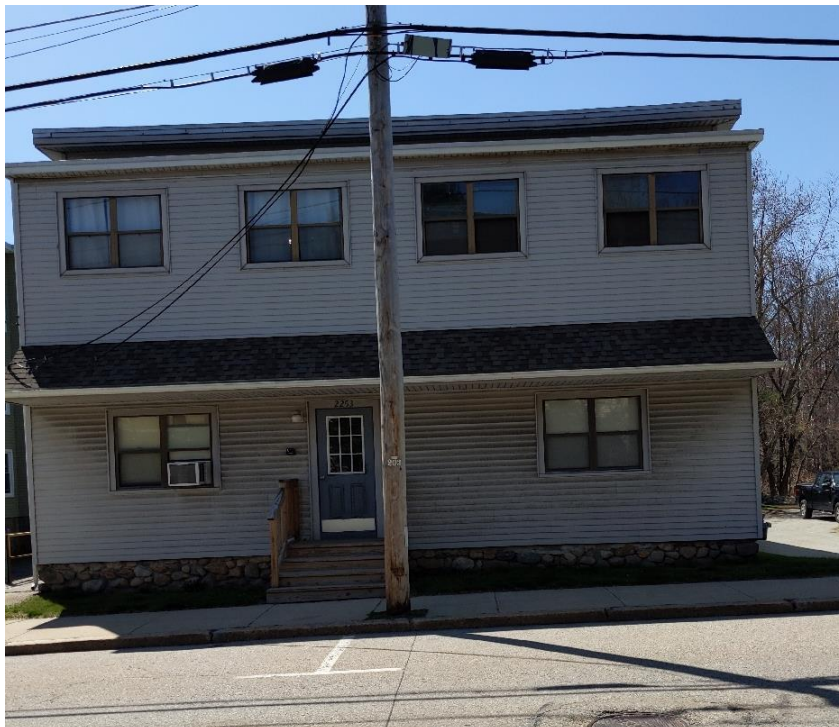
Roofing	Unknown – flat roof
Windows and Doors	Fair – old, door is stained
Exterior Walls	Fair – most of first floor is stained
Porch/Stairs/Deck	Good
Foundation	Good
Storefront & Signage	
Parking Lots	
Other:

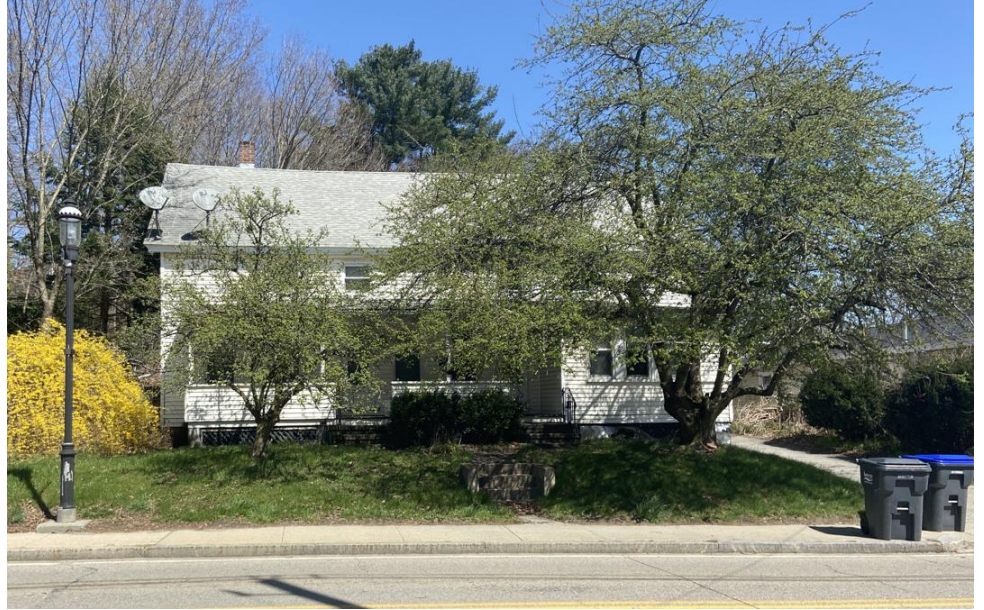
Roofing	Good
Windows and Doors	Good
Exterior Walls	Good
Porch/Stairs/Deck	Fair – damaged concrete steps
Foundation	Good
Storefront & Signage	
Parking Lots	
Other:

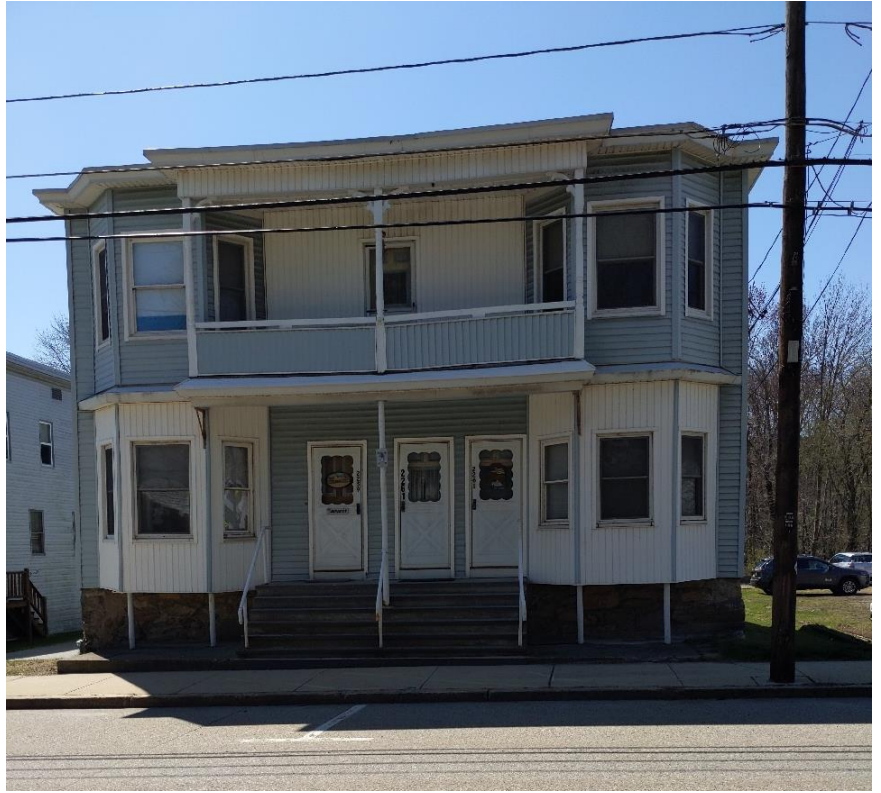
Exterior Walls            Fair – stained

Porch/Stairs/Deck       Fair – warped, stained, and railings are rusted

Foundation               Fair – some stains, poles holding up bay windows show rust and may not be sturdy

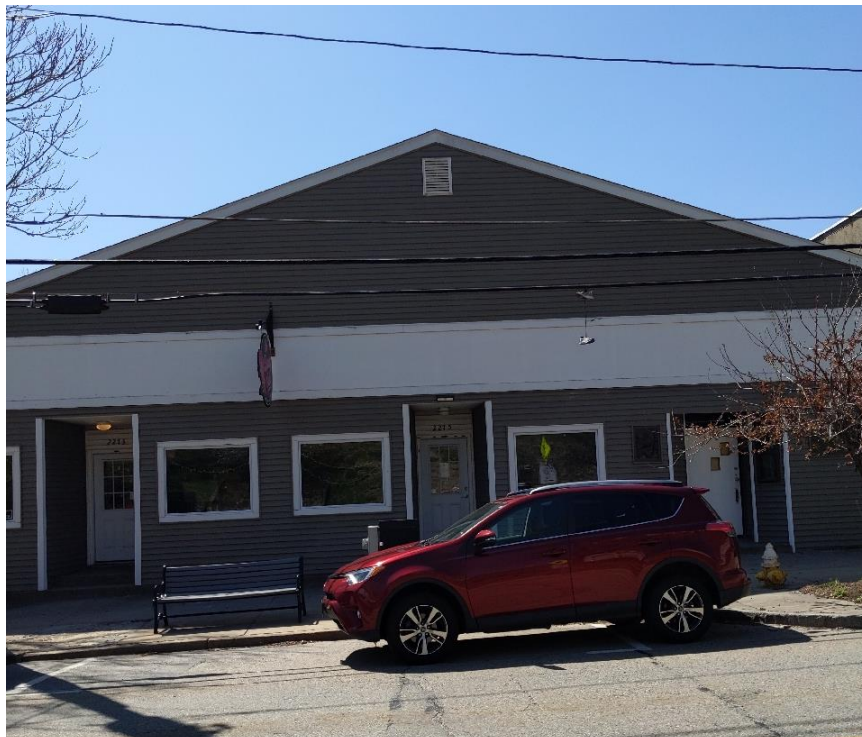
<u>Component</u>	<u>Condition</u>
Roofing	Good
Windows and Doors	Fair – right side are old
Exterior Walls	Fair – minor stains
Porch/Stairs/Deck	Fair – steps are stained and crooked
Foundation	Good
Storefront & Signage	Fair – small and not visible head on
Parking Lots	
Other:	
Overall Property Rating: (Excellent / Good / Fair / Poor) briefly state why. Fair

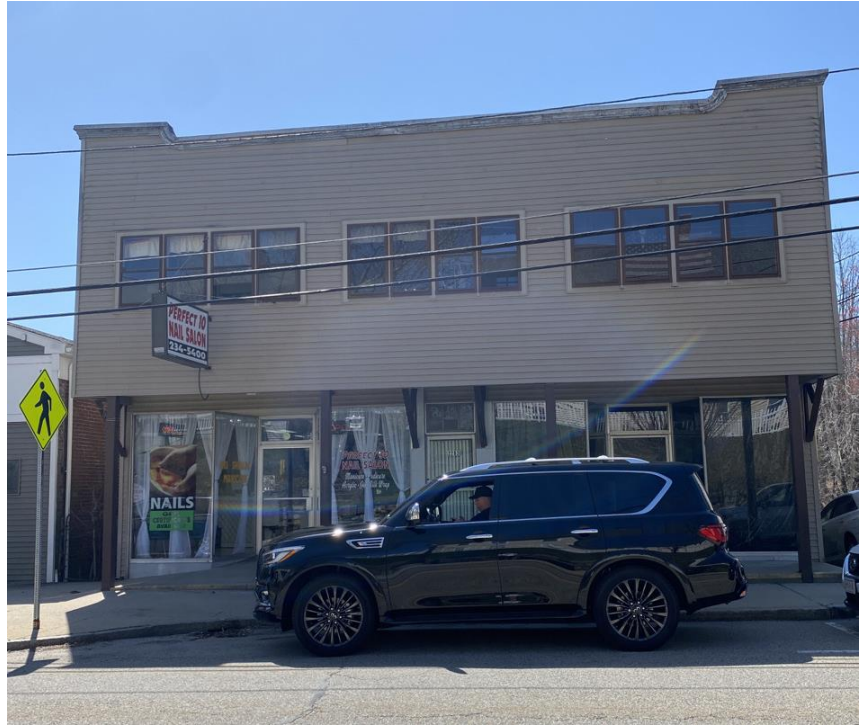
<u>Component</u>	<u>Condition</u>
Roofing	Unknown
Windows and Doors	Fair - old
Exterior Walls	Poor – some lifting siding, trim is rotting
Porch/Stairs/Deck	Good
Foundation	Good
Storefront & Signage	Fair
Parking Lots	
Other:	
Overall Property Rating: (Excellent / Good / Fair / Poor) briefly state why. Fair

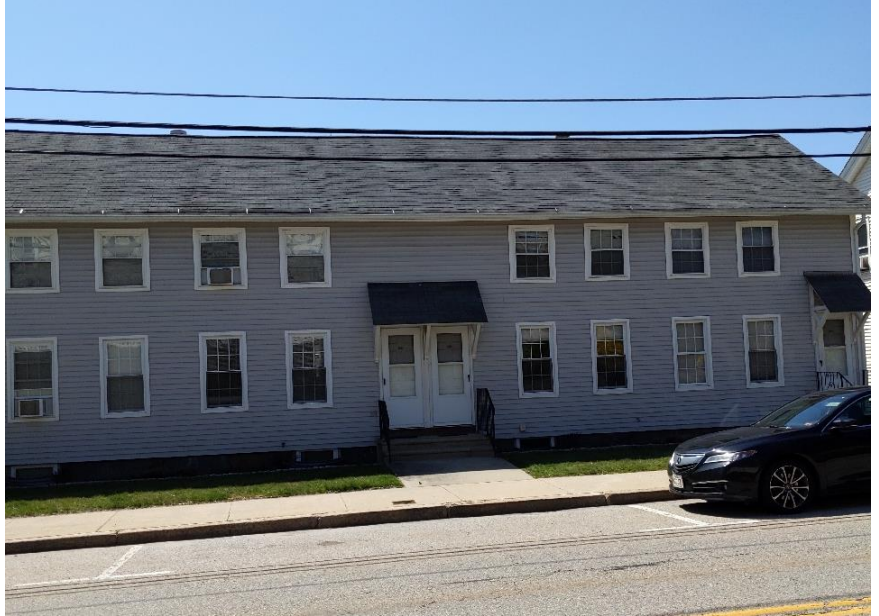
Exterior Walls Fair – some stains

Porch/Stairs/Deck Fair – steps are stained

Foundation Fair – few cracks

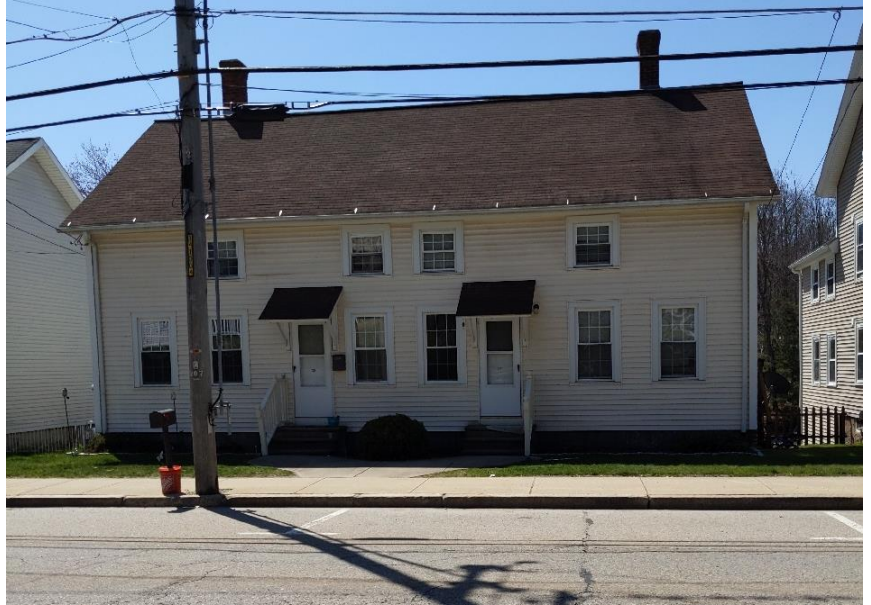
<u>Component</u>	<u>Condition</u>
Roofing	Fair – some shingles lifting
Windows and Doors	Fair – some trim is stained, older style
Exterior Walls	Fair – some stains
Porch/Stairs/Deck	Fair – railings coming loose, stained steps
Foundation	Good
Storefront & Signage	
Parking Lots	
Other:	
Overall Property Rating: (Excellent / Good / Fair / Poor) briefly state why. Fair

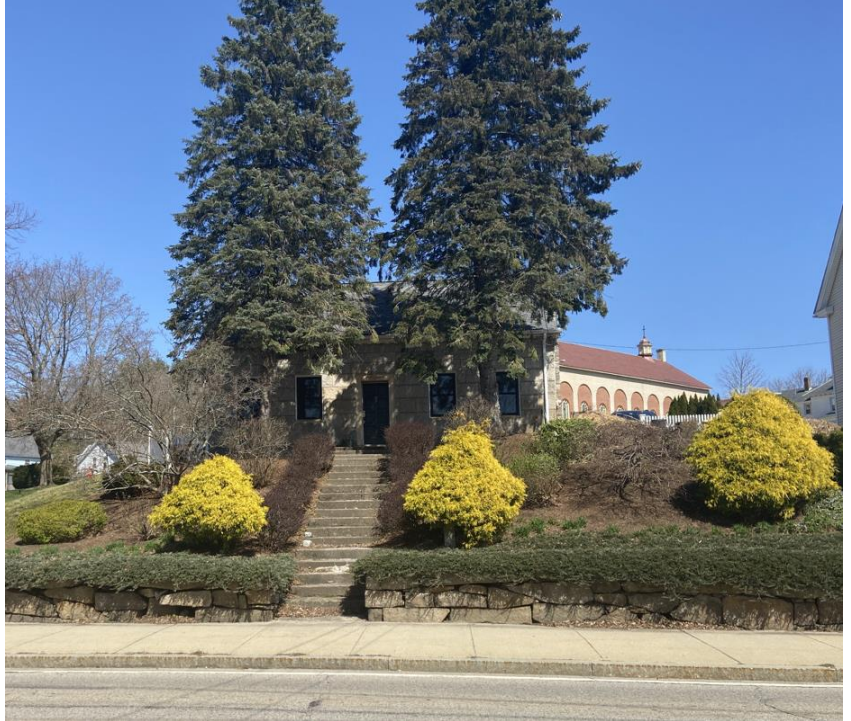
Foundation Good

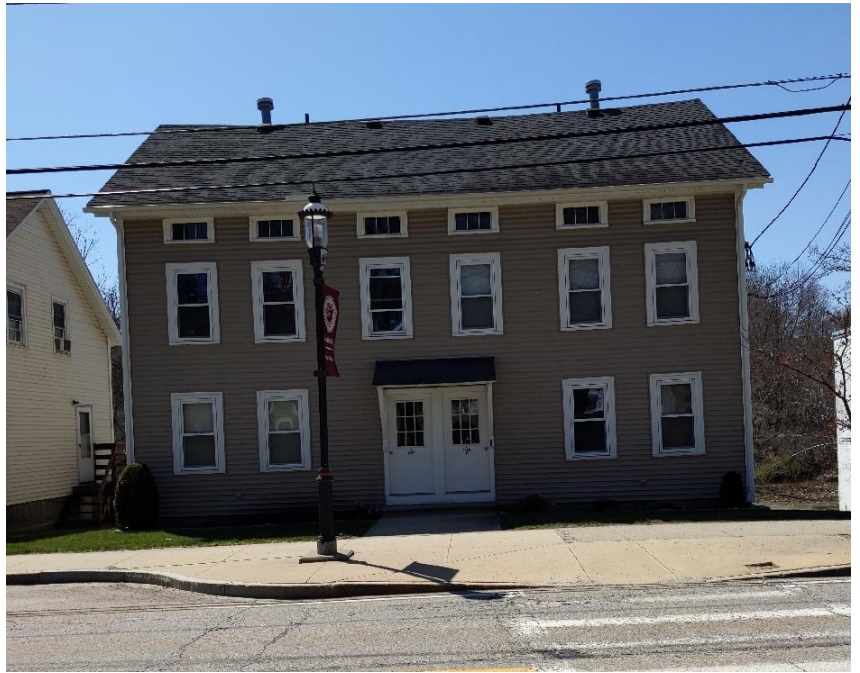
Roofing	Good
Windows and Doors	Good
Exterior Walls	Fair – some spots chipped or stained
Porch/Stairs/Deck	Good
Foundation	Fair – some moss and stains
Storefront & Signage	
Parking Lots	
Other:

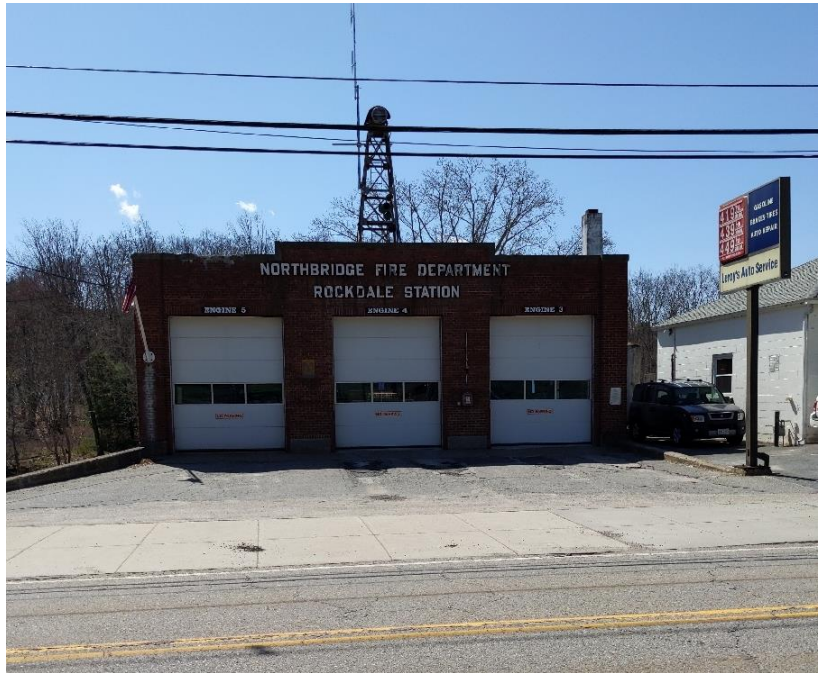
<u>Component</u>	<u>Condition</u>
Roofing	Unknown
Windows and Doors	Good
Exterior Walls	Poor – trim is weathered, stained brick
Porch/Stairs/Deck	n/a
Foundation	Good
Storefront & Signage	Fair – signs are very weathered
Parking Lots	
Other:	
Overall Property Rating: (Excellent / Good / Fair / Poor) briefly state why. Fair

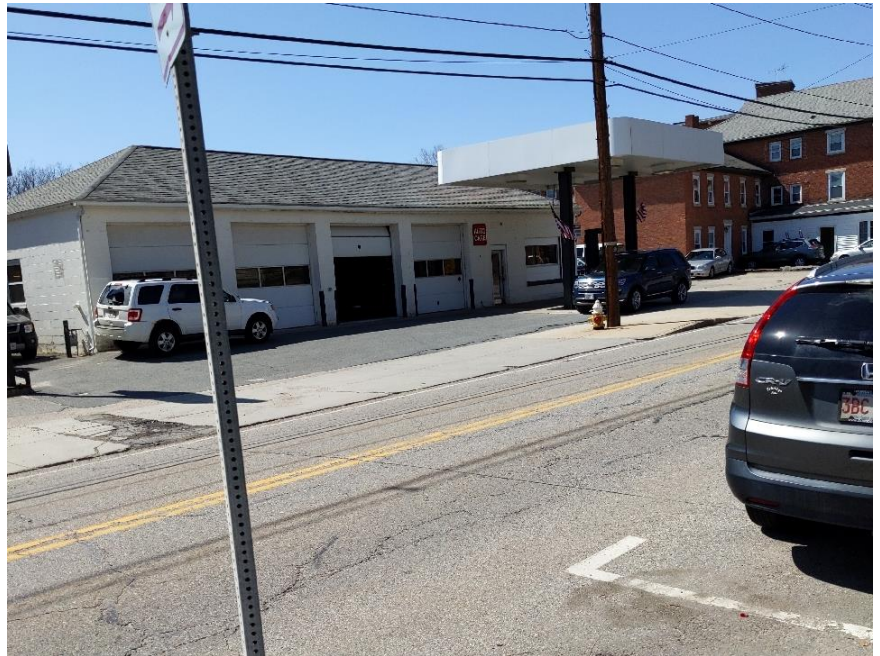
<u>Component</u>	<u>Condition</u>
Roofing	Good
Windows and Doors	Good
Exterior Walls	Fair
Porch/Stairs/Deck	n/a
Foundation	Fair – weathered, stains, minor growth
Storefront & Signage	Fair – minimal signage
Parking Lots	Fair – some cracks
Other:	
Overall Property Rating:	(Excellent / Good / Fair / Poor) briefly state why. Fair

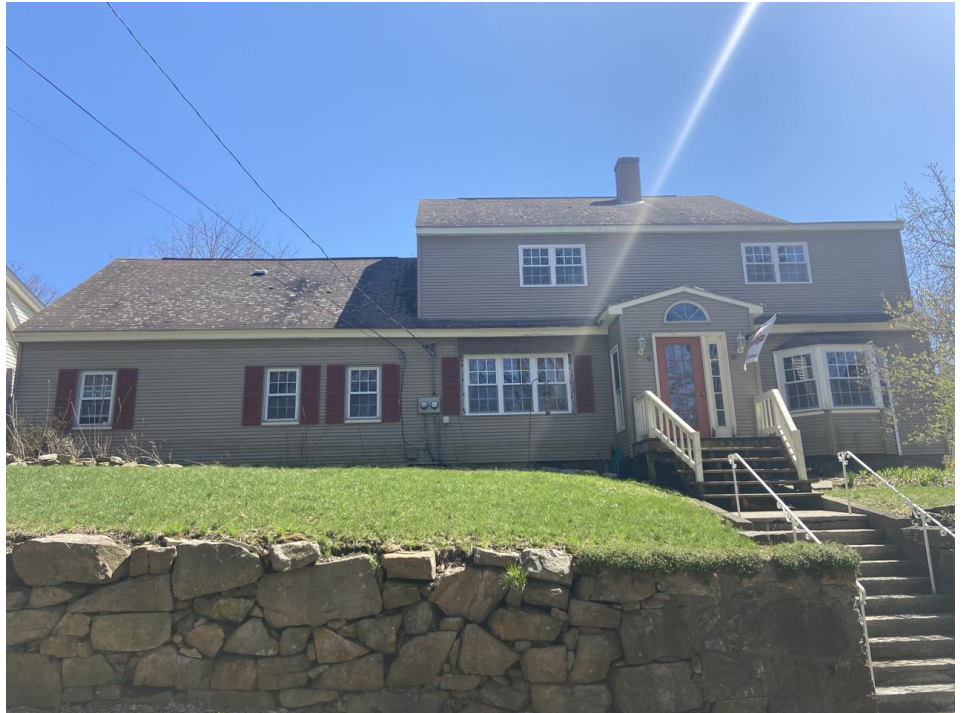
Porch/Stairs/Deck       Fair – worn paint

Foundation               Good

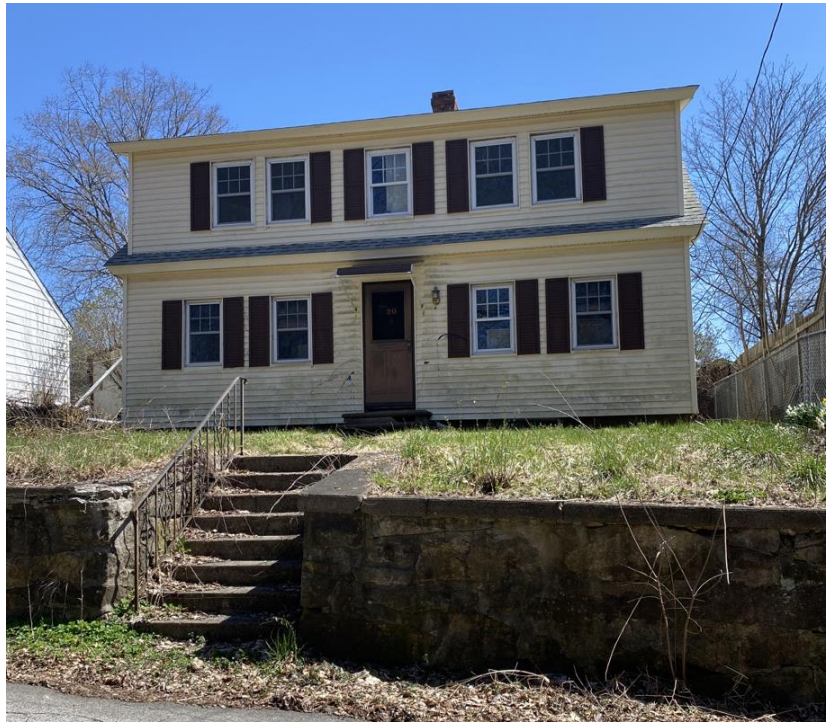
<u>Component</u>	<u>Condition</u>
Roofing	Unknown
Windows and Doors	Fair – old
Exterior Walls	Poor – very stained
Porch/Stairs/Deck	Poor – broken stairs
Foundation	Good
Storefront & Signage	
Parking Lots	
Other:	
Overall Property Rating: (Excellent / Good / Fair / Poor) briefly state why. Poor

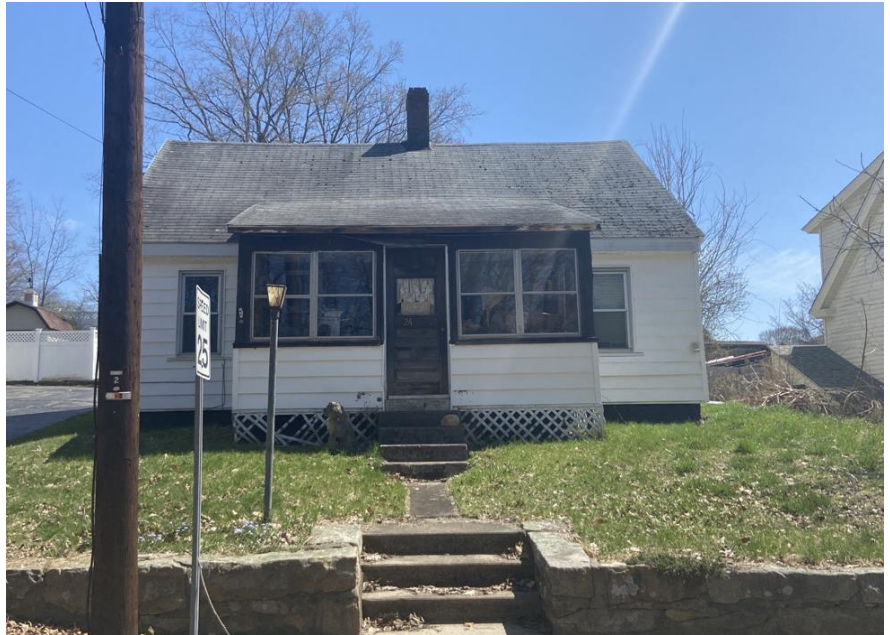
Roofing	Poor – stains, moss
Windows and Doors	Poor – old, broken windows
Exterior Walls	Fair
Porch/Stairs/Deck	Poor – no railings
Foundation	Poor
Storefront & Signage	
Parking Lots	
Other:

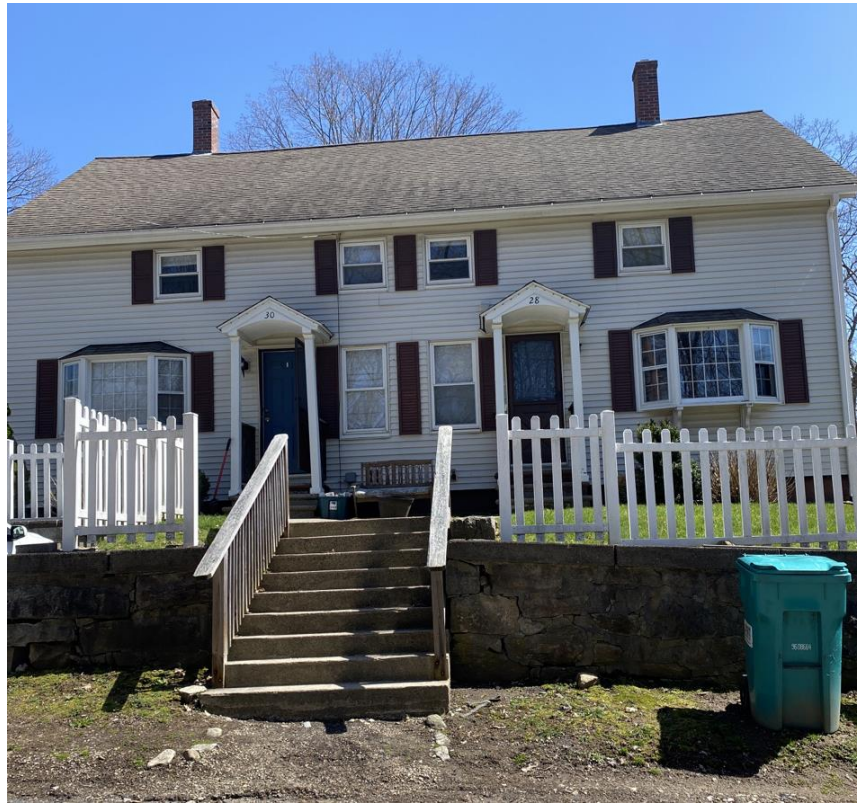
Roofing	Good
Windows and Doors	Fair – old
Exterior Walls	Good – vinyl siding
Porch/Stairs/Deck	Good
Foundation	Good
Storefront & Signage	
Parking Lots	
Other:

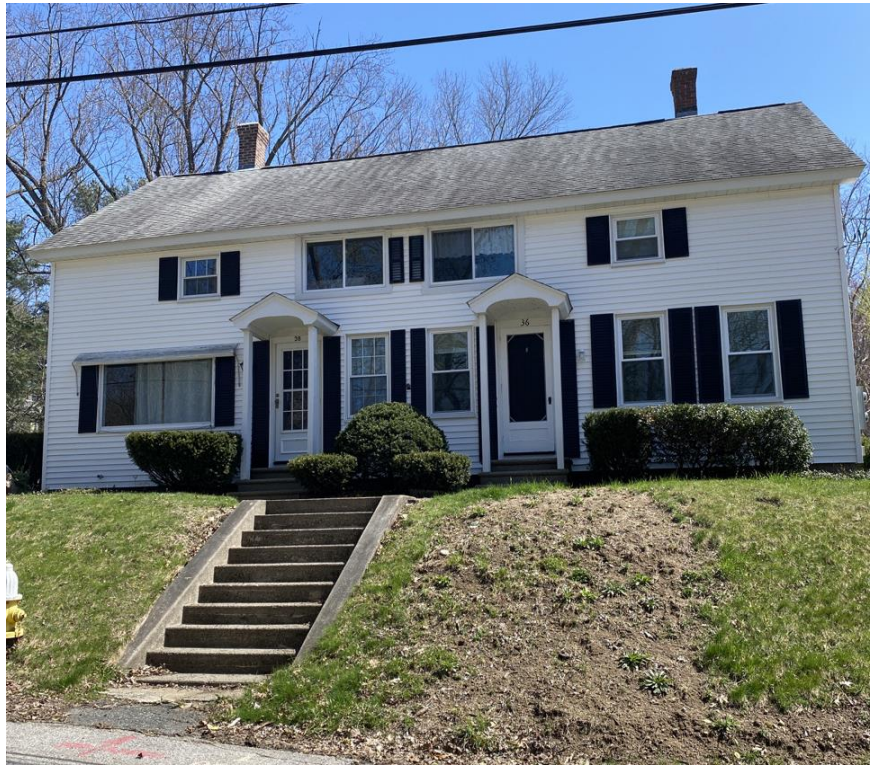
<u>Component</u>	<u>Condition</u>
Roofing	Fair – stains
Windows and Doors	Fair – old
Exterior Walls	Good
Porch/Stairs/Deck	Good
Foundation	Good
Storefront & Signage	
Parking Lots	
Other:	
Overall Property Rating: (Excellent / Good / Fair / Poor) briefly state why. Good

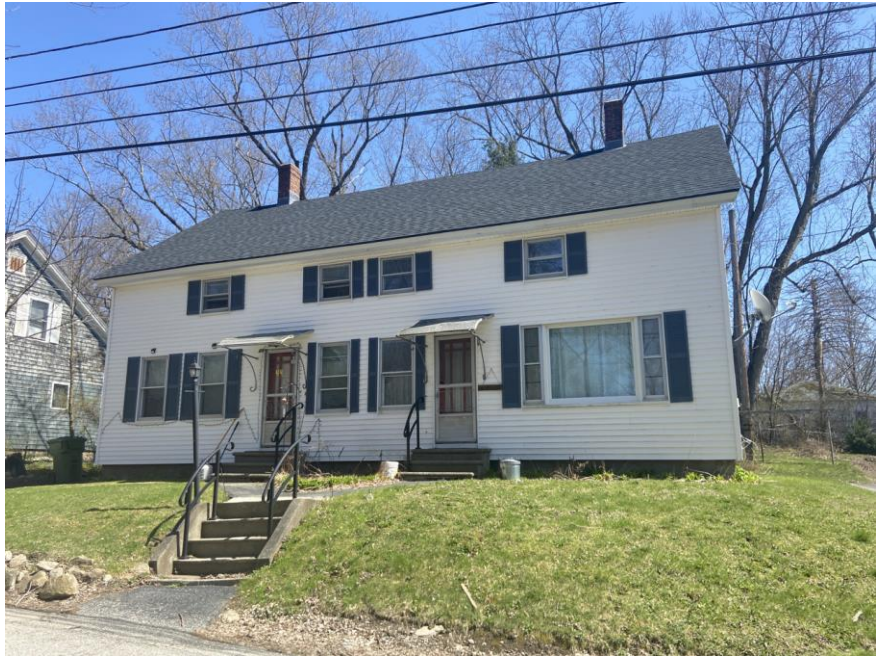
<u>Component</u>	<u>Condition</u>
Roofing	Good

Foundation	Good
------------	------

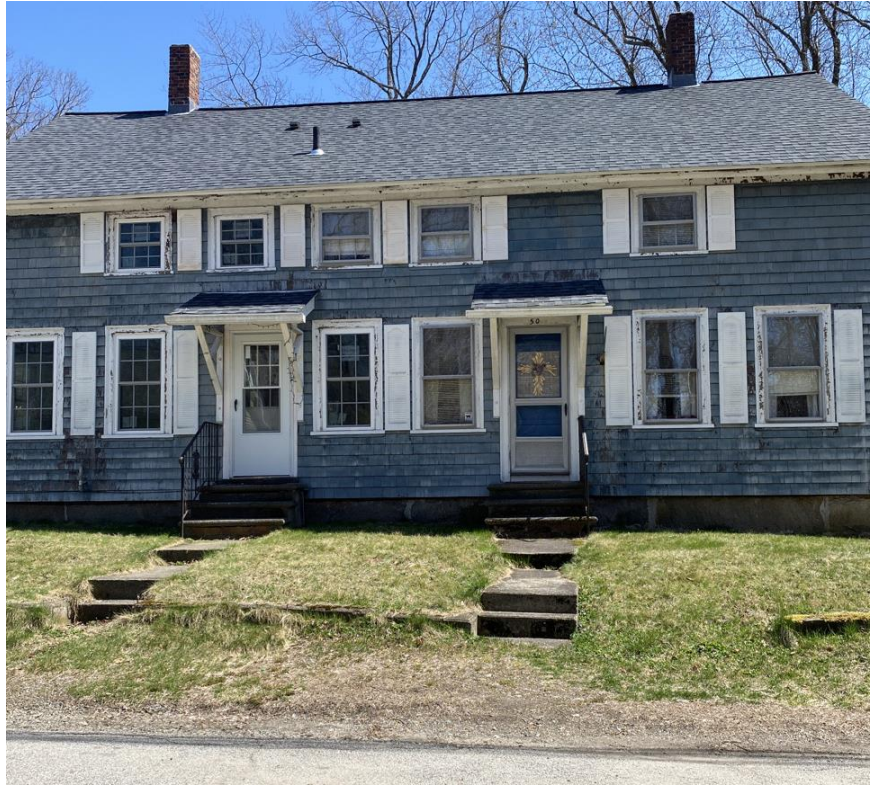
Roofing	Good – asphalt shingles
Windows and Doors	Fair – old
Exterior Walls	Poor – severely damaged siding and trim
Porch/Stairs/Deck	Poor – overgrown
Foundation	Good
Storefront & Signage	
Parking Lots	
Other:

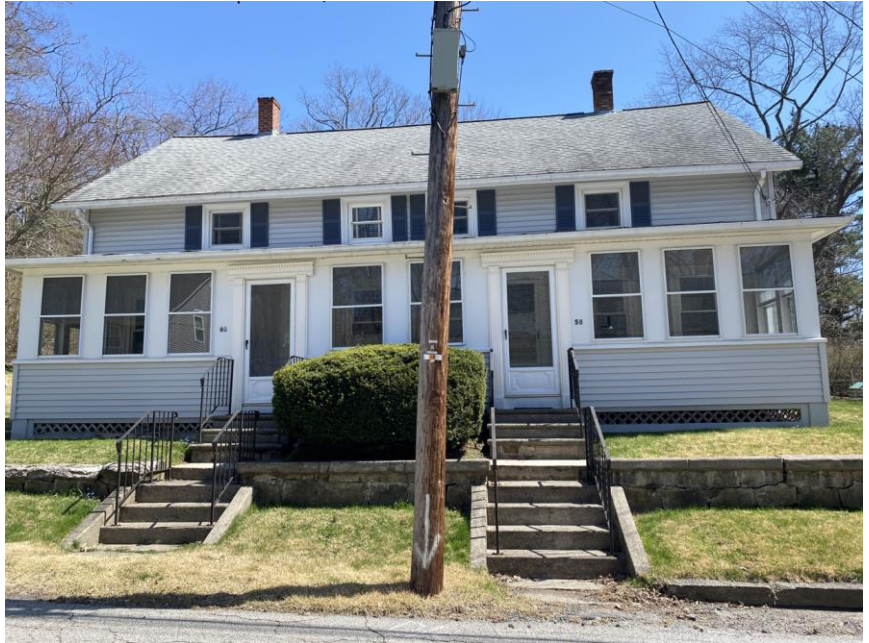
Roofing                      Poor – lifting shingles and stains

Foundation                Good

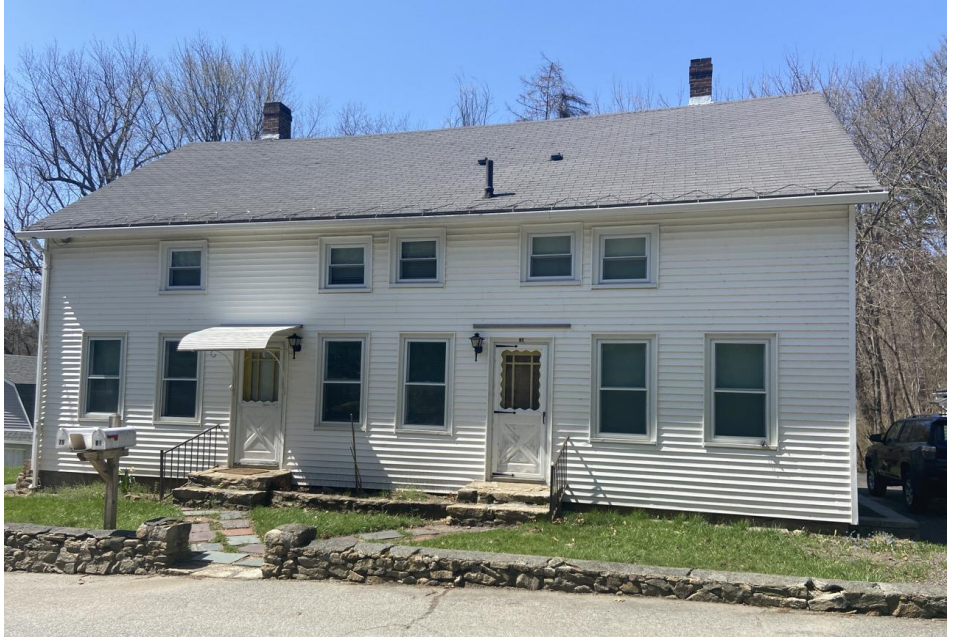
Roofing	Good
Windows and Doors	Fair – old
Exterior Walls	Good
Porch/Stairs/Deck	Good
Foundation	Good
Storefront & Signage	
Parking Lots	
Other:

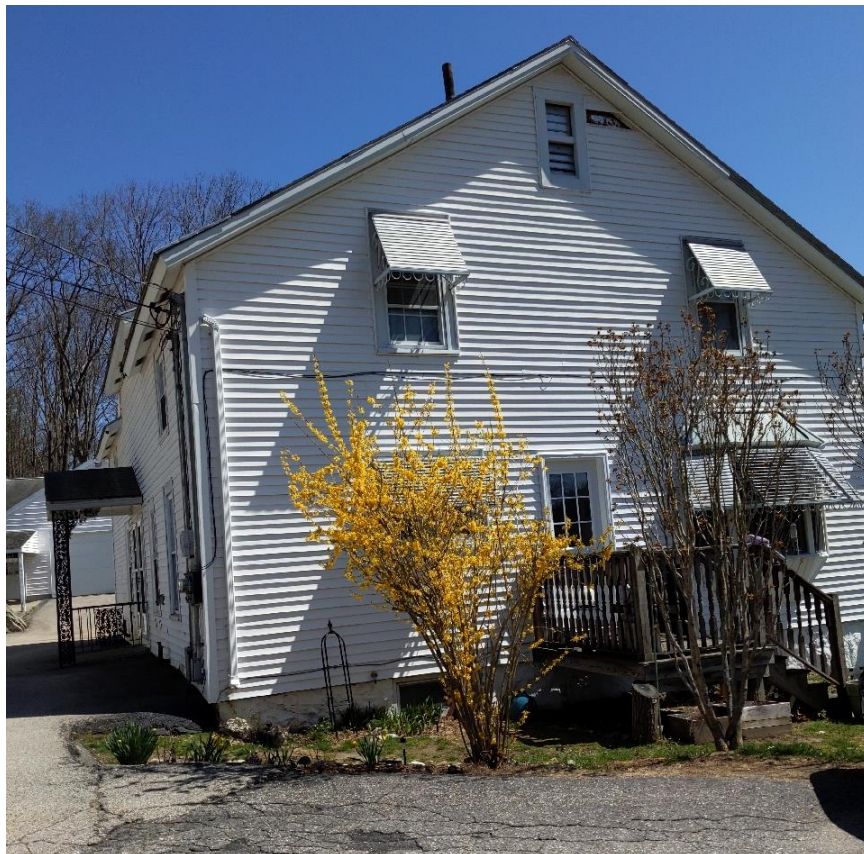
Roofing	Good
Windows and Doors	Good
Exterior Walls	Fair – minor stains
Porch/Stairs/Deck	Good
Foundation	Good
Storefront & Signage	
Parking Lots	
Other:

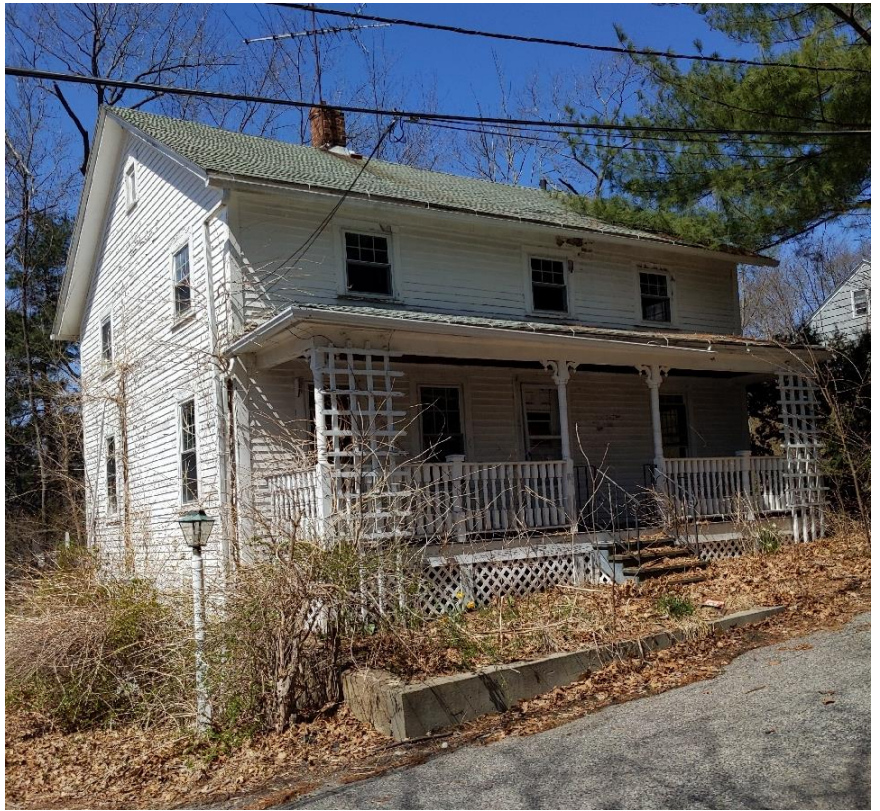
<u>Component</u>	<u>Condition</u>
Roofing	Fair – overgrown, stained
Windows and Doors	Poor – broken, paint is chipping on door, stained
Exterior Walls	Poor – wood siding, paint is very chipped, overgrown with vines
Porch/Stairs/Deck	Fair – overgrown
Foundation	Fair
Storefront & Signage	
Parking Lots	
Other:	
Overall Property Rating: (Excellent / Good / Fair / Poor) briefly state why. Poor

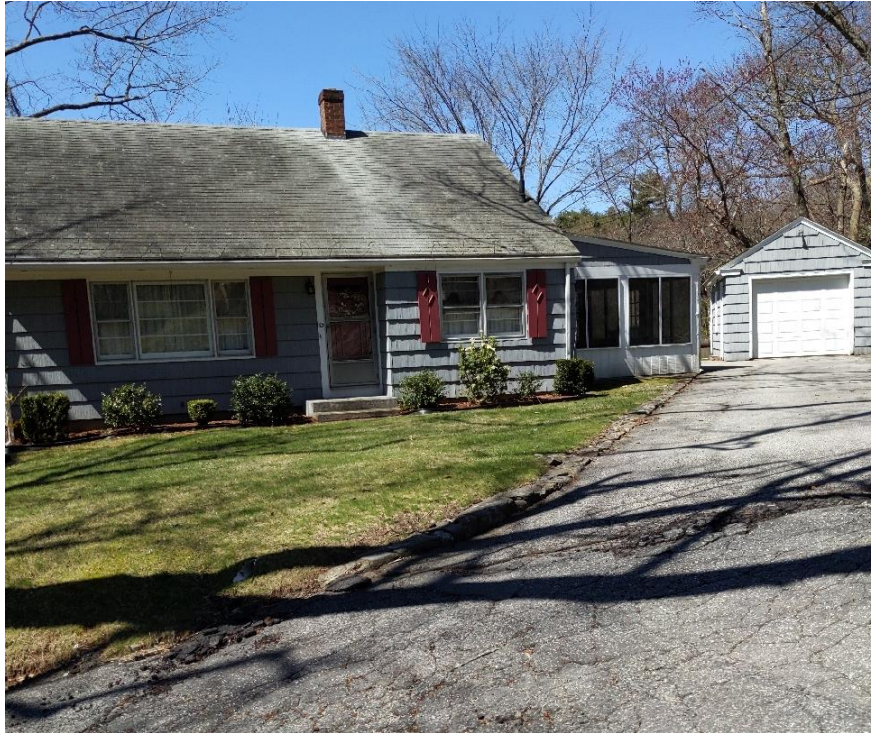
Roofing Poor – moss and stained

Foundation Good

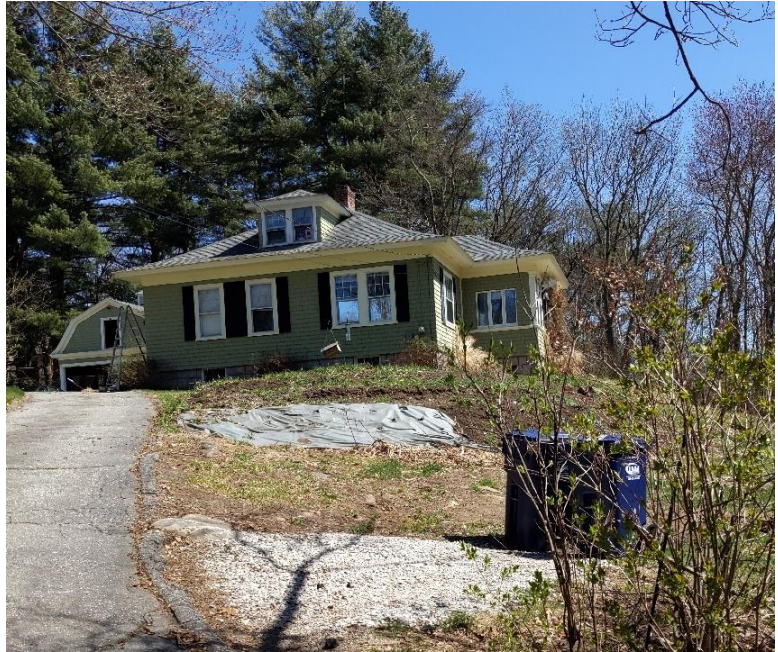
Roofing	Good
Windows and Doors	Good
Exterior Walls	Excellent
Porch/Stairs/Deck	Good
Foundation	Good
