# Northbridge Slum & Blight Inventory

## Rockdale Target Area

Report compiled by the Pioneer Valley  
Planning Commission for the Town of  
Northbridge

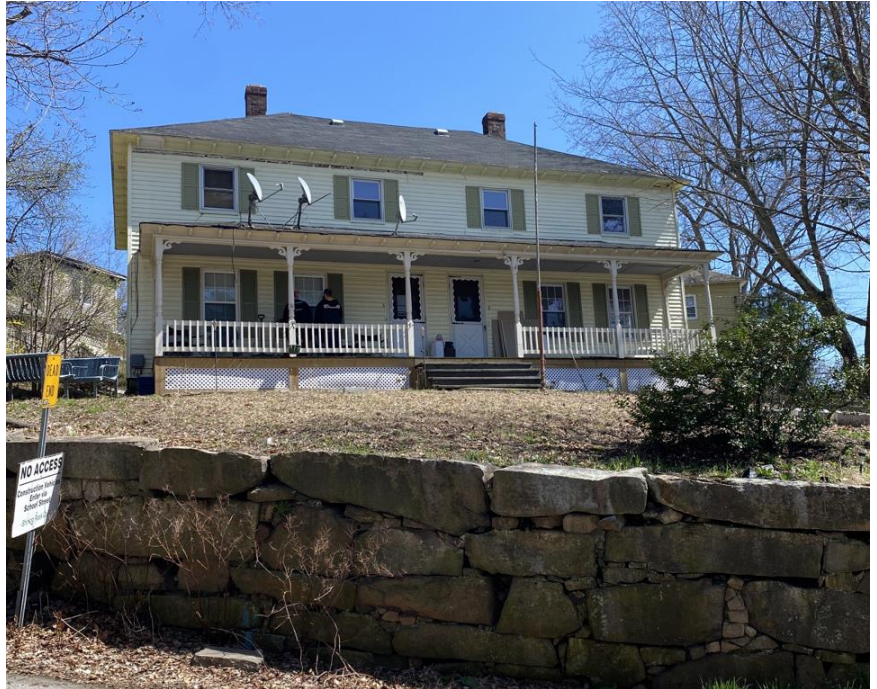
<u>Component</u>	<u>Condition</u>
Roofing	Fair – stains
Windows and Doors	Fair – old
Exterior Walls	Fair – stains
Porch/Stairs/Deck	Fair –weathered
Foundation	Good
Storefront & Signage	
Parking Lots	
Other:	
Overall Property Rating: (Excellent / Good / Fair / Poor) briefly state why. Fair

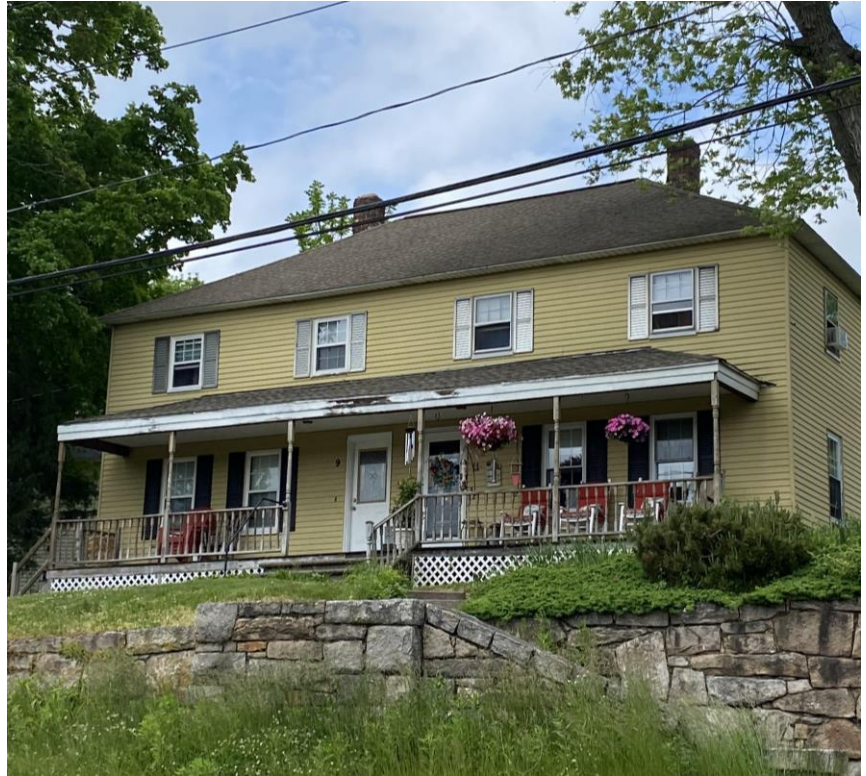
Roofing	Good
Windows and Doors	Fair
Exterior Walls	Fair – deteriorating trim
Porch/Stairs/Deck	Fair – weathered wood
Foundation	Unknown
Storefront & Signage	
Parking Lots	
Other:

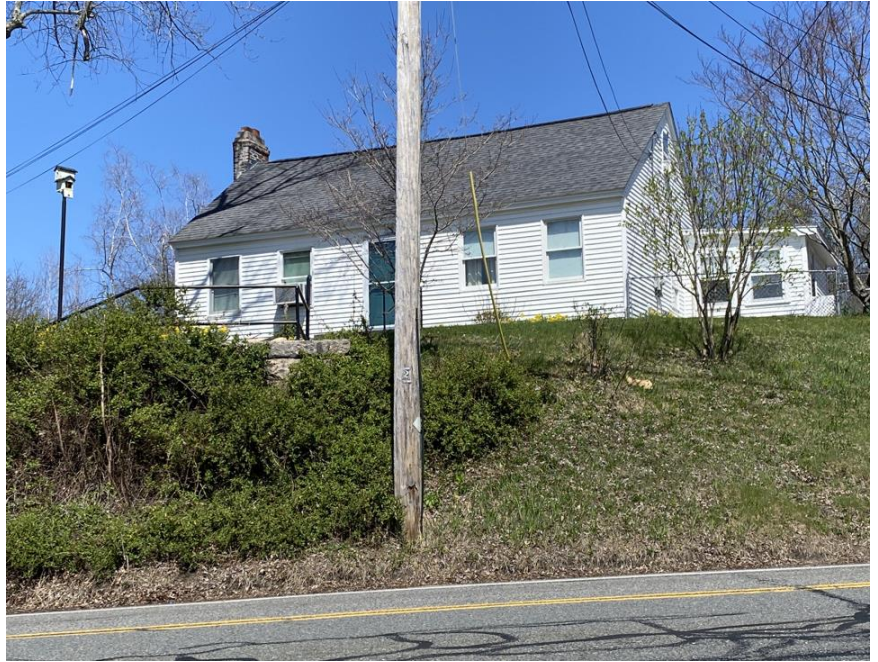
<b><u>Component</u></b>	<b><u>Condition</u></b>
Roofing	Good
Windows and Doors	Fair – older style
Exterior Walls	Good
Porch/Stairs/Deck	Unknown
Foundation	Unknown
Storefront & Signage	
Parking Lots	
Other:	
Overall Property Rating: (Excellent / Good / Fair / Poor) briefly state why. Good

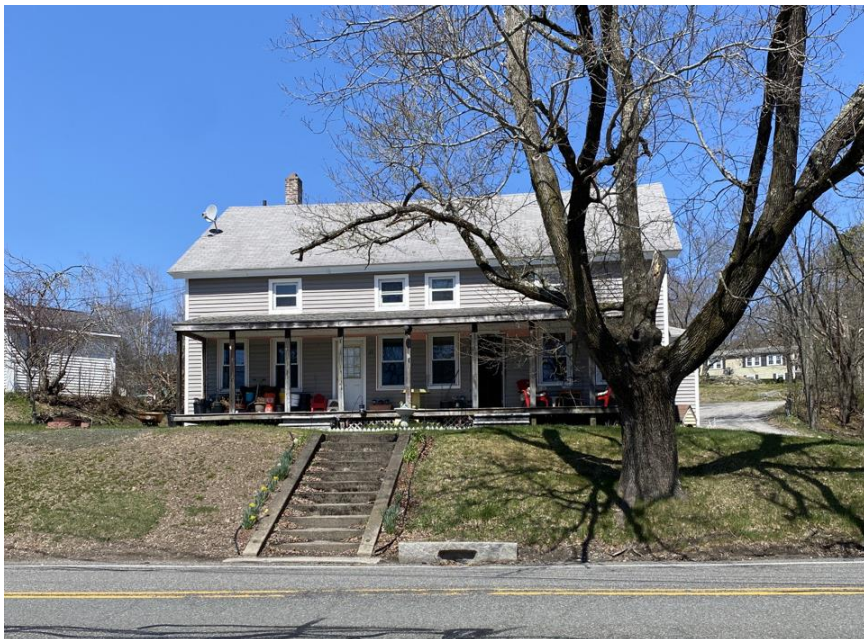
Roofing Fair – trim is stained

Porch/Stairs/Deck Fair – old, stained

Foundation Good

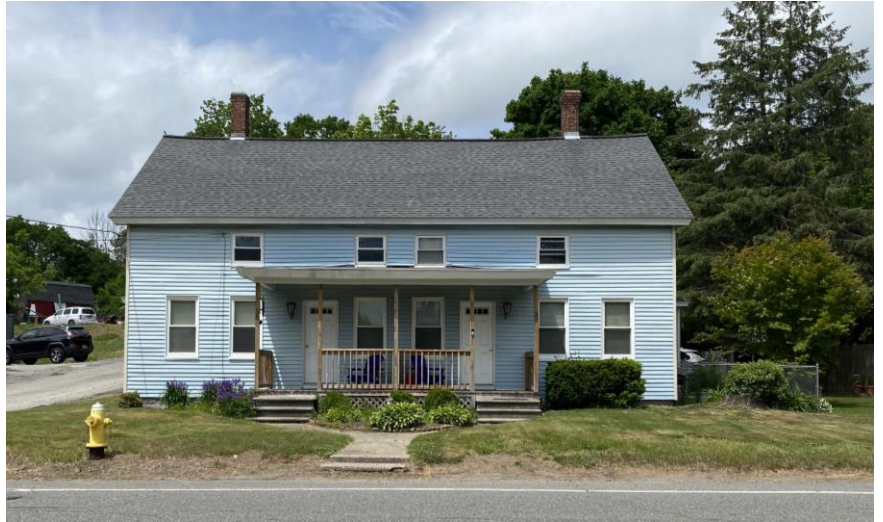
Roofing	Good
Windows and Doors	Fair – older
Exterior Walls	Fair – siding is lifting
Porch/Stairs/Deck	Fair – weathered/stained
Foundation	Good
Storefront & Signage	
Parking Lots	
Other:

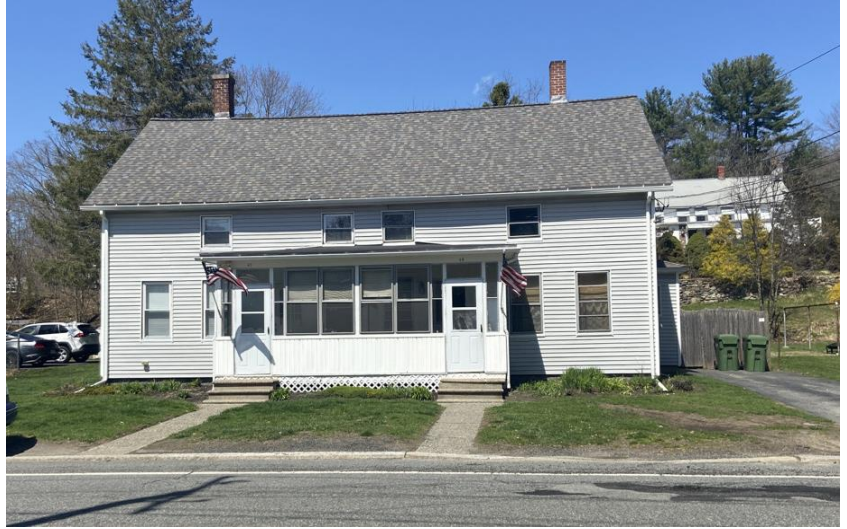
Roofing	Excellent
Windows and Doors	Fair – older style
Exterior Walls	Good
Porch/Stairs/Deck	Good
Foundation	Good
Storefront & Signage	
Parking Lots	
Other:

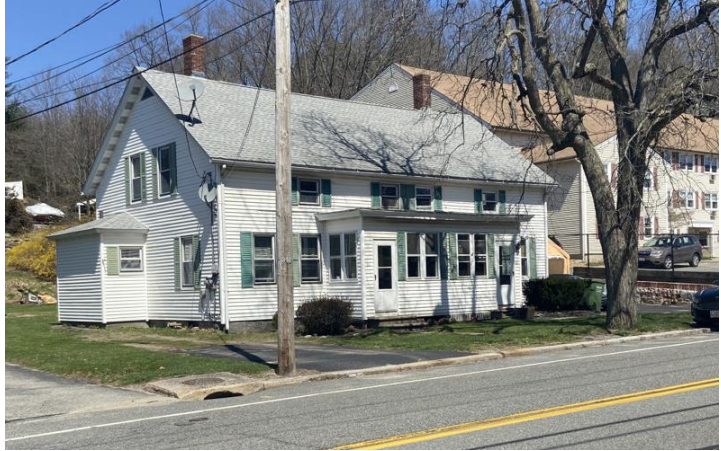
Roofing	Good
Windows and Doors	Fair – old
Exterior Walls	Good
Porch/Stairs/Deck	Good
Foundation	Good
Storefront & Signage	
Parking Lots	
Other:

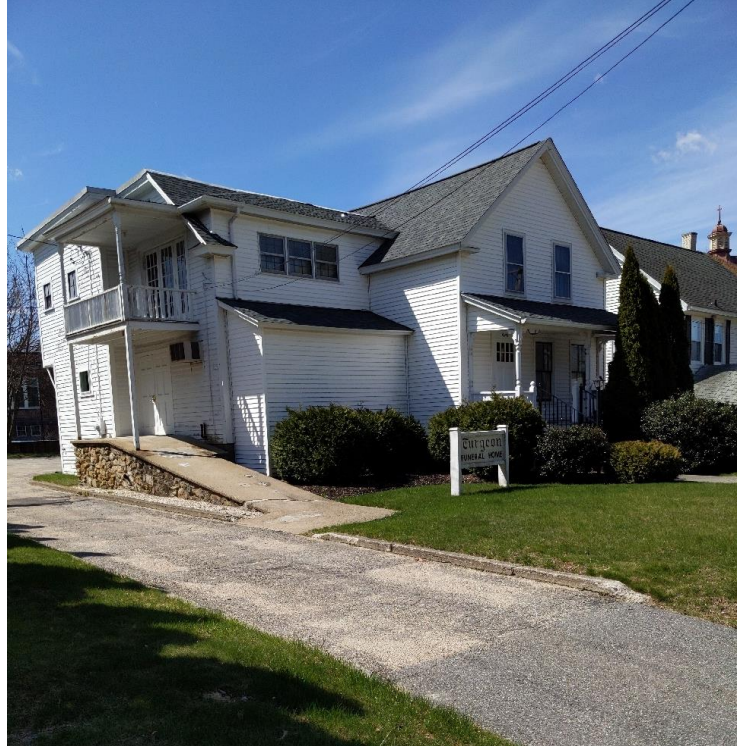
Roofing	Good – asphalt shingles
Windows and Doors	Good
Exterior Walls	Fair – side walls have chipped paint
Porch/Stairs/Deck	Fair – Front porch is good, but side balcony is poor, rotting and chipped
Foundation	Good
Storefront & Signage	Fair – only one small sign
Parking Lots	Fair – pavement is worn

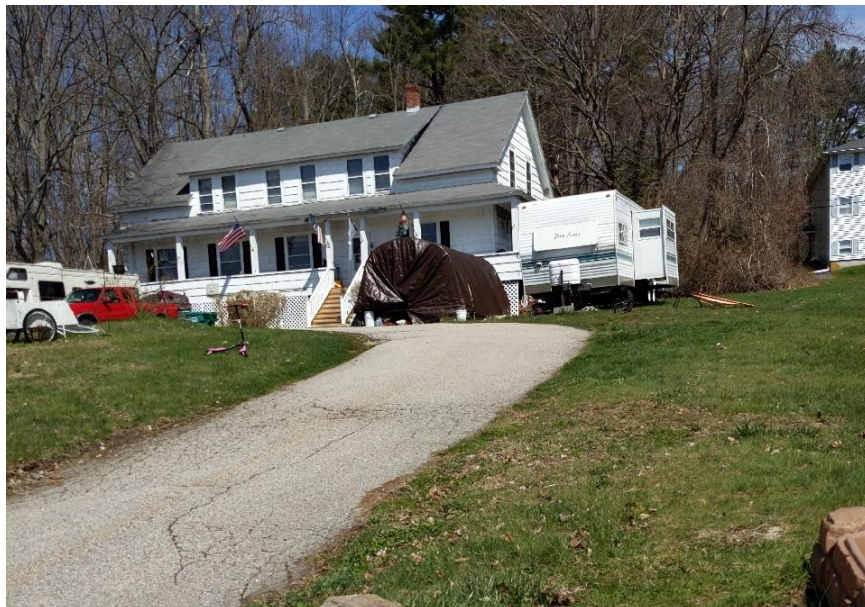
<u>Component</u>	<u>Condition</u>
Roofing	Good
Windows and Doors	Fair – old
Exterior Walls	Poor – wood siding, chipped paint, stains
Porch/Stairs/Deck	Good
Foundation	Good
Storefront & Signage	
Parking Lots	
Other:	
Overall Property Rating: (Excellent / Good / Fair / Poor) briefly state why. Fair

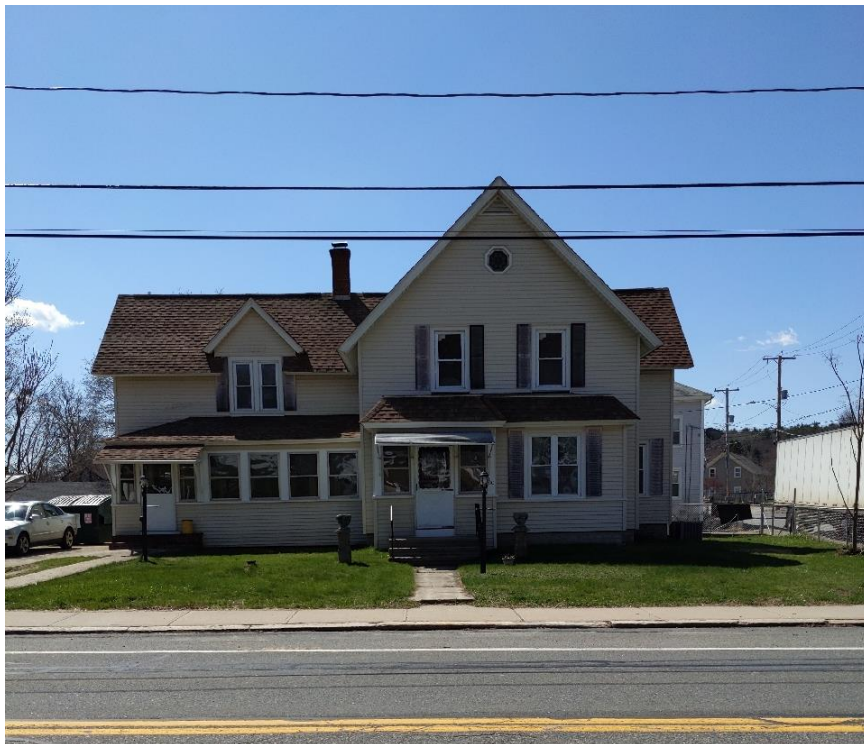
<u>Component</u>	<u>Condition</u>
Roofing	Fair – old
Windows and Doors	Fair – old style
Exterior Walls	Fair – some stains, shudders are faded
Porch/Stairs/Deck	Fair – minor stains
Foundation	Good
Storefront & Signage	
Parking Lots	
Other:	
Overall Property Rating: (Excellent / Good / Fair / Poor) briefly state why. Fair

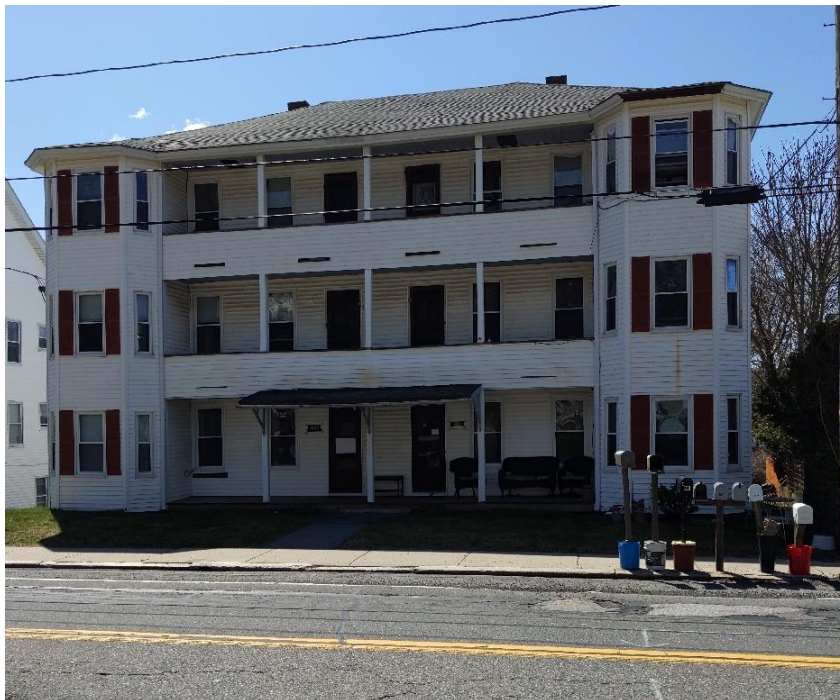
<u>Component</u>	<u>Condition</u>
Roofing	Good
Windows and Doors	Fair – old
Exterior Walls	Fair – stained
Porch/Stairs/Deck	Fair – chipped paint
Foundation	Good
Storefront & Signage	
Parking Lots	Fair – some potholes
Other:	
Overall Property Rating: (Excellent / Good / Fair / Poor) briefly state why. Fair

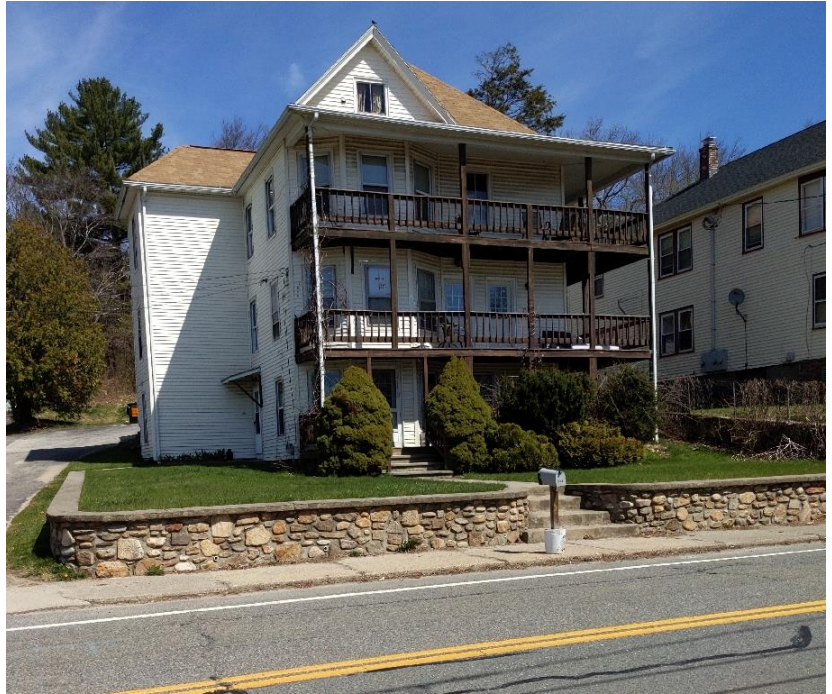
<u>Component</u>	<u>Condition</u>
Roofing	Good
Windows and Doors	Fair – older, some wear on trim
Exterior Walls	Fair – some vines
Porch/Stairs/Deck	Fair – upper decks are weathered and slanted
Foundation	Good
Storefront & Signage	
Parking Lots	
Other:	Fair – pavement is worn and cracked
Overall Property Rating: (Excellent / Good / Fair / Poor) briefly state why. Fair

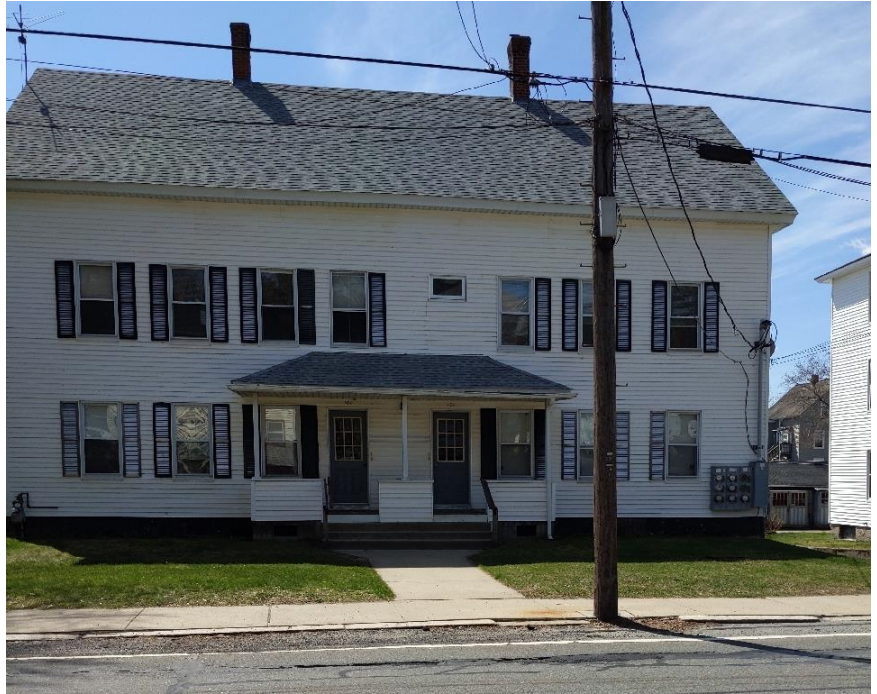
<u>Component</u>	<u>Condition</u>
Roofing	Good
Windows and Doors	Fair – old
Exterior Walls	Fair – stains
Porch/Stairs/Deck	Good
Foundation	Fair – cracks and moss
Storefront & Signage	
Parking Lots	
Other:	
Overall Property Rating: (Excellent / Good / Fair / Poor) briefly state why. Fair

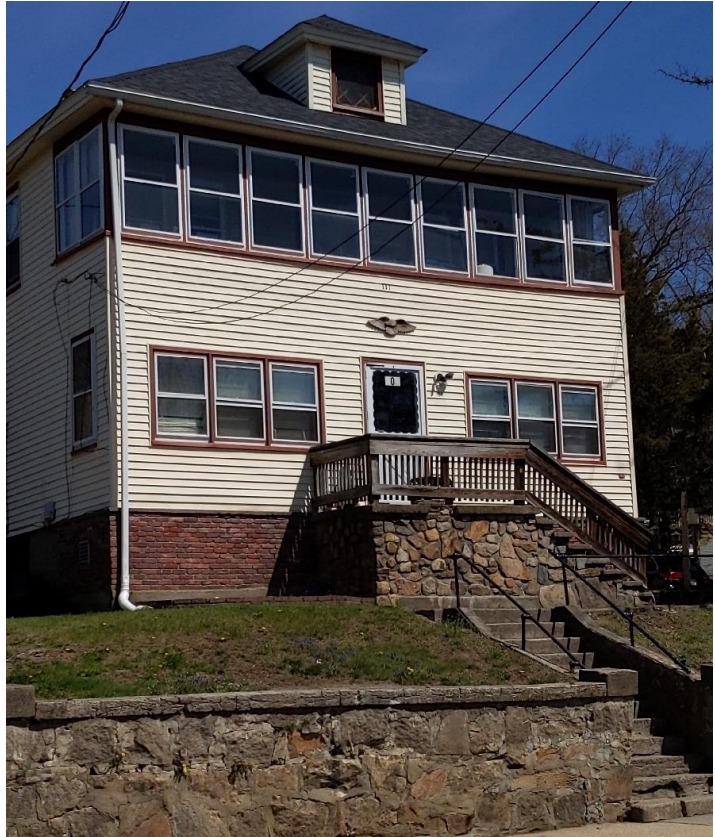
Roofing	Good
Windows and Doors	Fair – old
Exterior Walls	Good – vinyl siding
Porch/Stairs/Deck	Good
Foundation	Fair – some signs of wear
Storefront & Signage	
Parking Lots	
Other:

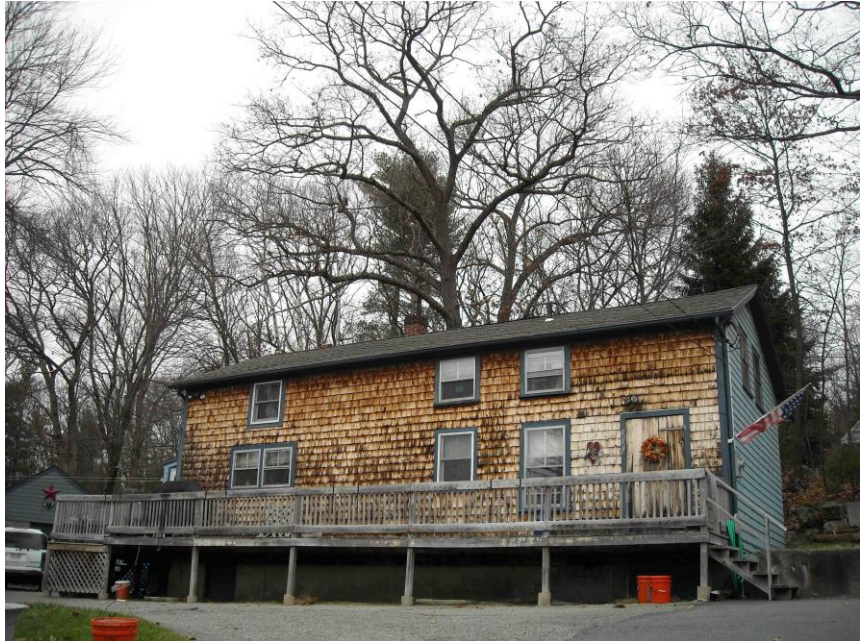
<u>Component</u>	<u>Condition</u>
------------------	------------------

Foundation	Unknown
------------	---------

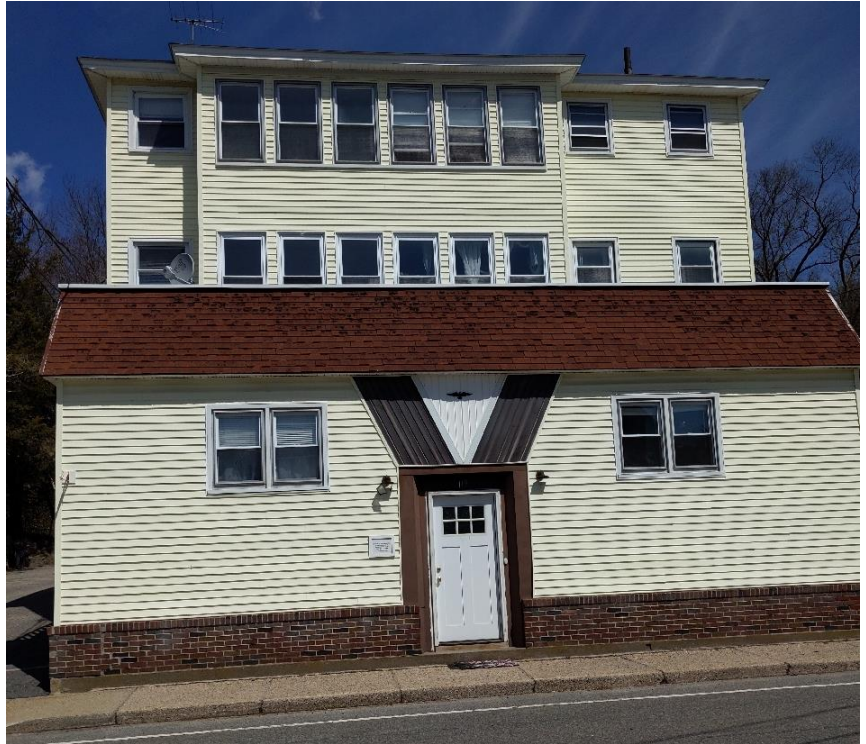
Roofing Fair – some wear

Foundation Good

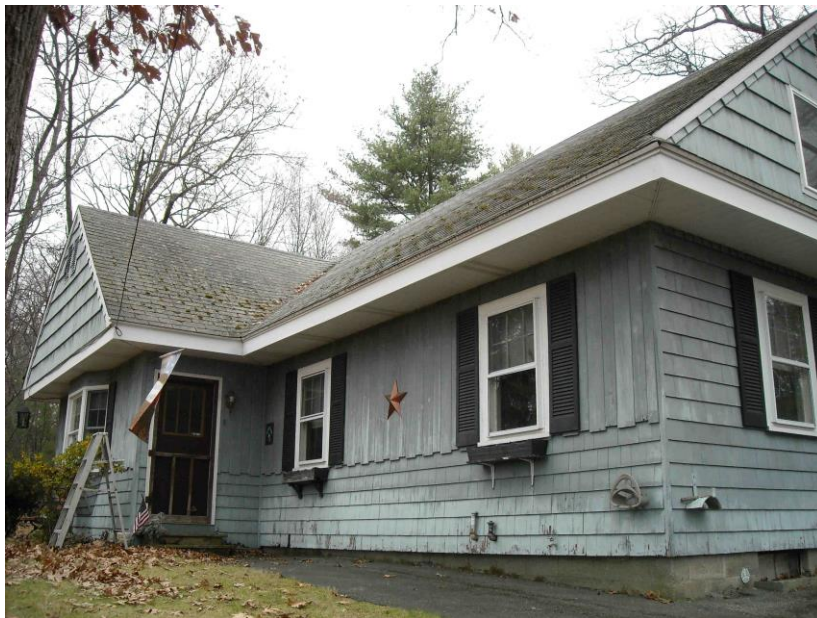
Foundation	Unknown
------------	---------

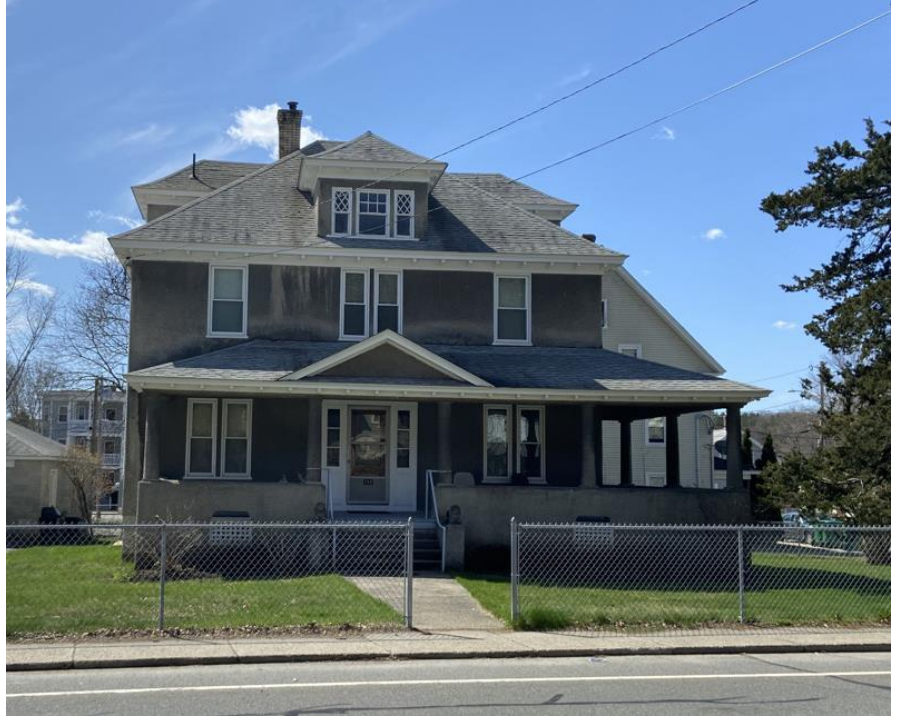
Roofing	Fair – significant staining
Windows and Doors	Fair – older style
Exterior Walls	Poor – worn paint/damaged
Porch/Stairs/Deck	Good
Foundation	Good
Storefront & Signage	
Parking Lots	
Other:

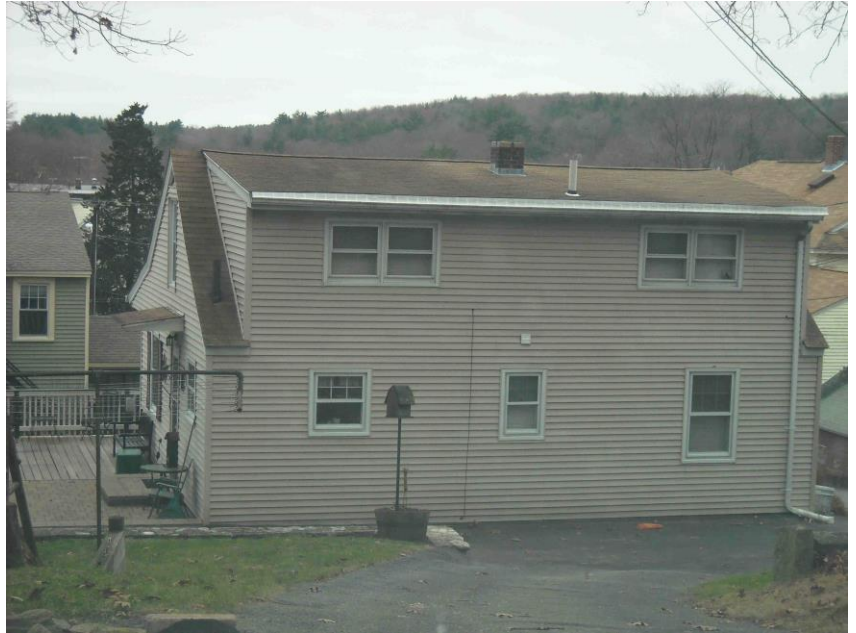
Foundation	Unknown
------------	---------

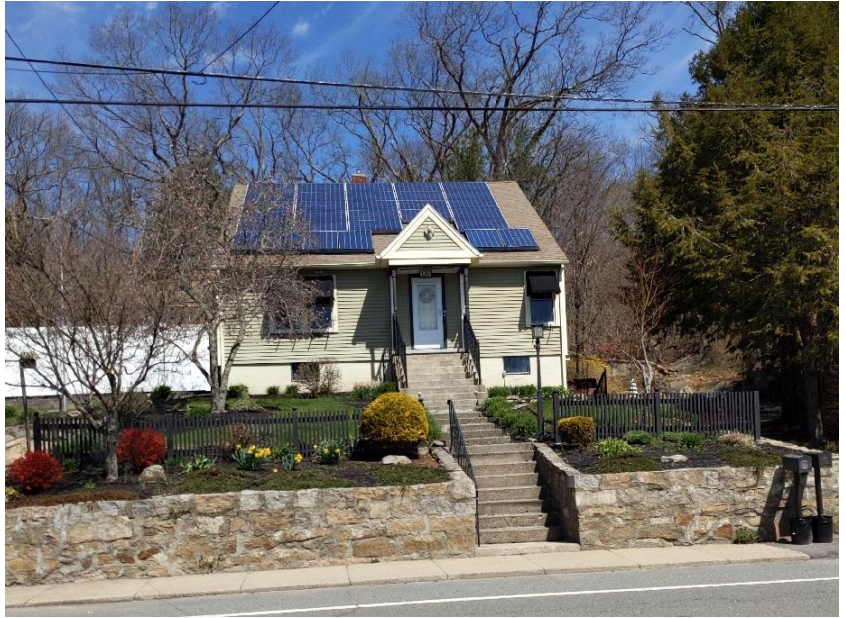
Foundation                        Good

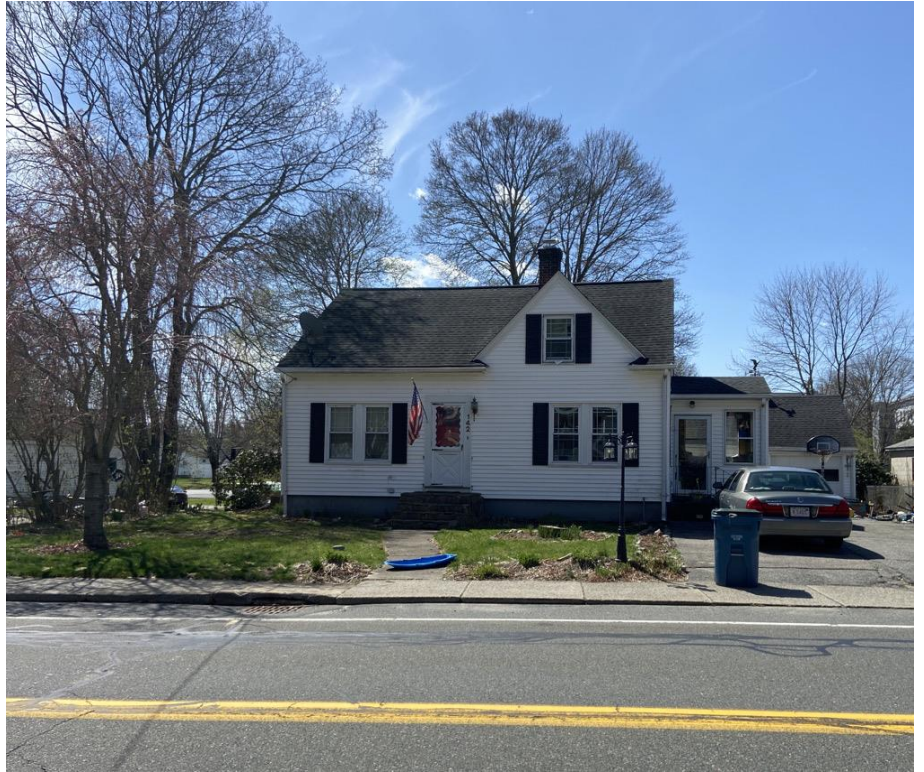
<u>Component</u>	<u>Condition</u>
Roofing	Good
Windows and Doors	Fair – older style
Exterior Walls	Fair – staining present
Porch/Stairs/Deck	Poor – no railings, damaged concrete
Foundation	Good
Storefront & Signage	
Parking Lots	
Other:	
Overall Property Rating: (Excellent / Good / Fair / Poor) briefly state why. Fair

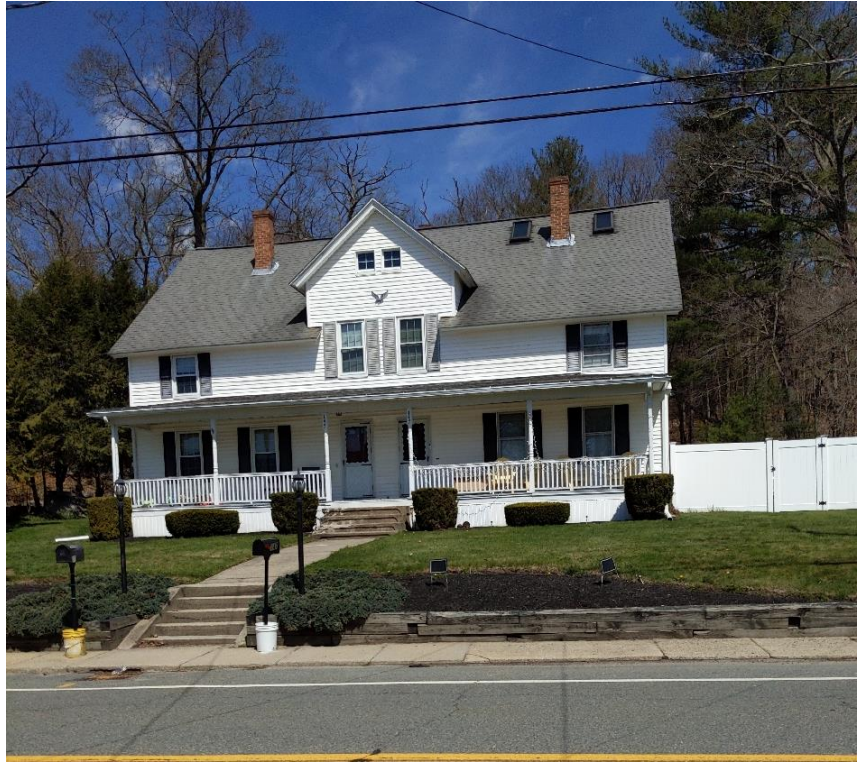
Roofing	Good – minor stains
Windows and Doors	Fair – older
Exterior Walls	Good
Porch/Stairs/Deck	Fair – porch in good condition, stairs are worn and stained
Foundation	Good
Storefront & Signage	
Parking Lots	
Other:

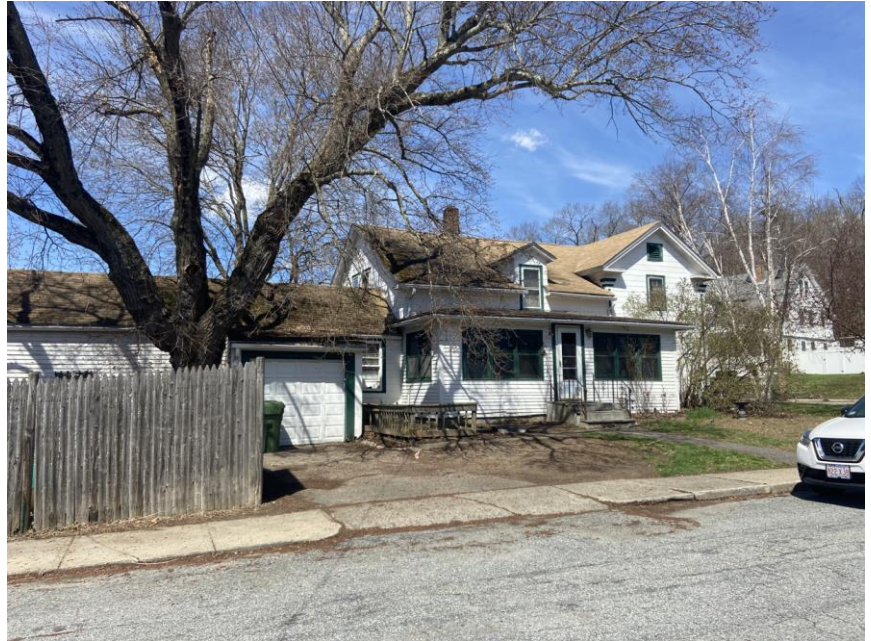
Roofing                      Poor – significant moss growth (side), damaged shingles

Windows and Doors      Poor – old/damaged windows

Exterior Walls            Fair – areas of damaged siding

Foundation               Fair

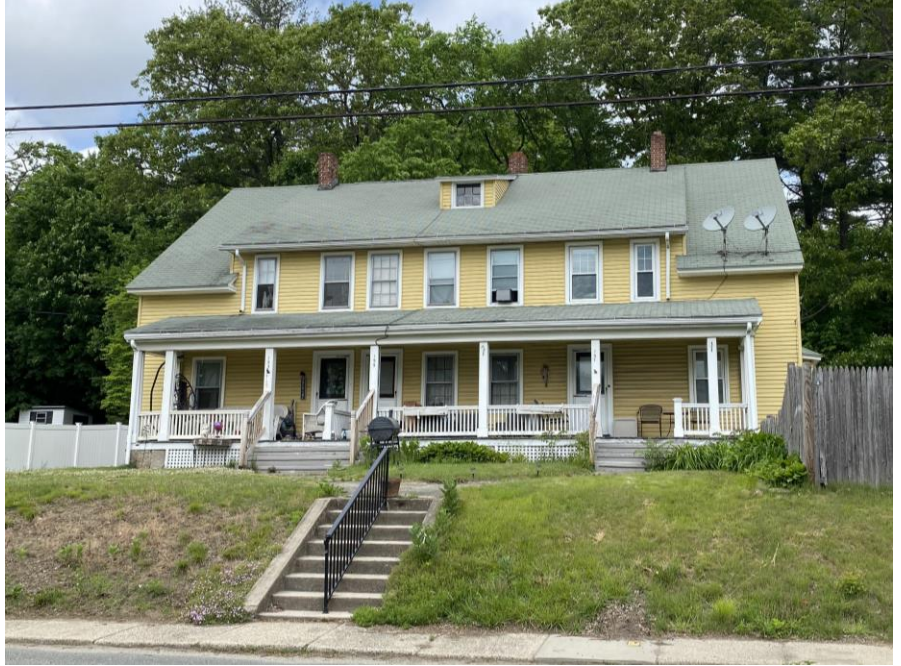
Roofing	Fair – stains
Windows and Doors	Fair – older
Exterior Walls	Good
Porch/Stairs/Deck	Fair – weathered, chipped paint
Foundation	Good
Storefront & Signage	
Parking Lots	
Other:	
Overall Property Rating:	(Excellent / Good / Fair / Poor) briefly state why. Fair

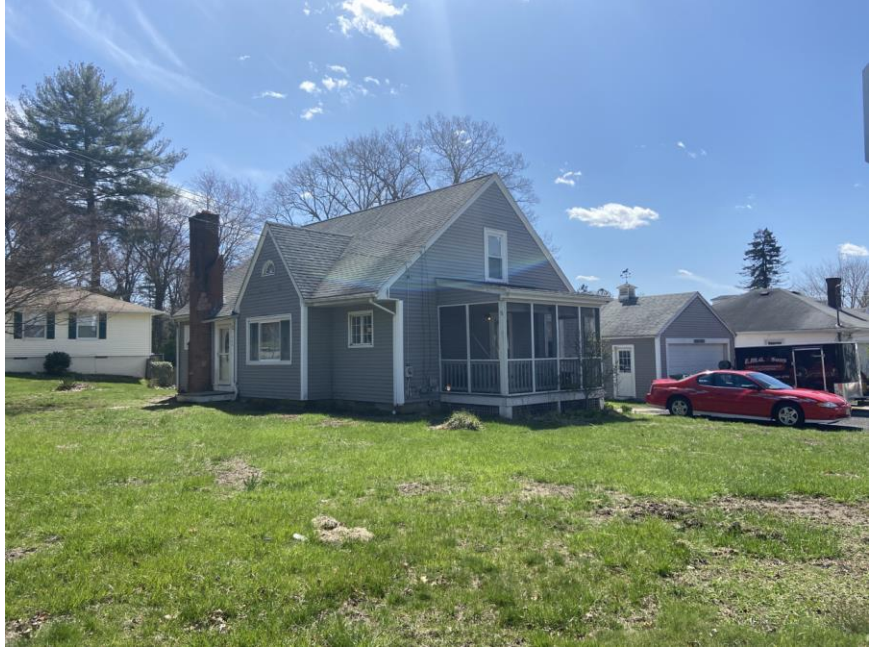
Roofing	Fair – stains
Windows and Doors	Fair – older style
Exterior Walls	Fair – damaged siding
Porch/Stairs/Deck	Good
Foundation	Good
Storefront & Signage	
Parking Lots	
Other:

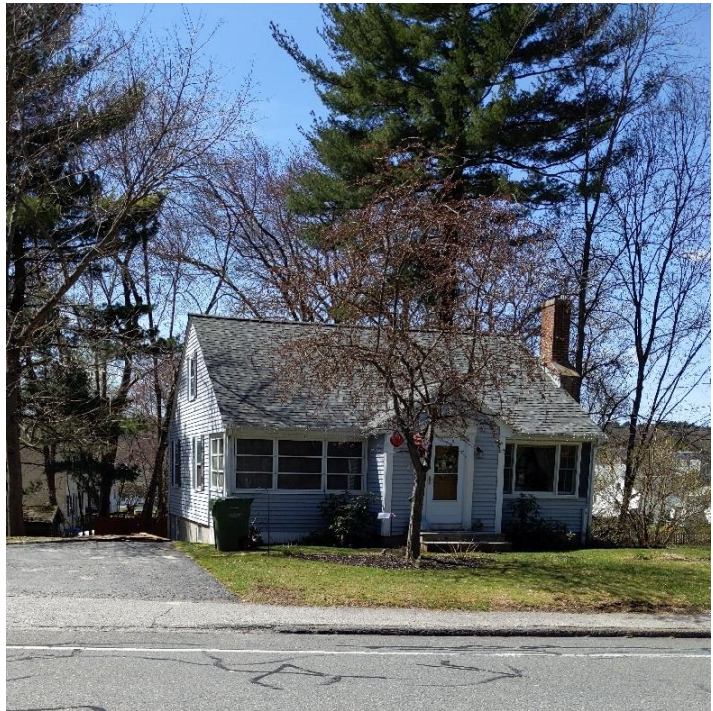
Roofing	Good
Windows and Doors	Fair – old
Exterior Walls	Good
Porch/Stairs/Deck	Good
Foundation	Good
Storefront & Signage	
Parking Lots	
Other:

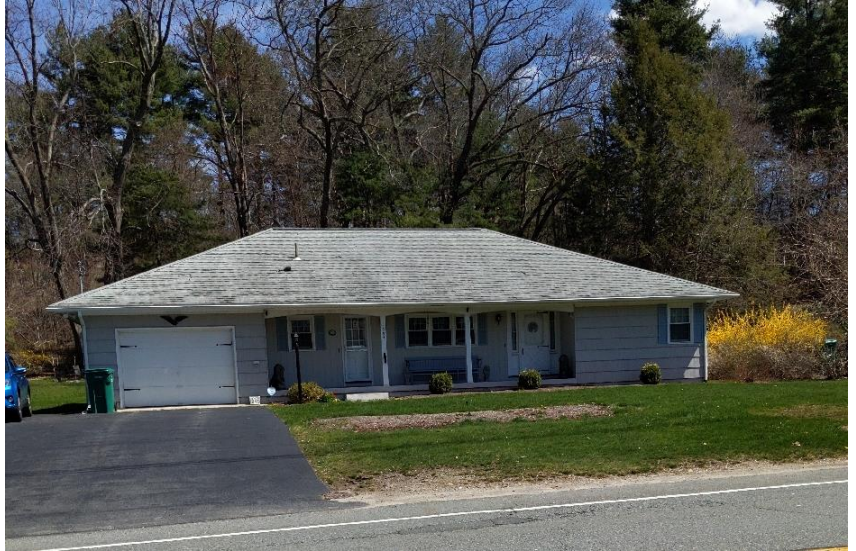
Roofing	Good
Windows and Doors	Fair – older style
Exterior Walls	Good
Porch/Stairs/Deck	Fair – some wear on porch
Foundation	Good
Storefront & Signage	
Parking Lots	
Other:

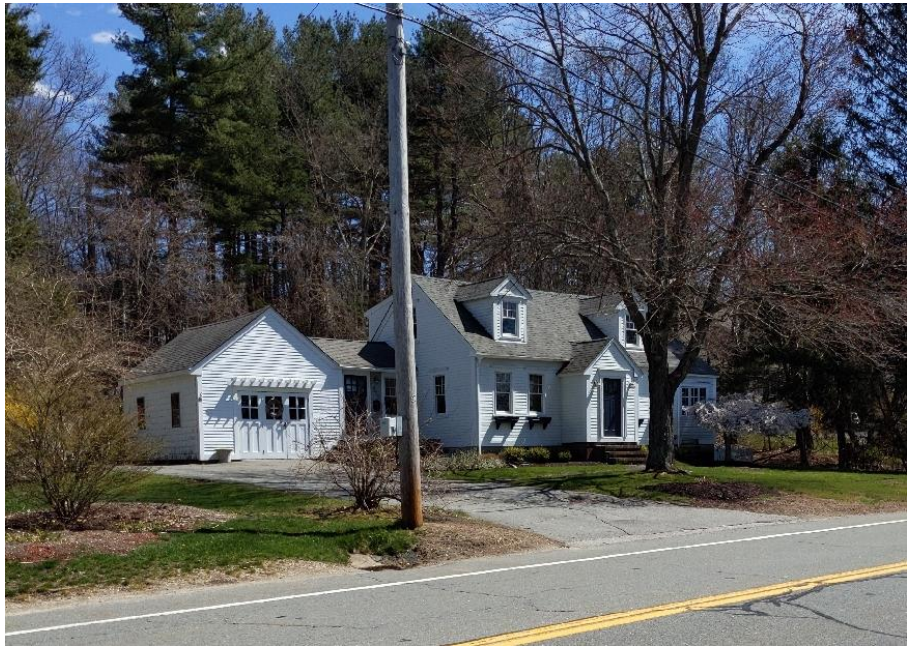
Roofing	Good
Windows and Doors	Excellent
Exterior Walls	Good
Porch/Stairs/Deck	Good
Foundation	Good
Storefront & Signage	
Parking Lots	
Other:

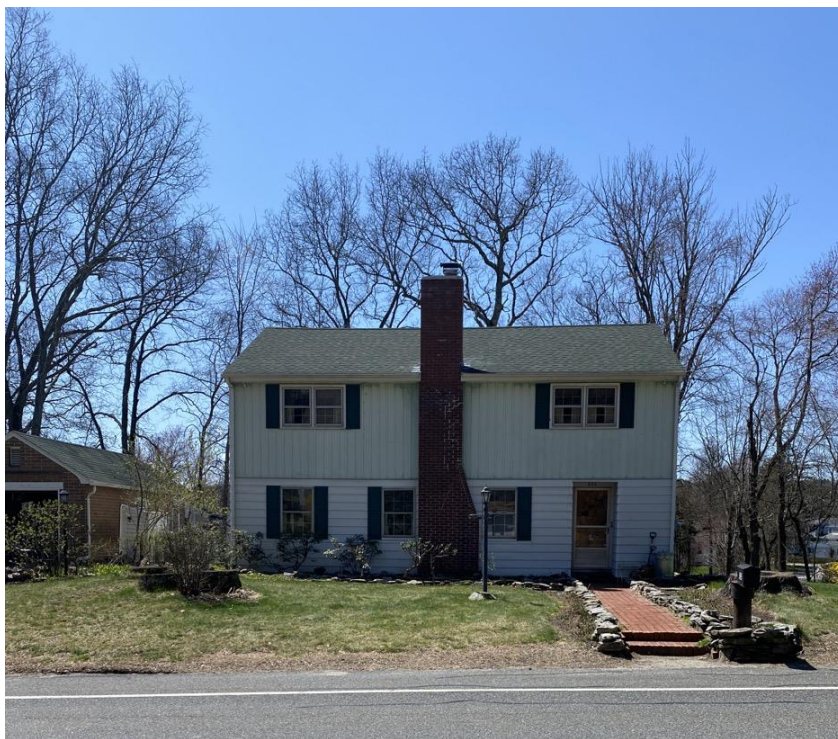
<u>Component</u>	<u>Condition</u>
Roofing	Good
Windows and Doors	Fair – old
Exterior Walls	Fair – stains
Porch/Stairs/Deck	Fair – uneven bricks
Foundation	Good
Storefront & Signage	
Parking Lots	
Other:	
Overall Property Rating: (Excellent / Good / Fair / Poor) briefly state why. Fair

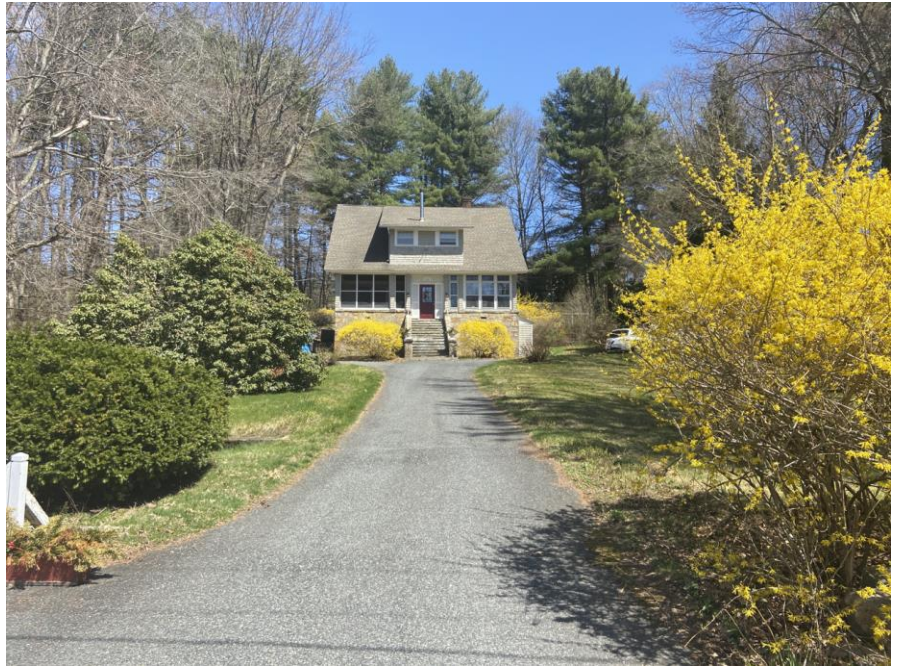
Roofing	Good
Windows and Doors	Fair – chipped paint
Exterior Walls	Good
Porch/Stairs/Deck	Good
Foundation	Good
Storefront & Signage	
Parking Lots	
Other:

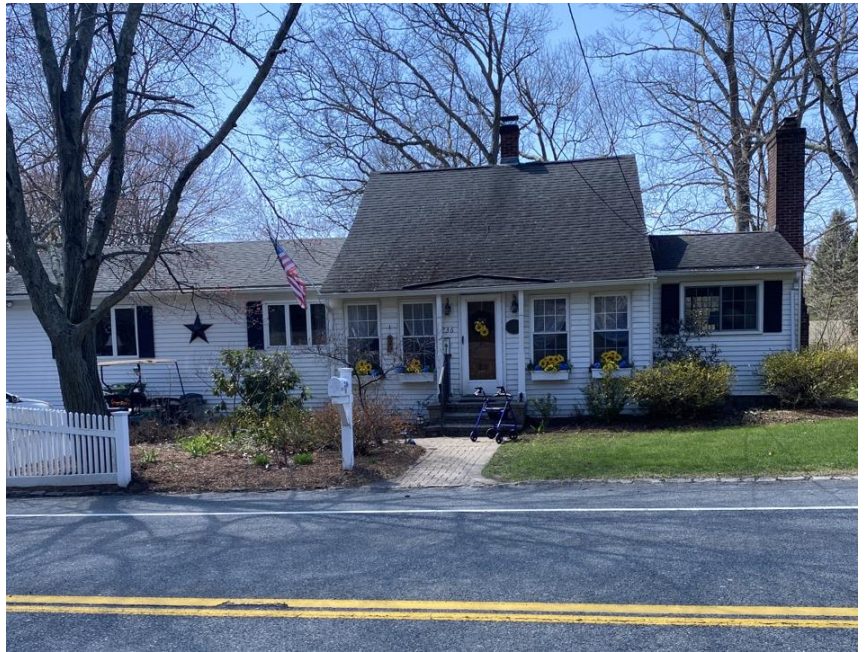
*x The property is not contributing to slum and blight*

Foundation Good

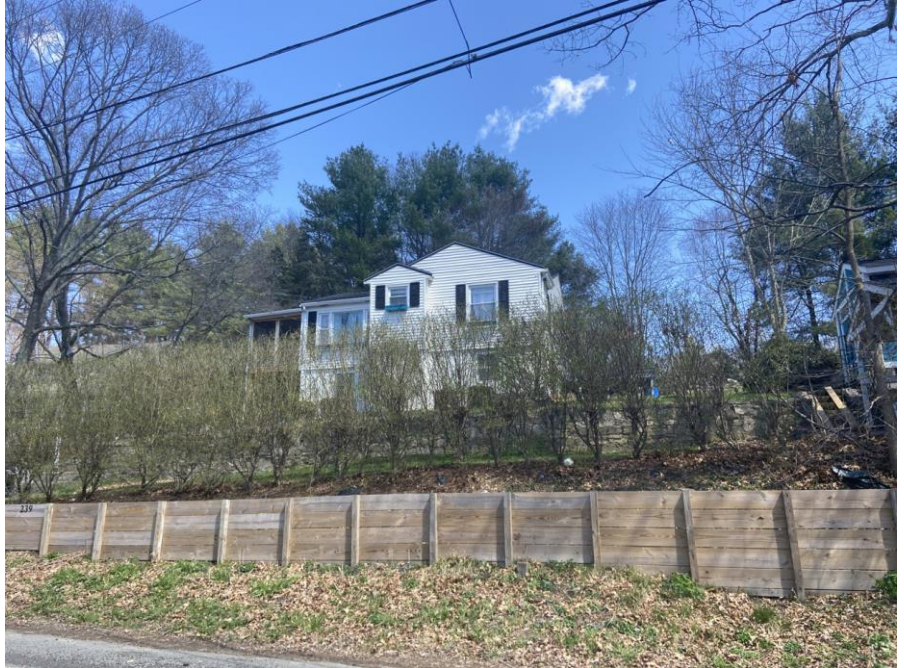
- ☐ Physical Deterioration of Building  
☐ Abandoned Property  
☐ Chronic High Occupancy Turnover  
☐ Chronic High Vacancy Rate  
☐ Significant Decline in Property Value  
☐ Abnormally Low Property Value  
☐ Known or Suspected Environmental Contamination  
☐ Other (please explain)  
☒ The property is not contributing to slum and blight

Foundation	Good
------------	------

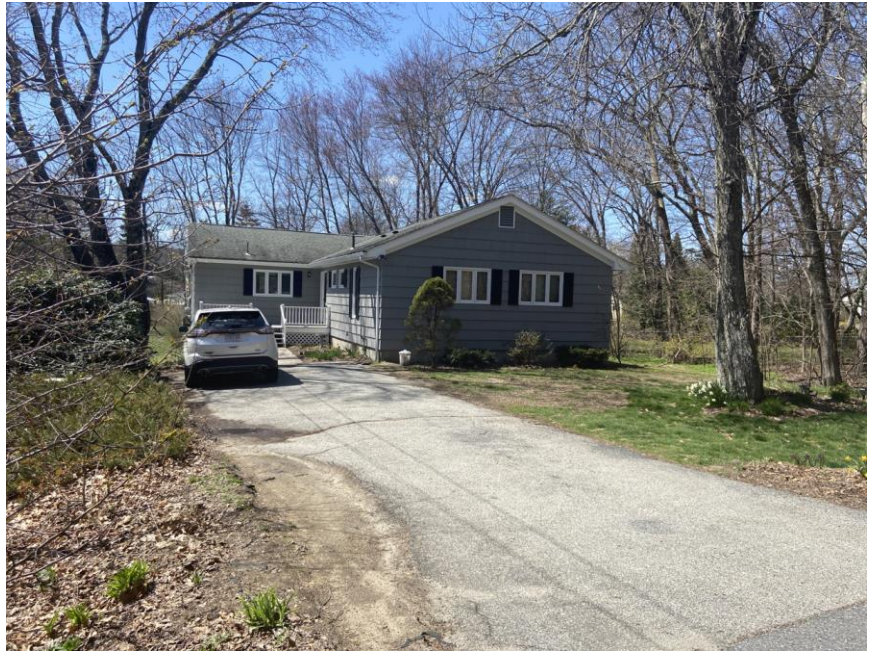
Roofing Fair – minor staining/mold growth

Foundation Good

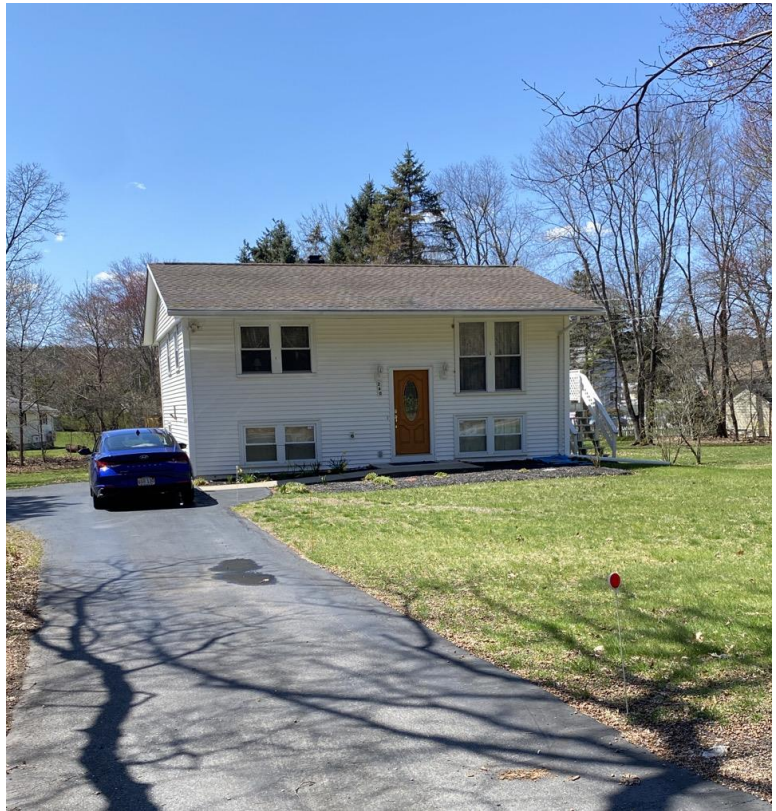
Roofing	Fair – minor stains
Windows and Doors	Fair – old windows, new door
Exterior Walls	Good
Porch/Stairs/Deck	Good
Foundation	Good
Storefront & Signage	
Parking Lots	
Other:

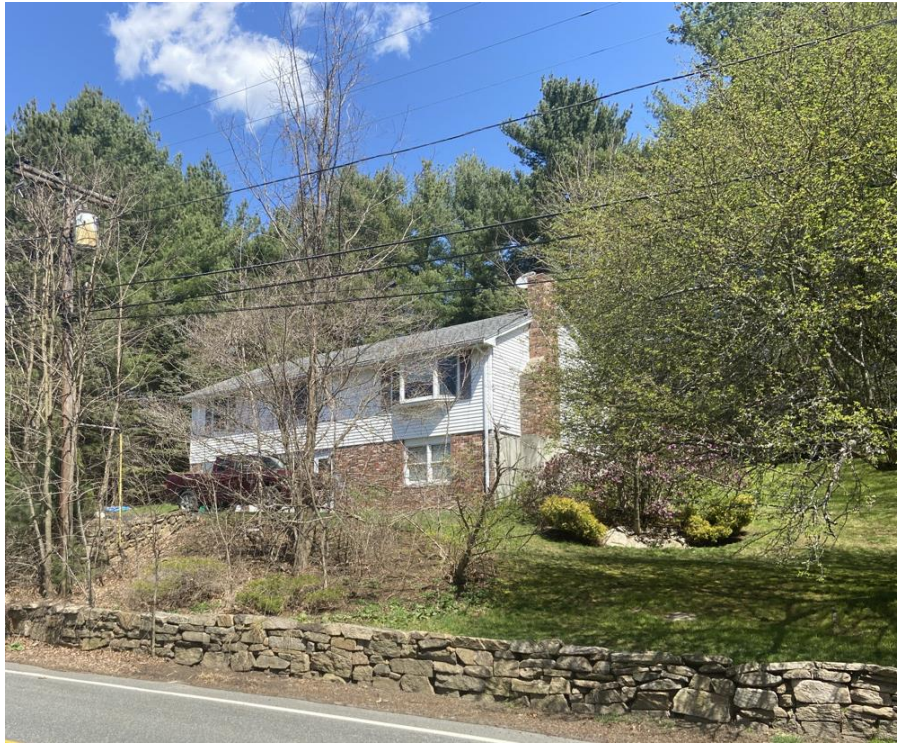
Foundation Good

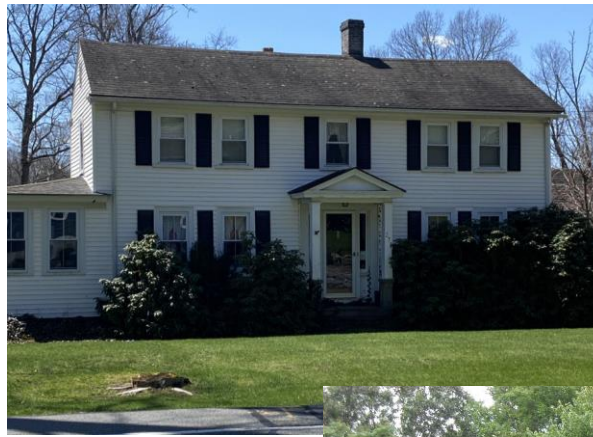
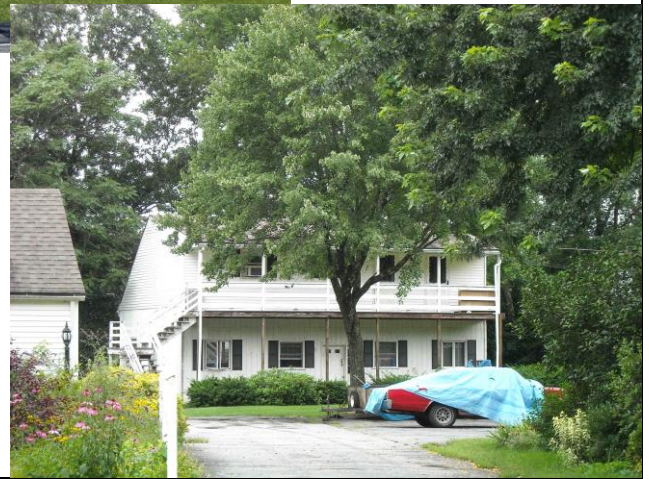
Roofing                      Poor – moss growth and stains

Foundation                Good

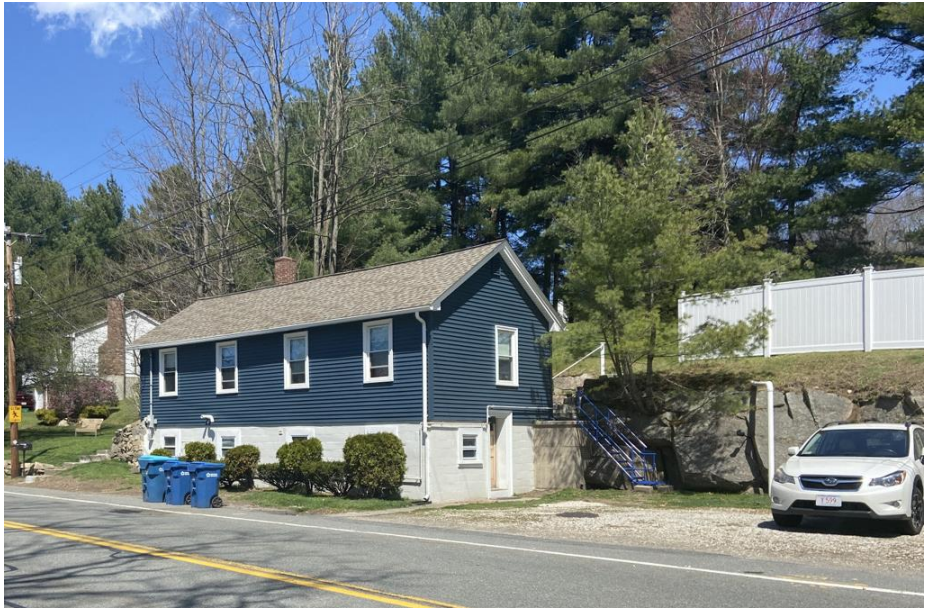
Foundation                      Excellent
