# Northbridge Slum & Blight Inventory

## Rockdale Target Area

Report compiled by the Pioneer Valley  
Planning Commission for the Town of  
Northbridge

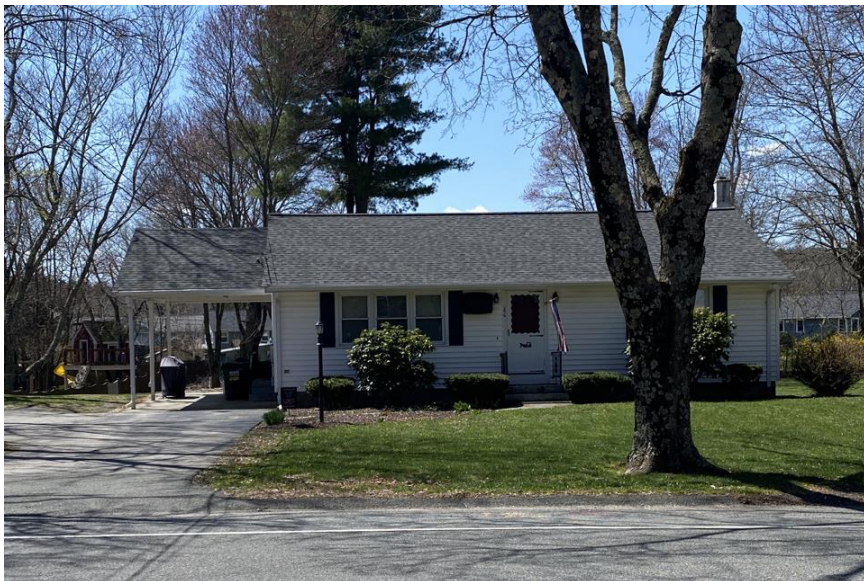
Roofing	Good
Windows and Doors	Fair – old
Exterior Walls	Good
Porch/Stairs/Deck	Good
Foundation	Good
Storefront & Signage	
Parking Lots	
Other:

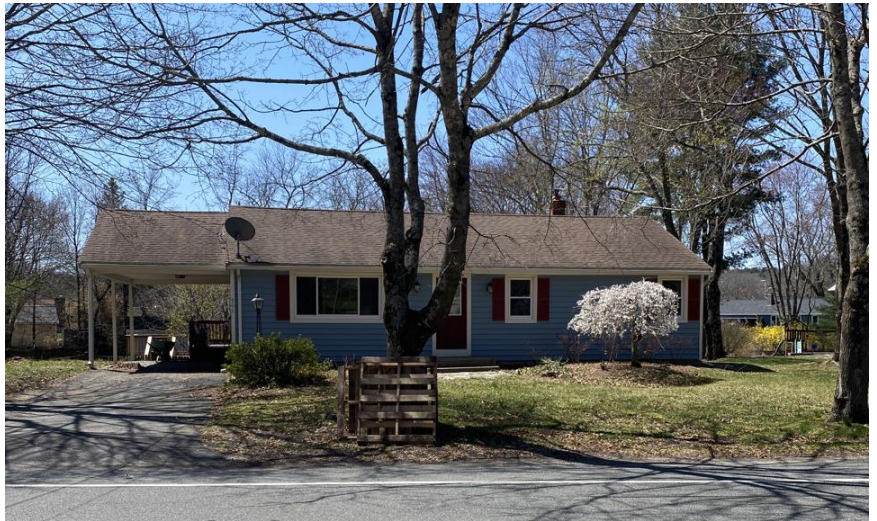
Roofing	Good
Windows and Doors	Fair – older
Exterior Walls	Good – wood siding
Porch/Stairs/Deck	Good
Foundation	Good
Storefront & Signage	
Parking Lots	
Other:

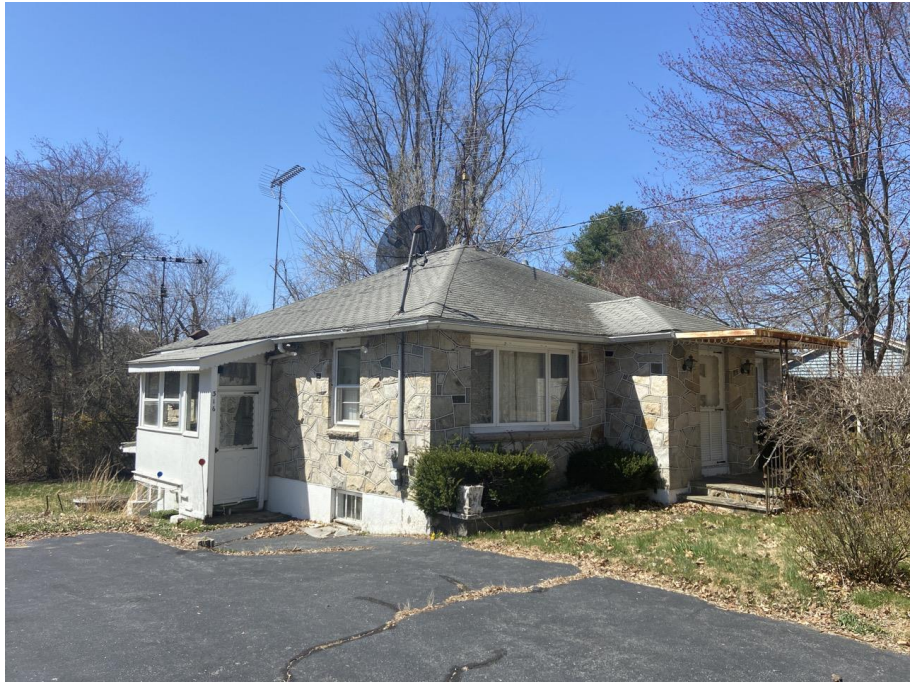
- x Physical Deterioration of Building
- ☐ Abandoned Property
  - ☐ Chronic High Occupancy Turnover
  - ☐ Chronic High Vacancy Rate
  - ☐ Significant Decline in Property Value
  - ☐ Abnormally Low Property Value
  - ☐ Known or Suspected Environmental Contamination
  - ☐ Other (please explain)
  - ☐ *The property is not contributing to slum and blight*

Roofing	Fair – stained
Windows and Doors	Fair – older style
Exterior Walls	Good
Porch/Stairs/Deck	Fair – awning is rusted and deteriorating
Foundation	Fair
Storefront & Signage	
Parking Lots	
Other:

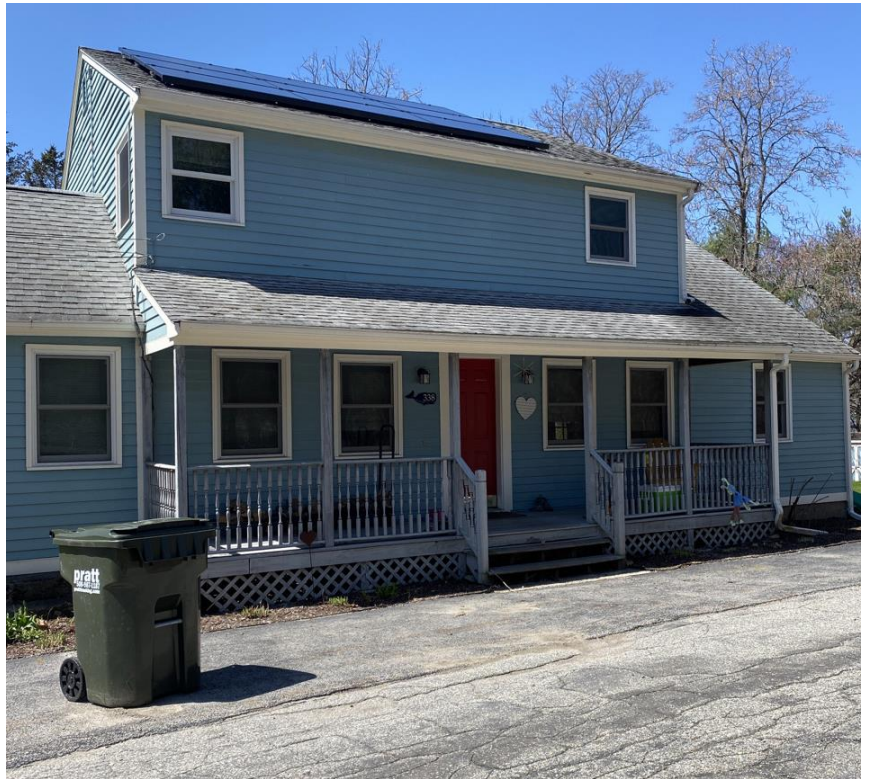
Roofing	Fair – asphalt shingles
Windows and Doors	Fair – older
Exterior Walls	Good – newly painted wood siding
Porch/Stairs/Deck	Good
Foundation	Good
Storefront & Signage	
Parking Lots	
Other:

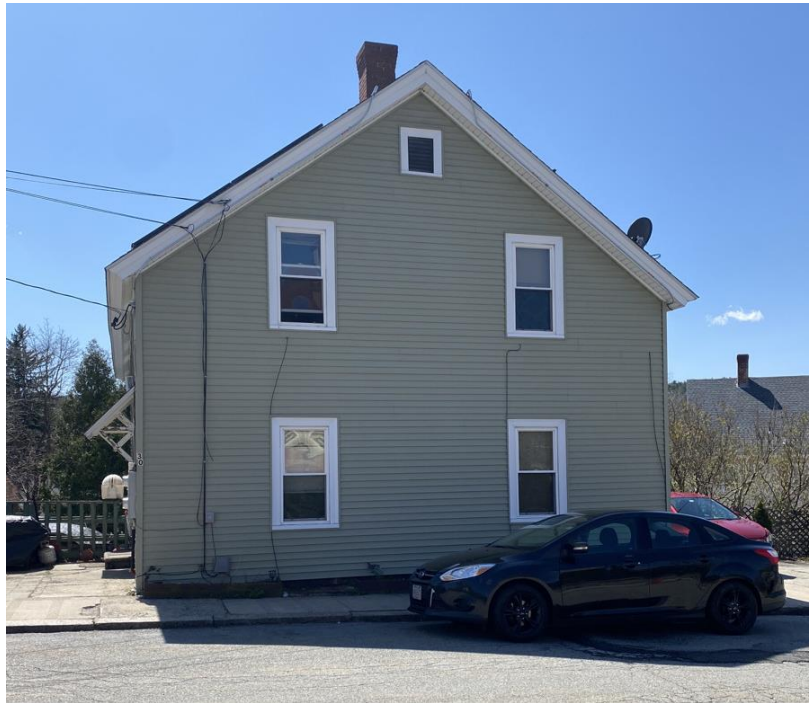
Foundation Good

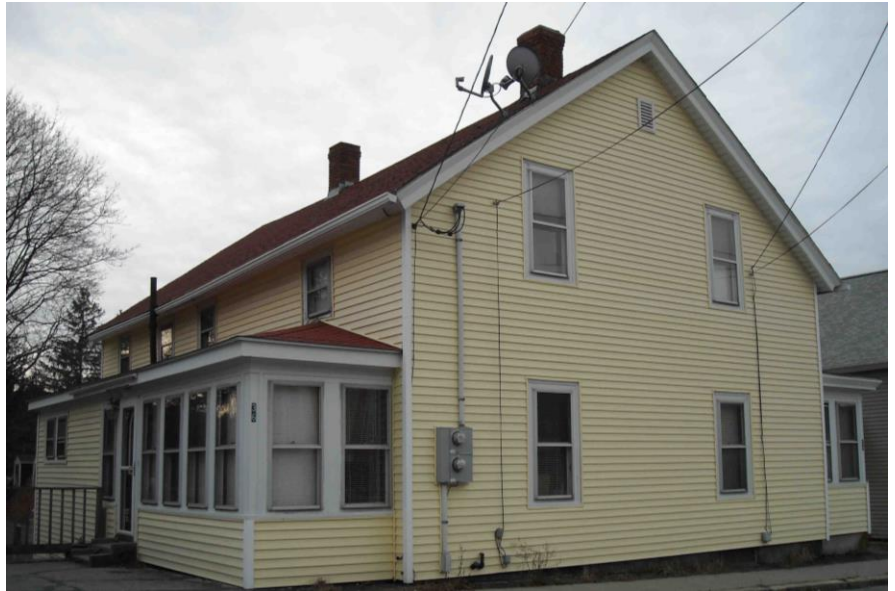
- x Physical Deterioration of Building
- ☐ Abandoned Property
  - ☐ Chronic High Occupancy Turnover
  - ☐ Chronic High Vacancy Rate
  - ☐ Significant Decline in Property Value
  - ☐ Abnormally Low Property Value
  - ☐ Known or Suspected Environmental Contamination
  - ☐ Other (please explain)
  - ☐ *The property is not contributing to slum and blight*

Roofing	Good
Windows and Doors	Fair – older style, trim is chipping
Exterior Walls	Good
Porch/Stairs/Deck	Fair – some moss growth and stains
Foundation	Fair - stains
Storefront & Signage	
Parking Lots	
Other:

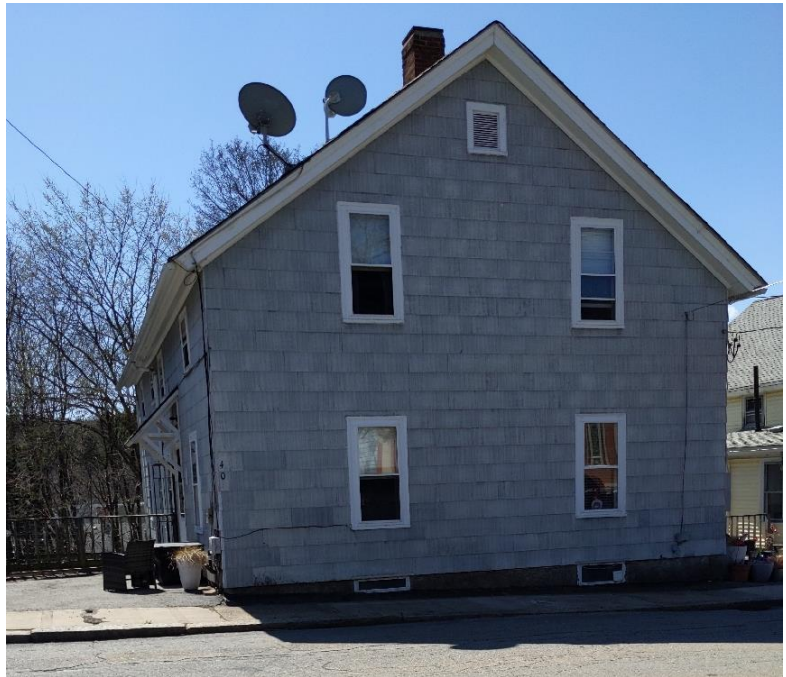
- x Physical Deterioration of Building  
☐ Abandoned Property  
☐ Chronic High Occupancy Turnover  
☐ Chronic High Vacancy Rate  
☐ Significant Decline in Property Value  
☐ Abnormally Low Property Value  
☐ Known or Suspected Environmental Contamination  
☐ Other (please explain)  
☐ *The property is not contributing to slum and blight*

<u>Component</u>	<u>Condition</u>
Roofing	Good
Windows and Doors	Fair - older
Exterior Walls	Fair – aluminum siding is chipping
Porch/Stairs/Deck	Fair
Foundation	Good
Storefront & Signage	
Parking Lots	
Other:	
Overall Property Rating: (Excellent / Good / Fair / Poor) briefly state why. Fair

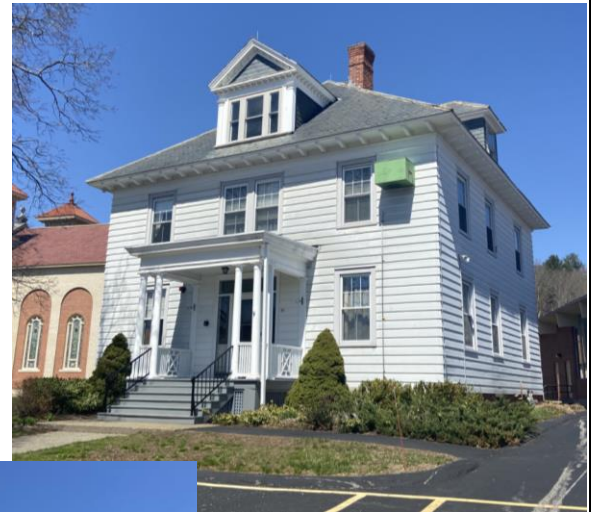
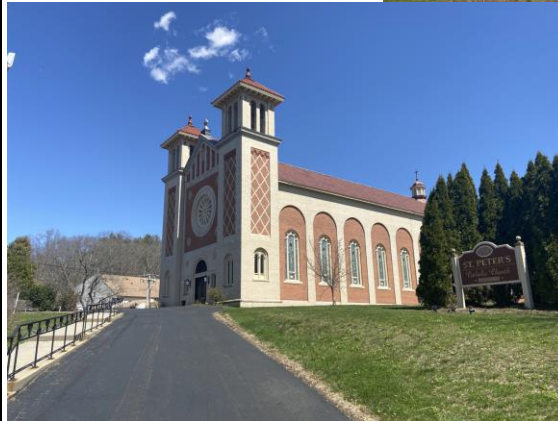
Roofing	Good
Windows and Doors	Good
Exterior Walls	Good
Porch/Stairs/Deck	Good
Foundation	Good
Storefront & Signage	Good
Parking Lots	Good

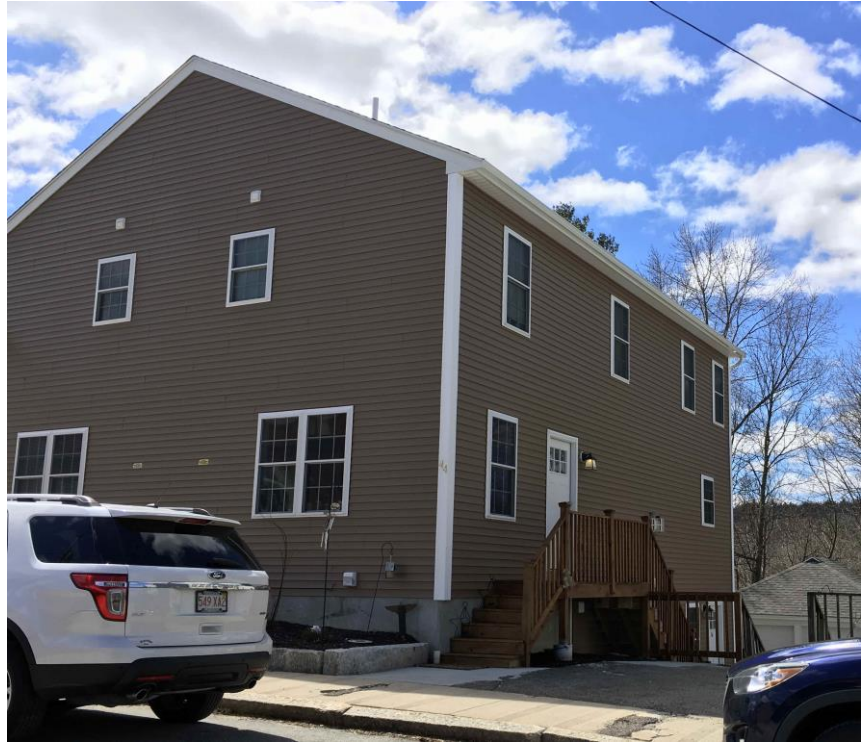
Roofing	Good
Windows and Doors	Excellent
Exterior Walls	Excellent
Porch/Stairs/Deck	Good
Foundation	Good
Storefront & Signage	
Parking Lots	
Other:

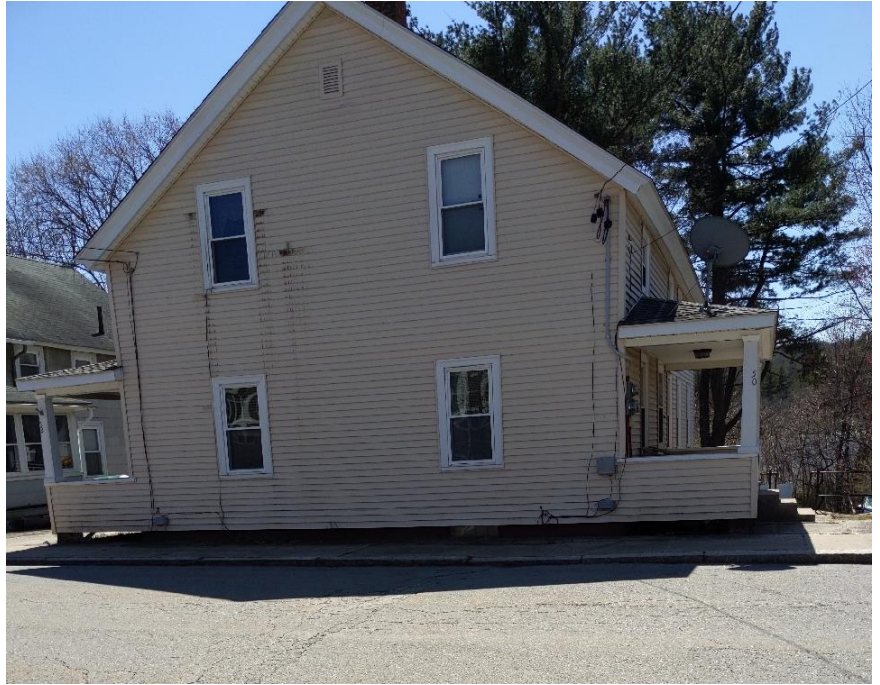
- ☒ Physical Deterioration of Building  
☐ Abandoned Property  
☐ Chronic High Occupancy Turnover  
☐ Chronic High Vacancy Rate  
☐ Significant Decline in Property Value  
☐ Abnormally Low Property Value  
☐ Known or Suspected Environmental Contamination  
☐ Other (please explain)  
☐ *The property is not contributing to slum and blight*

<u>Component</u>	<u>Condition</u>
Roofing	Good
Windows and Doors	Fair – old
Exterior Walls	Fair – stains
Porch/Stairs/Deck	Good
Foundation	Good
Storefront & Signage	
Parking Lots	
Other:	
Overall Property Rating: (Excellent / Good / Fair / Poor) briefly state why. Fair

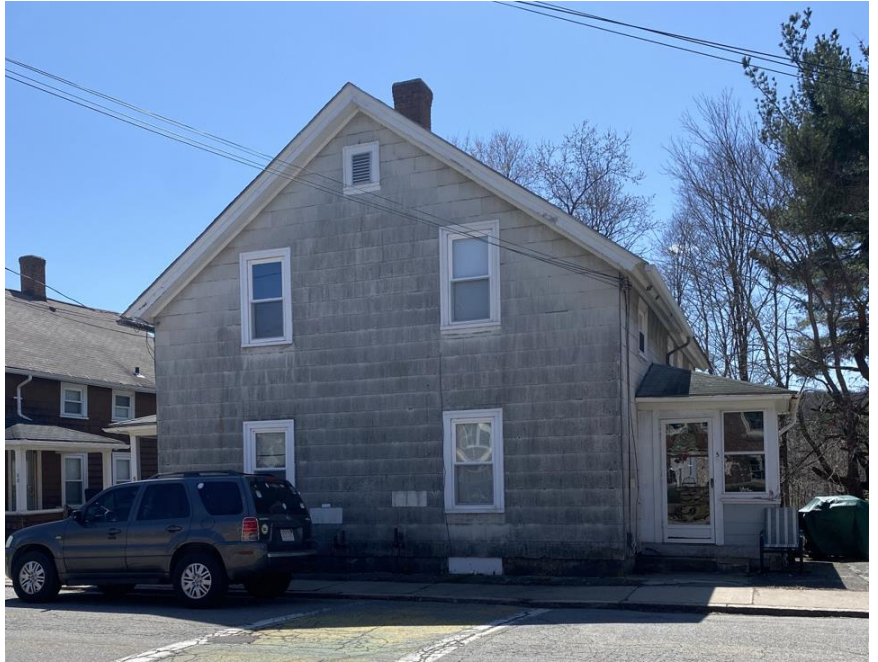
- ☒ Physical Deterioration of Building  
☐ Abandoned Property  
☐ Chronic High Occupancy Turnover  
☐ Chronic High Vacancy Rate  
☐ Significant Decline in Property Value  
☐ Abnormally Low Property Value  
☐ Known or Suspected Environmental Contamination  
☐ Other (please explain)  
☐ *The property is not contributing to slum and blight*

Roofing	Poor – a lot of stains
Windows and Doors	Fair – old
Exterior Walls	Poor – discoloration, rust
Porch/Stairs/Deck	Fair
Foundation	Fair
Storefront & Signage	
Parking Lots	
Other:

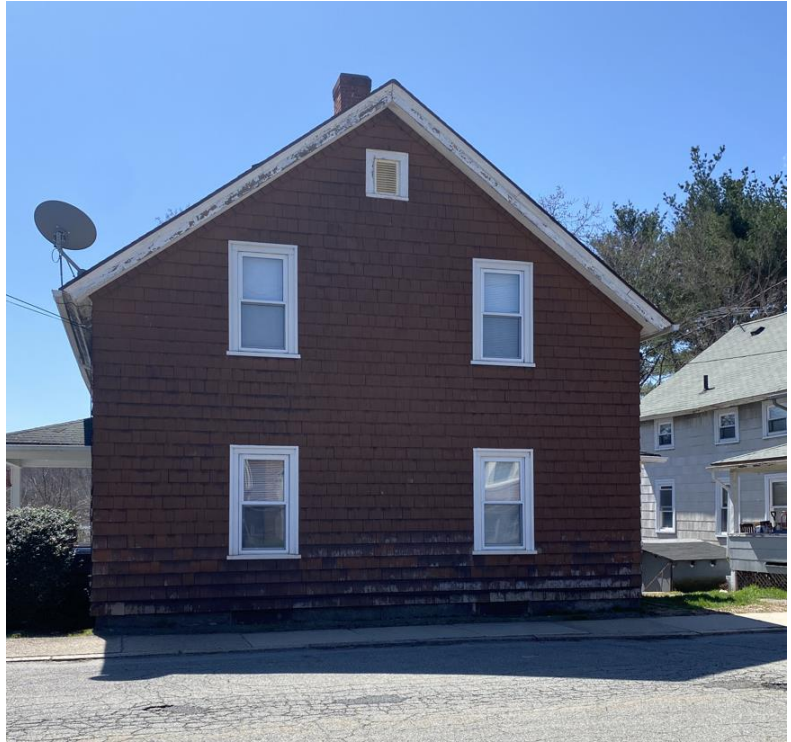
- ☒ Physical Deterioration of Building
- ☐ Abandoned Property
- ☐ Chronic High Occupancy Turnover
- ☐ Chronic High Vacancy Rate
- ☐ Significant Decline in Property Value
- ☐ Abnormally Low Property Value
- ☐ Known or Suspected Environmental Contamination
- ☐ Other (please explain)
- ☐ *The property is not contributing to slum and blight*

Roofing Fair – some shingles lifting, deteriorating trim

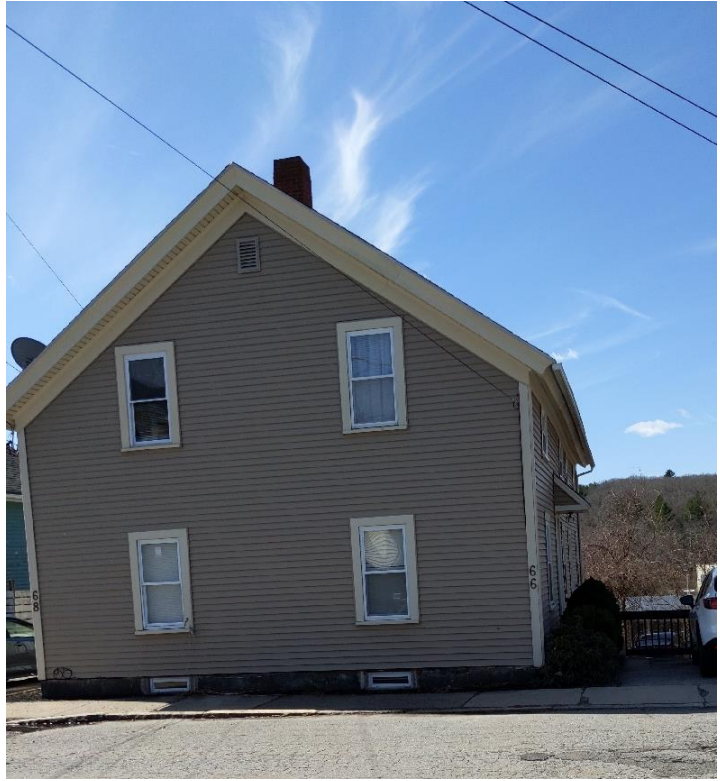
Roofing	Good
Windows and Doors	Fair – trim is stained and chipping
Exterior Walls	Good
Porch/Stairs/Deck	Good
Foundation	Good
Storefront & Signage	
Parking Lots	
Other:

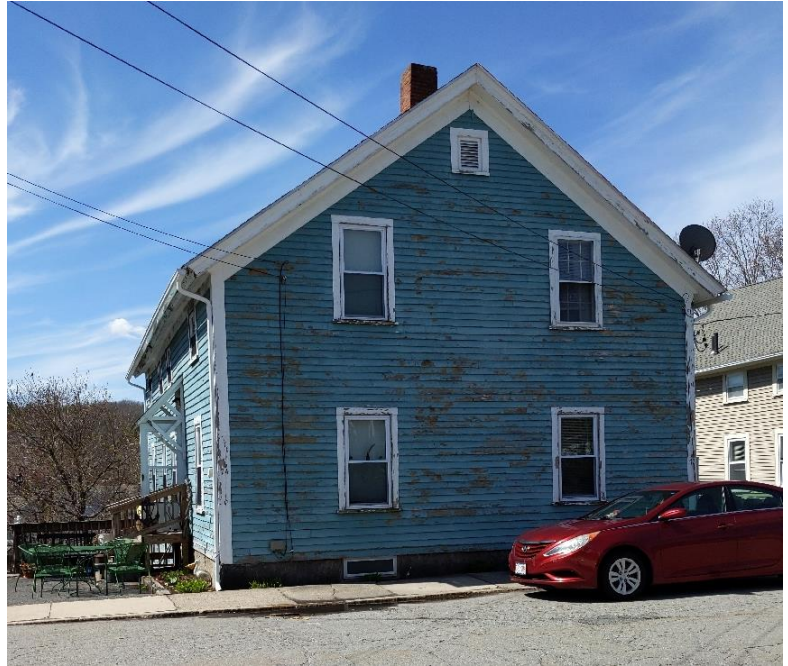
- ☒ Physical Deterioration of Building  
☐ Abandoned Property  
☐ Chronic High Occupancy Turnover  
☐ Chronic High Vacancy Rate  
☐ Significant Decline in Property Value  
☐ Abnormally Low Property Value  
☐ Known or Suspected Environmental Contamination  
☐ Other (please explain)  
☐ *The property is not contributing to slum and blight*

<u>Component</u>	<u>Condition</u>
Roofing	Good
Windows and Doors	Poor – old, trim is rotting
Exterior Walls	Poor – wood siding, mostly chipped
Porch/Stairs/Deck	Good
Foundation	Fair – stained
Storefront & Signage	
Parking Lots	
Other:	
Overall Property Rating: (Excellent / Good / Fair / Poor) briefly state why. Poor

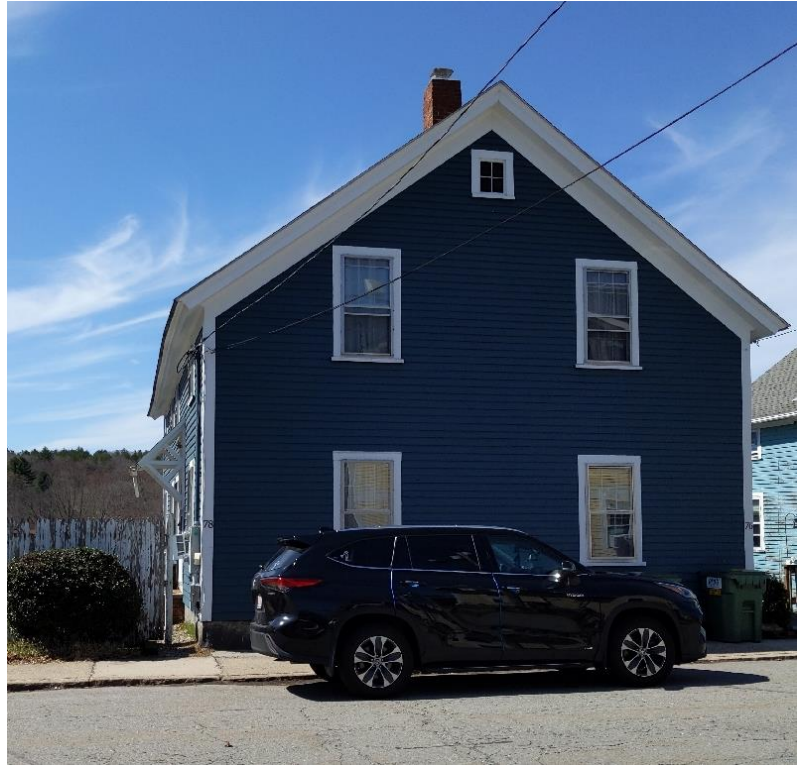
<b><u>Component</u></b>	<b><u>Condition</u></b>
Roofing	Good
Windows and Doors	Good
Exterior Walls	Good – wood siding
Porch/Stairs/Deck	Fair – brick steps, railings are crooked
Foundation	Fair – stained
Storefront & Signage	
Parking Lots	
Other:	
Overall Property Rating: (Excellent / Good / Fair / Poor) briefly state why. Good

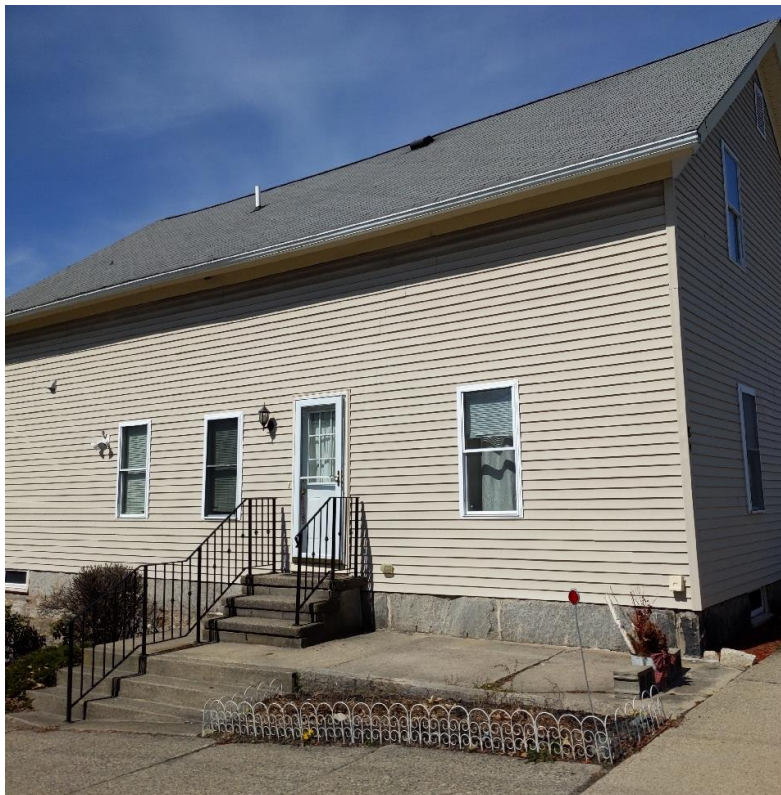
<u>Component</u>	<u>Condition</u>
Roofing	Good
Windows and Doors	Good
Exterior Walls	Good
Porch/Stairs/Deck	Fair – minor stains
Foundation	Good
Storefront & Signage	
Parking Lots	
Other:	
Overall Property Rating: (Excellent / Good / Fair / Poor) briefly state why. Good

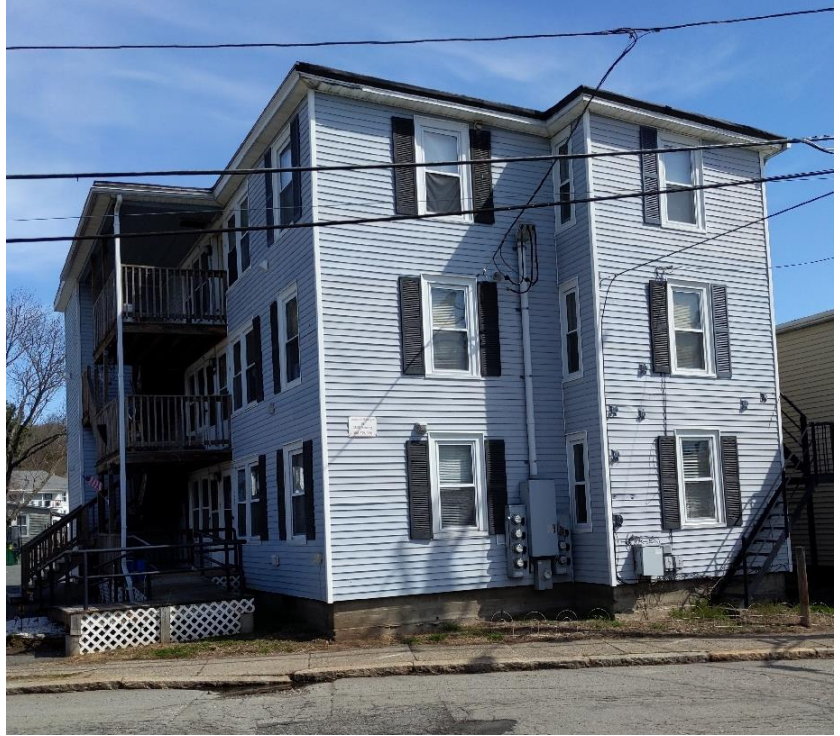
<u>Component</u>	<u>Condition</u>
Roofing	Unknown
Windows and Doors	Fair – older
Exterior Walls	Good
Porch/Stairs/Deck	Fair – wood is slanted and weathered
Foundation	Fair – some stains
Storefront & Signage	
Parking Lots	
Other:	
Overall Property Rating: (Excellent / Good / Fair / Poor) briefly state why. Fair

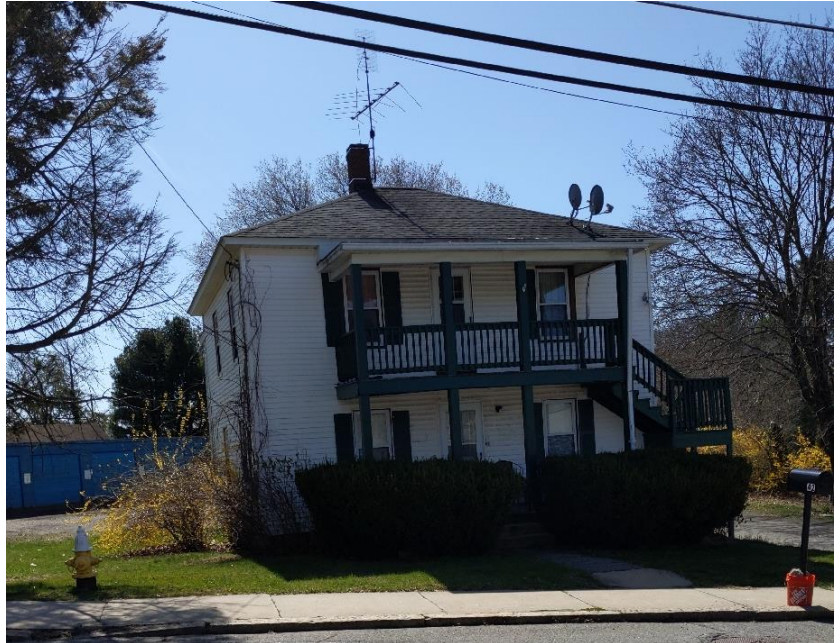
<u>Component</u>	<u>Condition</u>
Roofing	Fair – asphalt shingles
Windows and Doors	Fair – old
Exterior Walls	Poor – stained, chipped, overgrown ivy
Porch/Stairs/Deck	Poor – chipped paint
Foundation	Fair - stained
Storefront & Signage	
Parking Lots	
Other:	
Overall Property Rating: (Excellent / Good / Fair / Poor) briefly state why. Fair

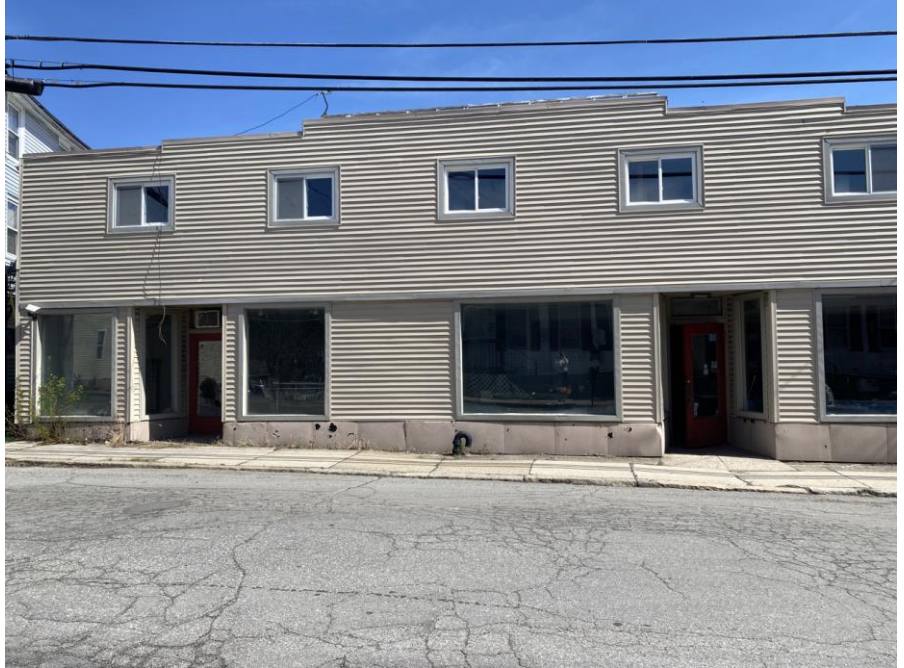
Roofing	Unknown
Windows and Doors	Fair
Exterior Walls	Poor – holes near bottom
Porch/Stairs/Deck	n/a
Foundation	Fair
Storefront & Signage	Poor – no signage
Parking Lots

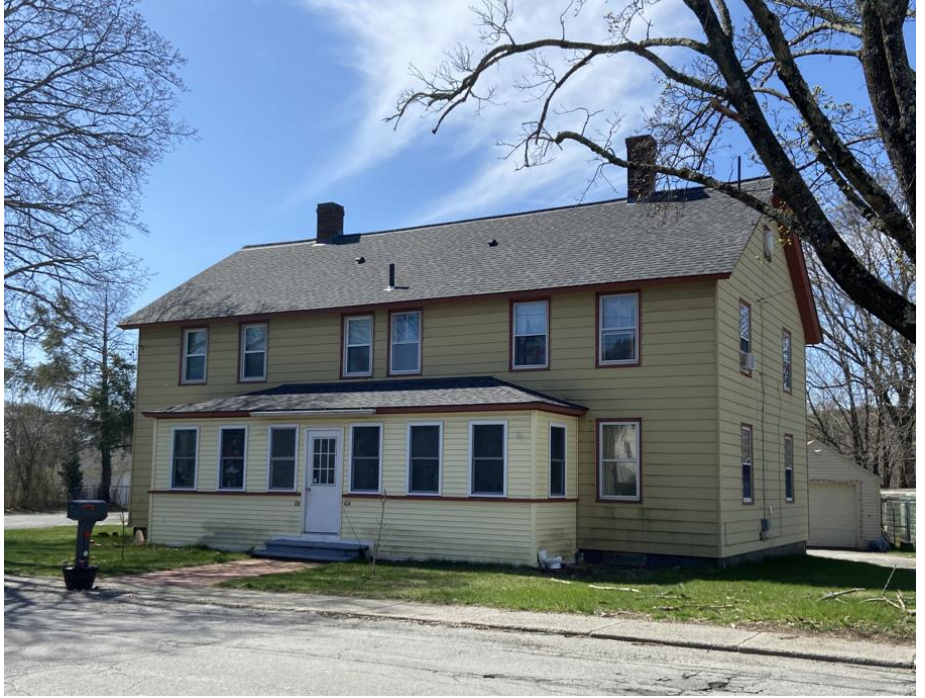
Roofing	Good
Windows and Doors	Good
Exterior Walls	Fair – dirty siding
Porch/Stairs/Deck	Good
Foundation	Good
Storefront & Signage	
Parking Lots	
Other:

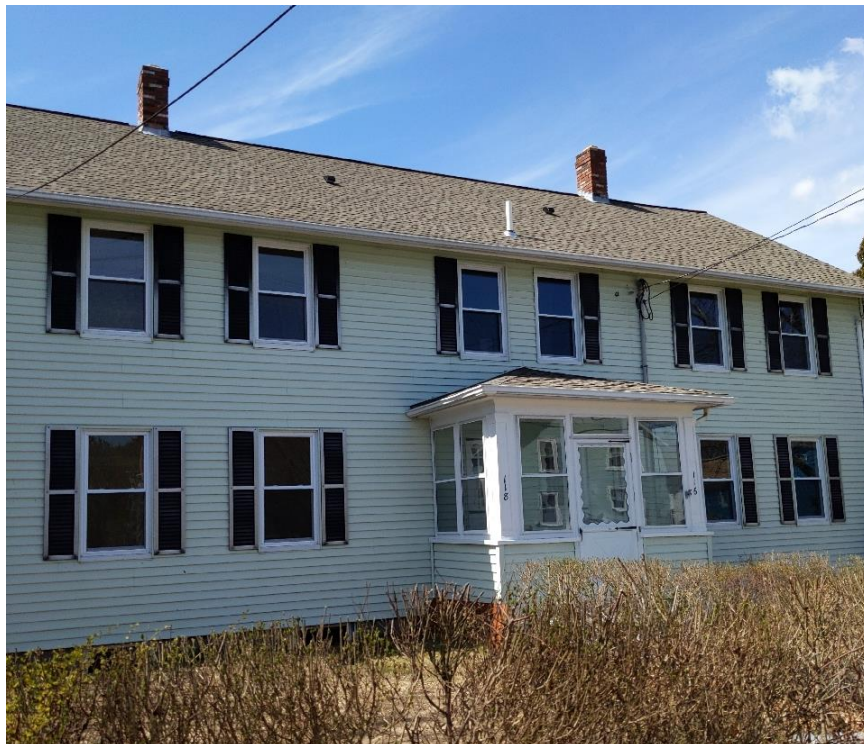
Roofing	Good
Windows and Doors	Good
Exterior Walls	Fair – paint on shutters is faded
Porch/Stairs/Deck	Good
Foundation	Good
Storefront & Signage	
Parking Lots	
Other:

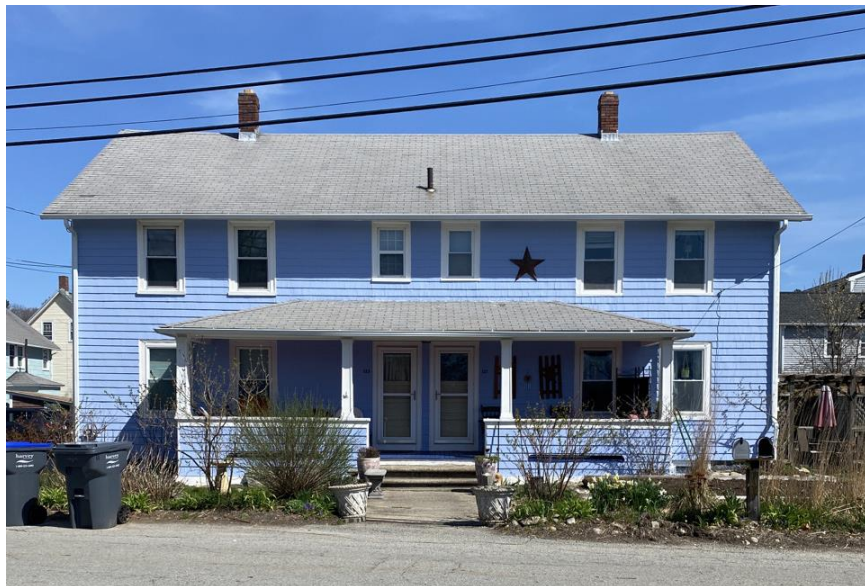
Roofing Fair – minor stains

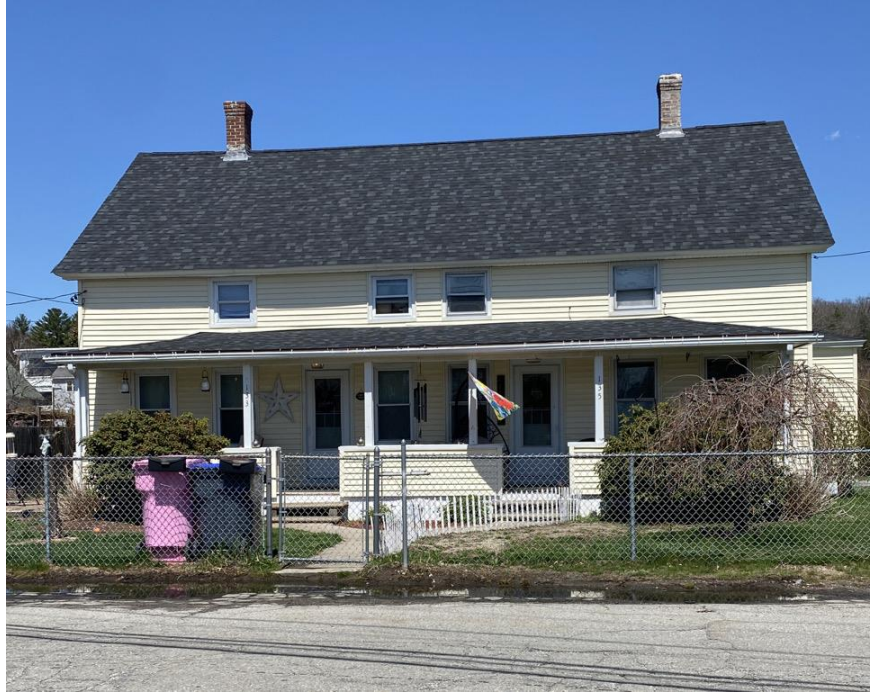
Roofing	Good
Windows and Doors	Fair – old
Exterior Walls	Good
Porch/Stairs/Deck	Good
Foundation	Good
Storefront & Signage	
Parking Lots	
Other:

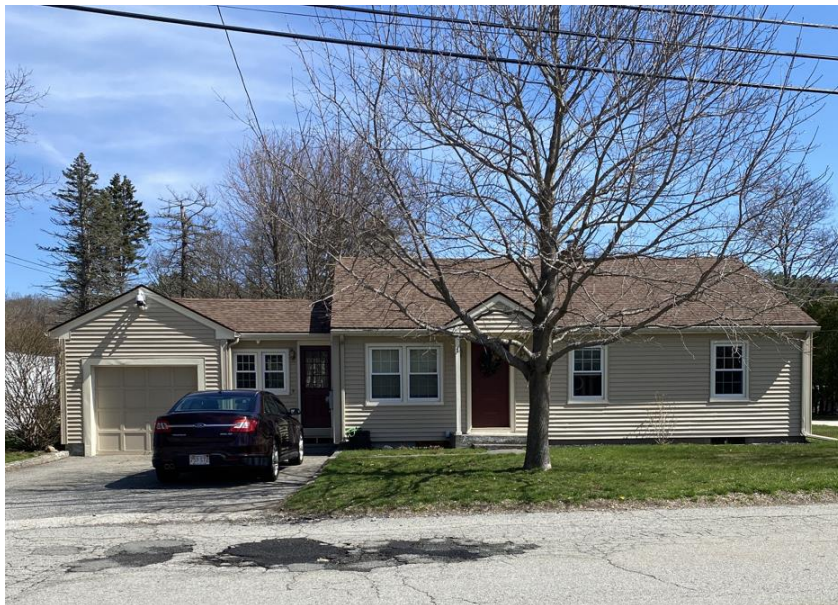
Roofing	Good
Windows and Doors	Excellent – new windows
Exterior Walls	Good
Porch/Stairs/Deck	Fair – uneven stairs
Foundation	Good
Storefront & Signage	
Parking Lots	
Other:

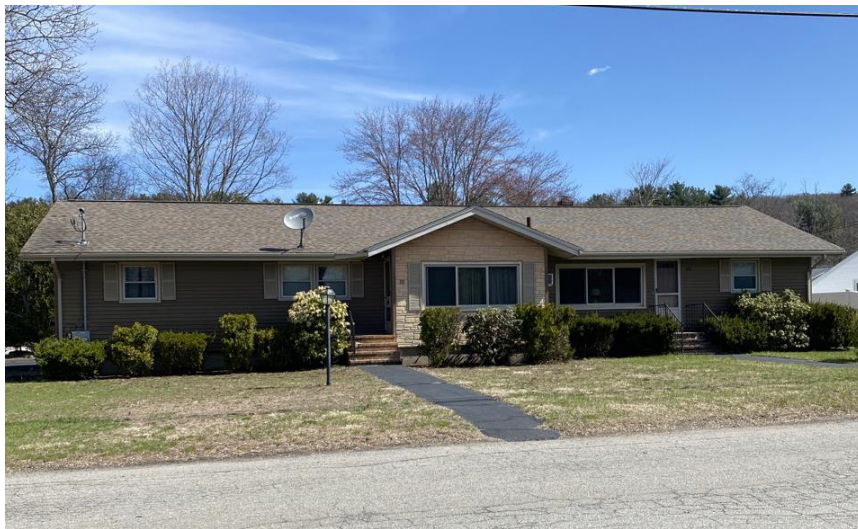
Roofing	Good
Windows and Doors	Fair – old
Exterior Walls	Good
Porch/Stairs/Deck	Good
Foundation	Good
Storefront & Signage	
Parking Lots	
Other:

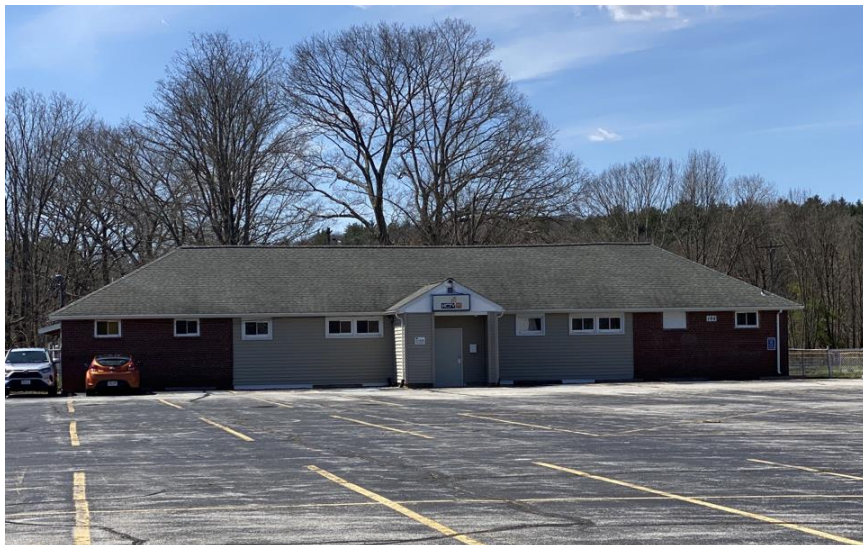
<u>Component</u>	<u>Condition</u>
Roofing	Good
Windows and Doors	Fair – old
Exterior Walls	Good
Porch/Stairs/Deck	n/a
Foundation	Good
Storefront & Signage	Poor – small, no sign on street
Parking Lots	Good
Other:	
Overall Property Rating: (Excellent / Good / Fair / Poor) briefly state why. Fair

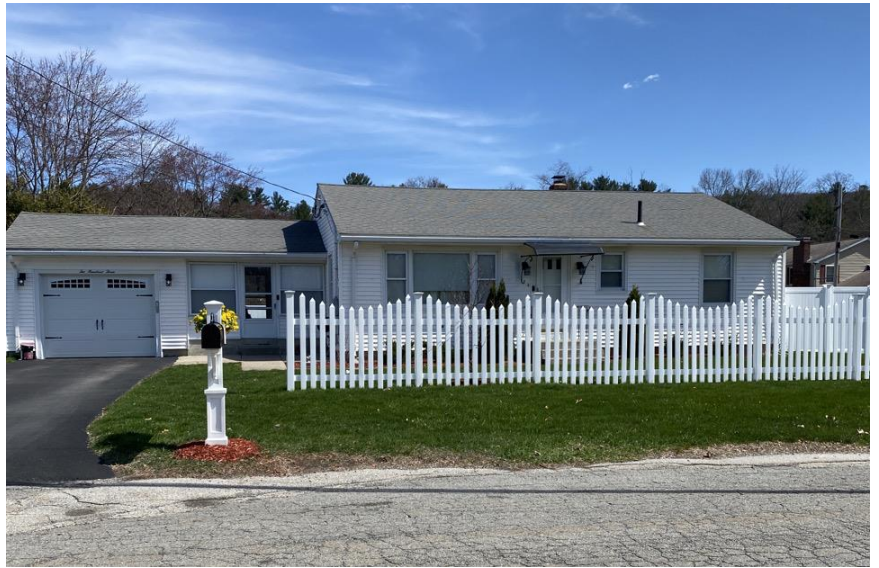
Roofing	Good
Windows and Doors	Fair – old
Exterior Walls	Good
Porch/Stairs/Deck	Good
Foundation	Good
Storefront & Signage	
Parking Lots	
Other:

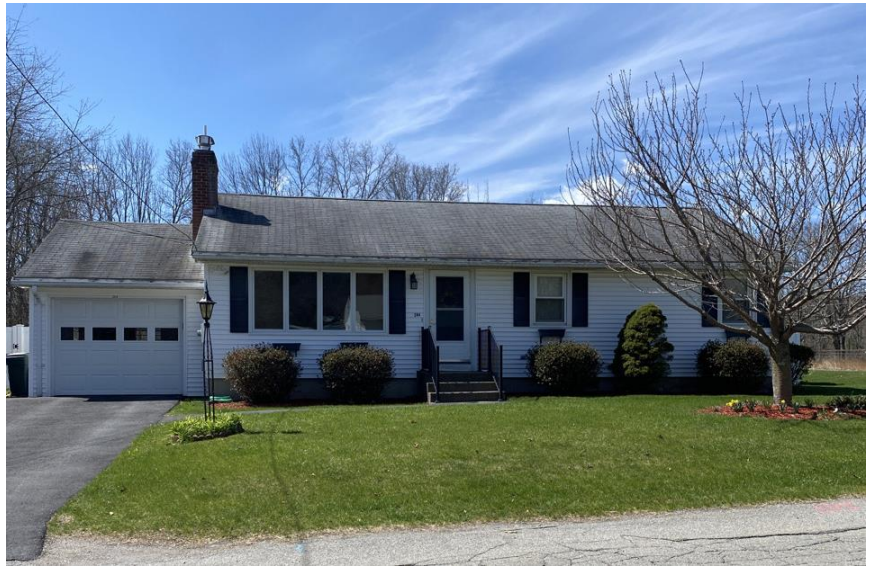
Roofing Fair – a lot of stains

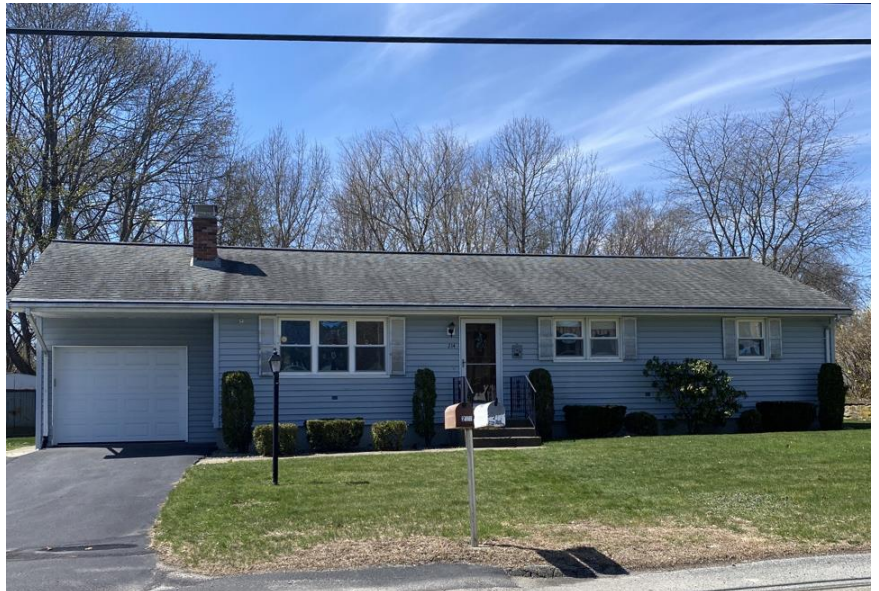
Roofing Fair – stained

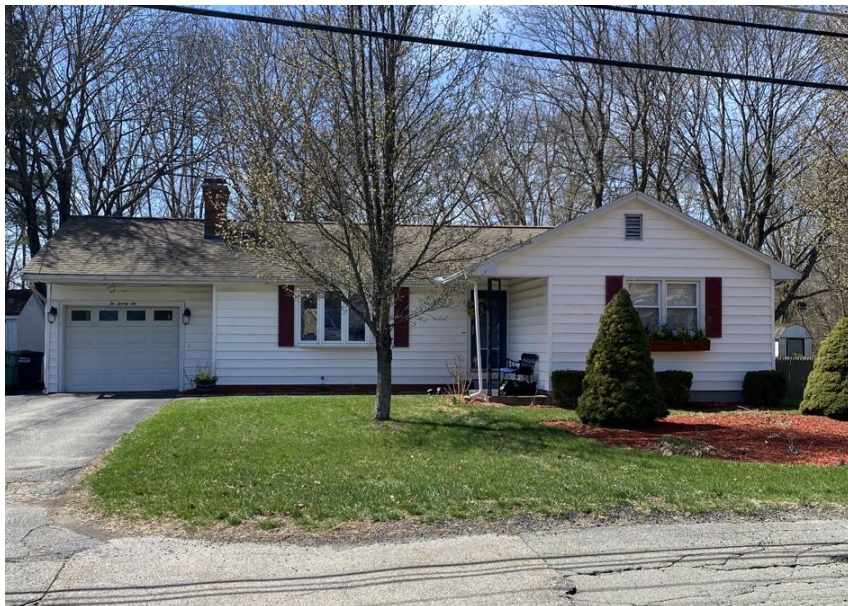
Roofing	Good
Windows and Doors	Fair – old
Exterior Walls	Good
Porch/Stairs/Deck	Good
Foundation	Good
Storefront & Signage	
Parking Lots	
Other:

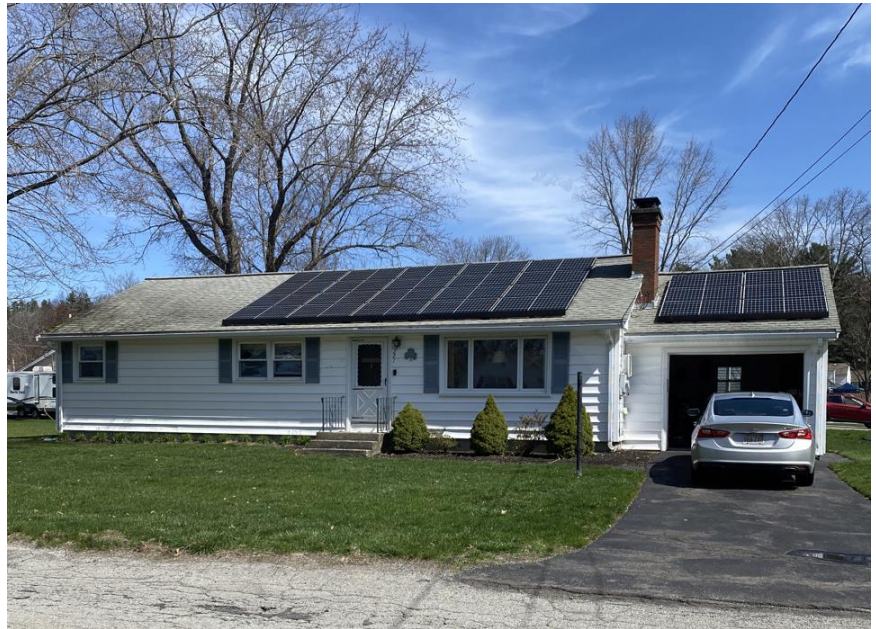
Roofing Fair – stains/moss on side

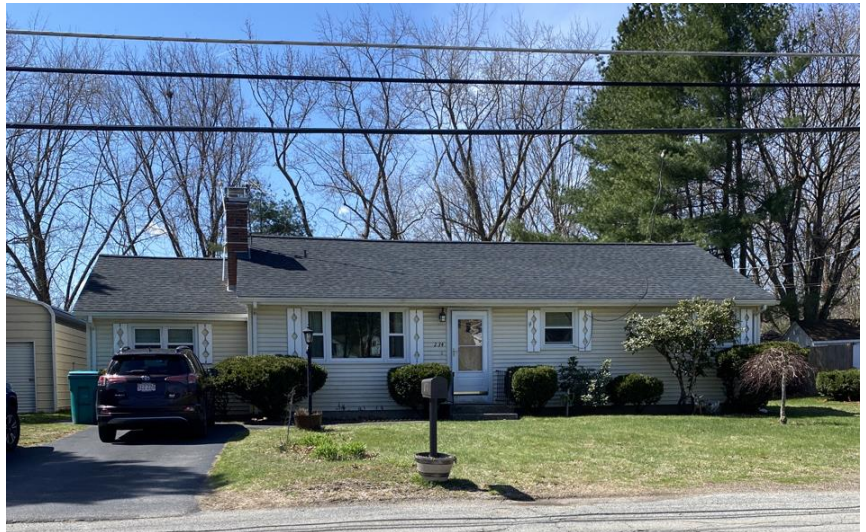
Roofing	Good
Windows and Doors	Fair – old
Exterior Walls	Good
Porch/Stairs/Deck	Good
Foundation	Good
Storefront & Signage	
Parking Lots	
Other:

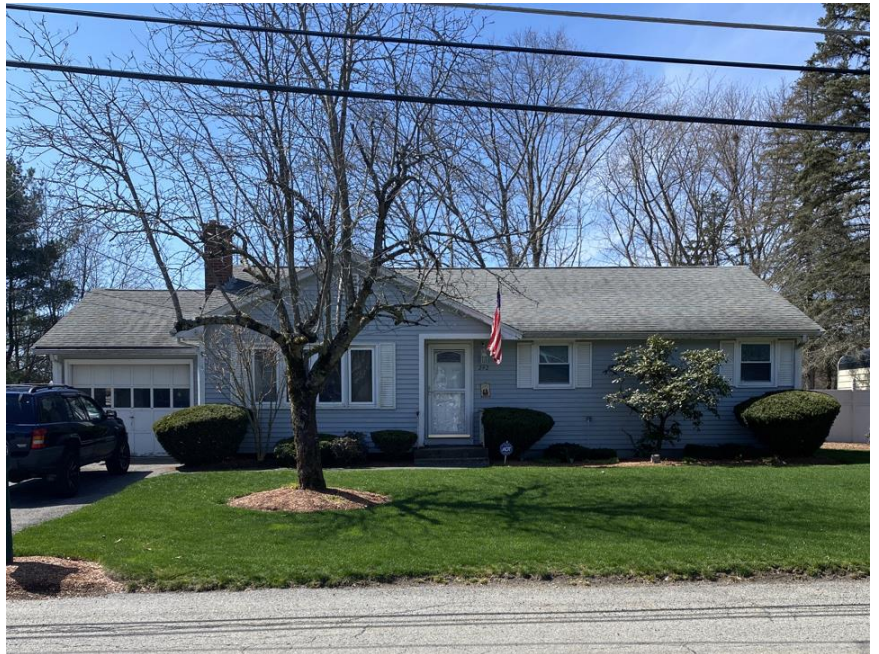
<u>Component</u>	<u>Condition</u>
Roofing	Good
Windows and Doors	Fair – old
Exterior Walls	Good
Porch/Stairs/Deck	Good
Foundation	Good
Storefront & Signage	
Parking Lots	
Other:	
Overall Property Rating: (Excellent / Good / Fair / Poor) briefly state why. Good

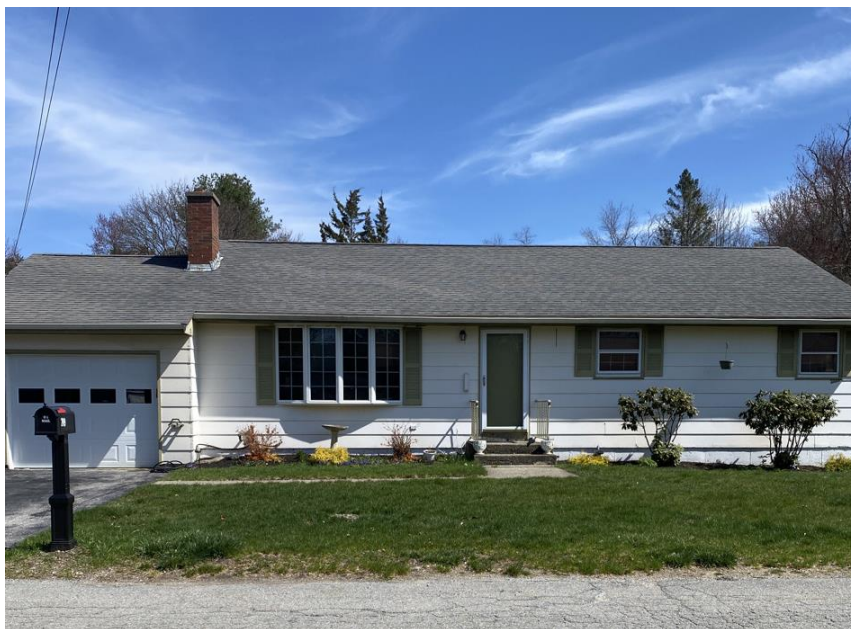
Roofing	Good
Windows and Doors	Good
Exterior Walls	Fair – aluminum siding with minor chips
Porch/Stairs/Deck	Good
Foundation	Good
Storefront & Signage	
Parking Lots	
Other:

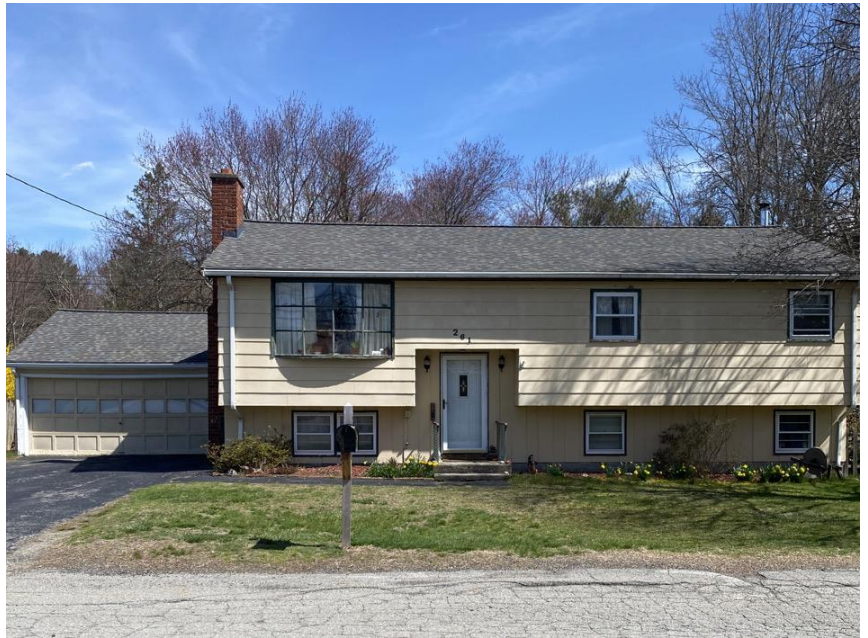
Roofing	Good
Windows and Doors	Poor – very old
Exterior Walls	Good
Porch/Stairs/Deck	Good
Foundation	Good
Storefront & Signage	
Parking Lots	
Other:

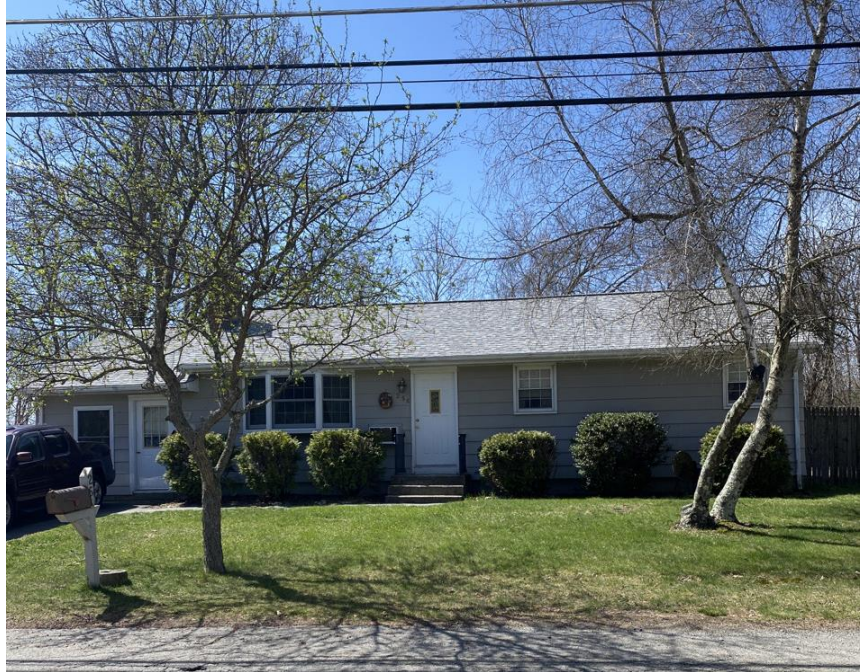
Roofing	Good
Windows and Doors	Fair – old
Exterior Walls	Good
Porch/Stairs/Deck	Good
Foundation	Good
Storefront & Signage	
Parking Lots	
Other:

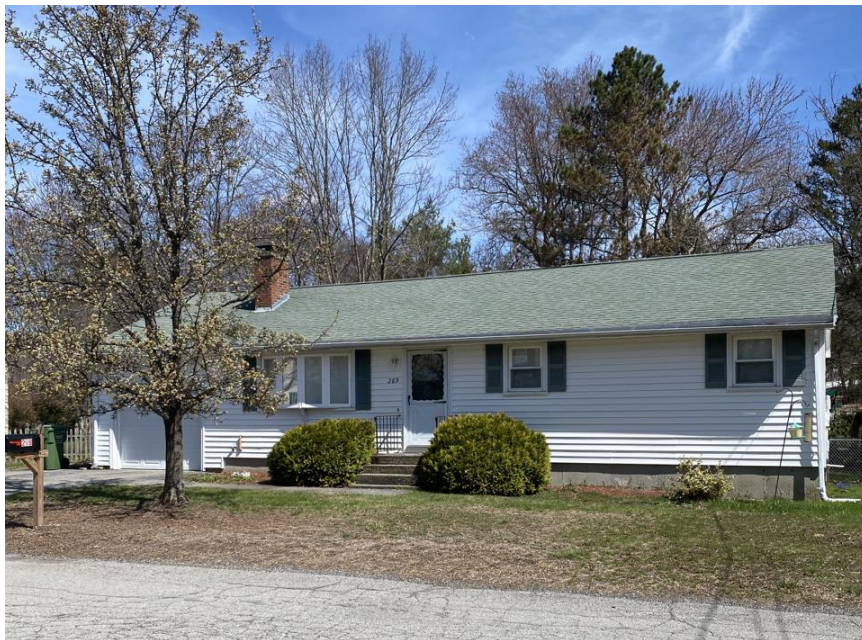
Roofing Fair – few missing shingles
