# Northbridge Slum & Blight Inventory

## Rockdale Target Area

Report compiled by the Pioneer Valley  
Planning Commission for the Town of  
Northbridge

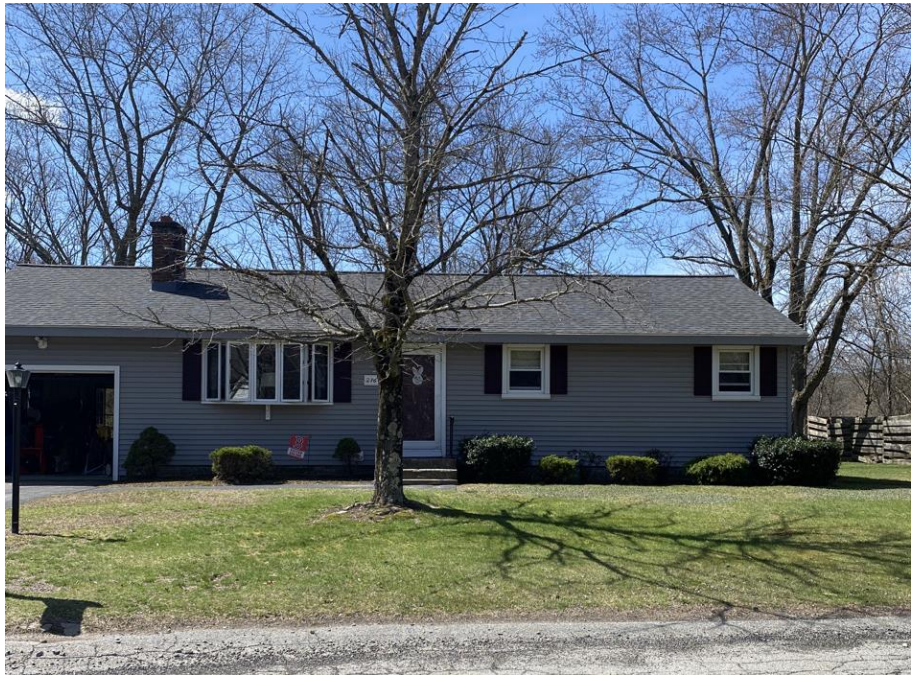
<u>Component</u>	<u>Condition</u>
Roofing	Good
Windows and Doors	Good
Exterior Walls	Good
Porch/Stairs/Deck	Good
Foundation	Good
Storefront & Signage	
Parking Lots	
Other:	
Overall Property Rating: (Excellent / Good / Fair / Poor) briefly state why. Good

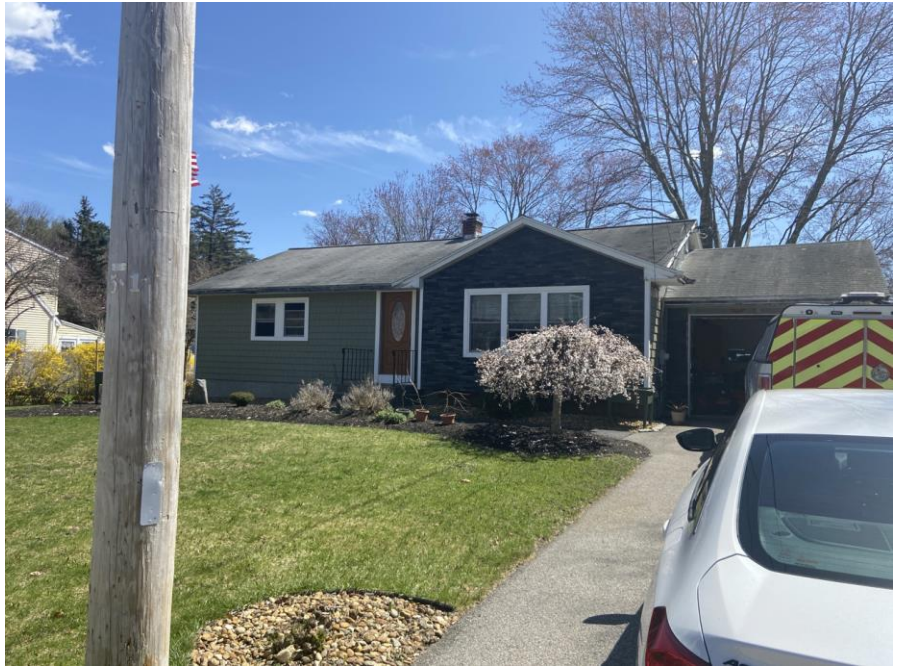
Roofing Fair – stains and moss growth

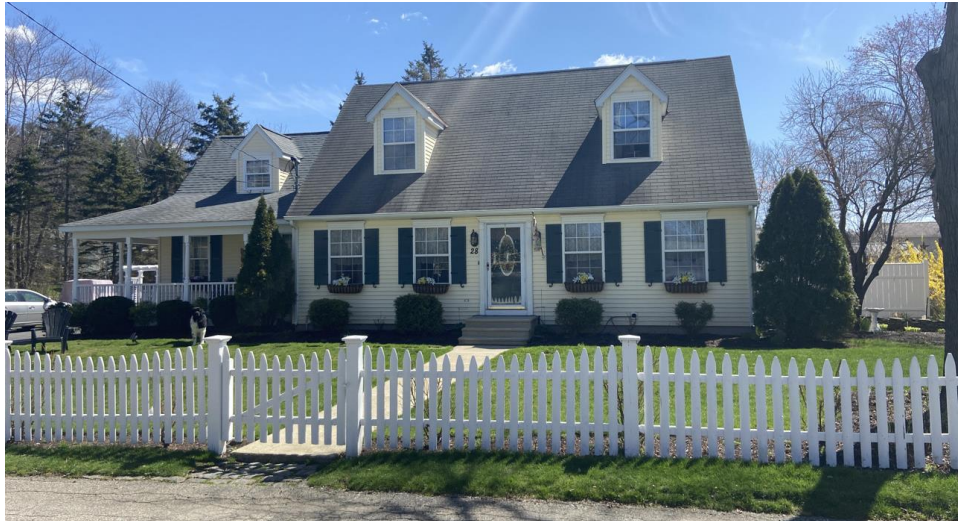
Roofing Fair – minor stains

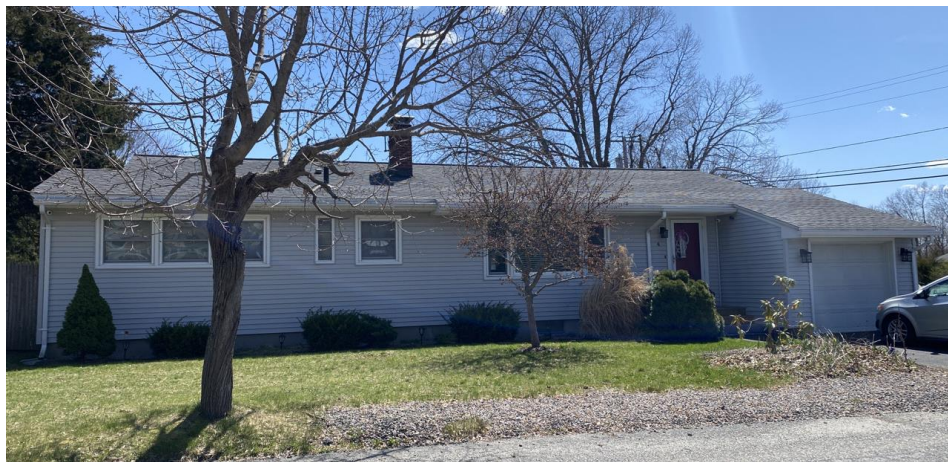
Roofing	Good
Windows and Doors	Fair – old
Exterior Walls	Good
Porch/Stairs/Deck	Good
Foundation	Good
Storefront & Signage	
Parking Lots	
Other:

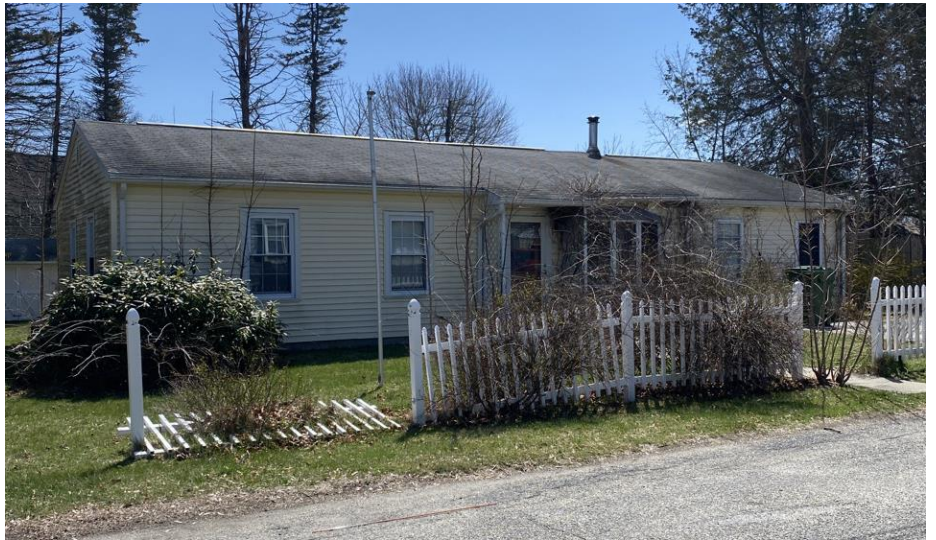
Roofing	Poor – a lot of staining
Windows and Doors	Good
Exterior Walls	Fair – a lot of staining with vines
Porch/Stairs/Deck	Unknown
Foundation	Good
Storefront & Signage	
Parking Lots	
Other:

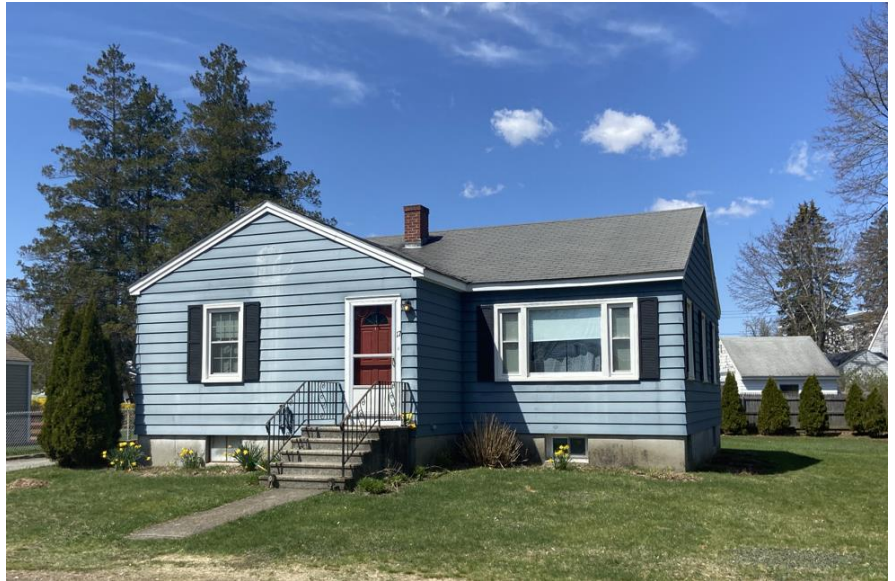
Roofing	Good
Windows and Doors	Good
Exterior Walls	Fair – faded paint
Porch/Stairs/Deck	Good
Foundation	Good
Storefront & Signage	
Parking Lots	
Other:

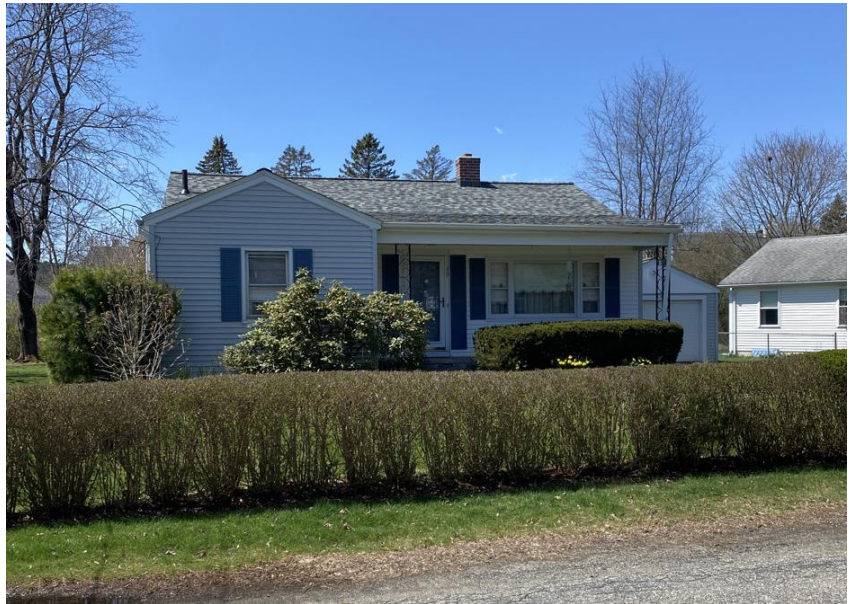
Roofing	Good – asphalt shingles
Windows and Doors	Fair – older style
Exterior Walls	Good – vinyl siding
Porch/Stairs/Deck	Fair – minor chips in cement
Foundation	Good
Storefront & Signage	
Parking Lots	
Other:

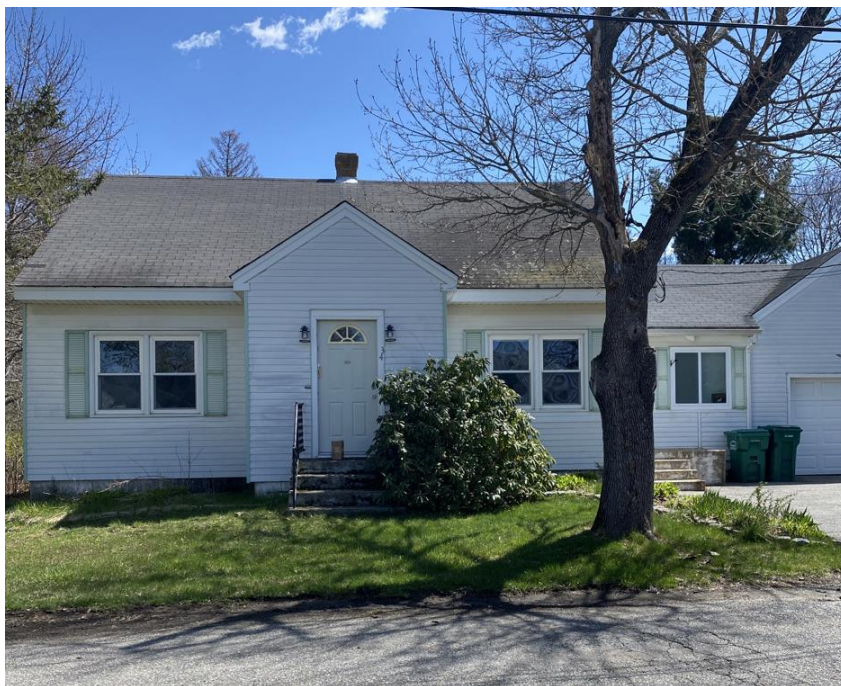
<u>Component</u>	<u>Condition</u>
Roofing	Poor – significant moss growth
Windows and Doors	Fair – older
Exterior Walls	Fair – faded paint with stains
Porch/Stairs/Deck	Poor – stains, chipped paint
Foundation	Fair
Storefront & Signage	
Parking Lots	
Other:	
Overall Property Rating: (Excellent / Good / Fair / Poor) briefly state why. Fair

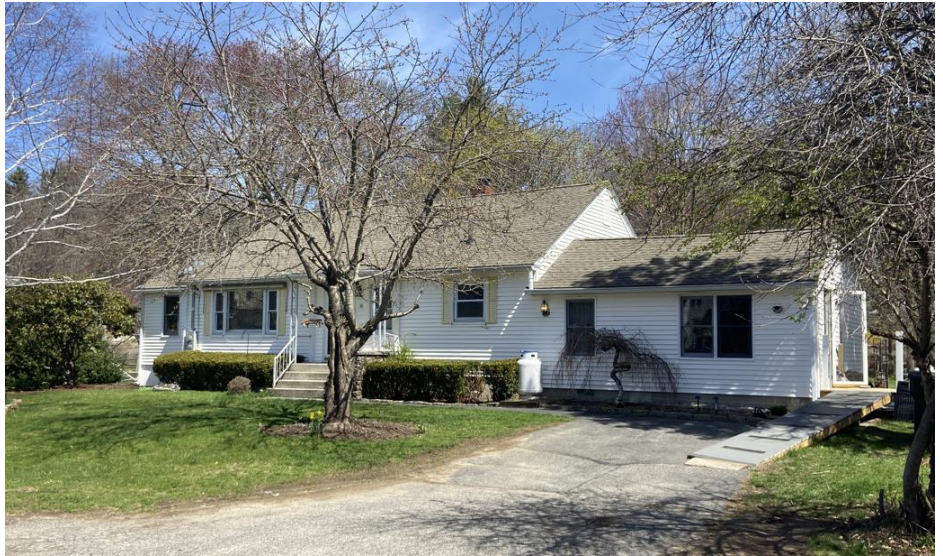
<u>Component</u>	<u>Condition</u>
Roofing	Good
Windows and Doors	Good
Exterior Walls	Good
Porch/Stairs/Deck	Good
Foundation	Good
Storefront & Signage	
Parking Lots	
Other:	
Overall Property Rating: (Excellent / Good / Fair / Poor) briefly state why. Good

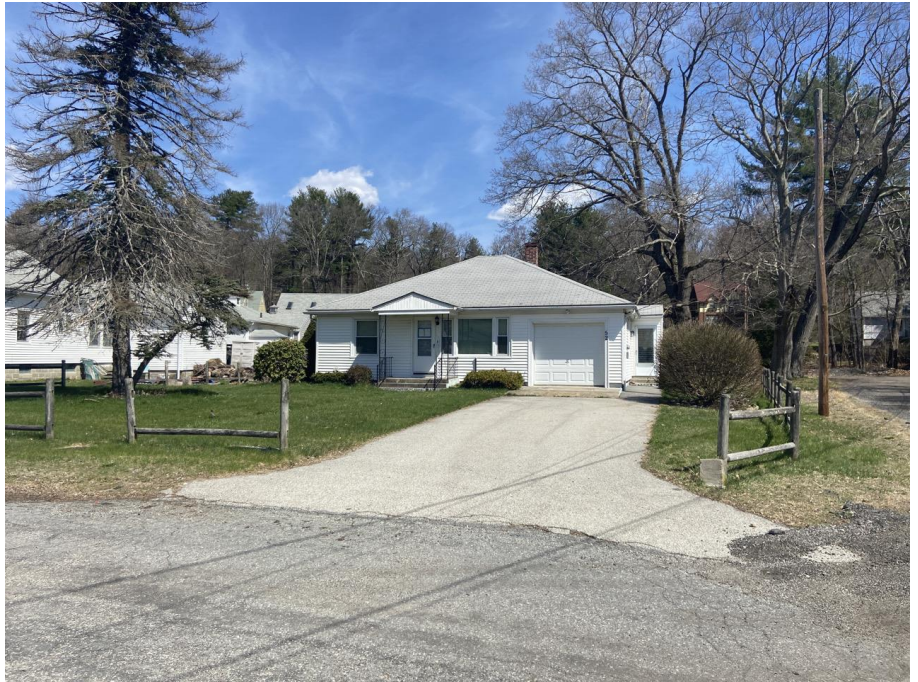
Roofing	Good
Windows and Doors	Good
Exterior Walls	Good
Porch/Stairs/Deck	Fair – faded/chipped paint
Foundation	Good
Storefront & Signage	
Parking Lots	
Other:

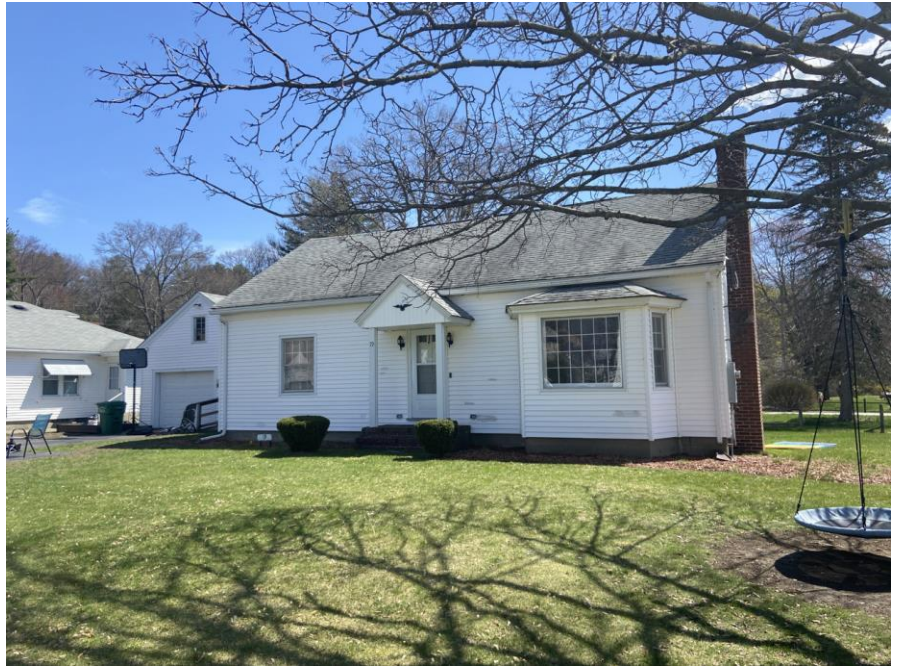
Roofing	Good
Windows and Doors	Good
Exterior Walls	Fair – damaged siding
Porch/Stairs/Deck	Good
Foundation	Good
Storefront & Signage	
Parking Lots	
Other:

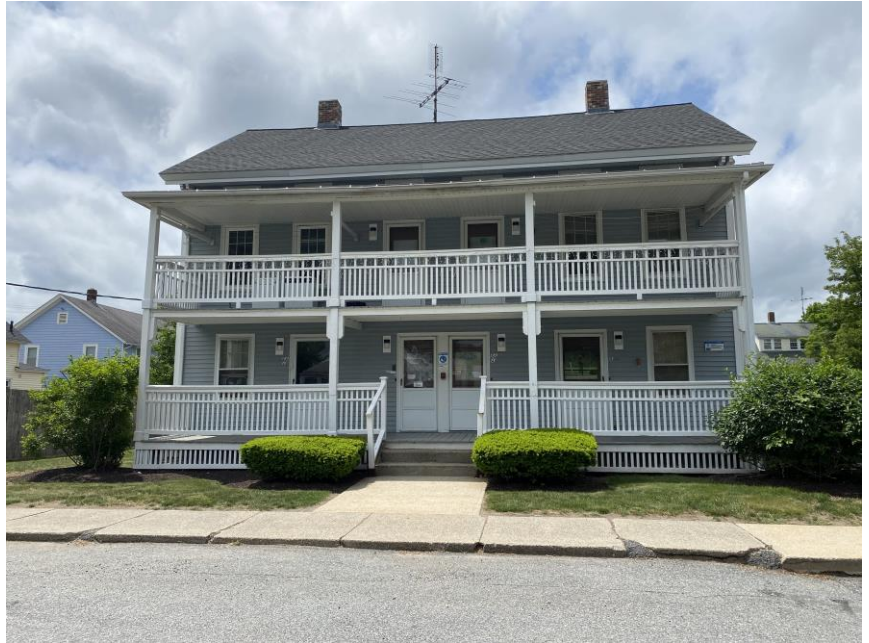
Roofing	Good
Windows and Doors	Fair – older
Exterior Walls	Good
Porch/Stairs/Deck	Good
Foundation	Good
Storefront & Signage	
Parking Lots	
Other:

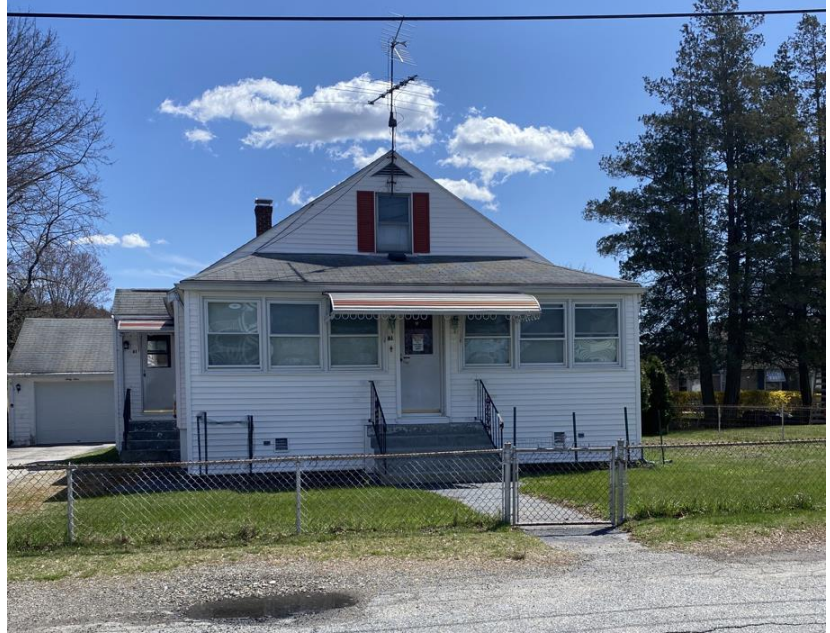
Roofing	Fair – minor stains
Windows and Doors	Fair – old
Exterior Walls	Good
Porch/Stairs/Deck	Fair – chipped paint
Foundation	Good
Storefront & Signage	
Parking Lots	
Other:

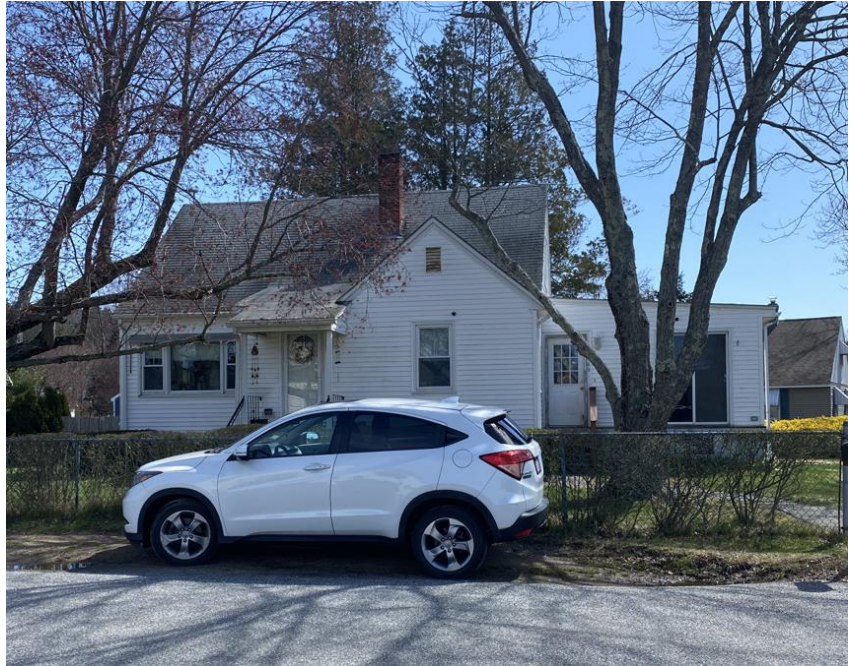
Roofing Fair – stains with minor moss growth

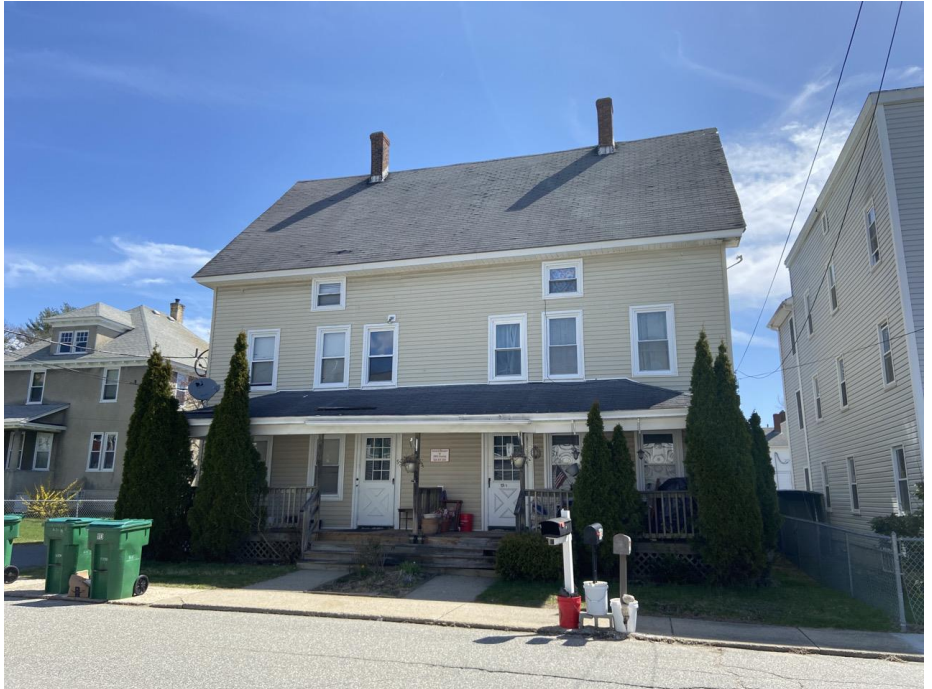
Roofing Fair – damaged/missing shingles

Exterior Walls Fair – faded/worn paint

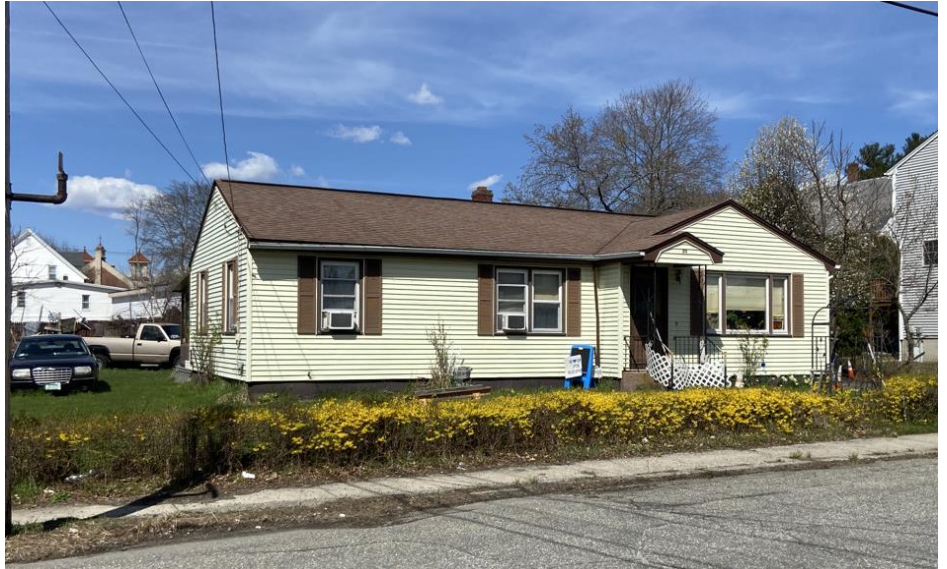
Roofing	Good
Windows and Doors	Fair – older style windows
Exterior Walls	Good
Porch/Stairs/Deck	Poor – damaged railings
Foundation	Good
Storefront & Signage	
Parking Lots	
Other:

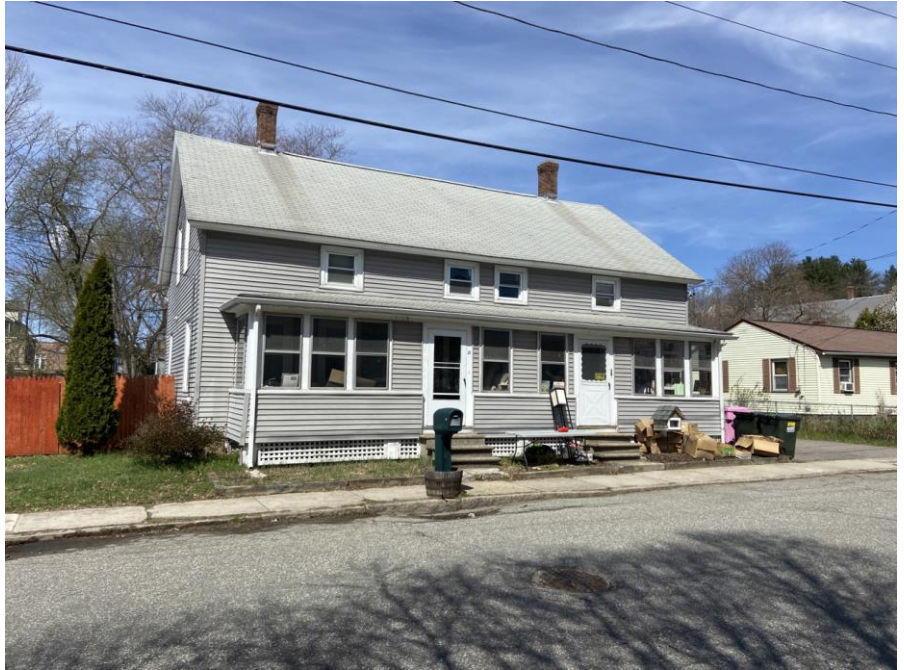
Roofing	Fair – minor stains
Windows and Doors	Fair – damaged screens, older style windows
Exterior Walls	Fair – paint worn
Porch/Stairs/Deck	Fair – no railings
Foundation	Good
Storefront & Signage	
Parking Lots	
Other:	
Overall Property Rating: (Excellent / Good / Fair / Poor) briefly state why. Fair

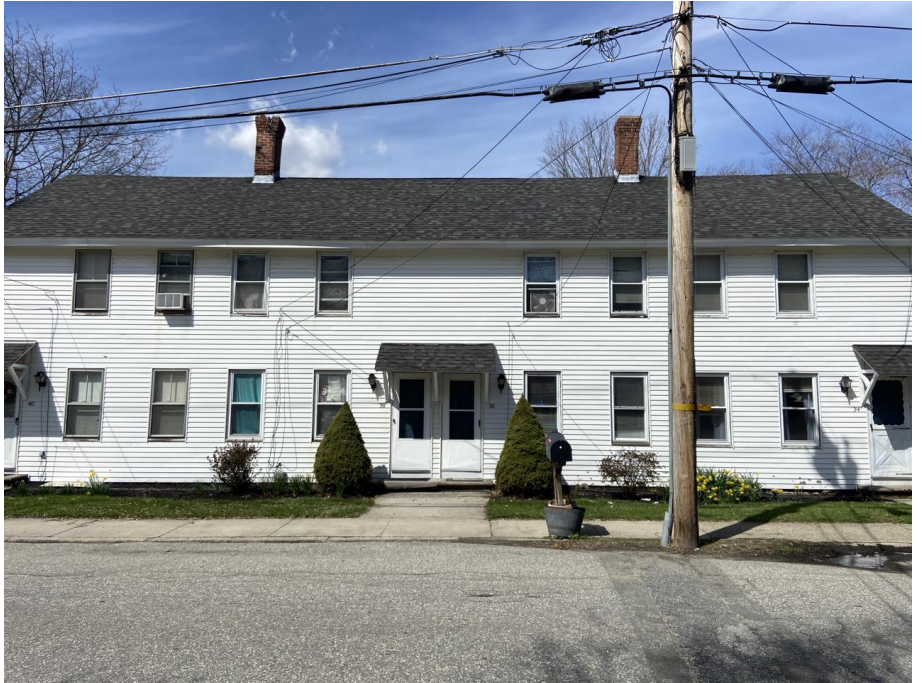
Roofing	Good
Windows and Doors	Fair – older
Exterior Walls	Good
Porch/Stairs/Deck	Fair
Foundation	Good
Storefront & Signage	
Parking Lots	
Other:

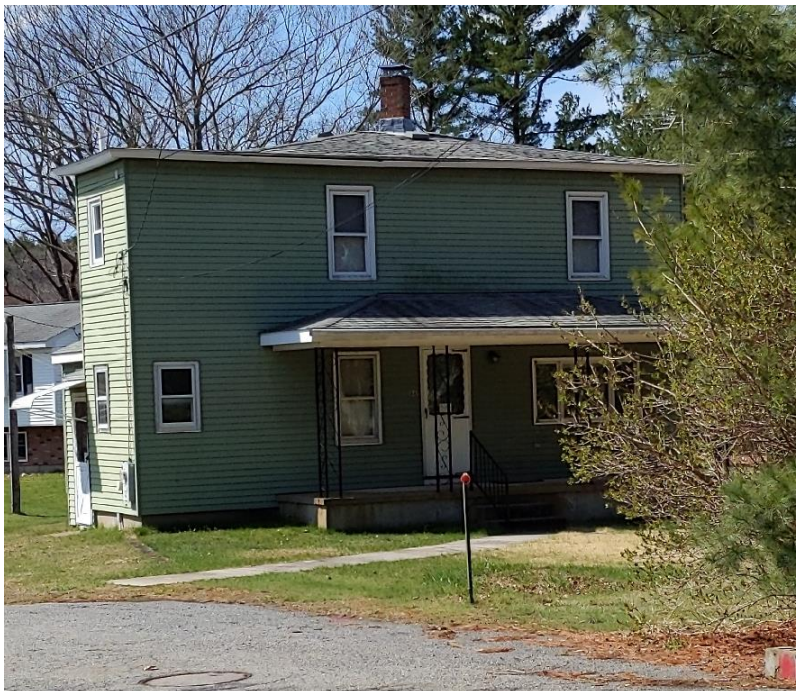
Roofing	Fair – stains
Windows and Doors	Fair – trim is stained
Exterior Walls	Fair – stained
Porch/Stairs/Deck	Fair – stained, stairs are crooked and worn
Foundation	Good
Storefront & Signage	
Parking Lots	
Other:

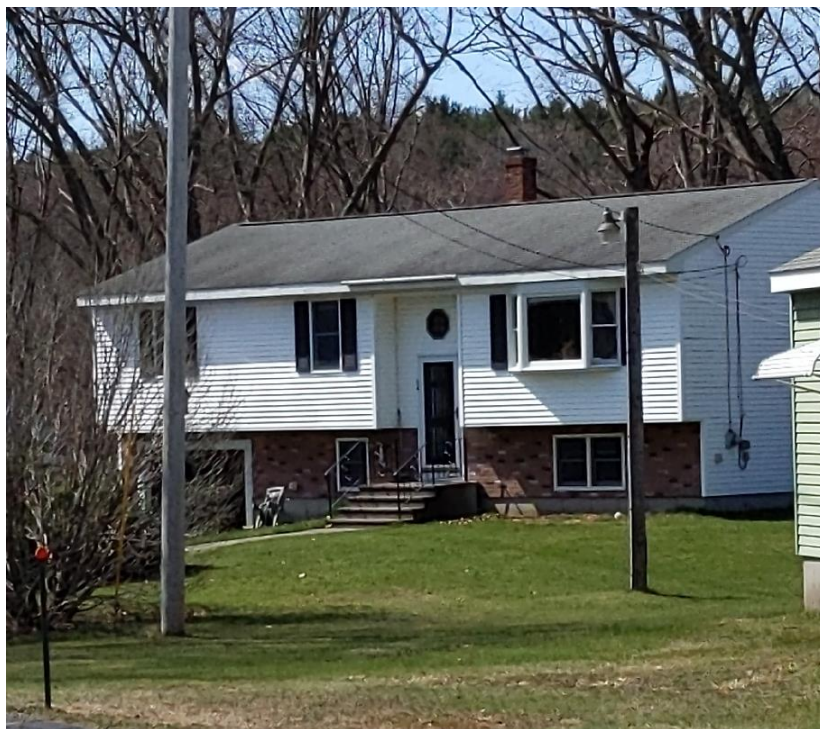
<u>Component</u>	<u>Condition</u>
Roofing	Fair – stains
Windows and Doors	Good
Exterior Walls	Good
Porch/Stairs/Deck	Fair – stained
Foundation	Good
Storefront & Signage	
Parking Lots	
Other:

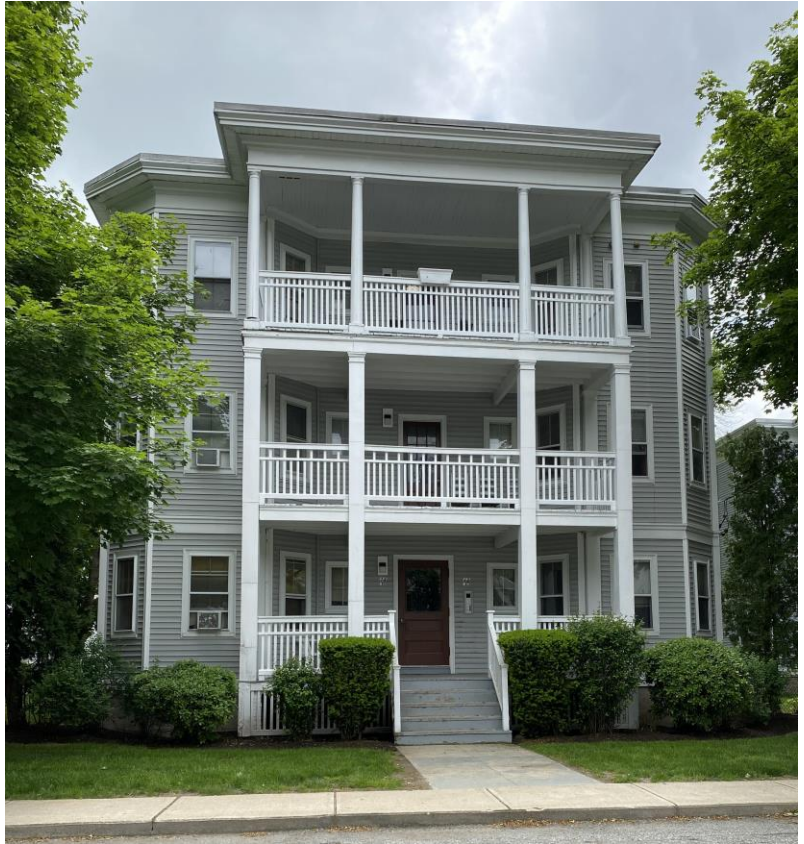
Roofing	Unknown
Windows and Doors	Fair – older
Exterior Walls	Good
Porch/Stairs/Deck	Fair – chipped paint
Foundation	Good
Storefront & Signage	
Parking Lots	
Other:

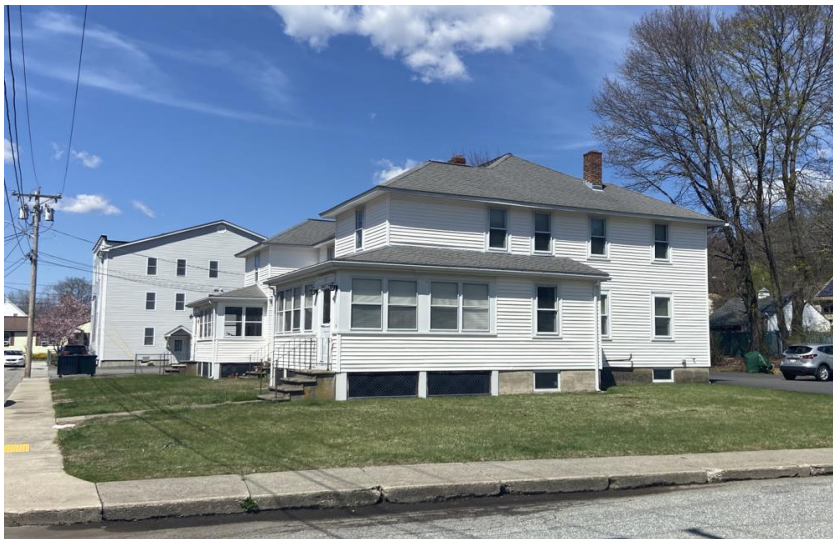
<u>Component</u>	<u>Condition</u>
Roofing	Good
Windows and Doors	Good
Exterior Walls	Good
Porch/Stairs/Deck	Fair – stained
Foundation	Good
Storefront & Signage	
Parking Lots	
Other:

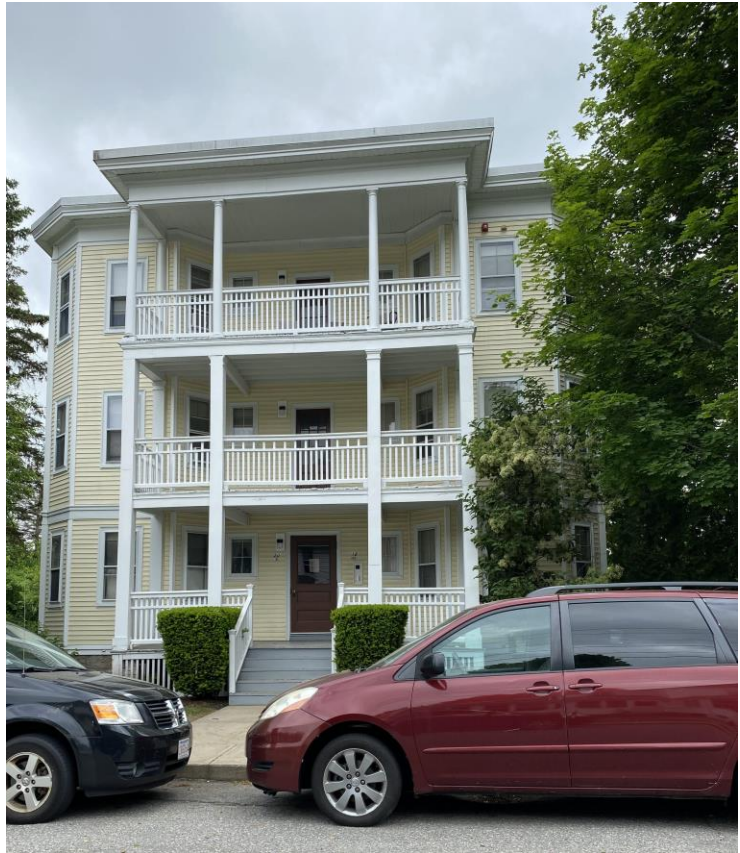
Roofing	Unknown
Windows and Doors	Good
Exterior Walls	Good
Porch/Stairs/Deck	Fair – minor chipped paint
Foundation	Good
Storefront & Signage	
Parking Lots	
Other:

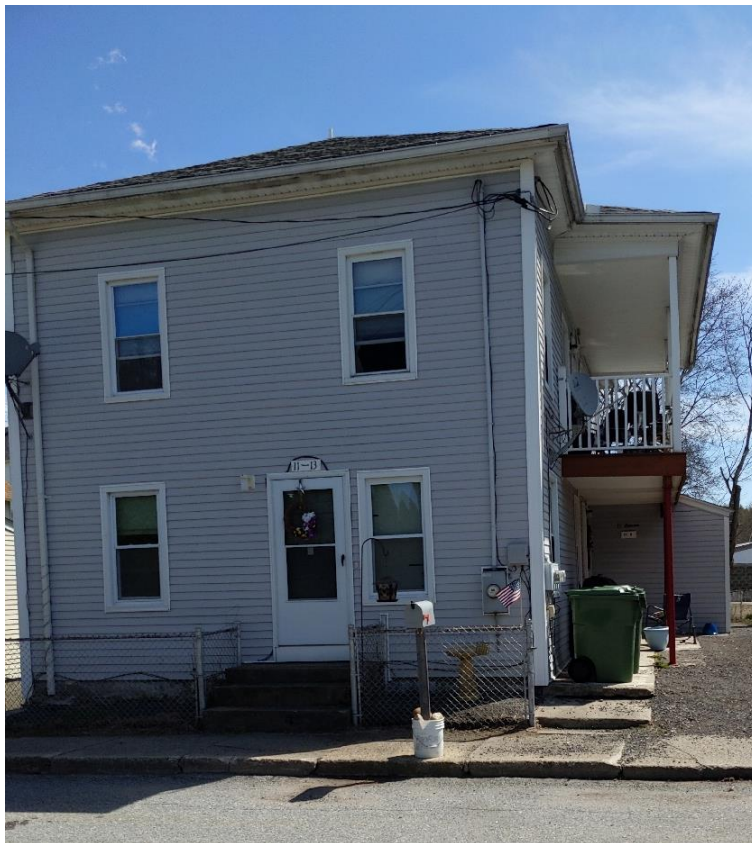
<u>Component</u>	<u>Condition</u>
Roofing	Good
Windows and Doors	Fair – damaged screens
Exterior Walls	Good
Porch/Stairs/Deck	Fair – stairs are stained and have minor moss growth
Foundation	Fair – stains and moss growth
Storefront & Signage	
Parking Lots	
Other:	
Overall Property Rating: (Excellent / Good / Fair / Poor) briefly state why. Fair

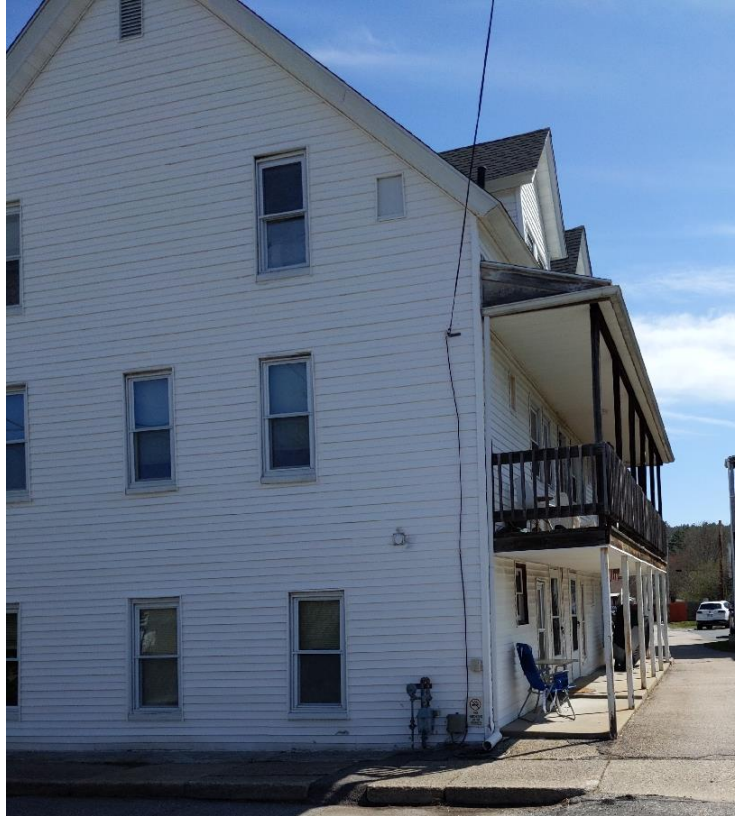
<u>Component</u>	<u>Condition</u>
Roofing	Good
Windows and Doors	Fair – old
Exterior Walls	Fair – siding is warping near foundation
Porch/Stairs/Deck	Fair – poles holding up deck are rusted, wood is worn
Foundation	Good
Storefront & Signage	
Parking Lots	
Other:	
Overall Property Rating: (Excellent / Good / Fair / Poor) briefly state why. Fair

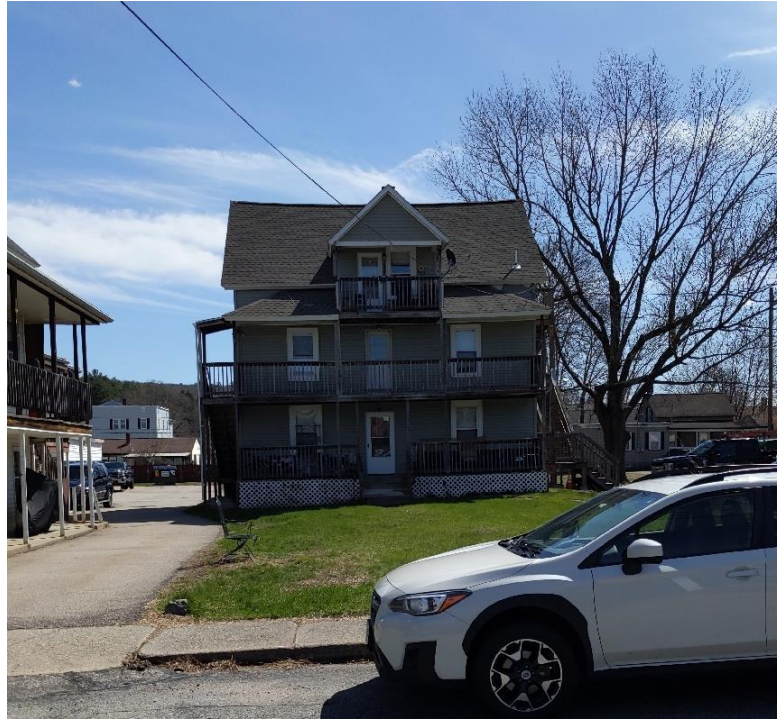
<b><u>Component</u></b>	<b><u>Condition</u></b>
Roofing	Good
Windows and Doors	Good
Exterior Walls	Good
Porch/Stairs/Deck	Poor – wood on deck is worn, stairs are crooked
Foundation	Good
Storefront & Signage	
Parking Lots	
Other:	
Overall Property Rating: (Excellent / Good / Fair / Poor) briefly state why. Fair

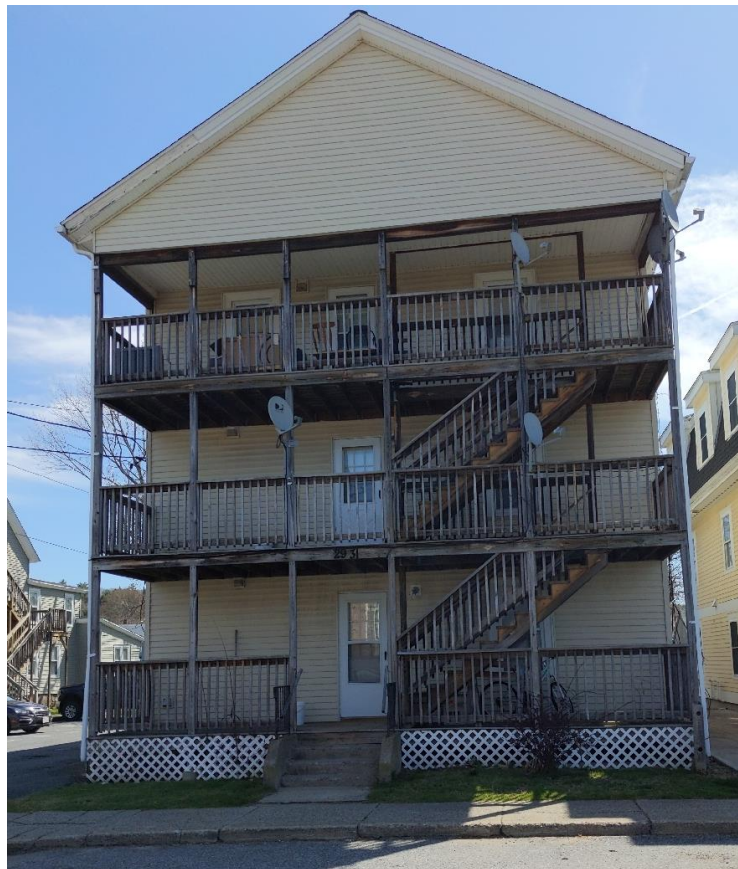
Roofing	Good
Windows and Doors	Fair – old
Exterior Walls	Fair – siding is stained
Porch/Stairs/Deck	Poor – all porches are worn and weathered, some are stained
Foundation	Fair
Storefront & Signage	
Parking Lots	
Other:

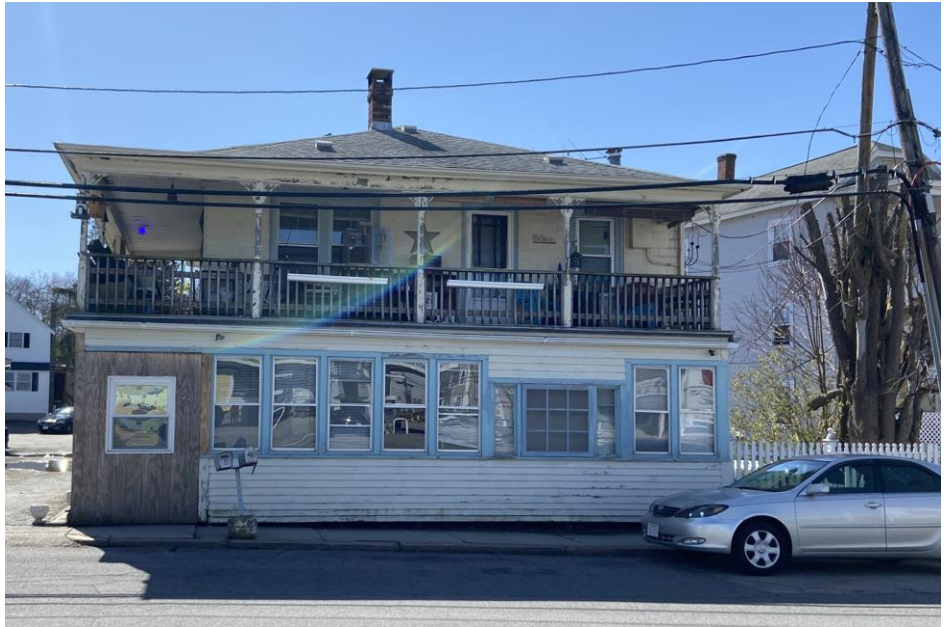
Roofing	Fair
Windows and Doors	Poor – old windows
Exterior Walls	Poor – faded/chipped paint, missing siding
Porch/Stairs/Deck	Poor – chipped paint, worn wood
Foundation	Fair
Storefront & Signage	
Parking Lots	
Other:

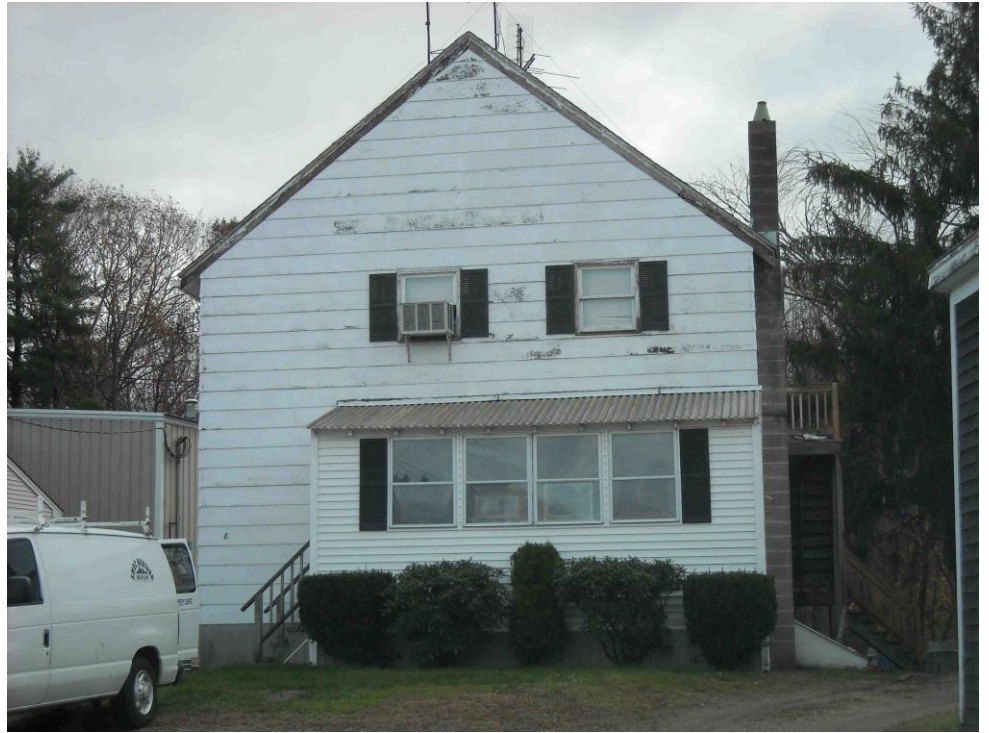
Roofing	Unknown
Windows and Doors	Fair – old
Exterior Walls	Poor – chipped/faded siding
Porch/Stairs/Deck	Fair – stained
Foundation	Unknown
Storefront & Signage	
Parking Lots

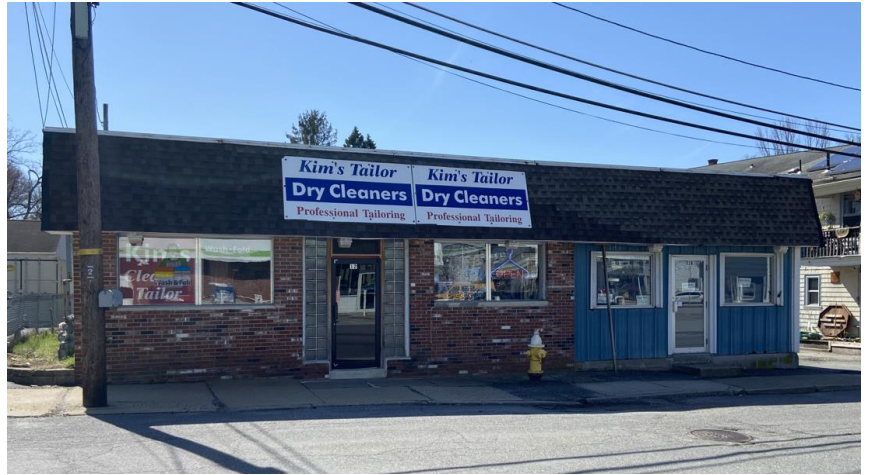
Address: 12 Beanes Lane  
 Zoning or Land Use: B-1  
 Commercial/Residential: Commercial  
 Stories: 1  
 General Construction: 1950  
 Storefront Construction:  
 Building Age: 72  
 Vacant: yes ☐ no ☒ other:  
 Assessed Value: 180,700  
 Other Relevant Data: Kim's Tailor/Dry Cleaners

<u>Component</u>	<u>Condition</u>
Roofing	Good
Windows and Doors	Fair – old
Exterior Walls	Good
Porch/Stairs/Deck	Good
Foundation	Fair - stained
Storefront & Signage	Fair – excessive signage
Parking Lots	
Other:	
Overall Property Rating: (Excellent / Good / Fair / Poor) briefly state why. Fair

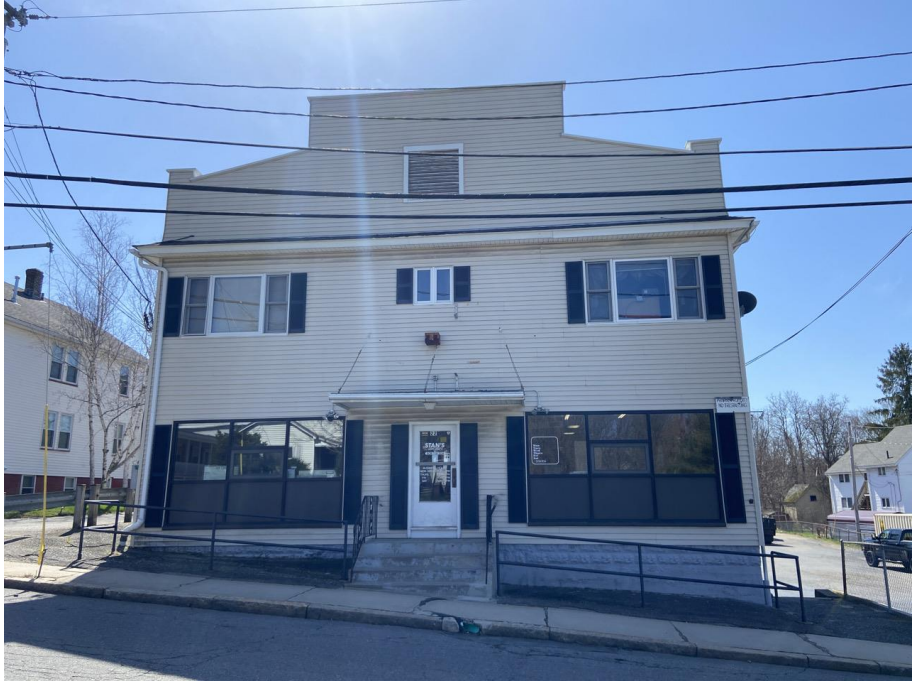
Roofing	Unknown
Windows and Doors	Fair – some older
Exterior Walls	Fair – damaged/dirty siding
Porch/Stairs/Deck	Fair – chipped paint
Foundation	Good
Storefront & Signage	
Parking Lots	
Other:

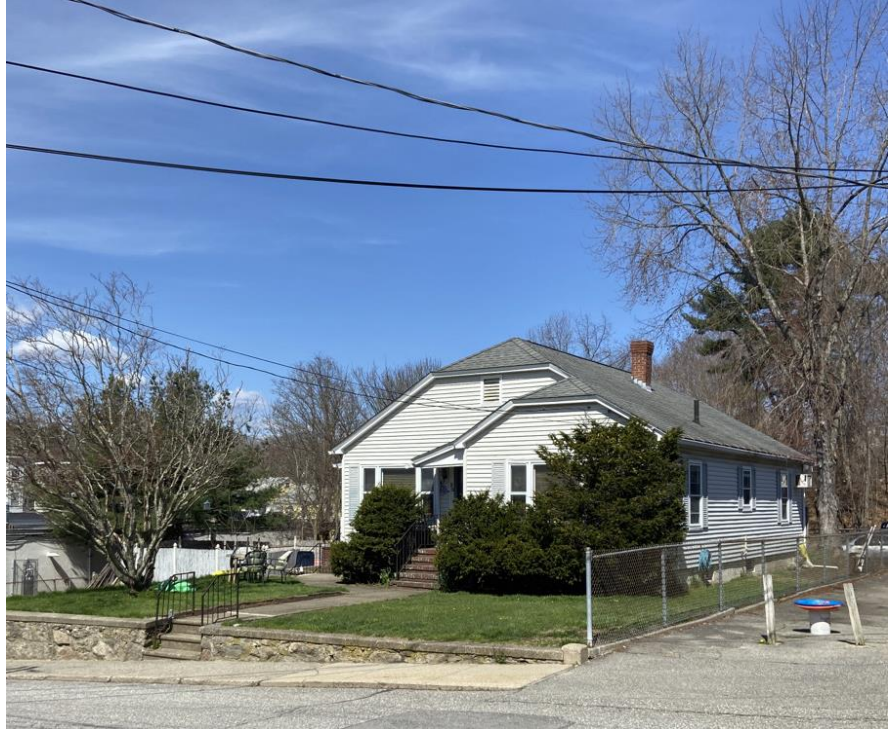
Roofing	Good
Windows and Doors	Fair – older style windows
Exterior Walls	Fair – dirty siding
Porch/Stairs/Deck	Good
Foundation	Good
Storefront & Signage	
Parking Lots	
Other:

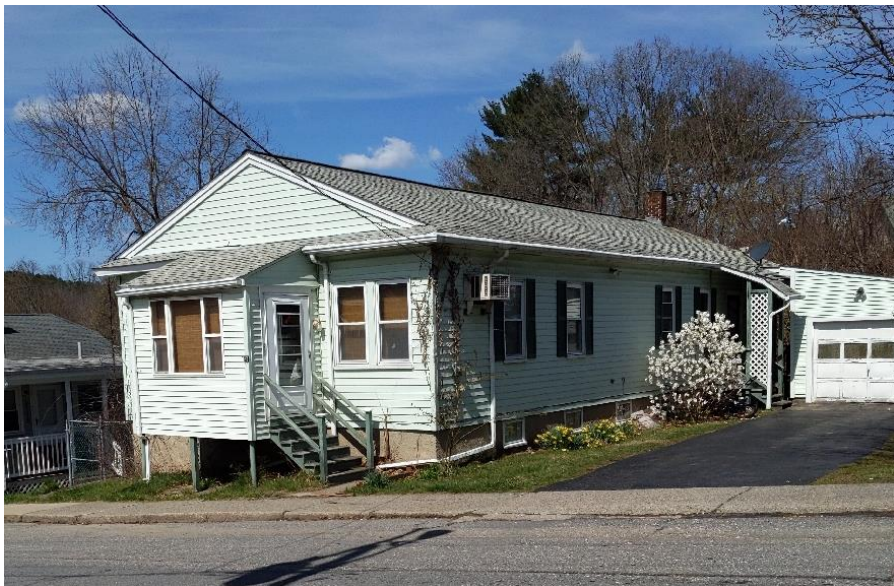
<u>Component</u>	<u>Condition</u>
Roofing	Good
Windows and Doors	Good
Exterior Walls	Fair – vinyl siding is good, garage door is worn and chipping
Porch/Stairs/Deck	Fair – steps are chipped and worn
Foundation	Fair – minor stains
Storefront & Signage	
Parking Lots	
Other:	
Overall Property Rating: (Excellent / Good / Fair / Poor) briefly state why. Fair

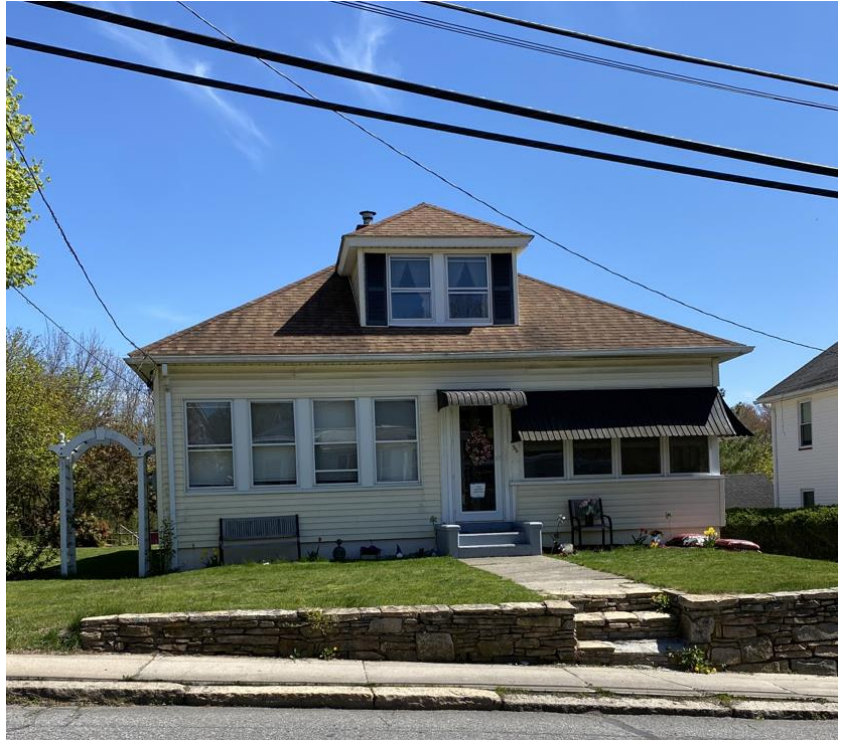
<u>Component</u>	<u>Condition</u>
Roofing	Fair – stains and minor moss growth
Windows and Doors	Fair – old
Exterior Walls	Good
Porch/Stairs/Deck	Fair – stairs by road are very uneven, some missing
Foundation	Good
Storefront & Signage	
Parking Lots	
Other:	
Overall Property Rating: (Excellent / Good / Fair / Poor) briefly state why. Fair

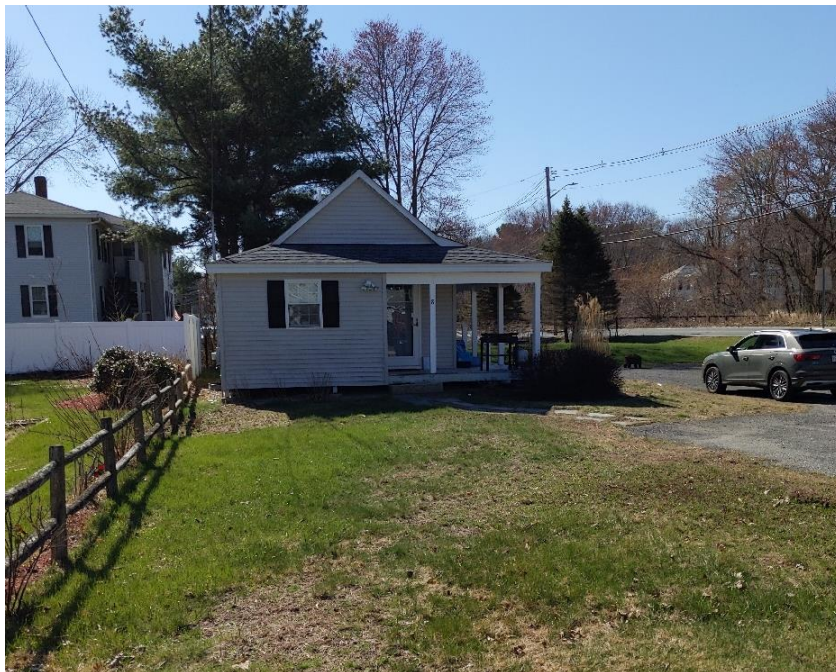
<u>Component</u>	<u>Condition</u>
Roofing	Good
Windows and Doors	Good
Exterior Walls	Fair – siding is stained
Porch/Stairs/Deck	Fair – paint is chipped around the base
Foundation	Good
Storefront & Signage	
Parking Lots	
Other:	
Overall Property Rating: (Excellent / Good / Fair / Poor) briefly state why. Good

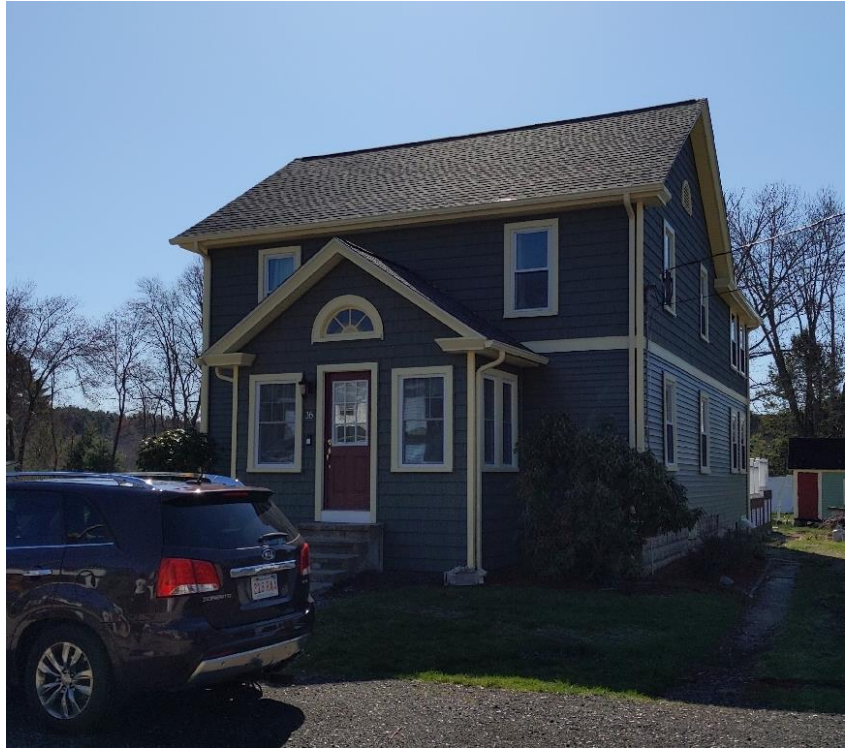
<u>Component</u>	<u>Condition</u>
Roofing	Excellent
Windows and Doors	Excellent
Exterior Walls	Excellent
Porch/Stairs/Deck	Fair – worn
Foundation	Good
Storefront & Signage	
Parking Lots	
Other:	
Overall Property Rating: (Excellent / Good / Fair / Poor) briefly state why. Good
