# Northbridge Slum & Blight Inventory

## Rockdale Target Area

Report compiled by the Pioneer Valley  
Planning Commission for the Town of  
Northbridge

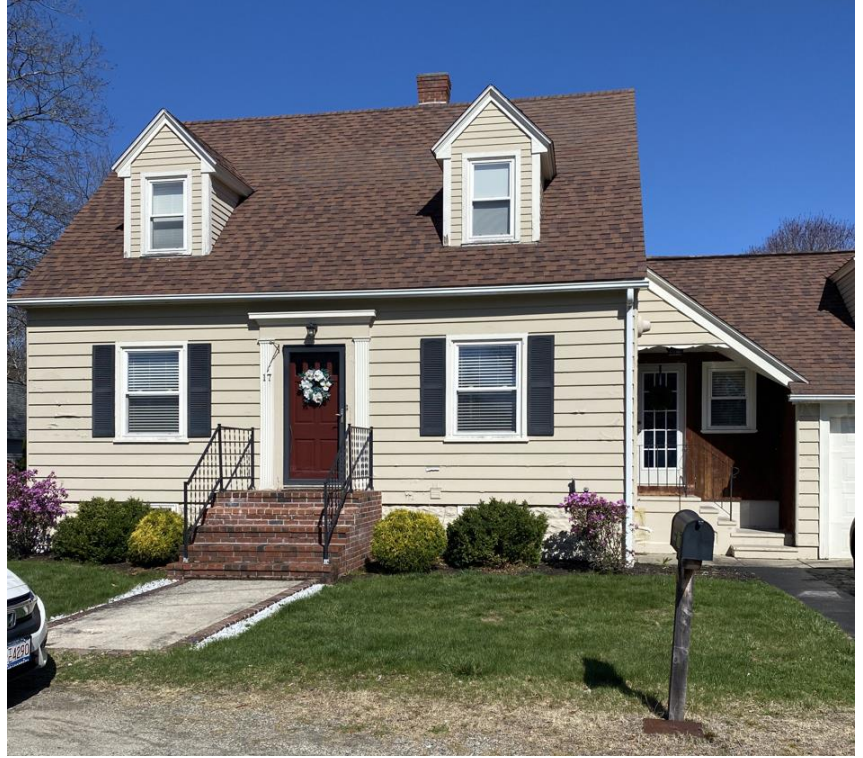
<b><u>Component</u></b>	<b><u>Condition</u></b>
Roofing	Good
Windows and Doors	Good
Exterior Walls	Fair – chipped paint on siding and trim
Porch/Stairs/Deck	Good
Foundation	Good
Storefront & Signage

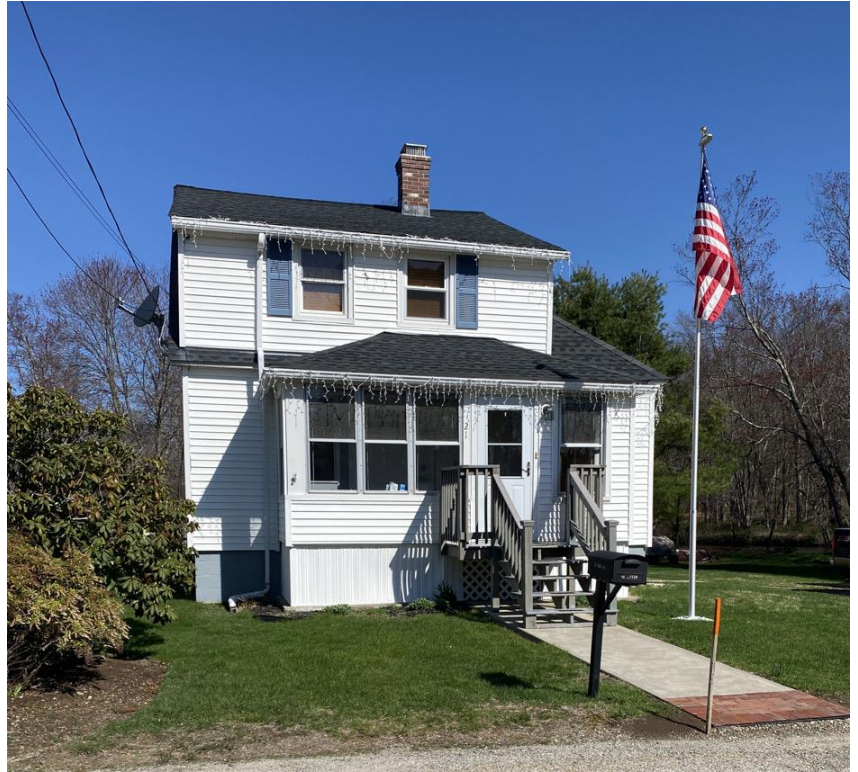
<u>Component</u>	<u>Condition</u>
Roofing	Good
Windows and Doors	Fair – older
Exterior Walls	Good
Porch/Stairs/Deck	Good
Foundation	Good
Storefront & Signage	
Parking Lots

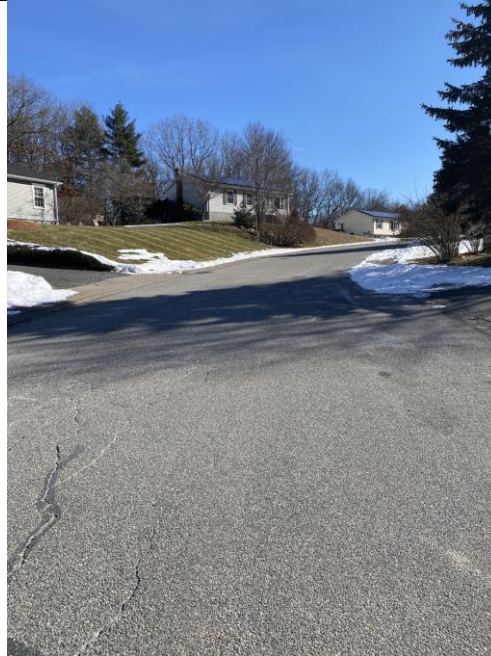
<b><u>Component</u></b>	<b><u>Condition</u></b>
Road Surface	Good
Water Lines	Fair
Sewer Lines	Good
Existing Sidewalk	Good – one side of street
Curbing	Good
Drainage	Good
Parking Lot:	
Lighting:	Good
Trees/Landscaping:	Fair
Park/Playground:	
Other:

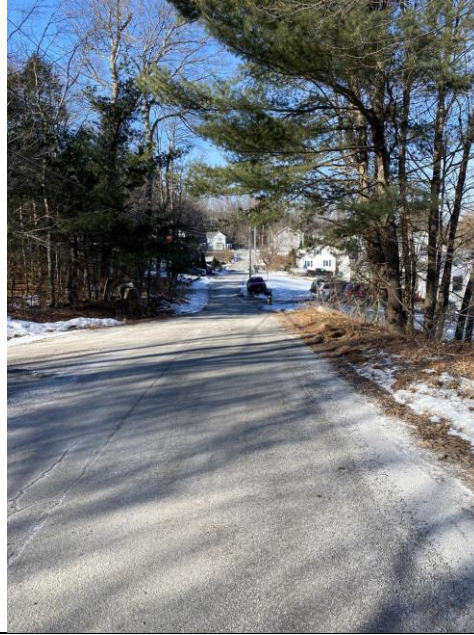
<u>Component</u>	<u>Condition</u>
Road Surface	Fair – some potholes, minor crumbling
Water Lines	Good – 6" ductile iron
Sewer Lines	n/a
Existing Sidewalk	n/a
Curbing	Poor - nonexistent
Drainage	Fair – minor flooding
Parking Lot:	
Lighting:	Poor – no streetlights
Trees/Landscaping:	Fair
Park/Playground:	
Other:	
Overall Rating:	(Excellent / Good / Fair / Poor) briefly state why. Fair

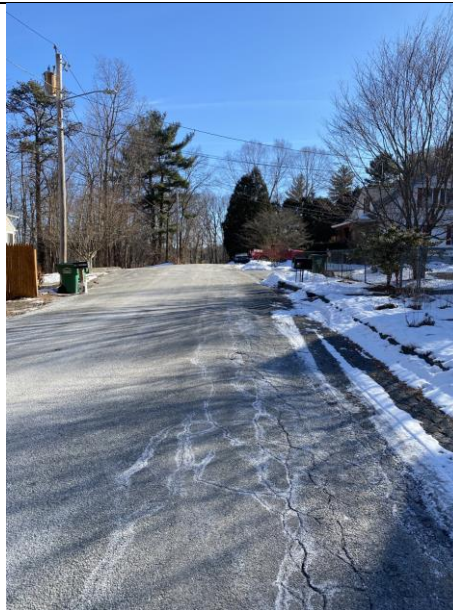
Road Surface Poor – alligator cracks, uneven

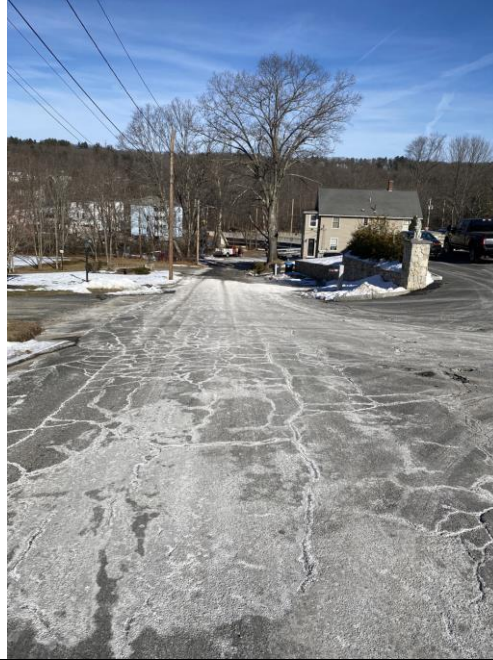
<b><u>Component</u></b>	<b><u>Condition</u></b>
Road Surface	Fair
Water Lines	Unknown
Sewer Lines	n/a
Existing Sidewalk	n/a
Curbing	Poor - nonexistent
Drainage	Poor – debris build up, minor flooding
Parking Lot:	
Lighting:	Good
Trees/Landscaping:	Fair
Park/Playground:	
Other:	
Overall Rating: (Excellent / Good / Fair / Poor) briefly state why.	Poor

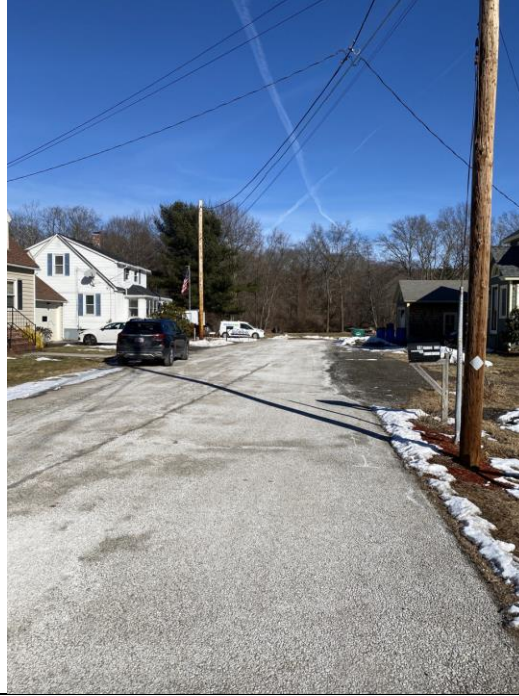
Road Surface	Fair – some cracks
Water Lines	Poor – 10” cement lined cast iron
Sewer Lines	Fair – 6” clay
Existing Sidewalk	n/a
Curbing	Poor – nonexistent
Drainage	Fair – minor flooding
Parking Lot:	
Lighting:	Good
Trees/Landscaping:	Fair
Park/Playground:	
Other:

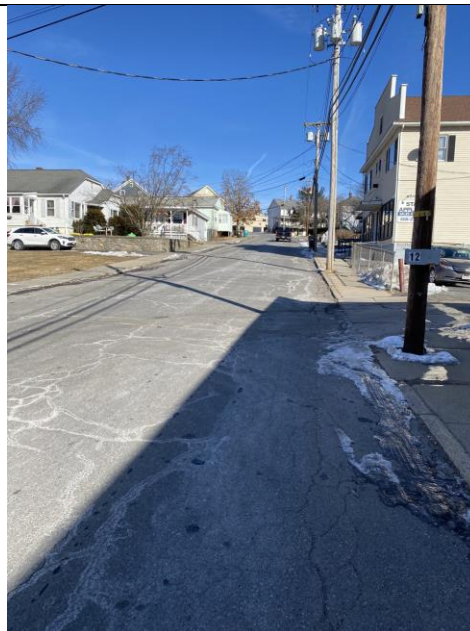
<b><u>Component</u></b>	<b><u>Condition</u></b>
Road Surface	Fair – alligator cracking, uneven
Water Lines	Fair – 10" cast iron
Sewer Lines	Poor – 6" and 8" clay
Existing Sidewalk	Poor – uneven, cracking
Curbing	Fair – some granite, minimal curbing
Drainage	Poor – flooding
Parking Lot:	
Lighting:	Good
Trees/Landscaping:	Poor
Park/Playground:	
Other:	
Overall Rating: (Excellent / Good / Fair / Poor) briefly state why.	Fair

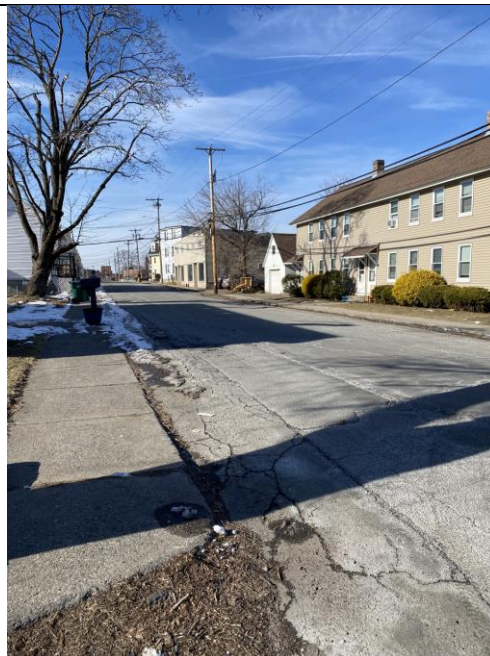
Road Surface	Poor – alligator cracking, potholes, uneven
Water Lines	Fair – 10” cast iron, 8” cement lined cast iron, 10” ductile iron
Sewer Lines	Fair – 8” clay
Existing Sidewalk	Poor – inconsistent, significant cracking
Curbing	Poor – crumbling, inconsistent
Drainage	Poor
Parking Lot:	Fair
Lighting:	Good
Trees/Landscaping:	Good
Park/Playground:	Fair – Rockdale Playground
Other:

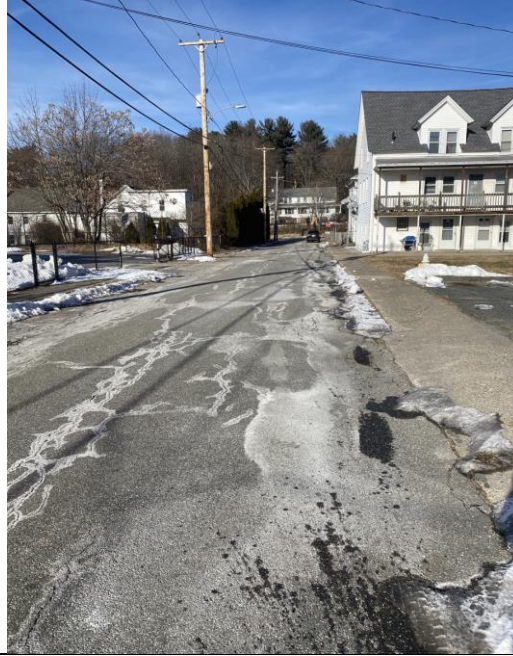
<b><u>Component</u></b>	<b><u>Condition</u></b>
Road Surface	Poor – uneven with cracks
Water Lines	Poor – 4” cast iron
Sewer Lines	Poor – 8” clay
Existing Sidewalk	Poor – uneven with cracks
Curbing	Poor – nonexistent in some areas
Drainage	Poor – flooding
Parking Lot:	
Lighting:	Good
Trees/Landscaping:	Fair
Park/Playground:	
Other:	
Overall Rating: (Excellent / Good / Fair / Poor) briefly state why.	Poor

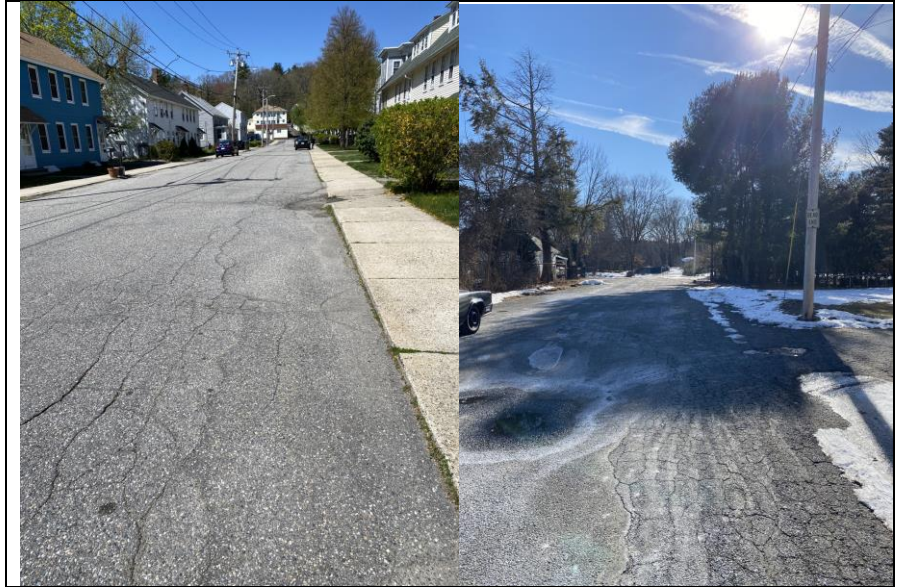
Road Surface      Poor – major cracking on southern end of street

Existing Sidewalk      Fair – uneven with cracks

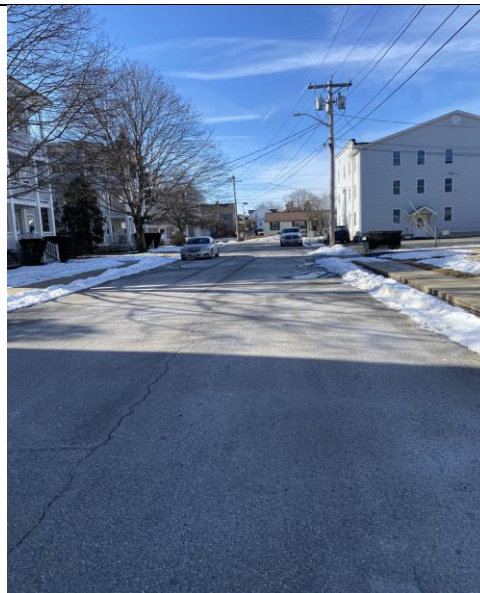
Road Surface Fair – uneven with divots and minor cracks

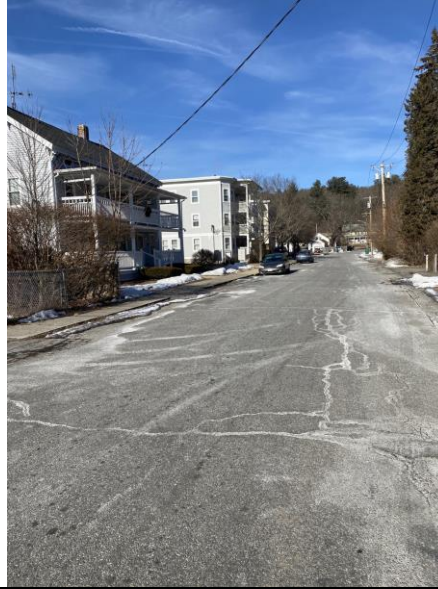
<u>Component</u>	<u>Condition</u>
Road Surface	Fair
Water Lines	Fair – 8" cast iron and 6" cement lined cast iron
Sewer Lines	Poor – 8" clay
Existing Sidewalk	Fair – uneven in some areas, only on one side of the street
Curbing	Fair
Drainage	Poor – flooding
Parking Lot:	
Lighting:	Good
Trees/Landscaping:	Fair
Park/Playground:	
Other:	
Overall Rating:	(Excellent / Good / Fair / Poor) briefly state why. Fair

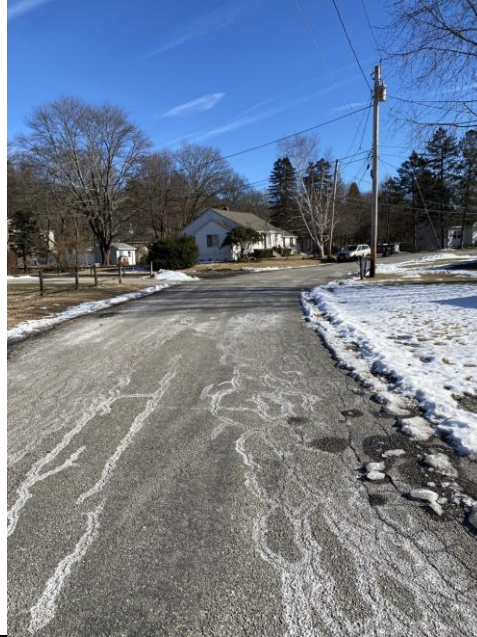
Road Surface Fair – a lot of cracks, extension of street is gravel and in poor condition

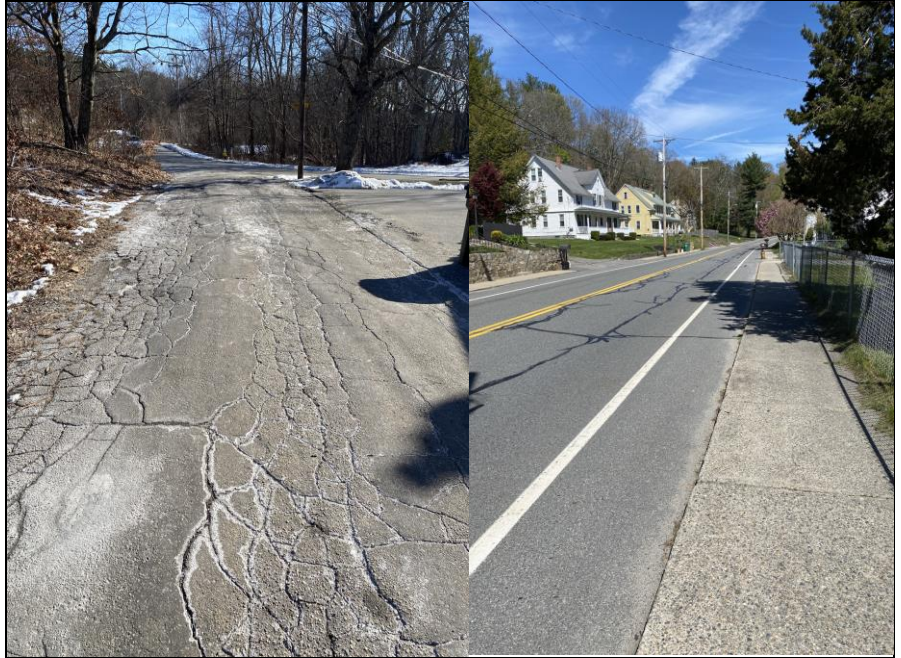
<b><u>Component</u></b>	<b><u>Condition</u></b>
Road Surface	Fair – minor cracks, School St extension is poor with major cracks and potholes
Water Lines	Fair – 12” and 16” ductile iron, 12” cement lined cast iron
Sewer Lines	n/a
Existing Sidewalk	Fair – minor cracks
Curbing	Fair
Drainage	Fair – minor flooding
Parking Lot:	
Lighting:	Good
Trees/Landscaping:	Fair
Park/Playground:	Good – Rockdale Park
Other:
