**TOWN OF NORTHBRIDGE
BOARD OF SELECTMEN'S MEETING
NORTHBRIDGE TOWN HALL
7 MAIN STREET - WHITINSVILLE, MA 01588
July 18, 2022 at 7:00 PM**

**Town of Northbridge
Self-Evaluation and Transition Plan
June 2022**

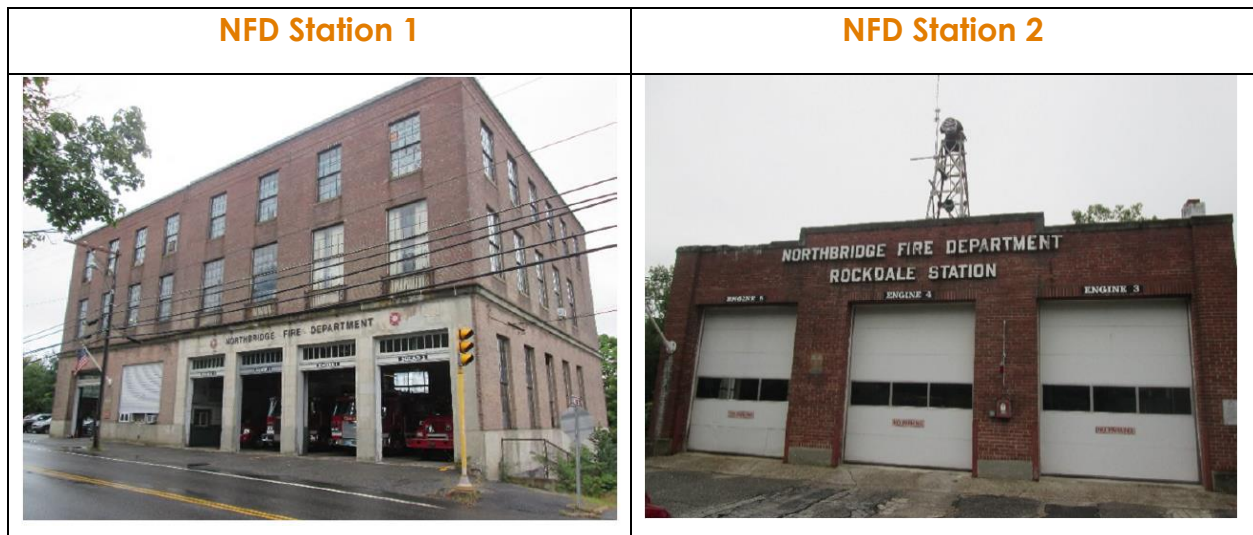
Figure 5: NFD Fire Stations

- The 2020 feasibility and facility report rates both stations as poor with multiple structural and environmental issues.
- Station 1 is a former mill and was renovated to serve as a fire station.
- Station 2 was built in the 1950s.

The 2020 feasibility and facility report recommended a new fire station, which the town acted on and approved. Town approval included funding for the project.

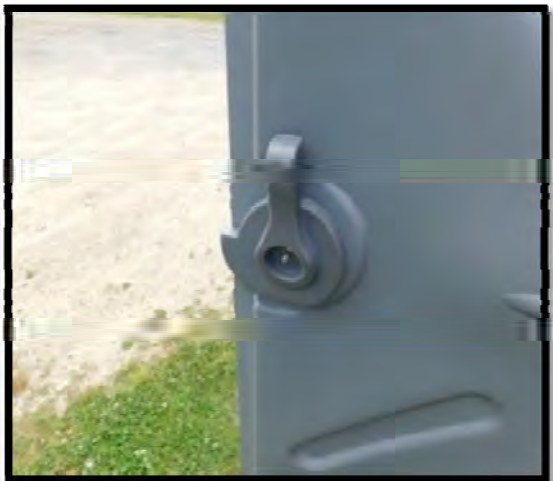
Representative Examples of an ADA Compliant Portable Toilet

If the Town provides portable toilets for short-term events or for seasonal use, then they must be “ADA Compliant”. **An important distinction to note is that “ADA Compliant” is not synonymous with “Wheelchair Accessible.”** Wheelchair Accessible usually indicates a ramped or ground level entrance with a wide enough door for a wheelchair to gain entry. Clearances; setbacks; and dispenser, grab bar, and water closet heights do not necessarily meet ADA or 521 CMR Standards. “ADA Compliant”, however, generally means reinforced construction; ramped or ground level and wheelchair accessible entrance; spring loaded magnetic door that closes automatically; reinforced grab bars; dispensers, grab bars, and the water closet at the proper height and near, far and front setbacks; compliant door hardware; and enough interior space for a wheelchair to make a 360 degree turn that all fully comply with the 2010 ADA Standards and/or 521 CMR, whichever is more stringent. Illustrative examples of an “ADA Compliant” portable toilet are shown below.

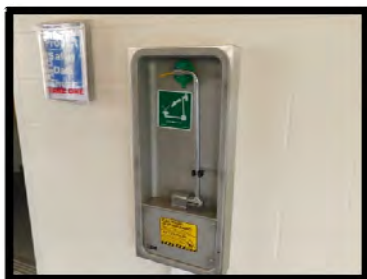
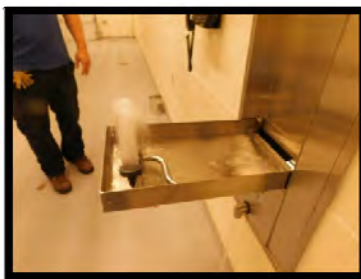
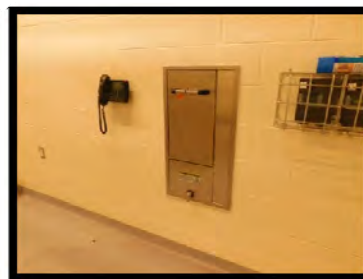
- When a shower/eyewash station is a combination unit, the eyewash should be about 14 inches from the wall to the center-line of the eyewash.
- ADA guidelines state that at least one out of five eyewash or shower stations in a specific area, or at least one, must meet ADA requirements.

Photographic examples of compliant emergency eyewash stations are provided below.

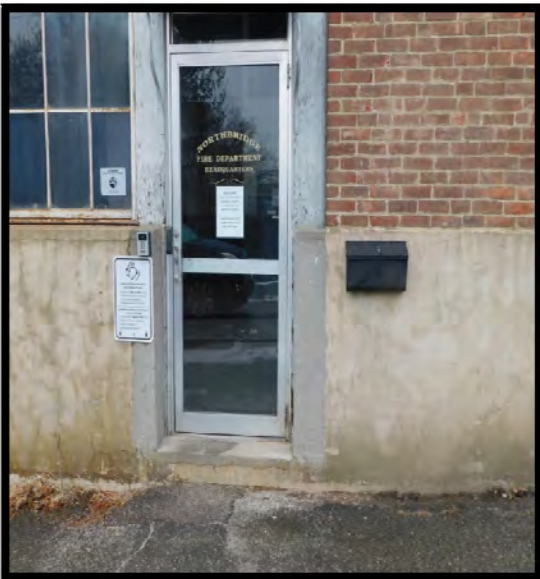
Photo Fire 1

<p>Reach Range The air phone buzzer (52" a.f.f.) and the drop box (50" a.f.f.) are 2" to 4" above reach range.</p> <p>See Photo Fire 1.</p>	<p>308.2 308.3</p>	<p>6.5 6.6</p>	<p>Lower the air phone and drop box so they are no more than 48" a.f.f.</p>	<p>2</p>	<p>2,3</p>	<p>N</p>	<p>\$0 to \$150</p>
<p>Level 1 Office Counter The counter is 42¼" a.f.f., which is 6¼" too high, is not 36" long, and does not provide adequate knee width clearance due to the support braces.</p> <p>See Photo Fire 2.</p>	<p>904.4</p>	<p>7.2</p>	<p>Replace the existing counter with one that is 36" long by no more than 36" high with a minimum of 27" of knee height and 30" knee width clearance.</p>	<p>2</p>	<p>3</p>	<p>N</p>	<p>Up to \$350</p>

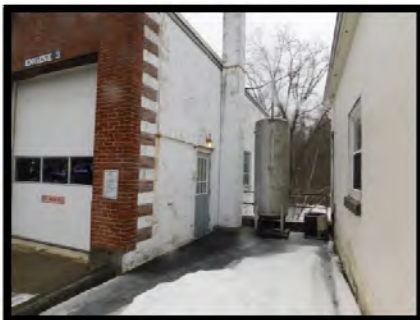
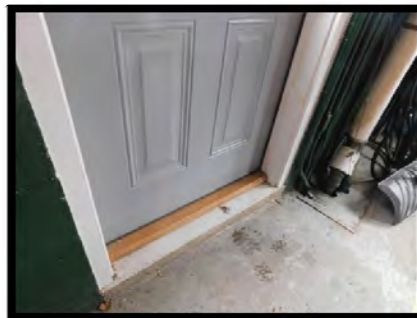
There is no designated accessible parking. There is a 4" abrupt change at the entrance threshold. The entrance door has non-compliant knob style hardware.

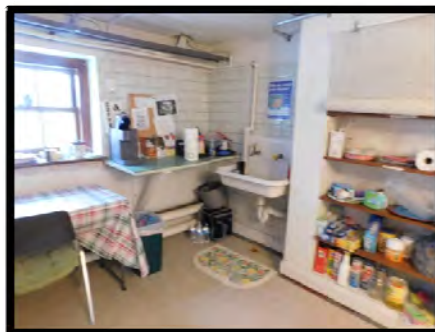
The Level 1 Staff Work Room has a spiral staircase to a mezzanine storage area with open risers and railings that are too low, lack extensions, and provides only one railing. The Ground Level Staff Kitchen has a sink with exposed piping, a sink basin that is too deep, and faucets that require pinching and twisting of the wrist. As these areas are closed to the public and used solely by library staff, future modifications would only be required as a result of a reasonable accommodation request. *See Photos Below.*

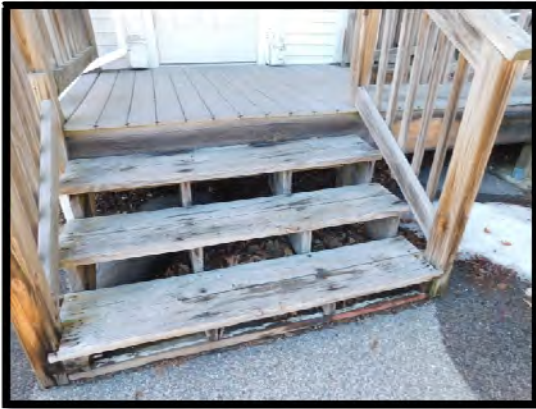
Photo Veterans 1

<p>Ramp to Front Entrance There are two 1" abrupt changes in level surface from the transition of concrete and asphalt and concrete and Trex ramp. The lower railing is up to 1½" too high. Segments of the upper railing are up to ½" too low. See Photo Veterans 2.</p>	403.4 505.4	22.4.1 24.5	Modify the transition to eliminate the abrupt change in level surface. The transition s/b no greater than ¼" or ¼" to ½" if beveled with a slope of no greater than 1:2. Modify/adjust/replace the lower railings so they are 18" to 20" a.f.f. to the top of the railings and the upper railings are 34" to 38" a.f.f. to the top of the railings.	1 1	2 3	N N	\$150 Up to \$5,000+
<p>Door Signage Tactile designation signage is not provided on four (4) Level 1 interior doors and five (5) Level 2 interior doors. See Photo Veterans 3.</p>	703	41.1	Install accessible compliant signage on the latch side of each door with appropriate finish and contrast and character height and proportions, raised and brailled characters should also be included. Under 521 CMR, signage s/b 60" a.f.f to the centerline of the sign. Tactile characters on signs s/b 48" min. a.f.f.. from baseline of lowest character and 60" max. a.f.f. to baseline of highest character. Characters must meet the ADA Standards for character height, finish and contrast, accompanied by Grade 2 Braille (703 ADA Standards).	2	2	I	Up to \$1,125

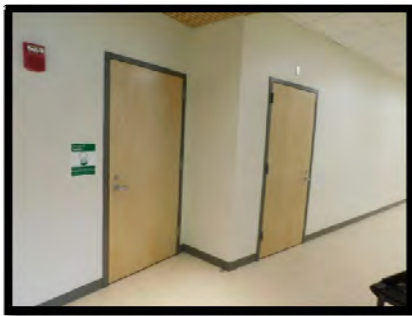
Photo NES 6

<ul style="list-style-type: none"> Three mechanical/storage rooms across from #3225 <p>See Photo NES 6.</p>							
<p>Accessible Hallway Lockers</p> <p>The designated accessible hallway lockers have operating mechanisms that are difficult to use with a loose grip or closed fist.</p> <p>See Photo NES 7.</p>	225.2.1 811.4 309	26.11 19.4.1	Modify the operating mechanisms to provide an extension to allow for easier use and operation with a closed fist.	4	3	I	Up to \$300
<p>Protruding Objects</p> <ul style="list-style-type: none"> Collaboration Room #3225 TV monitor (6½" protrusion at 38½" a.f.f) Hallway counter between #3104 and #3106 (18" protrusion at 32½" a.f.f) <p>Protruding objects extend more than 4" into the accessible route of travel between a height of 27" and 80" a.f.f. or have vertical headroom clearance reduced to less than 80".</p> <p>See Photo NES 8.</p>	307.2	20.6.1	Place fixed objects at each end of the TV monitor and hallway counter for cane detection.	2	2	I	\$0

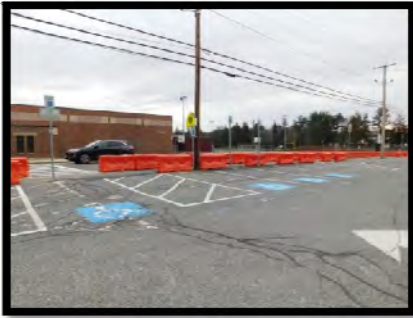
Photo NMS 1

The front designated accessible parking has signage that is too high, running slopes that vary up to 3.8%, deteriorated and unstable surfaces, and the lack of van designated spaces in 2 of the 3 separate front parking areas. Two of the spaces closest to the main entrance lack access aisles.

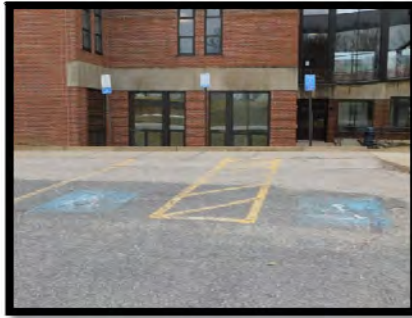
Photo NMS 2

The side designated accessible parking spaces next to the ramp are deteriorated creating an unstable surface. The van designated accessible space lacks an access aisle and the passenger designated accessible aisle is too narrow.

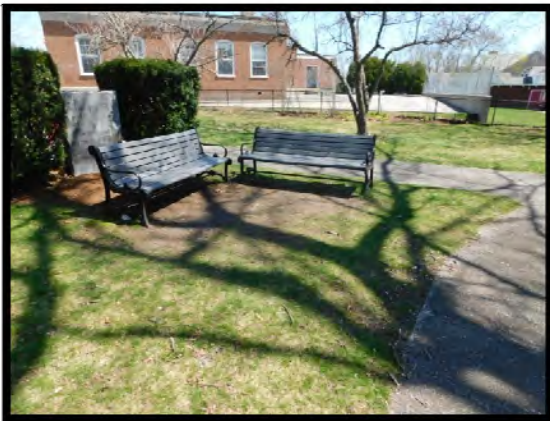
Photo Town Common 1

<p>See Photos Town Common 1, 2, and 3.</p>		<p>and a 5% maximum running slope.</p> <p>Repair/modify the concrete at the Civil War Monument to eliminate the abrupt changes in level surface and to provide a stable surface.</p> <p>Provide a stone dust accessible route and level area for a wheelchair at the Linwood Street side interpretive signage.</p>				
--	--	--	--	--	--	--

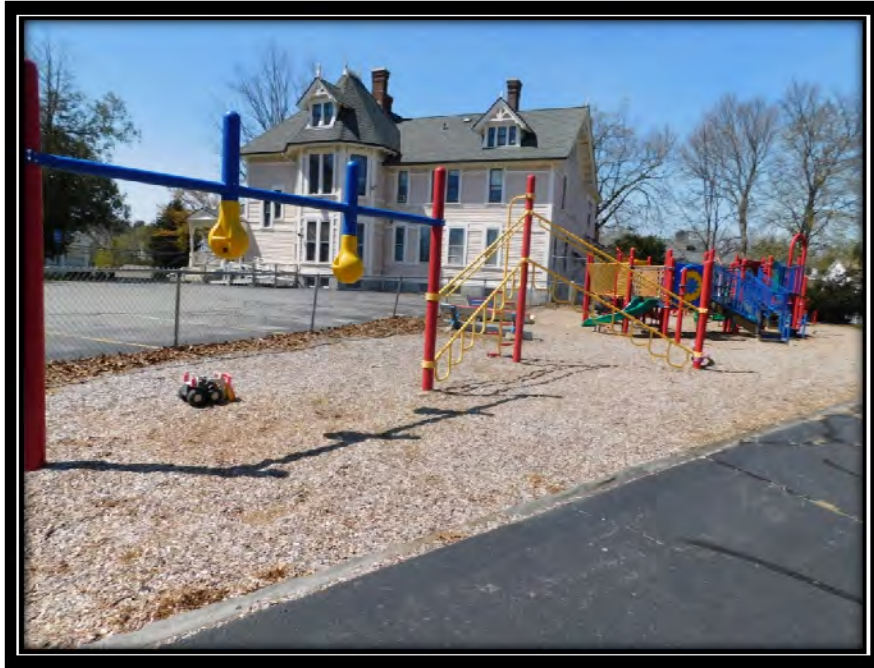
Function and Description of Facility and Programs: Cross Street Tot Lot is a small playground located next to the School Administration Building and the former elementary school on Cross Street. In addition to the play equipment, there is a sandbox and a bench.

General Description or Obstacle Which Limits Mobility or Access: The chain link gate to enter the playground is not smooth at the base. The walkway from the sidewalk to the playground has a running slope of up to 12.0%. There is no accessible route of travel fully around the entirety of the playground (one side only). There is no accessible route of travel to the play equipment, sandbox, and bench. Non-compliant wood chips are the primary surface throughout the playground. There are no accessible play components.

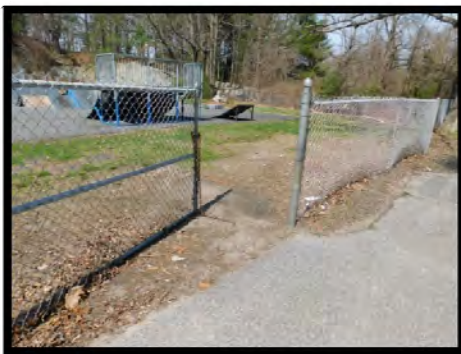
Photo Plummer 1

General Description or Obstacle Which Limits Mobility or Access: The chain link gate to enter the abandoned ballfield is not smooth at the base. There is no improved accessible route of travel to the skate park, memorial bench and portable toilet. The portable toilet is not accessible.

surface (no > than ¼" unbeveled or between ¼" and ½" beveled w/a slope of no > 1:2). Construction options can include compacted stone dust as long it is compacted to meet the requirement of stable, firm, and slip resistant.				
<p>Portable Toilet</p> <p>The portable toilet near the entrance to the park is not an accessible portable toilet and is not on an accessible route of travel.</p> <p>See Photo Plummer 4.</p>	<p>308.2</p> <p>308.3</p> <p>604.7</p> <p>309.4</p> <p>604.4</p> <p>604.</p>	<p>30.12</p> <p>30.7.6</p> <p>30.8.5</p> <p>30.7.2</p> <p>26.9</p>	<p>Replace the existing portable toilet with an "ADA Compliant" toilet such that soap/towel dispensers are no more than 42" a.f.f.; the toilet paper dispenser s/b a minimum of 24" a.f.f. and s/b 7" min. to 9" max. in front of the water closet measured to the centerline of the dispenser; the height of the water closet s/b 17" to 19" a.f.f. to the top of the seat; the water closet s/b 18" from the nearest sidewall, at least 42" from the farthest sidewall, and 42" from the front of the water closet to the nearest wall or fixture; and a door closing speed that is at least 6 seconds. The accessible portable toilet must be placed on a level surface (less than 2.0% slope) and on an accessible route of travel.</p>	3	2	I	TBD

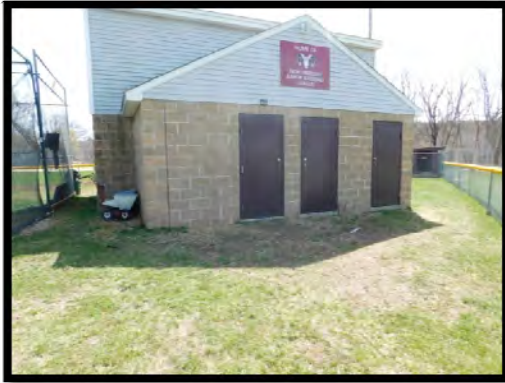
Photo Rockdale 1

General Description or Obstacle Which Limits Mobility or Access: There lacks an accessible route of travel to the swings, concession stand, ballfields, bleachers, batting cages, and portable accessible toilet. There is reduced clear width at the entrance (s) into the facility. The dugouts next to the concession stand have 4” abrupt changes in level surface to access, reduced clear width to one dugout and chain link gates which are not smooth at the base. The concession stand has a 3” abrupt change in level surface to enter and 4” to 8” abrupt changes in level surface to access the outside service counters. The 2 counters are also 7” to 9” too high. The “accessible” portable toilet is not ADA compliant. There is no designated accessible parking in the adjacent paved parking.

<p><u>Portable Accessible Toilet</u></p> <p>The portable "accessible" toilet is not ADA compliant as the soap dispenser is 10" too high and located over the grab bars; the toilet paper dispenser is too close to the front of the toilet and is located over the grab bars; the toilet is 2" too high, 2" too close to the near wall, and 10" too close to the door in front of the toilet; and the door closing speed is too fast.</p>	308.2 308.3 604.7 309.4 604.4 604 404.2.8	30.12 30.7.6 30.8.5 30.7.2 26.9	Replace the existing portable "accessible" toilet with an ADA Compliant toilet such that soap/towel dispensers are no more than 42" a.f.f.; the toilet paper dispenser s/b a minimum of 24" a.f.f. and s/b 7" min. to 9" max. in front of the water closet measured to the centerline of the dispenser; the height of the water closet s/b 17" to 19" a.f.f. to the top of the seat; the water closet s/b 18" from the nearest sidewall, at least 42" from the farthest sidewall, and 42" from the front of the water closet to the nearest wall or fixture; and a door closing speed that is at least 6 seconds. The accessible portable toilet must be placed on a level surface (less than 2.0% slope in any direction) and on an accessible route of travel.	3	2	I	TBD

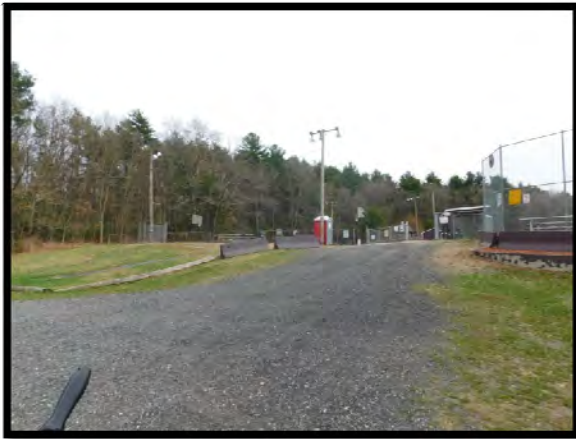
Photo Linwood 1

General Description or Obstacle Which Limits Mobility or Access: There is no accessible route of travel to the recreational facility or to the swings, concession stand, ballfields, basketball courts, bleachers, bench, and accessible toilet. There is no designated accessible parking. The interior of the concession stand is only accessible by a set of stairs, which lack railings. The concession stand counter is 19½” too high. The portable toilet is not accessible.

<p>Portable Toilet</p> <p>The portable toilet near the entrance to the park is not an accessible portable toilet and is not on an accessible route of travel.</p>	308.2 308.3 604.7 309.4 604.4 604.	30.12 30.7.6 30.8.5 30.7.2 26.9	Replace the existing portable toilet with an "ADA Compliant" toilet such that soap/towel dispensers are no more than 42" a.f.f.; the toilet paper dispenser s/b a minimum of 24" a.f.f. and s/b 7" min. to 9" max. in front of the water closet measured to the centerline of the dispenser; the height of the water closet s/b 17" to 19" a.f.f. to the top of the seat; the water closet s/b 18" from the nearest sidewall, at least 42" from the farthest sidewall, and 42" from the front of the water closet to the nearest wall or fixture; and a door closing speed that is at least 6 seconds. The accessible portable toilet must be placed on a level surface (less than 2.0% slope) and on an accessible route of travel.	3	2	N	TBD

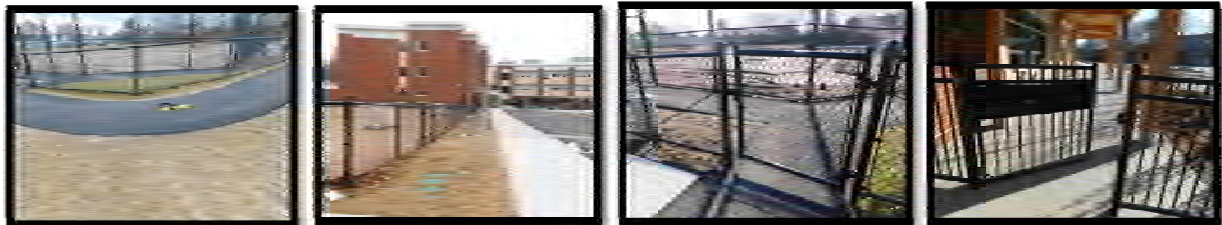
The asphalt walkway behind the front baseball field (home plate area) has a segment of roughly 3 to 5 feet with a running slope of up to 5.7%. The walkway at the side playground and basketball court has 2 locations where the walkway crosses a travel lane resulting in abrupt changes in level surface (granite curbing) of ½" to 2". Some of the practice fields at the side and rear of the school do not have an accessible route from the adjacent walkway to the field. Access gates into playing fields and the playgrounds are not smooth on the push side of the gates.

The detailed accessibility assessments are included in the transition plan for the Northbridge Elementary School. Representative photos are provided below.

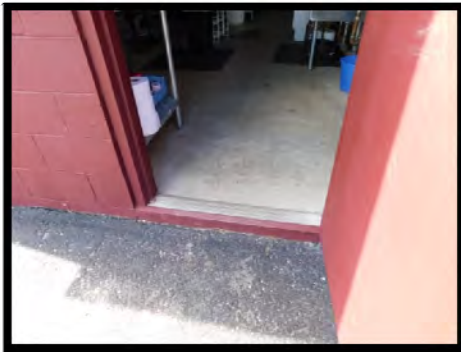
Photo Lasell 1

<p><u>Portable Toilet</u> Neither of the 2 portable toilets are accessible.</p>	308.2 308.3 604.7 309.4 604.4 604.	30.12 30.7.6 30.8.5 30.7.2 26.9	<p>Replace one of the existing portable toilets with an "ADA Compliant" toilet such that soap/towel dispensers are no more than 42" a.f.f.; the toilet paper dispenser s/b a minimum of 24" a.f.f. and s/b 7" min. to 9" max. in front of the water closet measured to the centerline of the dispenser; the height of the water closet s/b 17" to 19" a.f.f. to the top of the seat; the water closet s/b 18" from the nearest sidewall, at least 42" from the farthest sidewall, and 42" from the front of the water closet to the nearest wall or fixture; and a door closing speed that is at least 6 seconds. The accessible portable toilet must be placed on a level surface (less than 2.0% slope) and on an accessible route of travel.</p>	3	2	N	TBD
<p><u>Concession Stand Counters</u> The counters are 14" to 14½" too high.</p> <p style="color: red;">See Photo Lasell 5.</p>	904.5	17.6.2	<p>Create a 36" wide counter no higher than 34" a.f.f. below one of the existing counters.</p>	2	2	N	Up to \$175

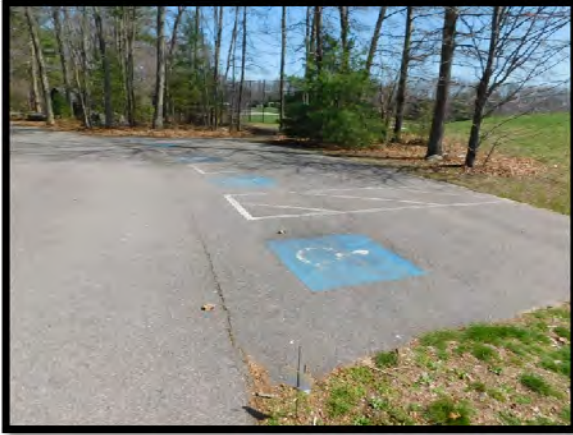
Photo HS Fields 1

General Description or Obstacle Which Limits Mobility or Access: There is no accessible route of travel fully around the soccer fields and baseball field and to player benches and bleacher seating. The designated accessible parking lacks signage and lacks van designated spaces. The portable “accessible” toilet is not on an accessible route of travel and is not ADA compliant. The stairs to the facility are not uniform and lack railings. Although the chain link gate at the entrance lacks a smooth surface at the base, it is not on an accessible route of travel so no further action is required.

<p>provided at the van accessible space. Slopes for the parking and access aisles should not exceed 2.0% in any direction.</p> <p>As the number of accessible spaces provided far exceeds that required, it is recommended that the 2 non-compliant spaces (excessive running slopes) at the soccer fields be taken out of service as formally designated accessible spaces but be reserved for elderly or persons with other mobility issues.</p>				
<p>Stairs The stairs to the athletic fields are not uniform and lack railings.</p> <p>See HS Fields 3 and 4.</p>	504 505	27	As feasible, modify the stairs so that they are uniform in width and height (at least 11" wide and 4" to 7" high) and provide compliant railings (34" – 38" a.f.f. on both sides with top and bottom extensions).	1	3	L	TBD
<p>Accessible Route of Travel There is no accessible route of travel fully around the soccer fields and baseball field and to player benches and bleacher seating. There is no level wheelchair area at the bleachers.</p> <p>See HS Fields 5 and 6.</p>	403	22	<p>An accessible route of travel needs to be provided to all areas available to the public. Construct an accessible route of travel fully to and around the playing fields, bleachers, and player benches.</p> <p>The accessible route of travel must be compliant with width (48" per 521 CMR) and slope (2% max. cross, 5% max. running) requirements as well as changes in level surface (no > than ¼" unbeveled or between ¼" and ½" beveled w/a slope of no > 1:2). Create an approach and wheelchair level area at the bleachers. The space should be 36" wide x 60" deep per wheelchair. If a front/rear approach, the depth can be reduced to 48" as opposed to 60" for a side approach. Construction options include compacted stone dust, asphalt or similar surfaces that meet the requirement of stable, firm, and slip resistant. Costs will vary depending on material used.</p> <p><u>Main Soccer Field Accessible Route of Travel</u> Option #1: Due to the terrain from the parking to the first soccer field with bleacher seating, a switchback ramp with compliant paired railings would be required.</p> <p>Option #2: Create additional designated accessible parking spaces and turn-around at the end of the soccer field.</p>	2	3	N	\$60,000 to \$160K+

<p>Portable Accessible Toilet The portable "accessible" toilet is not ADA compliant as both the soap dispenser and toilet paper dispenser are too high and located over the grab bars; the toilet is ¾" too high, 2" too far from the near wall and 9" too close to the door in front of the toilet; and the door closing speed is too fast. In addition, the portable toilet is not on an accessible route of travel.</p>	308.2 308.3 604.7 309.4 604.4 604 404.2.8	30.12 30.7.6 30.8.5 30.7.2 26.9	Replace the existing portable "accessible" toilet with an ADA Compliant toilet such that soap/towel dispensers are no more than 42" a.f.f.; the toilet paper dispenser s/b a minimum of 24" a.f.f. and s/b 7" min. to 9" max. in front of the water closet measured to the centerline of the dispenser; the height of the water closet s/b 17" to 19" a.f.f. to the top of the seat; the water closet s/b 18" from the nearest sidewall, at least 42" from the farthest sidewall, and 42" from the front of the water closet to the nearest wall or fixture; and a door closing speed that is at least 6 seconds. The accessible portable toilet must be placed on a level surface (less than 2.0% slope in any direction) and on an accessible route of travel.	3	2	I	TBD

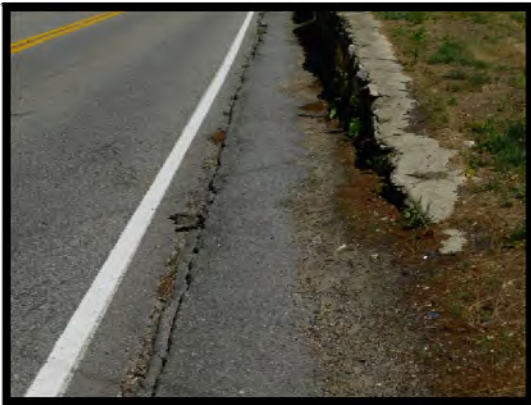
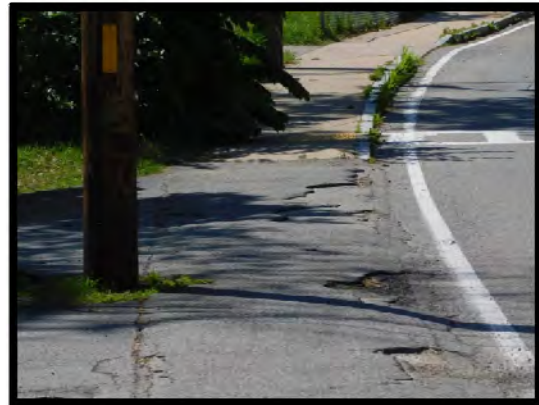
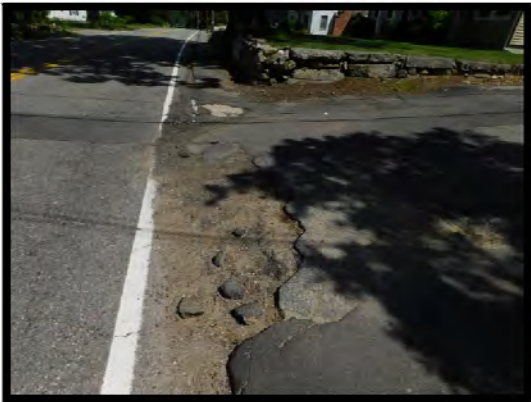
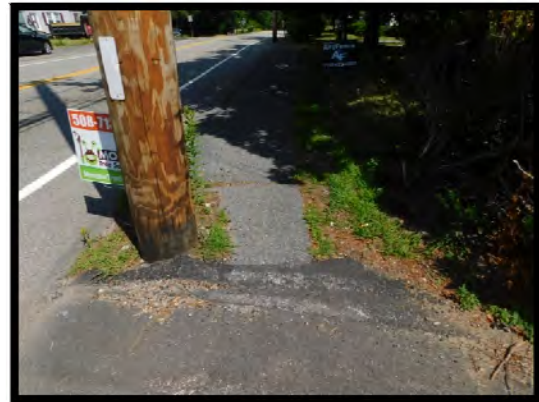
- Sidewalk clear width reduced to 18" to 28" due to debris and deterioration
- Severe deterioration at #246/#256 driveway
- #246 portion of driveway up to 6.0% cross slopes
- #256 portion of driveway up to 2" abrupt changes in level surface and up to 4.0% cross slopes
- A telephone pole at Sullivan Drive restricts the sidewalk clear width to only 20"

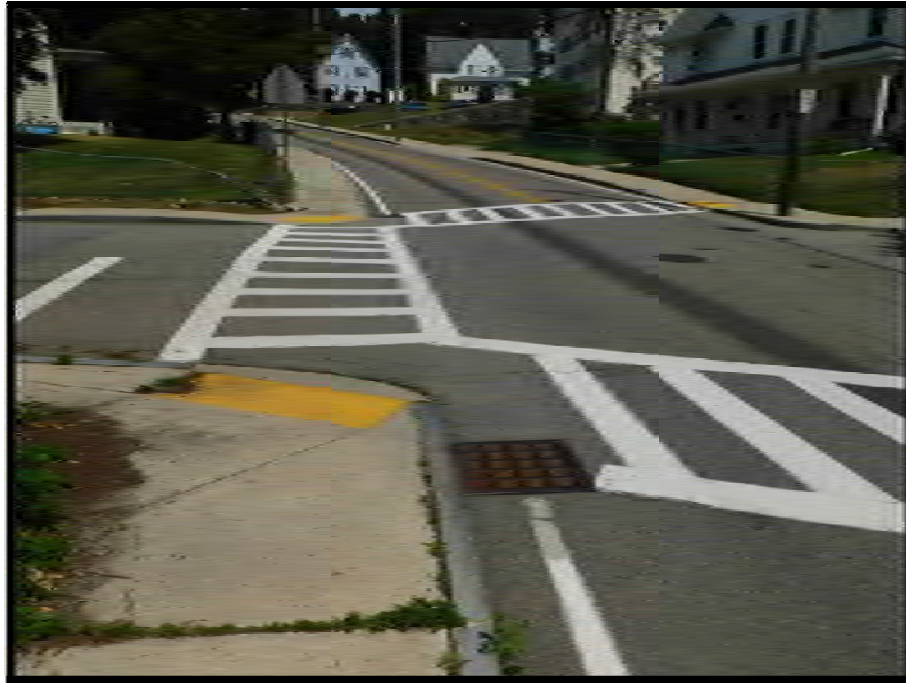
- The crosswalk at Crescent Street and North Main Street has 2 catch basins within the painted crosswalk area with grate openings of 3½" x 4½", which exceeds that allowed within an accessible route of travel

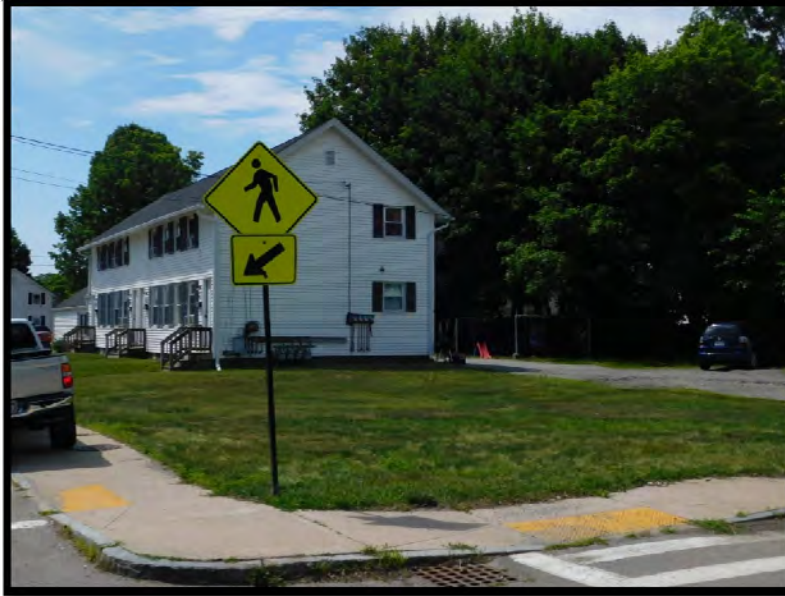
- Crossing signage at B Street is a protruding object at 74" a.f.f. with an 11" protrusion into the accessible route of travel
- Crossing signage at A Street (2 signs) are protruding objects at 70" and 72" a.f.f. with 9" protrusions into the accessible route of travel

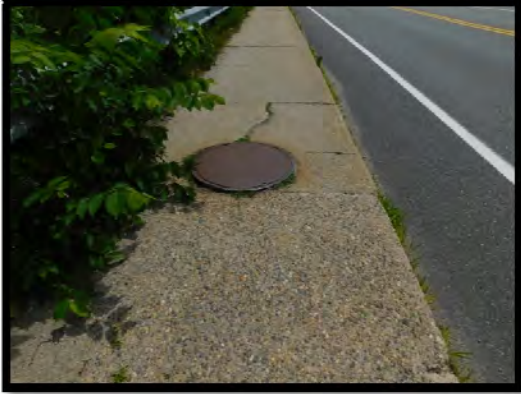
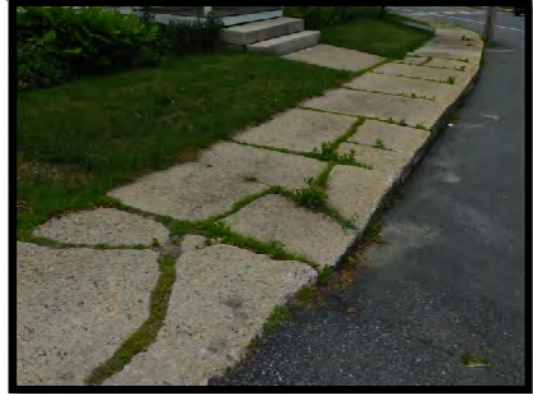
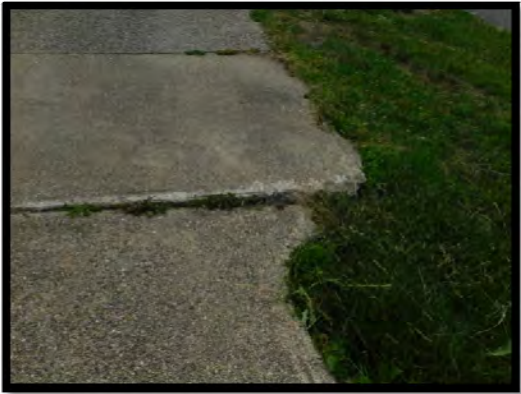
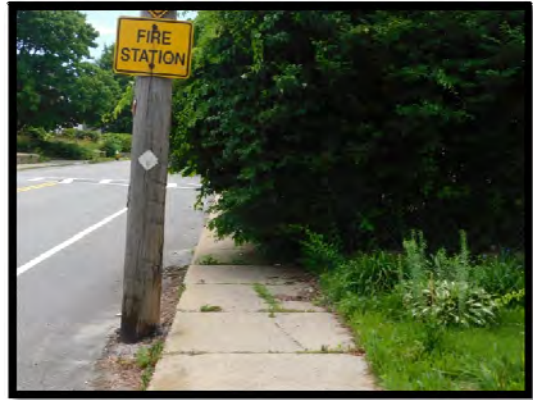
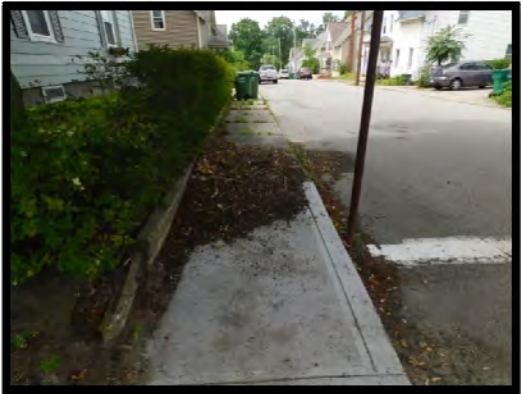
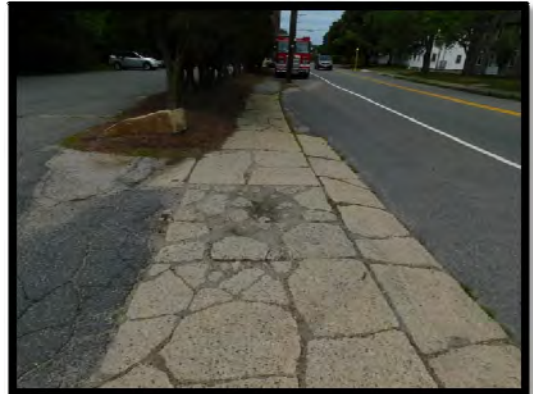
- Severe sidewalk deterioration, heaving, and/or abrupt changes in level surface at the sidewalk across from CoreMark, manhole cover in sidewalk opposite CoreMark (up to 1" change in level surface), sidewalk at #254/#252, sidewalk at #253/#254, sidewalk at the Fire Station (especially in the driveway area), sidewalk at Core Concepts parking, sidewalk at EAW and Access
- Sidewalk clear width at #253/#255 reduced to only 30" due to sidewalk deterioration
- Driveway cross slope at #203 varies from 3.4% to 4.0%
- Severe vegetative over growth at #231/#233 protrudes into the accessible route of travel
- Accumulation of debris on the Oak Street sidewalk eliminates the accessible route of travel in entirety
- Various debris on the sidewalk adjacent to Core Concepts creates an unstable surface

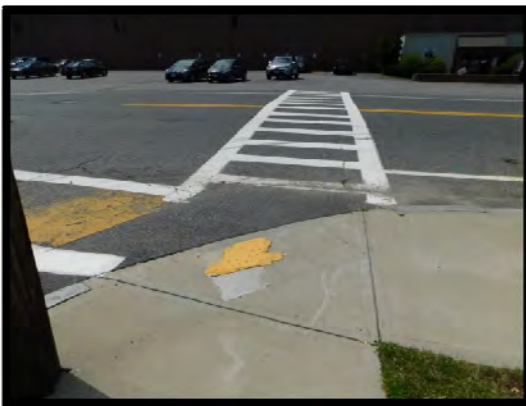
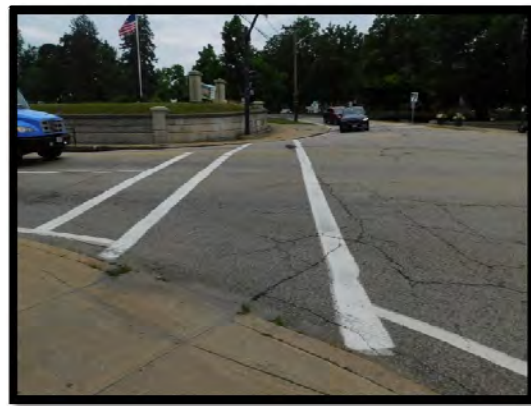
- Crosswalk at North Main and Main (4) across Main Street
- Crosswalk across Main at Arcade Street (warning strip partially missing on Arcade side, lacking on Unified2 side, and lacking on the east side)
- Crosswalk across West Street (both sides)
- Crosswalk at Forest Street across Main Street (no warning strip on the Polyfoam side)
- Crosswalk at Omni and the Community Center (none either side)
- Crosswalk at WRT Mgt and the Community Center (none either side)
- Crosswalk at Douglas and Main across Main (both sides)
- Crosswalk at Douglas and Main across Douglas (both sides)
- Crosswalk at Hill and Main across Main (both sides)
- Crosswalk at Hill and Main across Hill (both sides)
- Crosswalk across Church Street to Common (both sides)
- Crosswalk across Linwood Street (both sides)

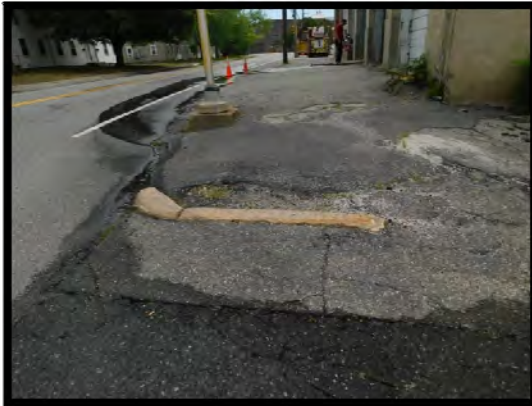
- Maple Street curb ramp (new) up to 1" abrupt change in level surface on #242/#240 side
- Street to Regional Recycling on the Fire Station side up to 3" granite curbing
- Douglas and Main (across Douglas on the library side) up to 1" abrupt change in level surface
- Douglas and Main (across Main on the library side) up to 1" abrupt change in level surface
- Crossing at Omni and the Community Center empties into up to 5" granite curbing on the Community Center side
- Crossing at WRT Mgt and the Community Center empties into up to 1" granite curbing on the Community Center side
- There is no curb ramp on the Fire Station side of the crossing at the Fire Station and Regional Recycling

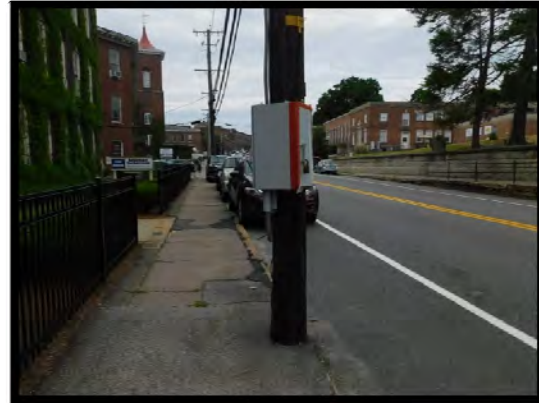
- The control box on Pole #4 at EAW and Access protrudes 8" into the accessible route of travel at a height of 51½" a.f.f.

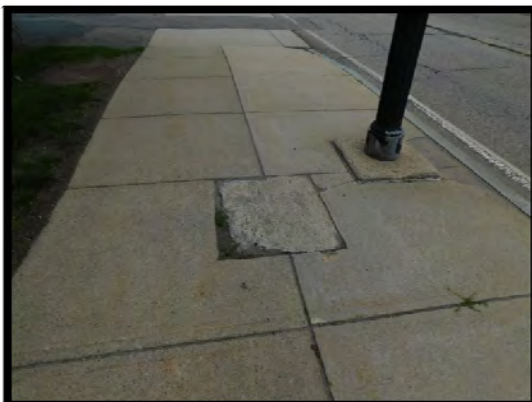
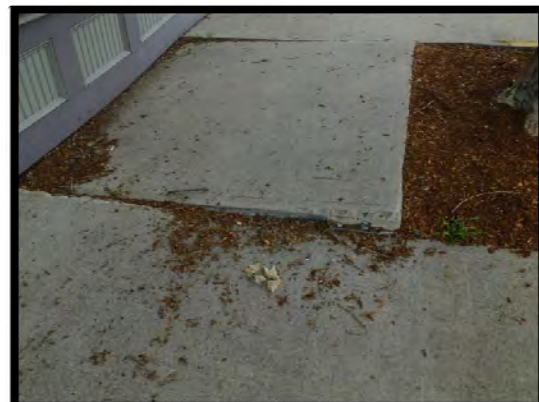
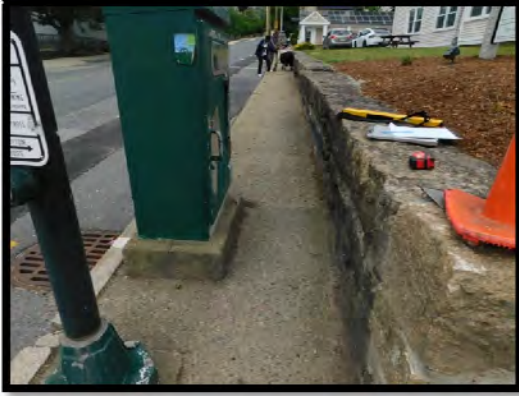
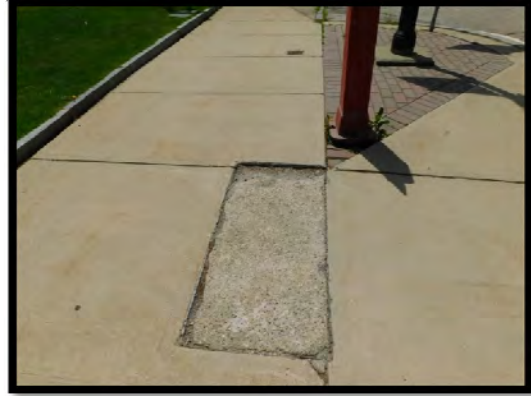
- There are abrupt changes in level surface at the Unibank driveway including up to a 1" pavement drop
- There is a 1½" abrupt change in level surface due to lifting of the concrete pad at #83 Church Street
- Deterioration of the driveway at #95 Church Street creates an up to 1" abrupt change in level surface
- Concrete pad heaving at #214 results in up to a 1" abrupt change in level surface
- Concrete deterioration at the Post Office results in roughly 6" x 20" missing concrete at depth of 1"
- The electric control box on Prospect Street restricts the clear width to only 27" between the box and the Family Dentistry stone wall

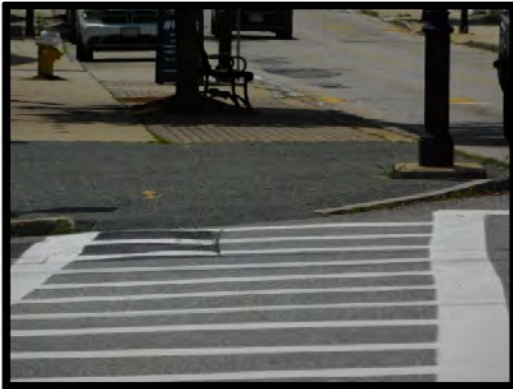
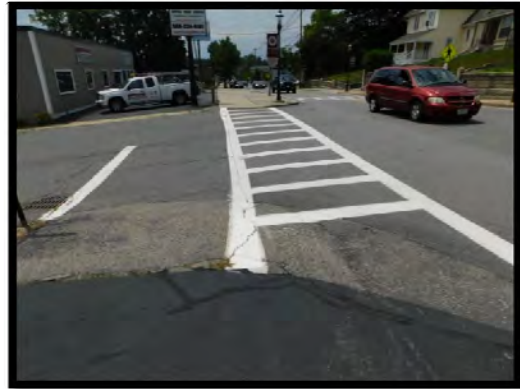
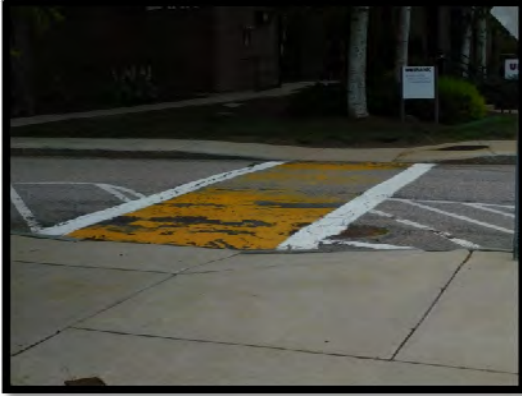
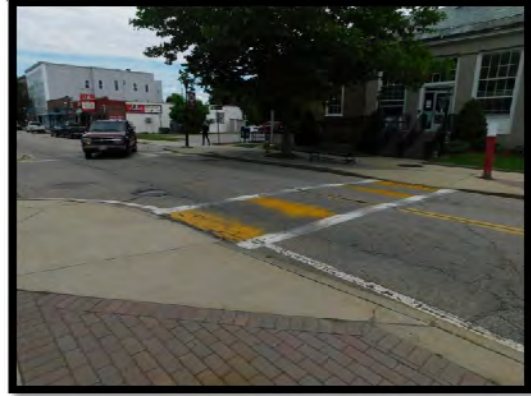
Lack of Detectable Warning Strips

Overall, the sidewalks are in very good condition with some limited concrete pad heaving. Curb ramps lack detectable warning strips, lack level landings, and have abrupt changes in level surface. Signage and telephone pole guy wires serve as protruding objects.

- Across Church Street at Library/Common (both sides)
- Across Church and Park Street (2 – both sides)
- Across Park Street (both sides)
- Across Church Street #95 to #98A (both sides)
- Across Church Street at Cross Street and Fisher Auto (odd side)
- Across Prospect Street (at #125 side)
- Across Church at Crystal Gas and Valley Gas (both sides)
- Across Church at #229 and Superior Roofing (both sides)
- Across Johnston Avenue on the odd side of the street (both sides)
- Across Church at Johnston Avenue (even side)
- Across Johnston Avenue on the even side of the street (both sides)
- Across Cross Street (Fisher Auto side)

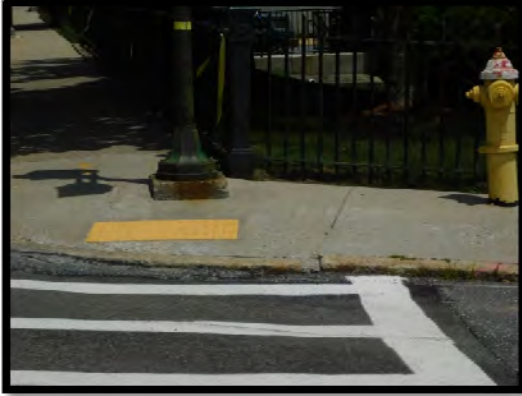
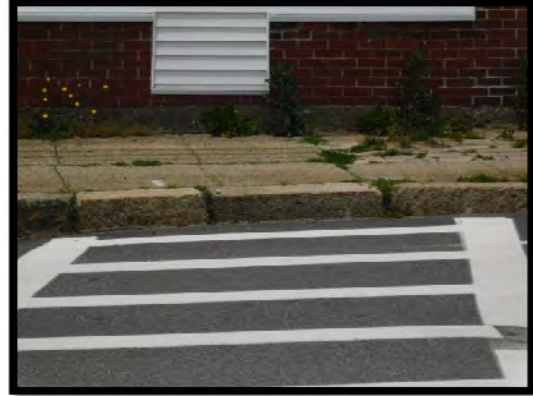
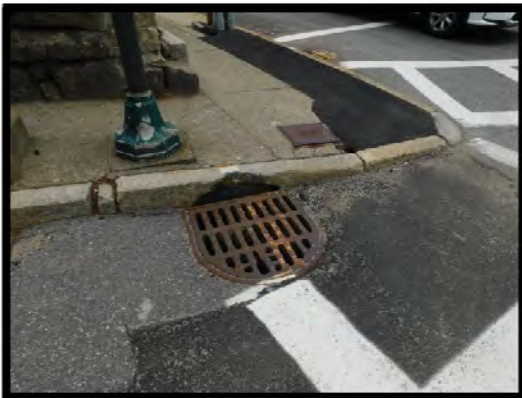
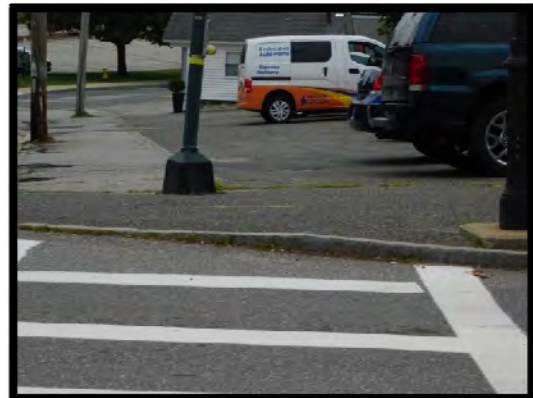
- The crossing across Johnston Avenue on #230 side terminates in 1" to 4" of granite curbing
- The crossing across Church Street at Johnston Avenue on the #237-#239 side terminates in up to 7" of granite curbing

- The crossing across Cross Street on the brick church side terminates in 1" to 2" of granite curbing

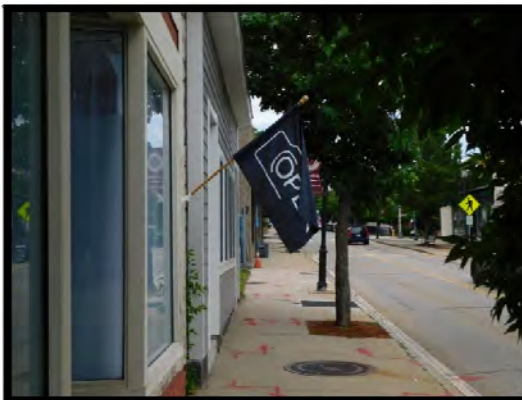
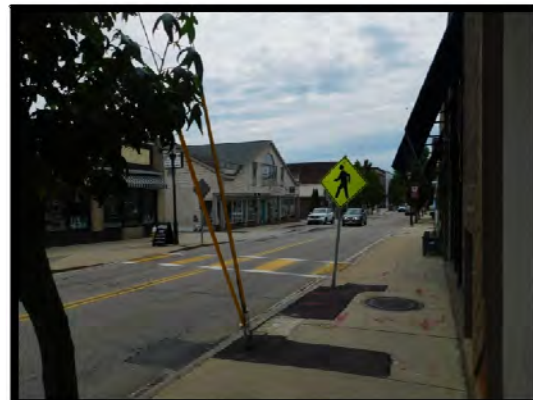
- The #105 “open” sign protrudes into the accessible route of travel with a 4” protrusion at a height of 73” a.f.f. and a 12” protrusion at a height of 80” a.f.f.
- The crossing sign near #117 Church Street has a 4” protrusion at a height of 66” a.f.f. and a 20” protrusion at a height of 80” a.f.f.
- The telephone guy wire (Pole #13) at #117 is a protruding object
- The crossing sign at Park Street has an up to 18” protrusion at a height of up to 80” a.f.f.
- The flag at Valley café and Bakery has a 4” protrusion at a height of 73” a.f.f. and a 14” protrusion at a height of 80” a.f.f. *Note: There were other sign holders on Church Street but flags were not on display to determine level of compliance*

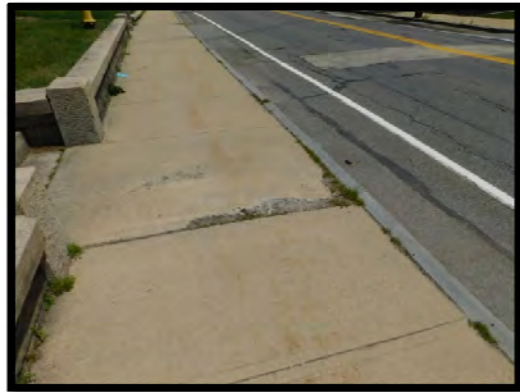
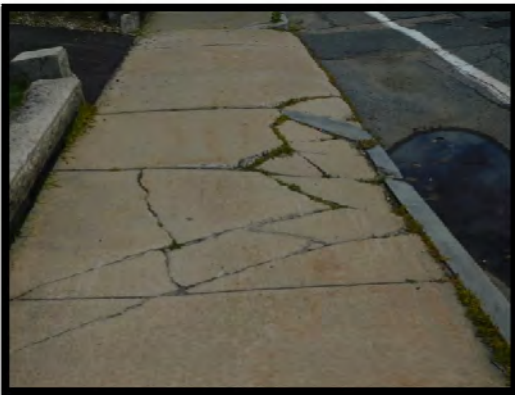
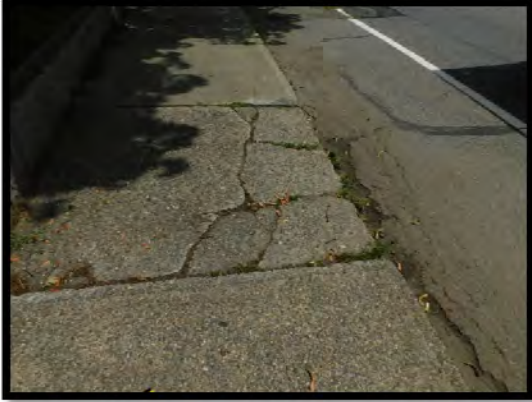
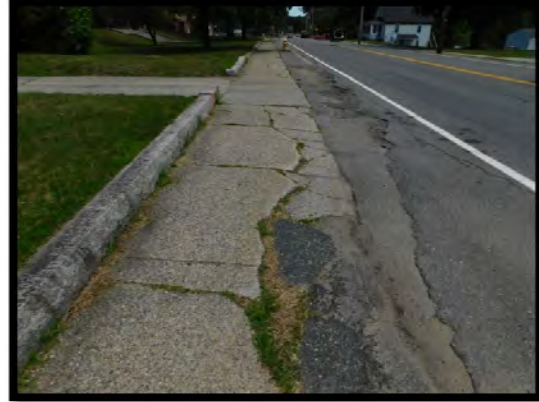
- Severe sidewalk deterioration, cracking, heaving, and/or abrupt changes in level surface occur at #49, near driveway at Methodist Church, near #121, near #135/#137, near #172 especially near the driveway, near # 158, near #144, near #134, near #128, #110, and near Crothers Tire Company
- Excessive driveway cross slopes of 3.0% to 5.0% occur at #121 and #145
- Recycling and Trash Bins placed in the sidewalk reduce the clear width to less than 36”

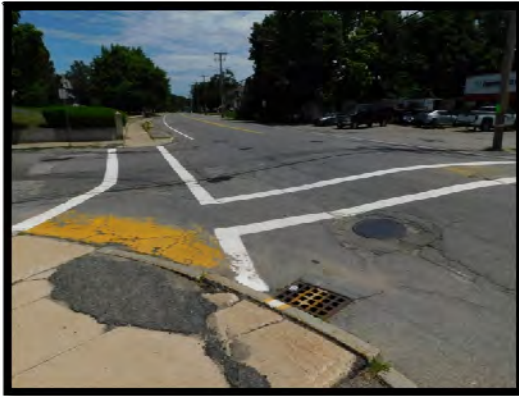
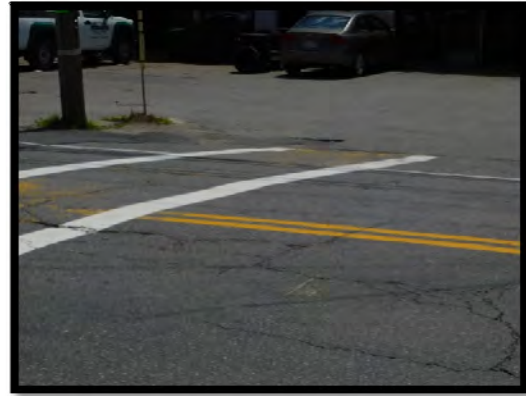
Lack of Detectable Warning Strips

- Curb ramps at #30/#32 and Episcopal Church (both sides)
- Linwood and Cross across Linwood (2 – both sides)
- Linwood and Cross across Cross (2 – both sides)

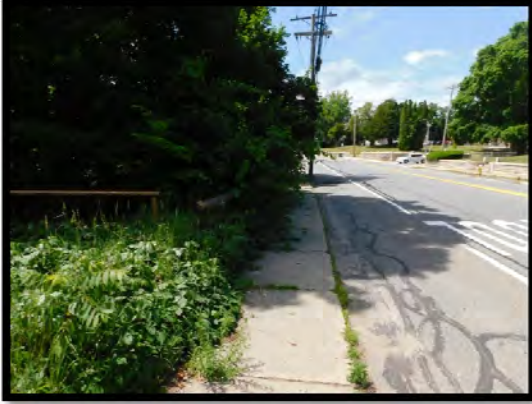
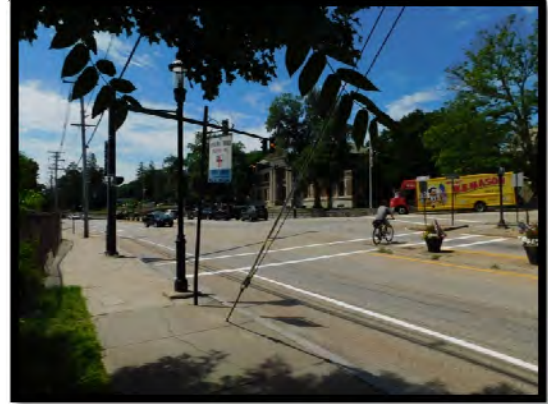
- Vegetative overgrowth past #128 to Crothers Tire Company clear width reduced to less than 36"
- The telephone guy wire near Church and Linwood (even side of street) is a protruding object

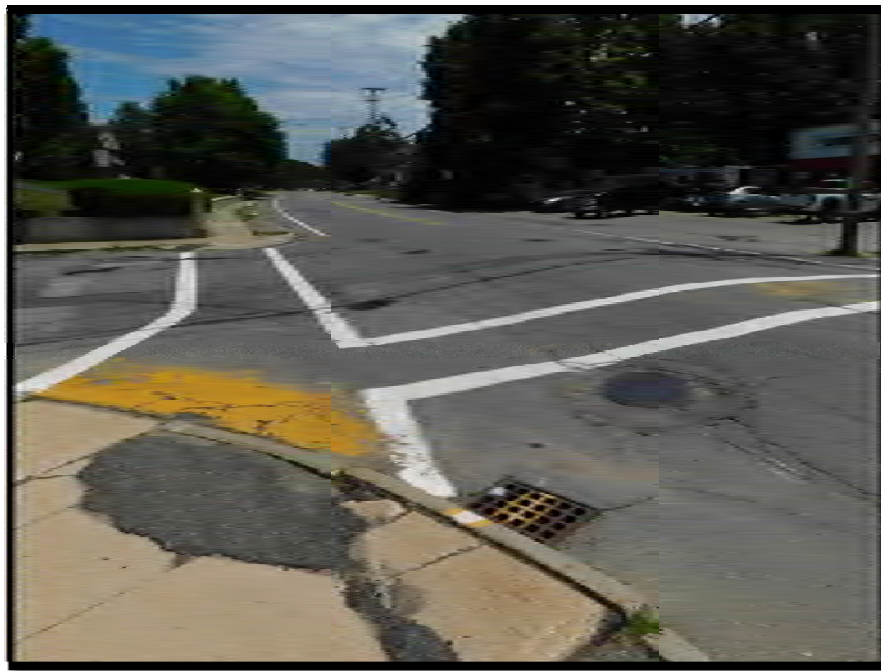
- An “apex” crossing at Cross and Linwood empties into the street on the Cross Street side
