THE SECRETARY
OF THE INTERIOR'S
**STANDARDS FOR
THE TREATMENT
OF HISTORIC
PROPERTIES**

WITH
**GUIDELINES FOR
PRESERVING,
REHABILITATING,
RESTORING &
RECONSTRUCTING
HISTORIC
BUILDINGS**

U.S. Department of the Interior
National Park Service
Technical Preservation Services

2017

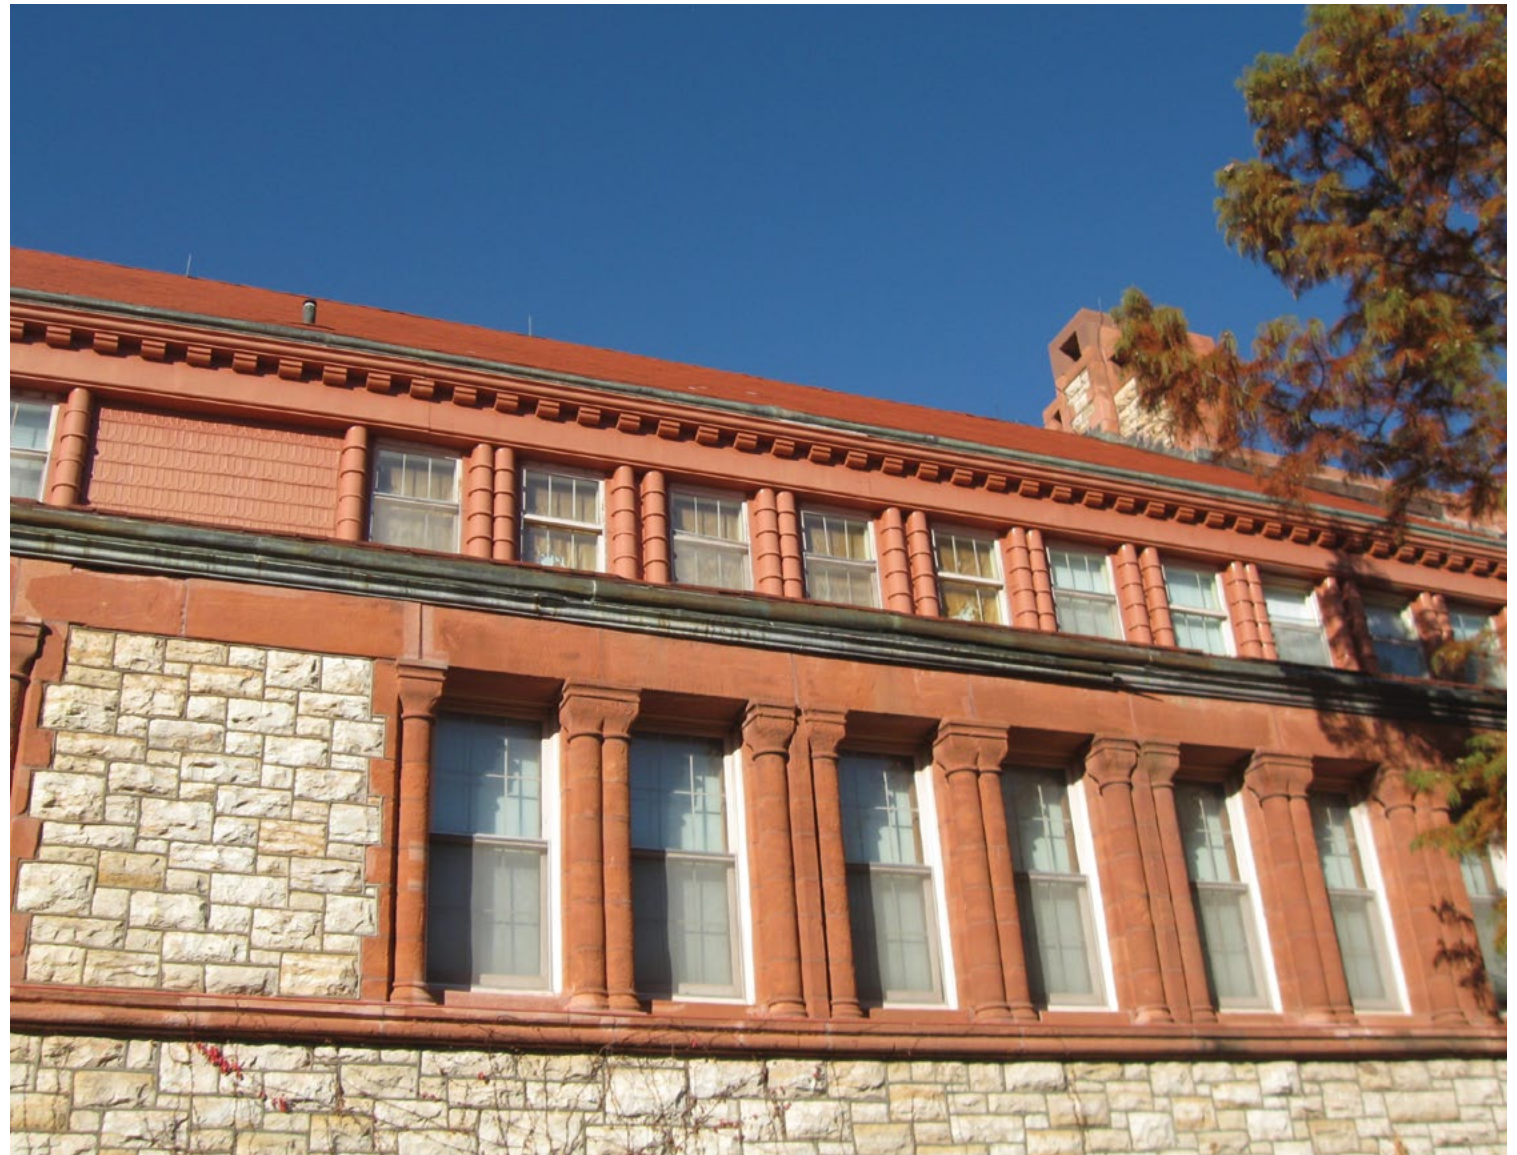
[6] Preliminary work before starting restoration revealed that the columns and the decorative shingles ornamenting the top floor of this historic building were fabricated of metal to imitate the red sandstone used elsewhere on the building.
