# Task I – Exterior Building Conditions Assessment

## Northbridge Memorial Town Hall Northbridge, Massachusetts

February 15, 2012

## TASK I – EXTERIOR BUILDING CONDITIONS ASSESSMENT

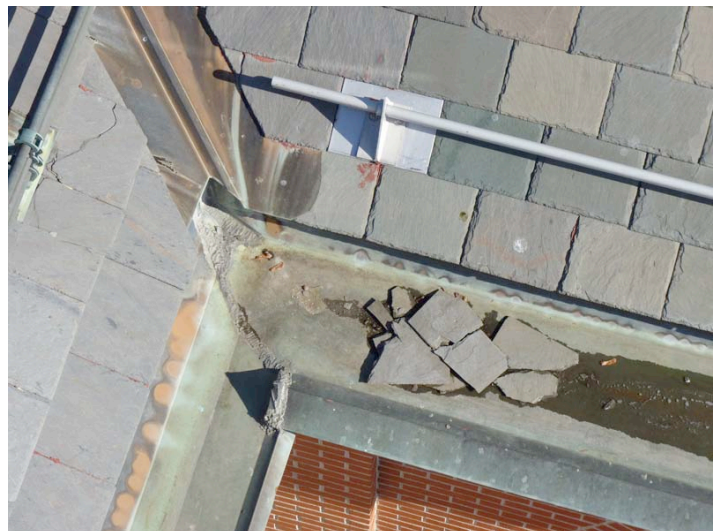
*Photo 3*

The slate on the gabled main roof (Photo 2), completely replaced in the year 2000, and the hipped roof of the stair tower are both in good condition and require simple maintenance-related repairs. Approximately a dozen slates are broken (Photo 3) or missing from both roofs. The annual loss of a small number of roof slates is typical and should be part of a scheduled maintenance plan. Slates typically break due to foot traffic during installation or roof repairs, failure of the slates themselves and over nailing. Two pipes on separate snow guards have slid sideward and should be fixed during routine roof maintenance.

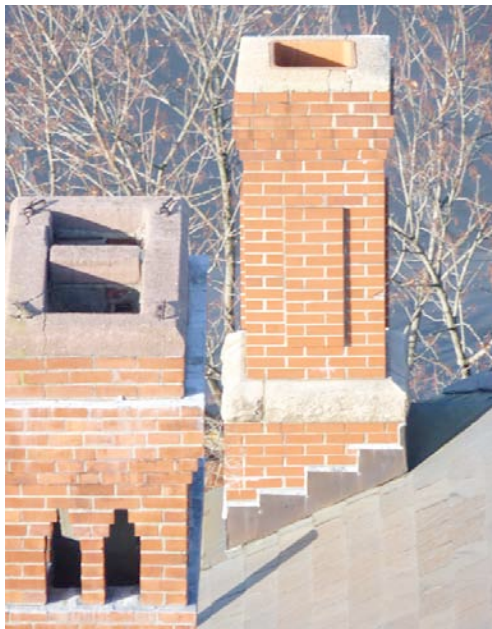
*Photo 5*

Generally the red copper ridge, valley and chimney flashing are in good condition. The copper ridge flashing at the stair tower roof has loose hold down clips that prevent the ridge flashing from wind damage and should be soldered to ridge. The sealant is failing at joints between the chimney and flashing (Photo 5) and needs to be replaced. The lead chimney flashing at the upper-corbelled ledges (Photo 6) is in need of replacement in the next two years.

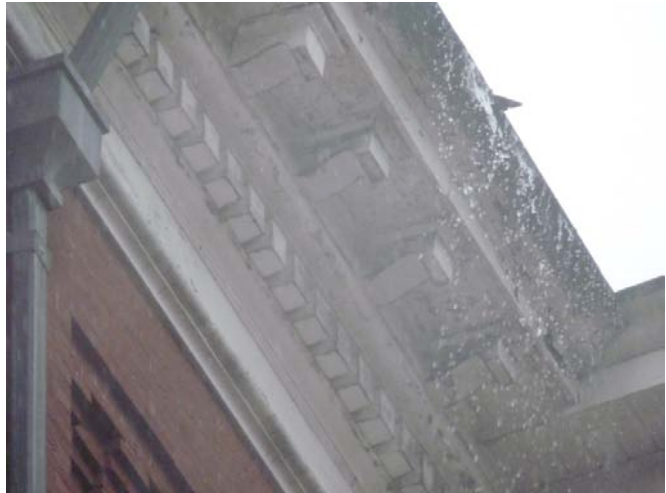
*Photo 8*

The gutters and downspouts at the main roof are in good condition. The membrane lined gutters and outlets at the two portico roofs are clogged with leaf debris (Photo 7) and should be cleaned immediately. The below grade drainpipes connected to the downspouts are clogged and should have all debris removed and the pipes inspected by video camera to assess the condition of the below grade system. During a rainstorm, it was observed that the gutters were overflowing (Photo 8) at four locations at the main roof. The roof inspection revealed the gutter outlets were not clogged and there was no standing water in the gutters. Due to the clogged underground pipes (Photo 9) the rainwater is backing up the entire height of the downspouts and overflowing at the gutters outlet. The water cascading off the main and portico roofs due to clogged gutter outlets and underground drainpipes is causing the painted wood cornice and soffit (Photo 10) below to rot.

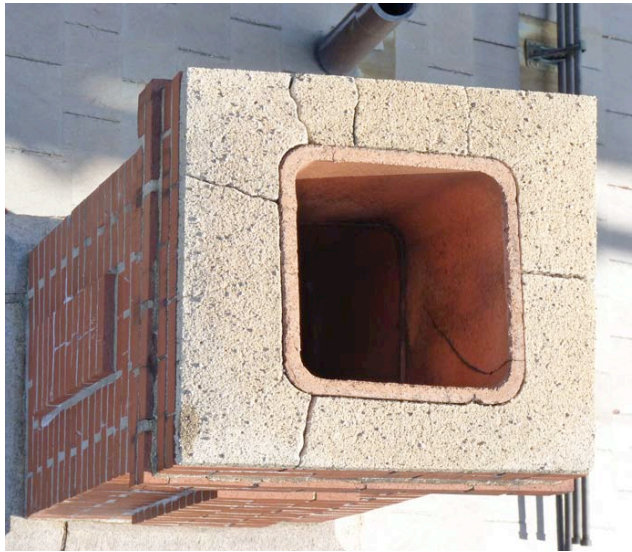
*Photo 11*

The brick masonry is generally in good condition except at selective areas on the façade and the chimney capstones. Two of the cast stone chimney capstones are severely broken (Photo 11), pose a potential safety hazard from falling sections and should be replaced. The southwest chimney has broken mortar (Photo 12) and joints should be cut and repointed. Brick areas with missing mortar at vertical joints below the circular attic windows (Photo 13) require selective cutting and repointing to stop water infiltration. Most brick areas in need of selective cutting and repointing of mortar joints (Photo 14) do not pose an immediate contribution to water infiltration or brick failure.

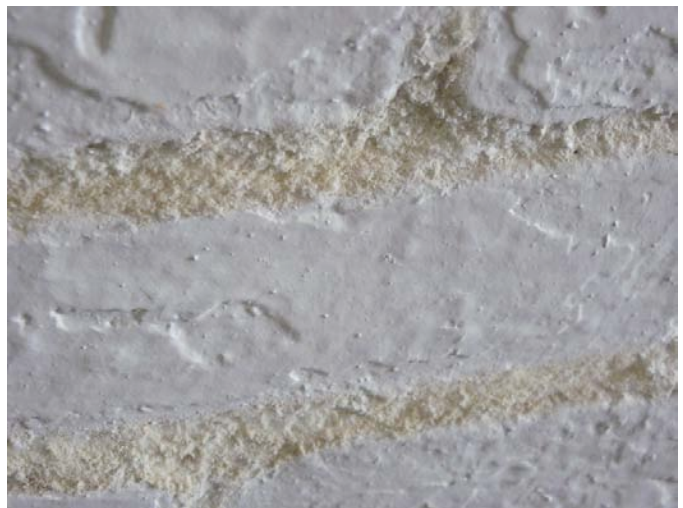
*Photo 17*

The interior granite and brick walls along the western and northwestern foundation are missing mortar to a maximum depth of 1¼" (Photo 16) and need to be repointed. Painted interior brick walls along the eastern foundation are exhibiting efflorescence through the painted mortar joints (Photo 17) indicating moisture migration through the masonry from the exterior. This efflorescence is likely aggravated by roof water saturating the ground from the adjacent portico roof.

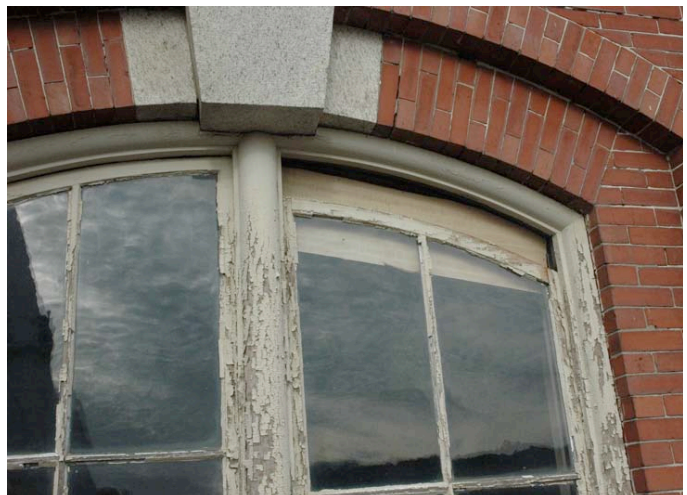
*Photo 21*

At present the broken and missing glass (Photo 18), failed glazing putty and sealants at window perimeters (Photo 19), failed paint (Photo 20) and broken/missing window hardware at the original historic windows are the major cause of water and air infiltration (Photo 21) into the building. The window repair work needs to be completed as the highest priority to prevent further damage to the interior and consequently escalating repair costs and loss of historic fabric. Overall the wood components of the historic windows are in repairable condition, which is the preferred course of action given by *Secretary of the Interior's Standards for the Treatment of Historic Properties*.

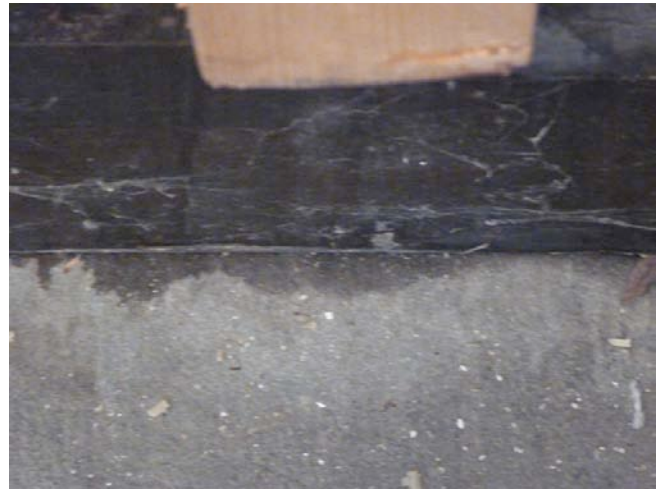
*Photo 23*

The exterior doors, thresholds and hardware are overall in serviceable condition. The blocked (Photo 22) and no longer code-required (due to the construction of exit tower) exit door from the auditorium to the 1947 steel fire escape leaks water at the threshold (Photo 23) and perimeter and minimally needs to be sealed to the weather.

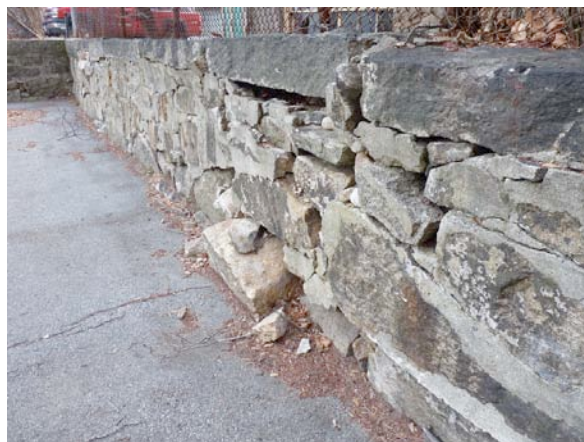
*Photo 29*

The site elements of retaining walls, rails, fences and walkways are in various conditions of maintenance and repair. The approximately 42” high retaining wall at the south and west perimeters (Photo 29) of the parking lot are collapsing and need to be rebuilt. Along the top section of the retaining wall, the steel and cast iron fencing has failed (Photo 30), is missing sections and poses a safety hazard along the south wall for pedestrians and vehicles due to the drop off. New historically appropriate fencing that meets current codes should be installed. The displaced granite stones at the east entrance stair cheek walls (Photo 31) need to be reset. The deteriorated mortar joint below the capstone (Photo 31) at the retaining wall along Douglas Street and the parking lot needs to be repaired to deter water infiltration into the wall below.
