#### **XIV. ACTIVE AND PASSIVE RECREATIONAL FACILITIES ASSESSMENTS**

## **Town Common/Memorial Square Accessibility Assessment**

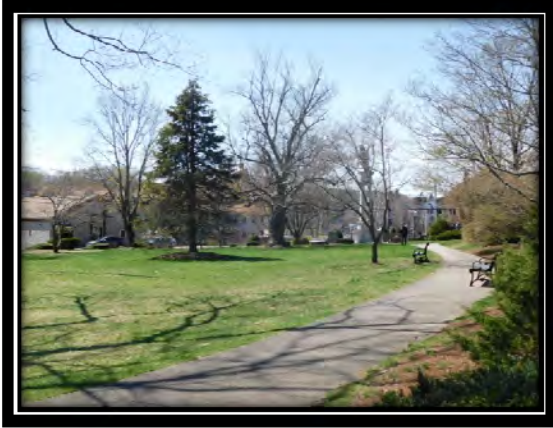
Only one of the dispersed benches is on an accessible route of travel with an accompanying level area for a wheelchair. The Linwood Street interpretive sign lacks a level area and stable surface for a wheelchair to view the sign. There are abrupt changes in level surface on the route of travel to the Civil War Monument. Although the running slopes to access the common exceed 8.3% in all but one of the entry points, the natural topography of the site prevents compliance from occurring, so no further action is required.

See Photos Town Common 1, 2, and 3.		<p>and a 5% maximum running slope.</p> <p>Repair/modify the concrete at the Civil War Monument to eliminate the abrupt changes in level surface and to provide a stable surface.</p> <p>Provide a stone dust accessible route and level area for a wheelchair at the Linwood Street side interpretive signage.</p>				
-------------------------------------	--	--	--	--	--	--

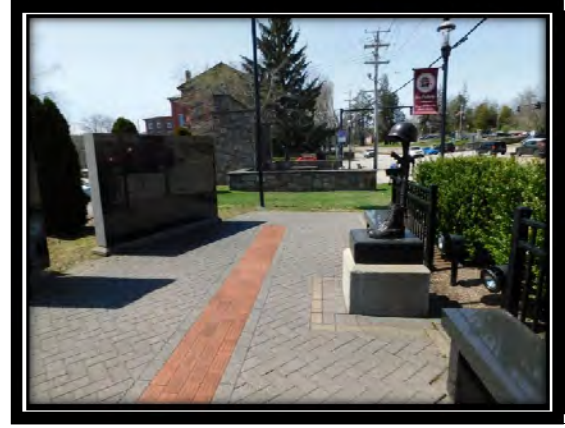
Memorial Square is fully accessible and compliant.

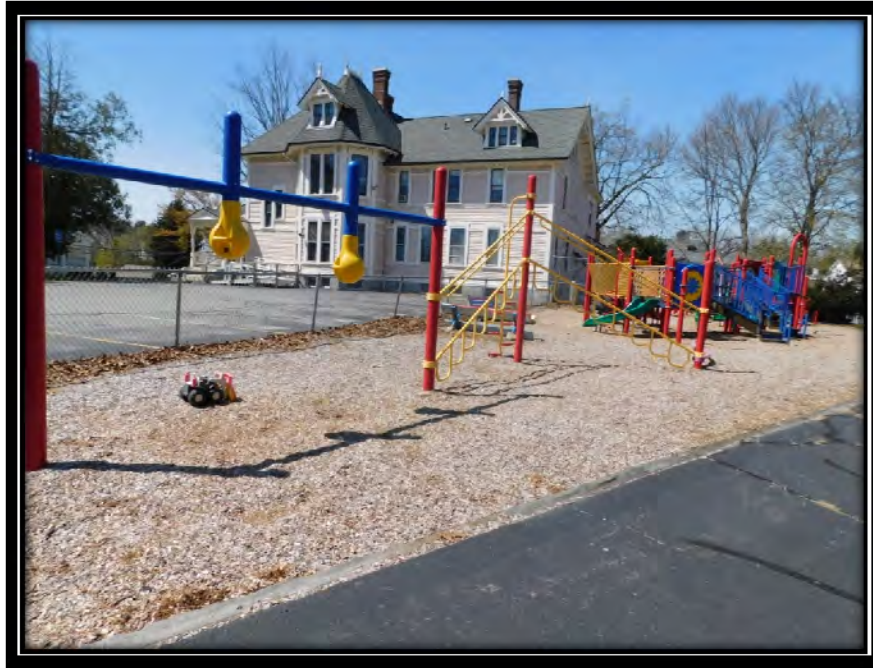
**General Description or Obstacle Which Limits Mobility or Access:** The chain link gate to enter the playground is not smooth at the base. The walkway from the sidewalk to the playground has a running slope of up to 12.0%. There is no accessible route of travel fully around the entirety of the playground (one side only). There is no accessible route of travel to the play equipment, sandbox, and bench. Non-compliant wood chips are the primary surface throughout the playground. There are no accessible play components.

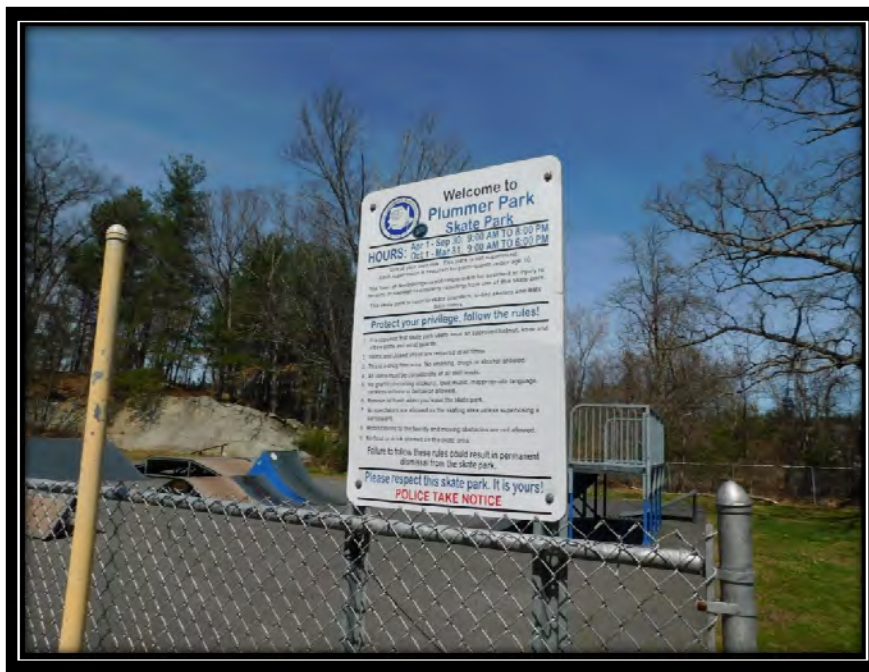
**General Description or Obstacle Which Limits Mobility or Access:** The chain link gate to enter the abandoned ballfield is not smooth at the base. There is no improved accessible route of travel to the skate park, memorial bench and portable toilet. The portable toilet is not accessible.

surface (no > than ¼" unbeveled or between ¼" and ½" beveled w/a slope of no > 1:2). Construction options can include compacted stone dust as long it is compacted to meet the requirement of stable, firm, and slip resistant.				
<b>Portable Toilet</b> The portable toilet near the entrance to the park is not an accessible portable toilet and is not on an accessible route of travel.  See Photo Plummer 4.	308.2 308.3 604.7 309.4 604.4 604.	30.12 30.7.6 30.8.5 30.7.2 26.9	Replace the existing portable toilet with an "ADA Compliant" toilet such that soap/towel dispensers are no more than 42" a.f.f.; the toilet paper dispenser s/b a minimum of 24" a.f.f. and s/b 7" min. to 9" max. in front of the water closet measured to the centerline of the dispenser; the height of the water closet s/b 17" to 19" a.f.f. to the top of the seat; the water closet s/b 18" from the nearest sidewall, at least 42" from the farthest sidewall, and 42" from the front of the water closet to the nearest wall or fixture; and a door closing speed that is at least 6 seconds. The accessible portable toilet must be placed on a level surface (less than 2.0% slope) and on an accessible route of travel.	3	2	I	TBD

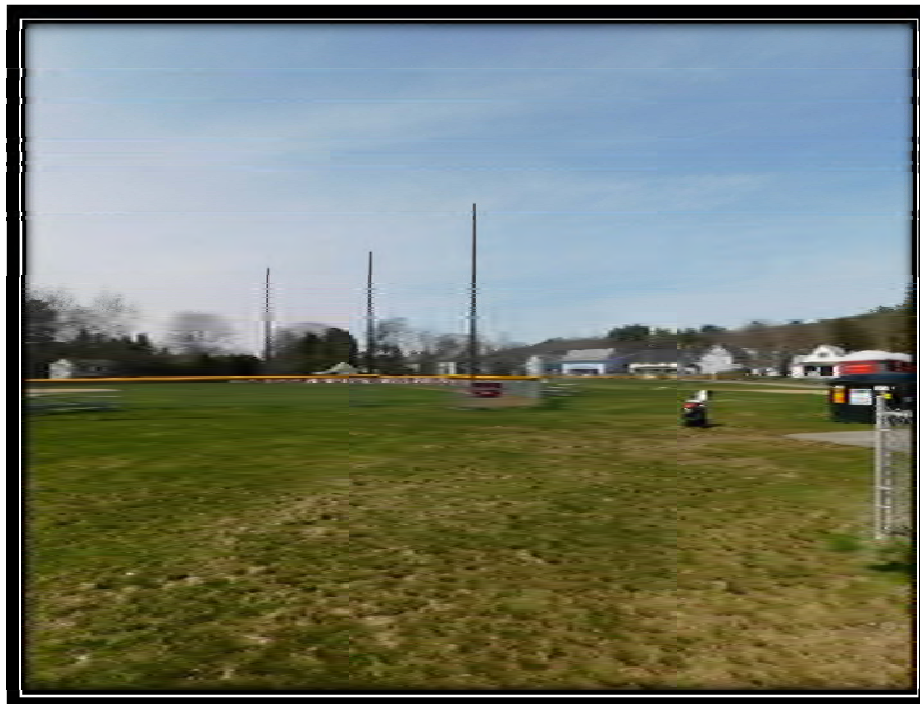
**General Description or Obstacle Which Limits Mobility or Access:** There lacks an accessible route of travel to the swings, concession stand, ballfields, bleachers, batting cages, and portable accessible toilet. There is reduced clear width at the entrance (s) into the facility. The dugouts next to the concession stand have 4” abrupt changes in level surface to access, reduced clear width to one dugout and chain link gates which are not smooth at the base. The concession stand has a 3” abrupt change in level surface to enter and 4” to 8” abrupt changes in level surface to access the outside service counters. The 2 counters are also 7” to 9” too high. The “accessible” portable toilet is not ADA compliant. There is no designated accessible parking in the adjacent paved parking.

<p><b><u>Portable Accessible Toilet</u></b></p> <p>The portable "accessible" toilet is not ADA compliant as the soap dispenser is 10" too high and located over the grab bars; the toilet paper dispenser is too close to the front of the toilet and is located over the grab bars; the toilet is 2" too high, 2" too close to the near wall, and 10" too close to the door in front of the toilet; and the door closing speed is too fast.</p>	308.2 308.3 604.7 309.4 604.4 604 404.2.8	30.12 30.7.6 30.8.5 30.7.2 26.9	Replace the existing portable "accessible" toilet with an ADA Compliant toilet such that soap/towel dispensers are no more than 42" a.f.f.; the toilet paper dispenser s/b a minimum of 24" a.f.f. and s/b 7" min. to 9" max. in front of the water closet measured to the centerline of the dispenser; the height of the water closet s/b 17" to 19" a.f.f. to the top of the seat; the water closet s/b 18" from the nearest sidewall, at least 42" from the farthest sidewall, and 42" from the front of the water closet to the nearest wall or fixture; and a door closing speed that is at least 6 seconds. The accessible portable toilet must be placed on a level surface (less than 2.0% slope in any direction) and on an accessible route of travel.	3	2	I	TBD

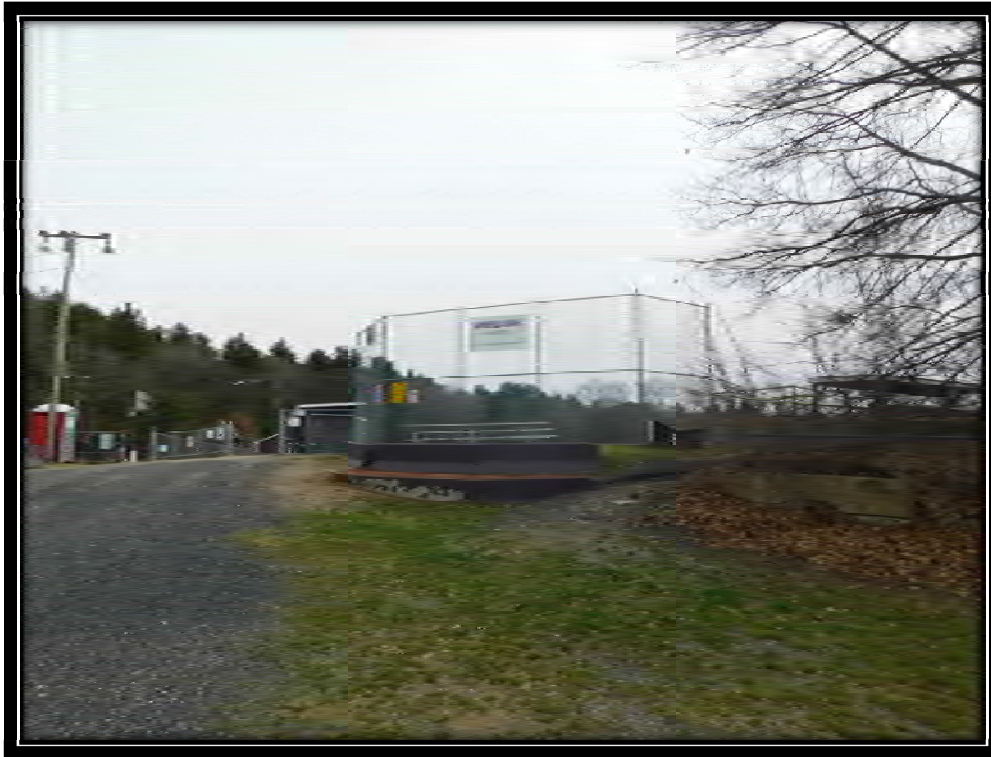
**General Description or Obstacle Which Limits Mobility or Access:** There is no accessible route of travel to the recreational facility or to the swings, concession stand, ballfields, basketball courts, bleachers, bench, and accessible toilet. There is no designated accessible parking. The interior of the concession stand is only accessible by a set of stairs, which lack railings. The concession stand counter is 19½" too high. The portable toilet is not accessible.

<p><b><u>Portable Toilet</u></b></p> <p>The portable toilet near the entrance to the park is not an accessible portable toilet and is not on an accessible route of travel.</p>	308.2 308.3 604.7 309.4 604.4 604.	30.12 30.7.6 30.8.5 30.7.2 26.9	Replace the existing portable toilet with an "ADA Compliant" toilet such that soap/towel dispensers are no more than 42" a.f.f.; the toilet paper dispenser s/b a minimum of 24" a.f.f. and s/b 7" min. to 9" max. in front of the water closet measured to the centerline of the dispenser; the height of the water closet s/b 17" to 19" a.f.f. to the top of the seat; the water closet s/b 18" from the nearest sidewall, at least 42" from the farthest sidewall, and 42" from the front of the water closet to the nearest wall or fixture; and a door closing speed that is at least 6 seconds. The accessible portable toilet must be placed on a level surface (less than 2.0% slope) and on an accessible route of travel.	3	2	N	TBD

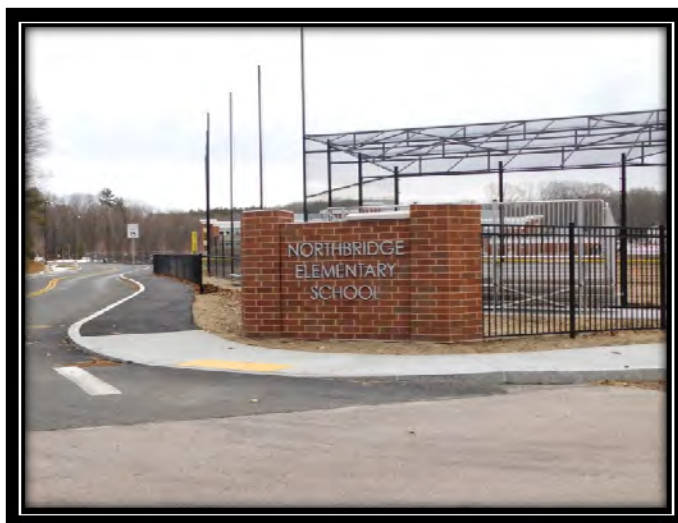
**Function and Description of Facility and Programs:** Playground areas adjacent to the school are fully compliant. The front playing fields were still under construction at the time of assessment.

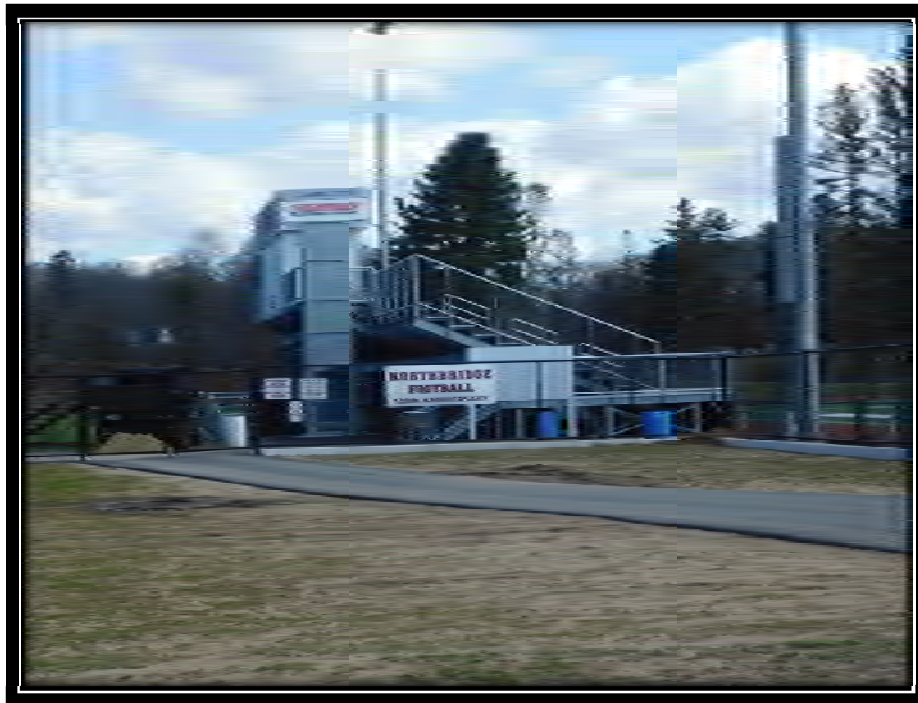
**General Description or Obstacle Which Limits Mobility or Access:** There is no accessible route of travel to the 2 baseball fields, baseball bleachers and dugouts. The baseball bleachers lack a level area for a wheelchair. There is a 3" abrupt change in level surface to access the interior of the concession stand. The concession stand sinks lack knee clearance and a towel dispenser is 13" too high. The concession stand service counters (2) are 14" to 14½" too high. The portable toilets (2) are not accessible and only one is on an accessible route of travel. The chain link gate to the track and multi-purpose field is not smooth at the base. The last 4 feet at the bottom of the ramp to the bleachers has a running slope of 8.5%, which exceeds the maximum allowed of 8.3%. The door into the broadcast booth has a glass pane that exceeds the maximum allowed height by 14".

<p><b><u>Portable Toilet</u></b> Neither of the 2 portable toilets are accessible.</p>	308.2 308.3 604.7 309.4 604.4 604.	30.12 30.7.6 30.8.5 30.7.2 26.9	Replace one of the existing portable toilets with an "ADA Compliant" toilet such that soap/towel dispensers are no more than 42" a.f.f.; the toilet paper dispenser s/b a minimum of 24" a.f.f. and s/b 7" min. to 9" max. in front of the water closet measured to the centerline of the dispenser; the height of the water closet s/b 17" to 19" a.f.f. to the top of the seat; the water closet s/b 18" from the nearest sidewall, at least 42" from the farthest sidewall, and 42" from the front of the water closet to the nearest wall or fixture; and a door closing speed that is at least 6 seconds. The accessible portable toilet must be placed on a level surface (less than 2.0% slope) and on an accessible route of travel.	3	2	N	TBD
<p><b><u>Concession Stand Counters</u></b> The counters are 14" to 14½" too high.</p> <p>See Photo Lasell 5.</p>	904.5	17.6.2	Create a 36" wide counter no higher than 34" a.f.f. below one of the existing counters.	2	2	N	Up to \$175

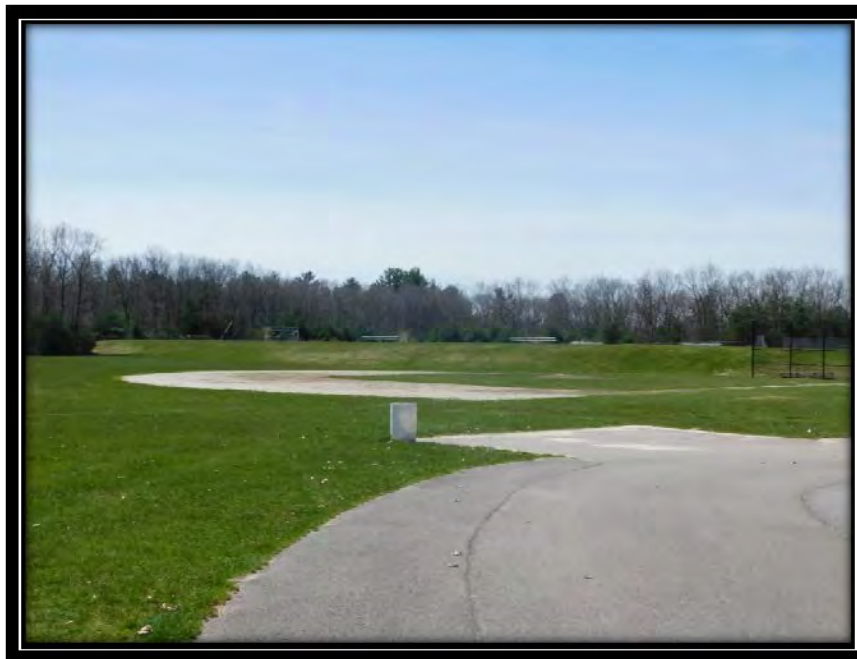
**General Description or Obstacle Which Limits Mobility or Access:** There is no accessible route of travel fully around the soccer fields and baseball field and to player benches and bleacher seating. The designated accessible parking lacks signage and lacks van designated spaces. The portable “accessible” toilet is not on an accessible route of travel and is not ADA compliant. The stairs to the facility are not uniform and lack railings. Although the chain link gate at the entrance lacks a smooth surface at the base, it is not on an accessible route of travel so no further action is required.

<p>provided at the van accessible space. Slopes for the parking and access aisles should not exceed 2.0% in any direction.</p> <p>As the number of accessible spaces provided far exceeds that required, it is recommended that the 2 non-compliant spaces (excessive running slopes) at the soccer fields be taken out of service as formally designated accessible spaces but be reserved for elderly or persons with other mobility issues.</p>				
<p><b>Stairs</b></p> <p>The stairs to the athletic fields are not uniform and lack railings.</p> <p>See HS Fields 3 and 4.</p>	504 505	27	<p>As feasible, modify the stairs so that they are uniform in width and height (at least 11" wide and 4" to 7" high) and provide compliant railings (34" – 38" a.f.f. on both sides with top and bottom extensions).</p>	1	3	L	TBD
<p><b>Accessible Route of Travel</b></p> <p>There is no accessible route of travel fully around the soccer fields and baseball field and to player benches and bleacher seating. There is no level wheelchair area at the bleachers.</p> <p>See HS Fields 5 and 6.</p>	403	22	<p>An accessible route of travel needs to be provided to all areas available to the public. Construct an accessible route of travel fully to and around the playing fields, bleachers, and player benches.</p> <p>The accessible route of travel must be compliant with width (48" per 521 CMR) and slope (2% max. cross, 5% max. running) requirements as well as changes in level surface (no &gt; than ¼" unbeveled or between ¼" and ½" beveled w/a slope of no &gt; 1:2). Create an approach and wheelchair level area at the bleachers. The space should be 36" wide x 60" deep per wheelchair. If a front/rear approach, the depth can be reduced to 48" as opposed to 60" for a side approach. Construction options include compacted stone dust, asphalt or similar surfaces that meet the requirement of stable, firm, and slip resistant. Costs will vary depending on material used.</p> <p><u>Main Soccer Field Accessible Route of Travel</u></p> <p>Option #1: Due to the terrain from the parking to the first soccer field with bleacher seating, a switchback ramp with compliant paired railings would be required.</p> <p>Option #2: Create additional designated accessible parking spaces and turn-around at the end of the soccer field.</p>	2	3	N	\$60,000 to \$160K+

<p><b>Portable Accessible Toilet</b></p> <p>The portable "accessible" toilet is not ADA compliant as both the soap dispenser and toilet paper dispenser are too high and located over the grab bars; the toilet is ¾" too high, 2" too far from the near wall and 9" too close to the door in front of the toilet; and the door closing speed is too fast. In addition, the portable toilet is not on an accessible route of travel.</p>	308.2 308.3 604.7 309.4 604.4 604 404.2.8	30.12 30.7.6 30.8.5 30.7.2 26.9	<p>Replace the existing portable "accessible" toilet with an ADA Compliant toilet such that soap/towel dispensers are no more than 42" a.f.f.; the toilet paper dispenser s/b a minimum of 24" a.f.f. and s/b 7" min. to 9" max. in front of the water closet measured to the centerline of the dispenser; the height of the water closet s/b 17" to 19" a.f.f. to the top of the seat; the water closet s/b 18" from the nearest sidewall, at least 42" from the farthest sidewall, and 42" from the front of the water closet to the nearest wall or fixture; and a door closing speed that is at least 6 seconds. The accessible portable toilet must be placed on a level surface (less than 2.0% slope in any direction) and on an accessible route of travel.</p>	3	2	I	TBD
