## **Town of Northbridge, MA**

Sewer Infrastructure Assessment

PROJECT NO: 2090242.A

October 2009

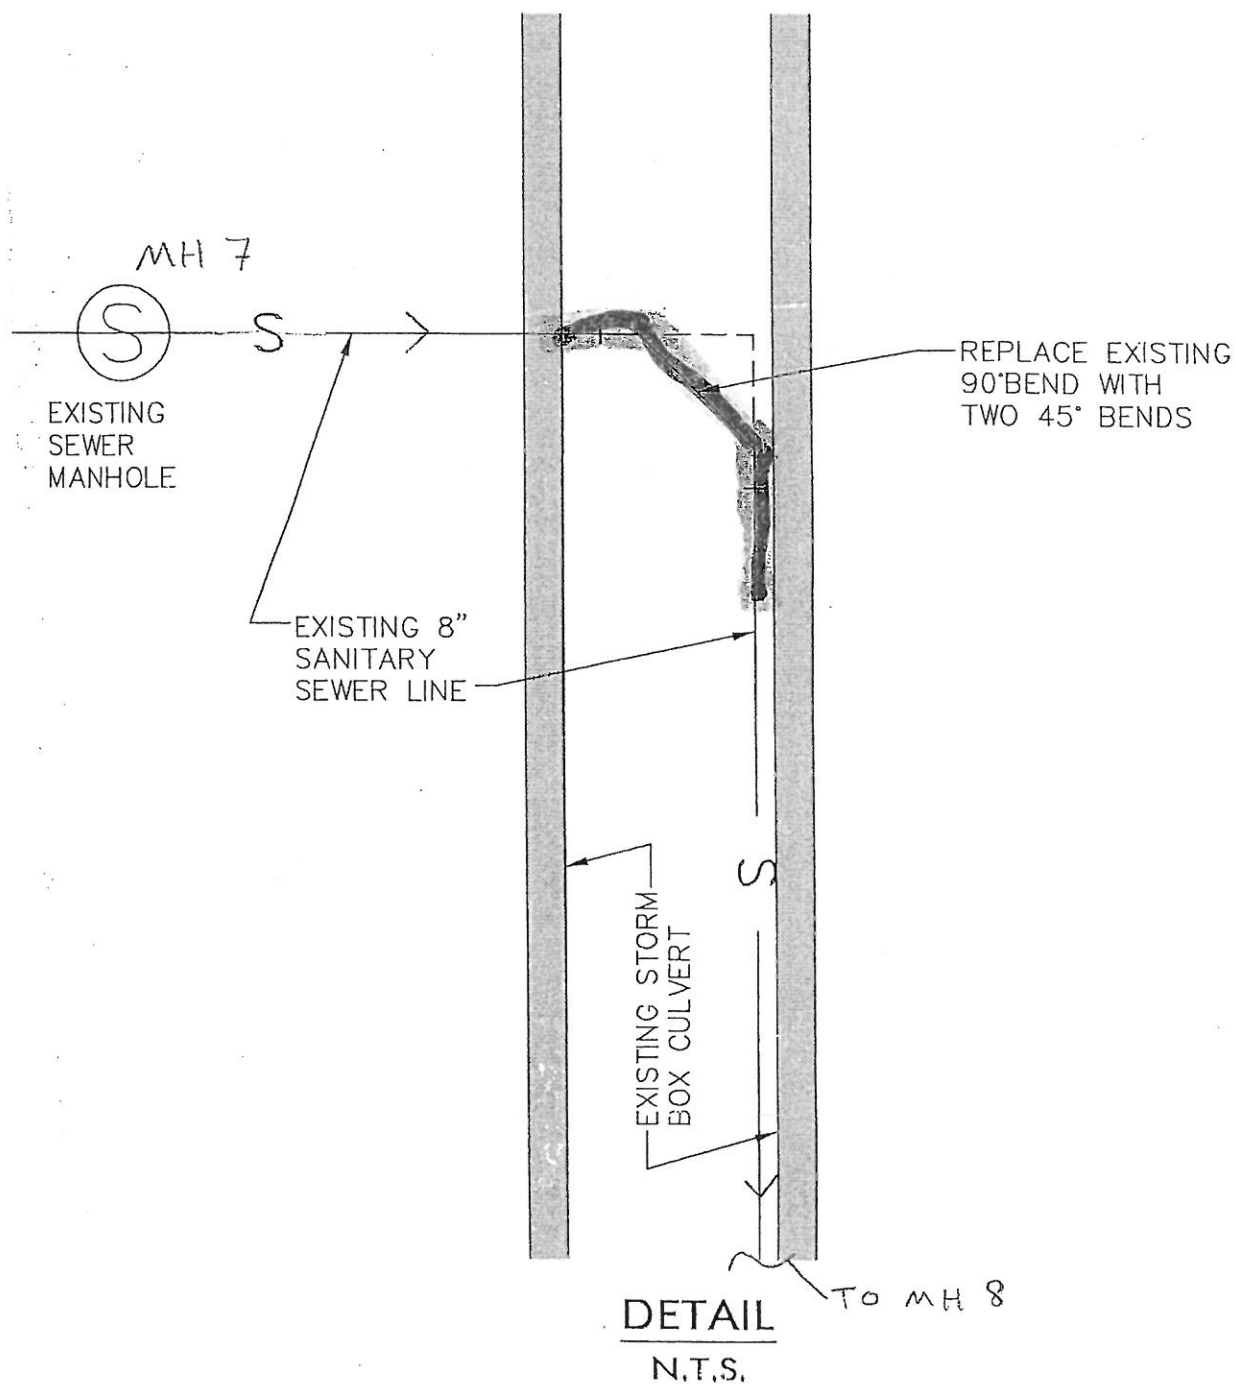
FIGURE 2  
TOWN OF NORTHBRIDGE MASSACHUSETTS  
SEWER INFRASTRUCTURE ASSESSMENT  
PIPE CONFIGURATION DETAIL
