The following is a brief summary prepared by McGinley Kalsow & Associates, Inc concerning the Town Hall window mock-up. The consensus of everyone present was that the interior paint color of the window sash looks to be a good match, that the sash operate easily with the new sash lifts and weatherstripping, and the sash locks are properly aligned and lock without undo effort. The contractor was given the go-ahead to proceed with this aspect of the work.

Site visit -April 24 2013

Northbridge Memorial Town Hall (Window Mock-up)

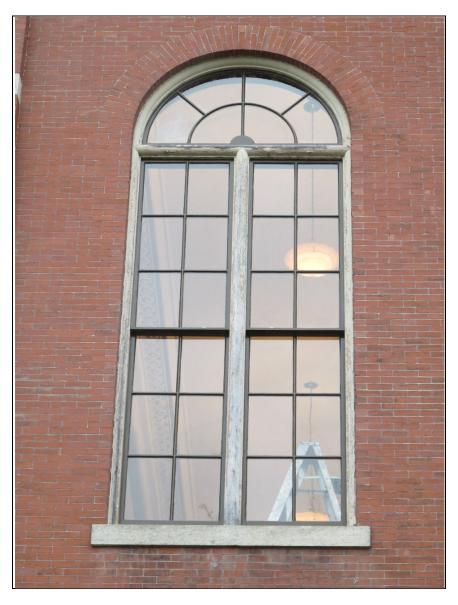
The exterior view shows the sash painted the proper dark chocolate color. The window trim and brick moulding have not yet received their lighter, milk chocolate color

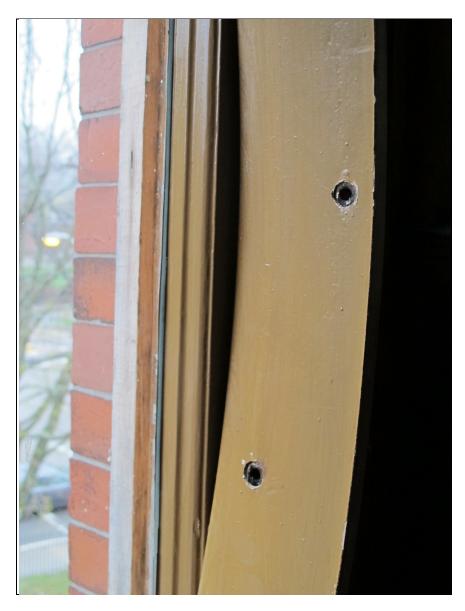
The curved stop resting adjacent to the mock-up window is from the top of another semi-circular window. Note the close similarity of the color. We think this is a very good match. The curved stop has the original paint color, apparently without any coats of paint or varnish from later years

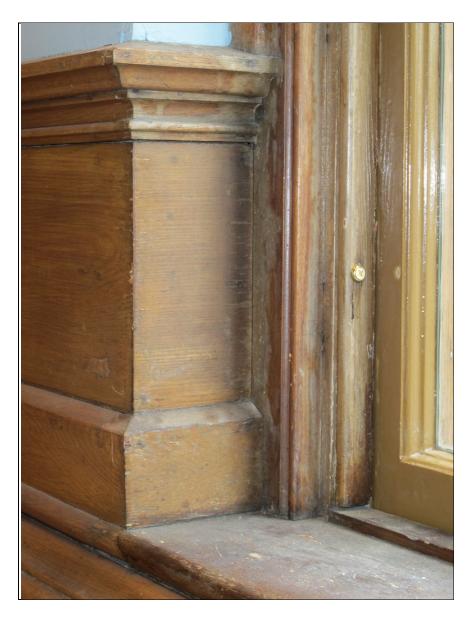
The window stops at the jambs will also be painted in the same manner as the sash. The window sill, sill sash stop, chair rail and wainscot will receive a new varnish finish, not an opaque paint finish, as part of a future interior renovation project

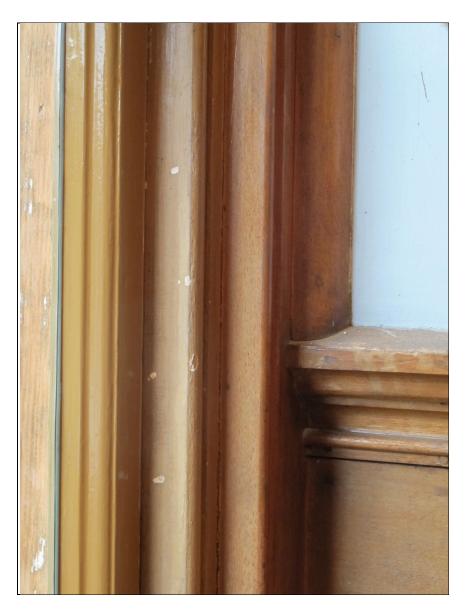
Painted window sash adjacent to reinstalled jamb stop (yet to be painted to match sash), with adjoining wood trim (existing clear varnish finish)

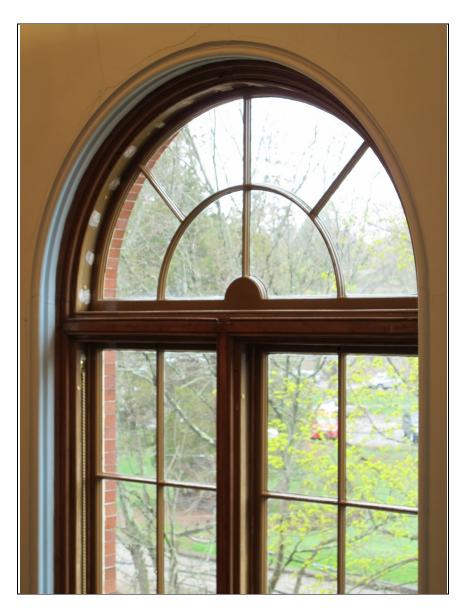
Upper portion of mock-up window showing new sash chains and reinstalled upper, curved window stop at top of semicircular fixed window. Former holes in curved stop will be filled and stop painted to match sash color

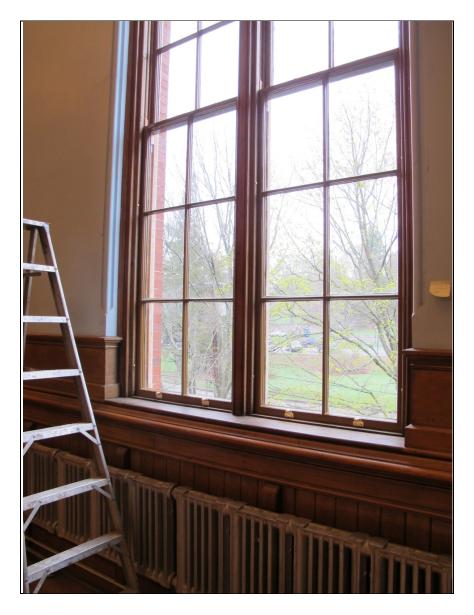
Bottom of window sash showing new sash lifts and reinstalled original window glass

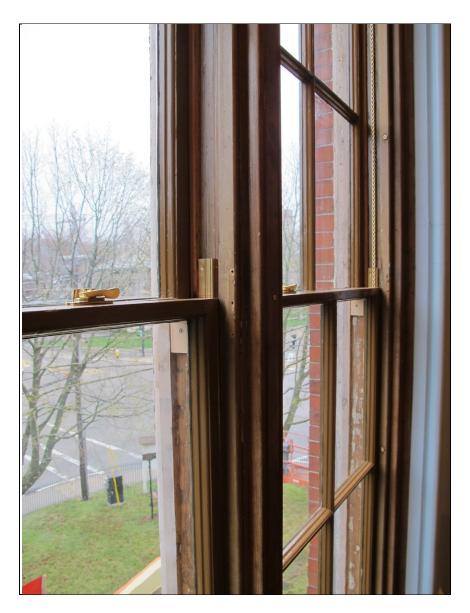
The upper sash have been fixed in-place with small, wood restraining blocks. Note new sash locks at meeting rail, and sash chains and bronze weatherstripping at jambs. The jamb stops have been reinstalled with brass grommets and screws.
