# Task II - Comprehensive Window Survey

## Northbridge Memorial Town Hall

Northbridge, Massachusetts

March 8, 2012

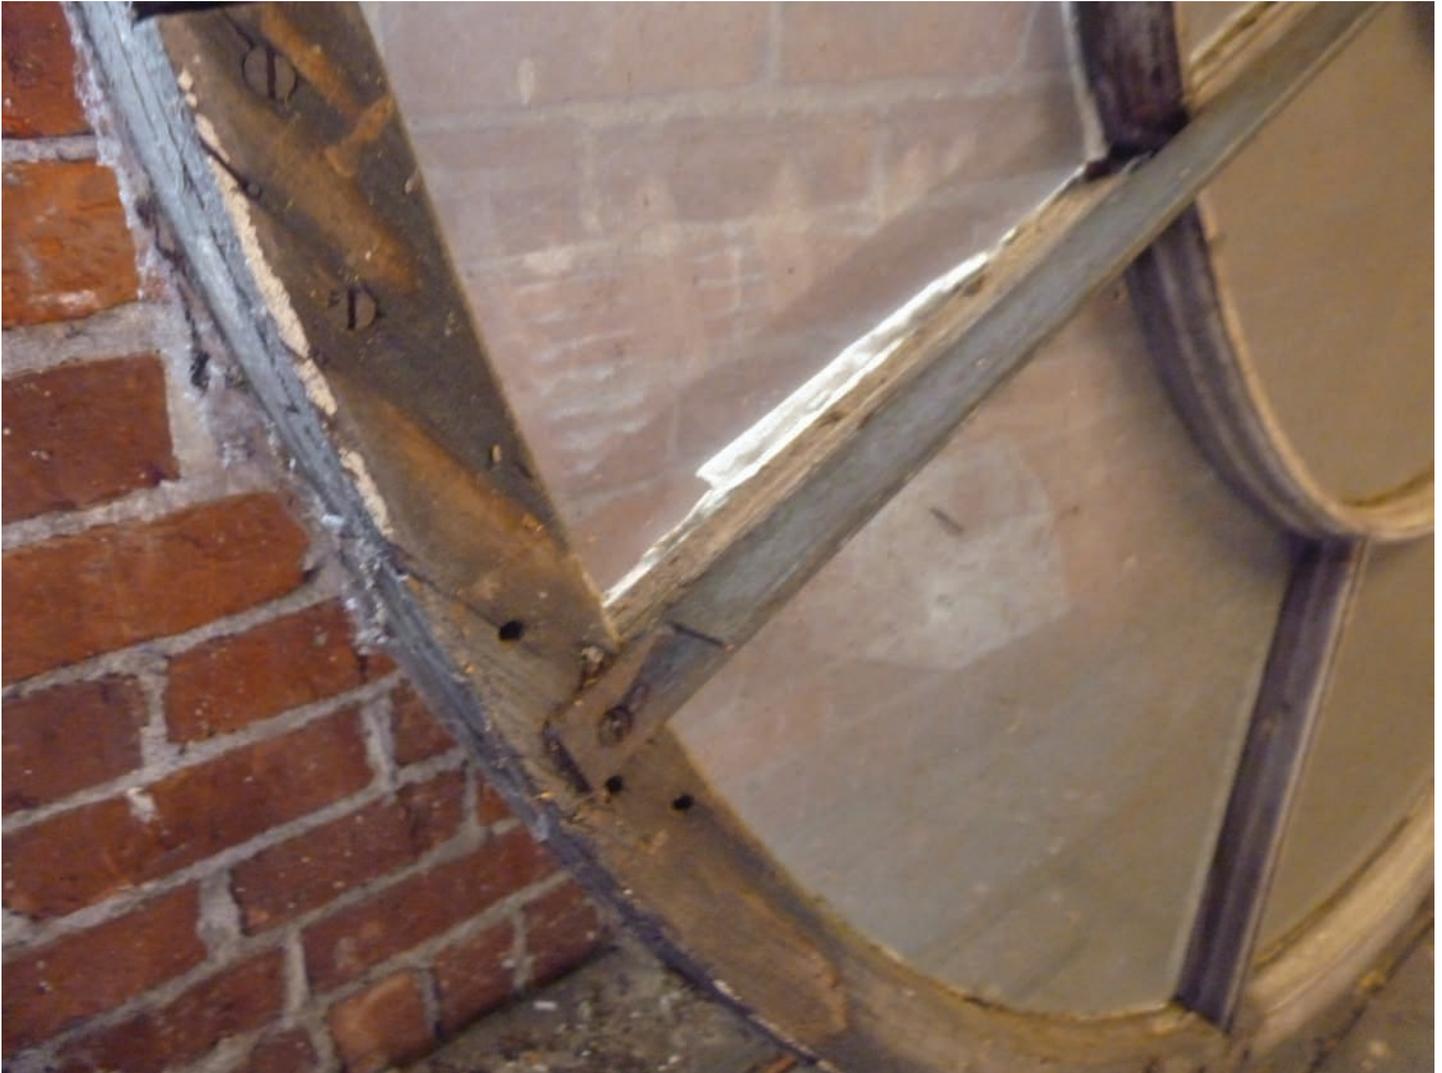
*Historic Wheel Window Discovered in Attic*

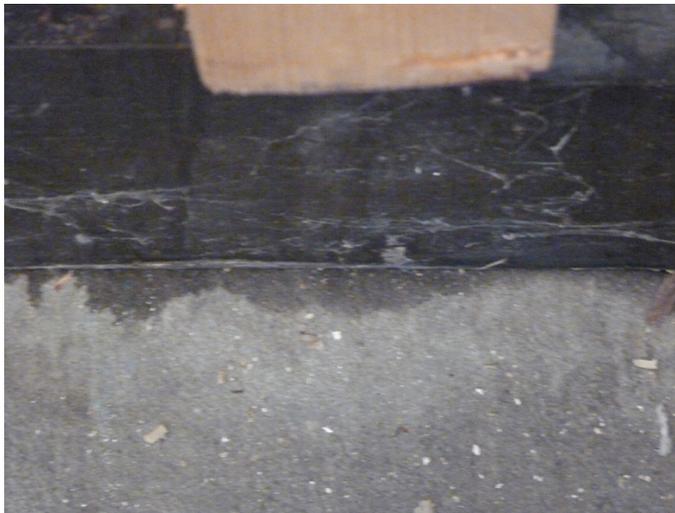
*Photo 9*

The exterior doors, thresholds and hardware are overall in serviceable condition. The blocked (Photo 9) and no longer code-required (due to construction of exit tower) exit door from the auditorium to the 1947 steel fire escape leaks water at the threshold (Photo 10) and perimeter and minimally needs to be sealed to the weather.

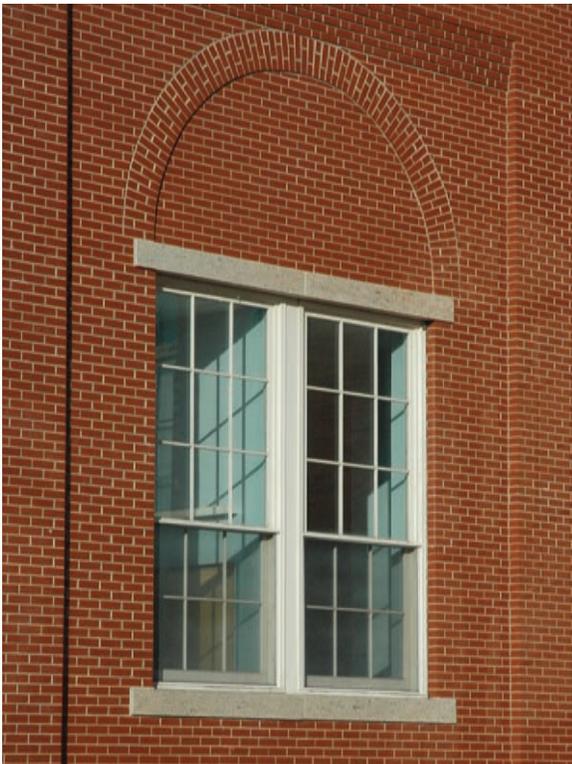
E002 (Exterior) - Exit Stair Window

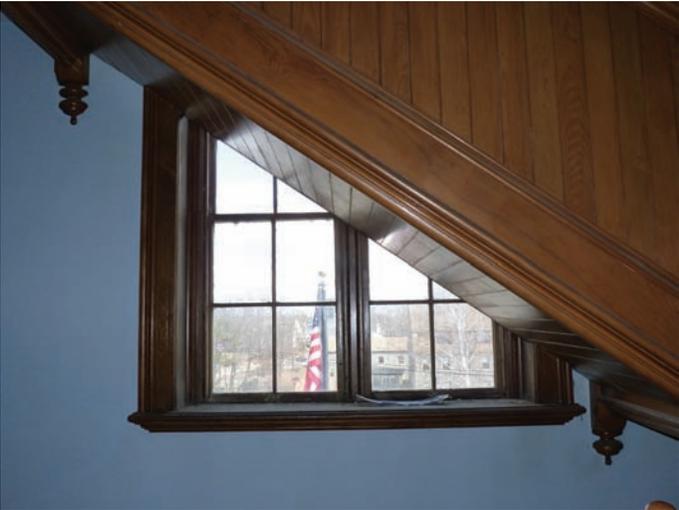
E003 (Interior) - Balcony Lower Half (2 of 2)

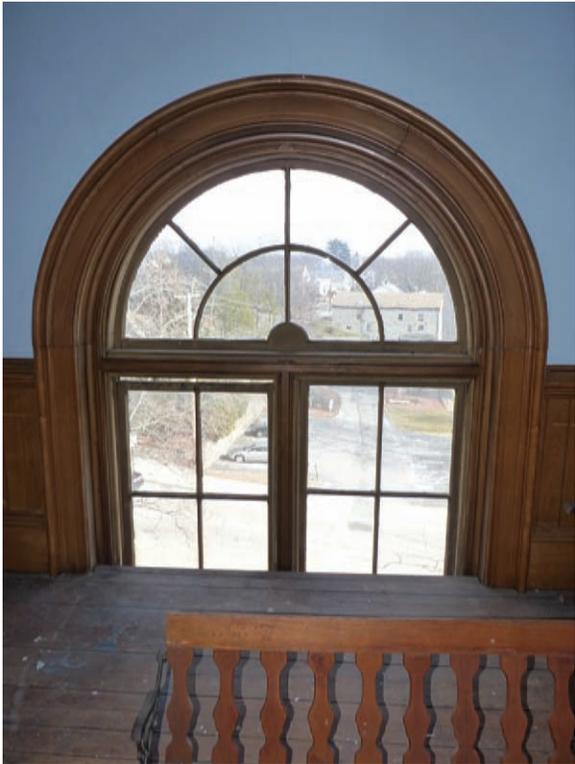
E004 (Interior) - Balcony Upper Half (1 of 2)

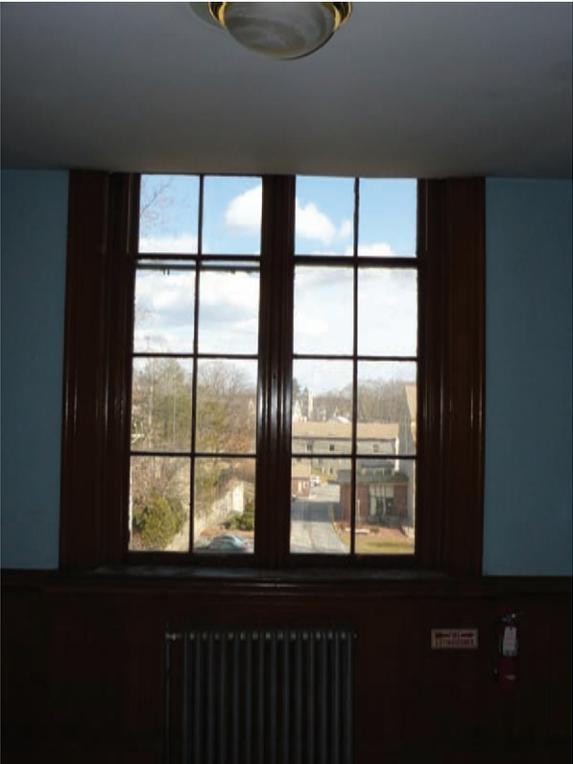
E004 (Interior) - Balcony Lower Half (2 of 2)

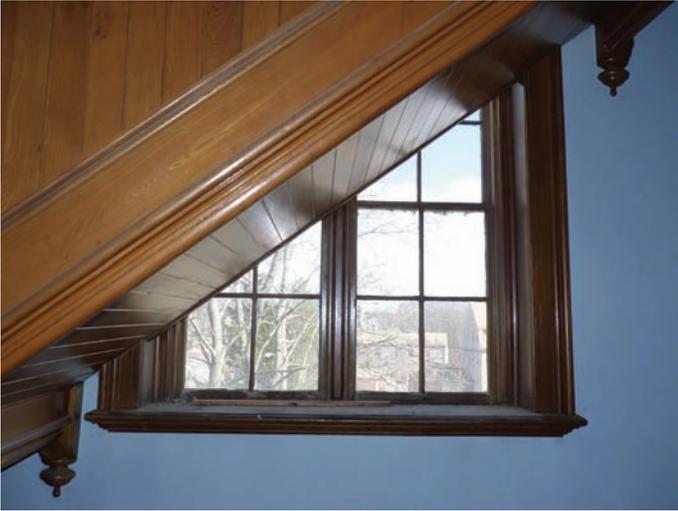
E005 (Interior) - Balcony Lower Half (2 of 2)

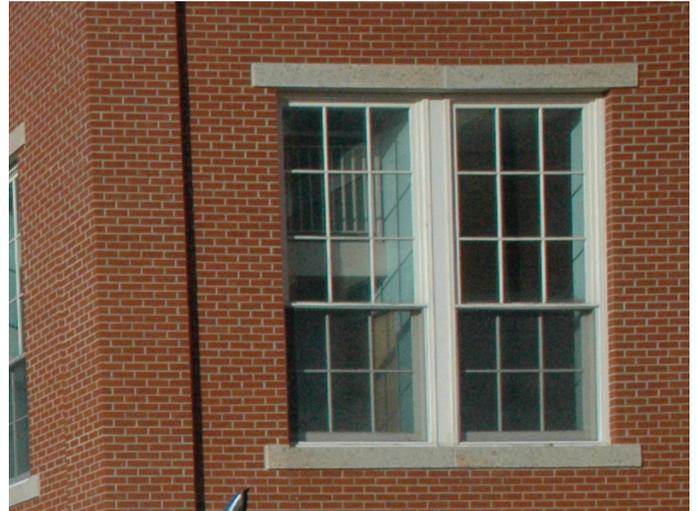
E006 (Exterior) - Exit Stair Tower

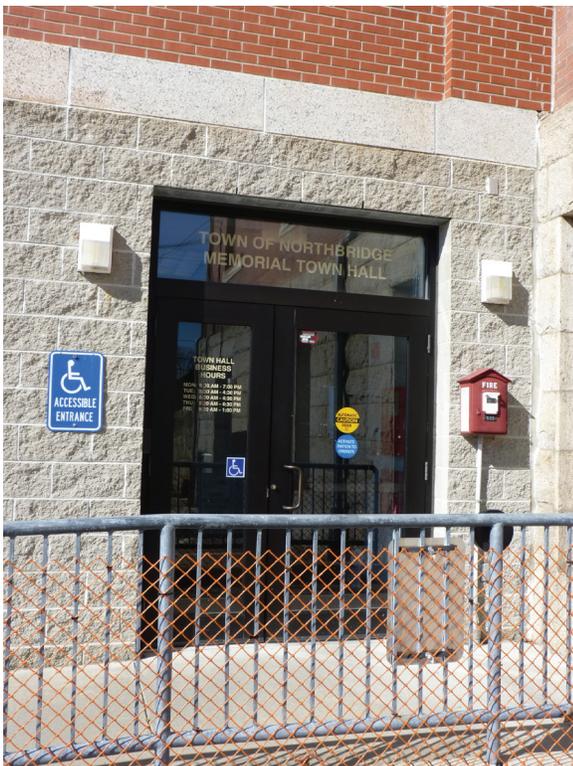
E007 & ED01 - First Floor Entrance Door

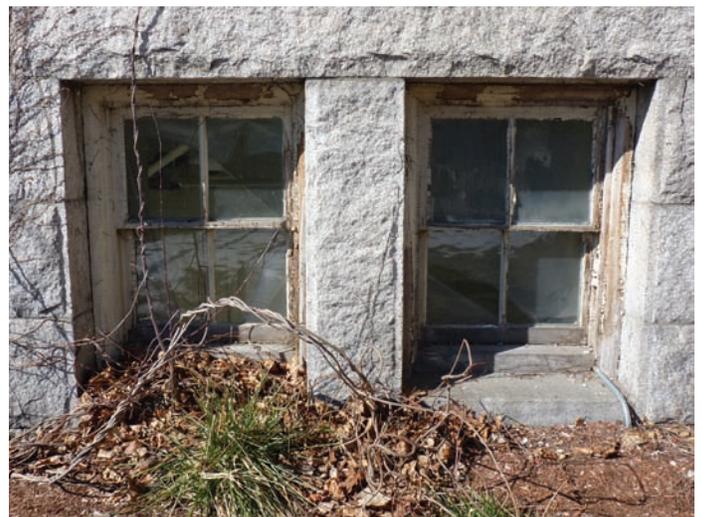
E008 & E009 (Exterior) - Basement Level

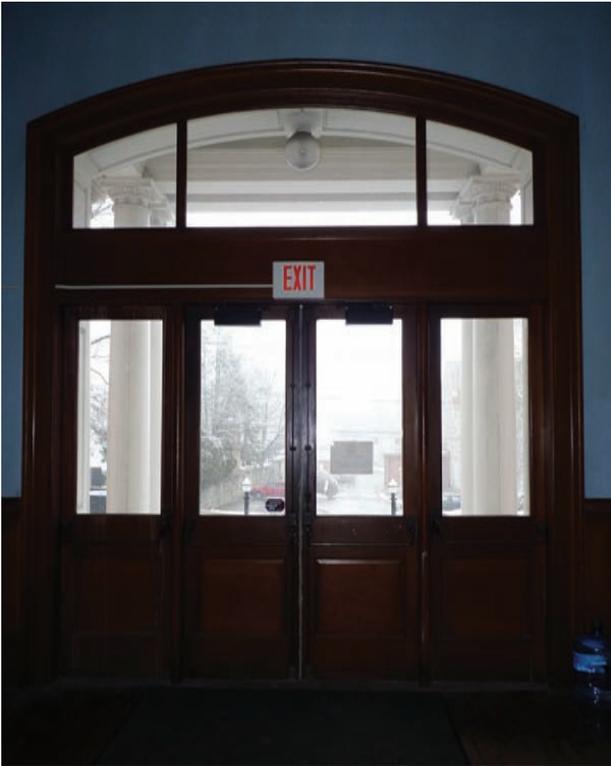
E010 (Interior) - First Floor  
ED02 - East Elevation Entrance Door

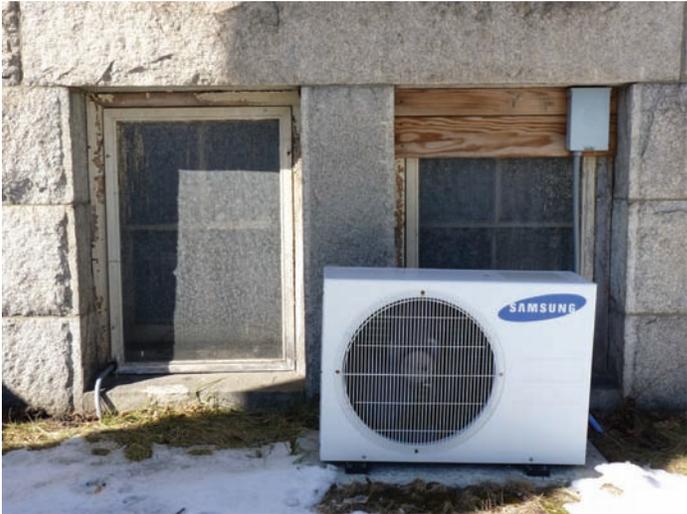
E011 & E012 (Exterior) - Basement Level

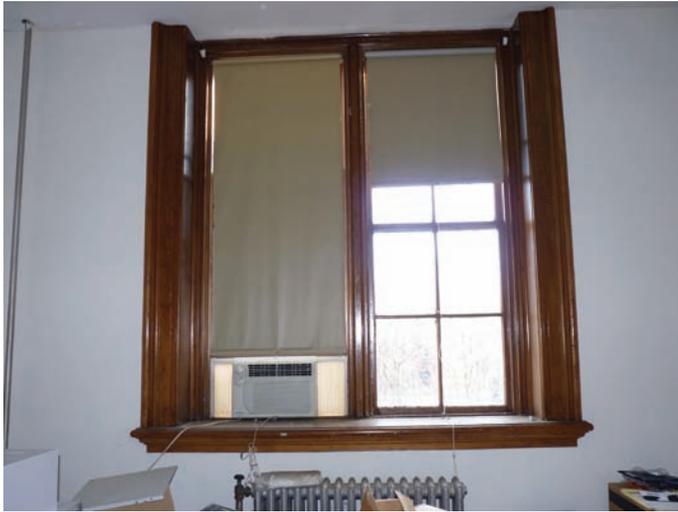
S001 (Interior) - Auditorium / Second Floor Lower Half (2 of 2)

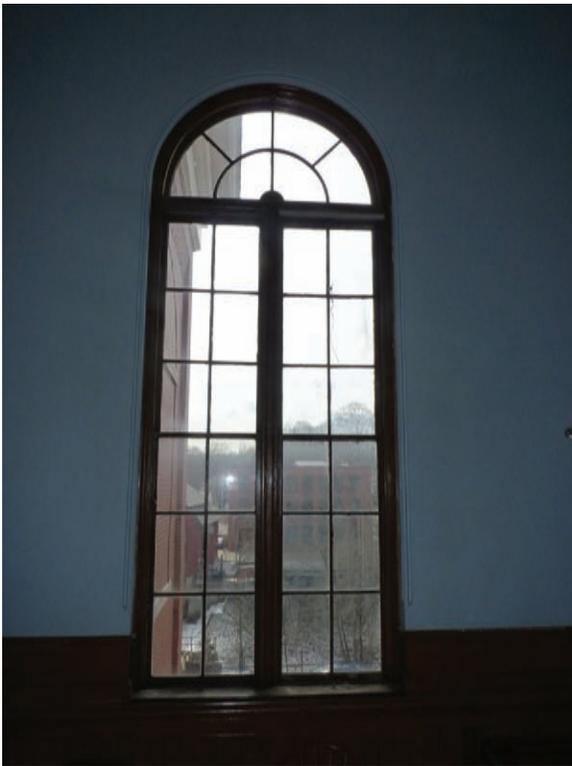
S003 (Interior) - Main Hall

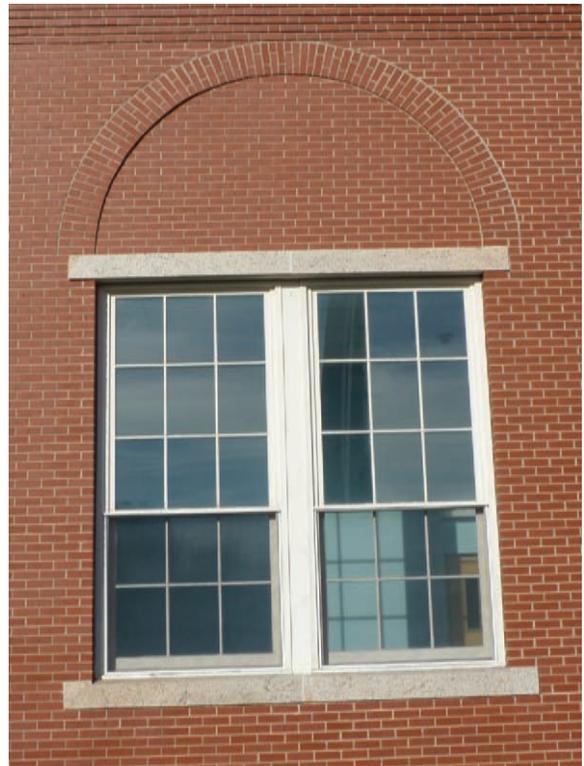
S004 (Exterior) - Exit Stair Tower

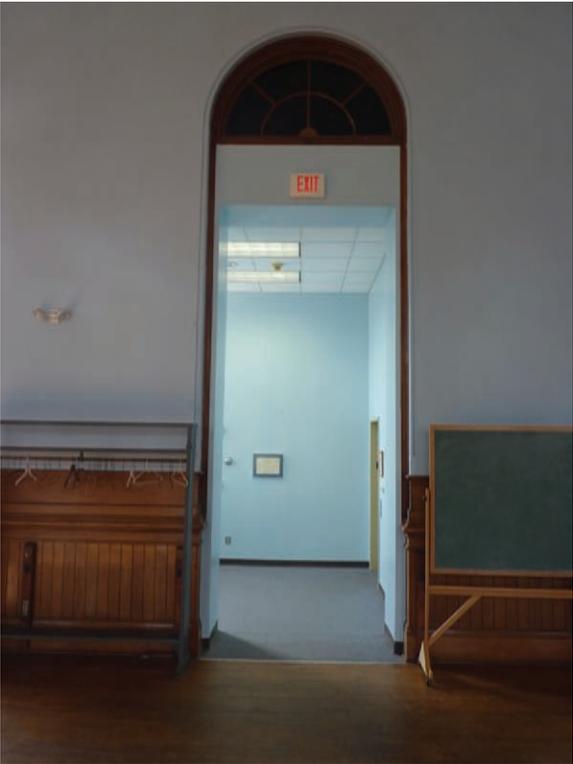
S004.5 (Interior) - Main Hall

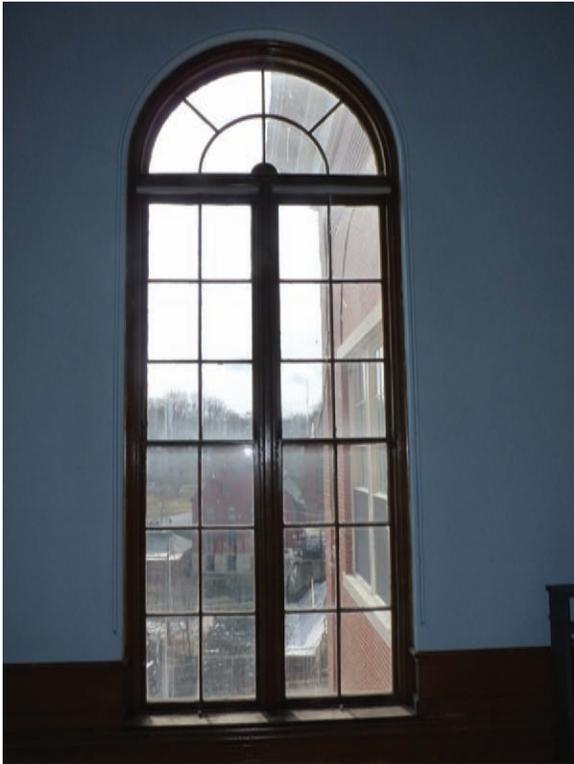
S005 (Interior) - Main Hall

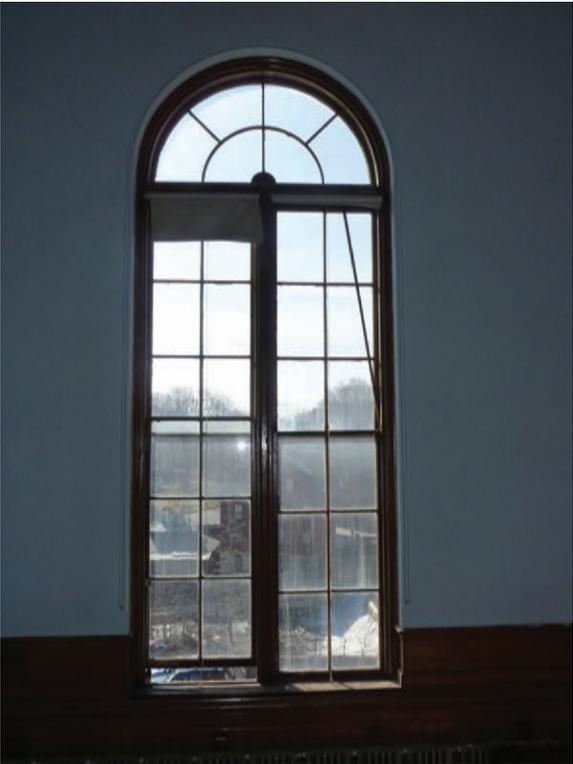
S006 (Interior) - Main Hall

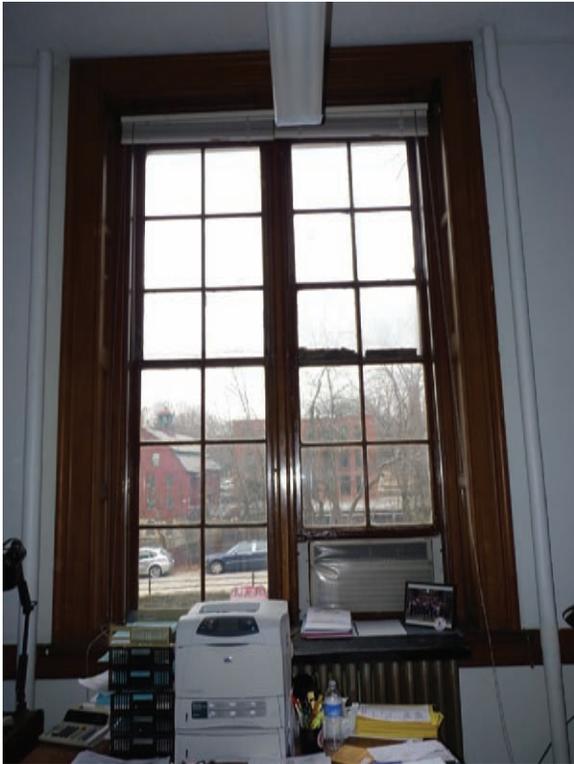
S007 (Interior) - First Floor

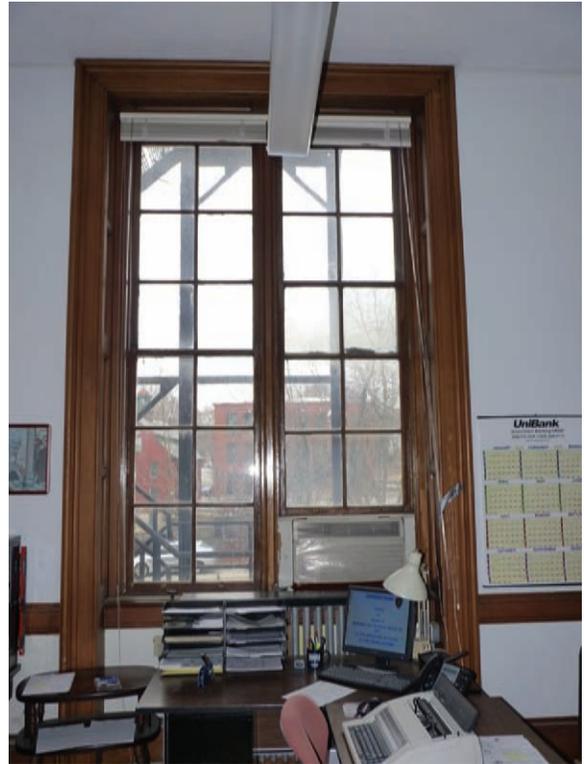
S008 (Interior) - First Floor

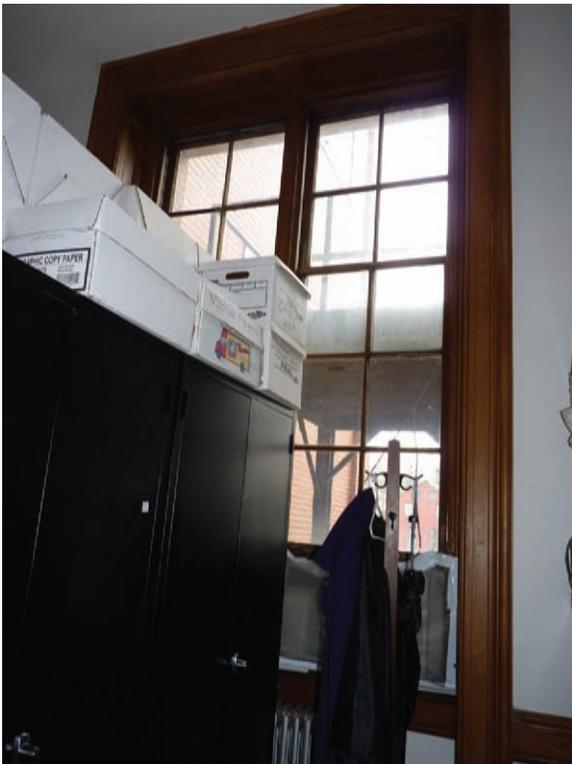
S009 (Interior) - First Floor Right Half

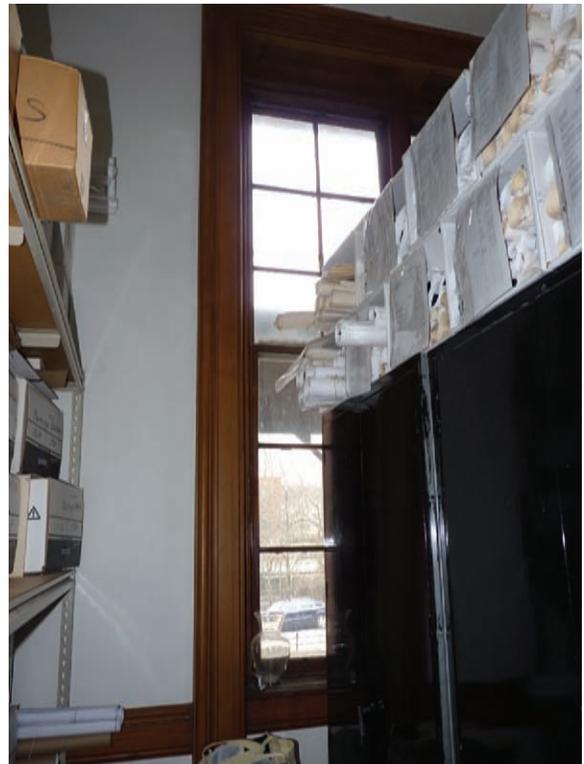
S009 (Interior) - First Floor Left Half

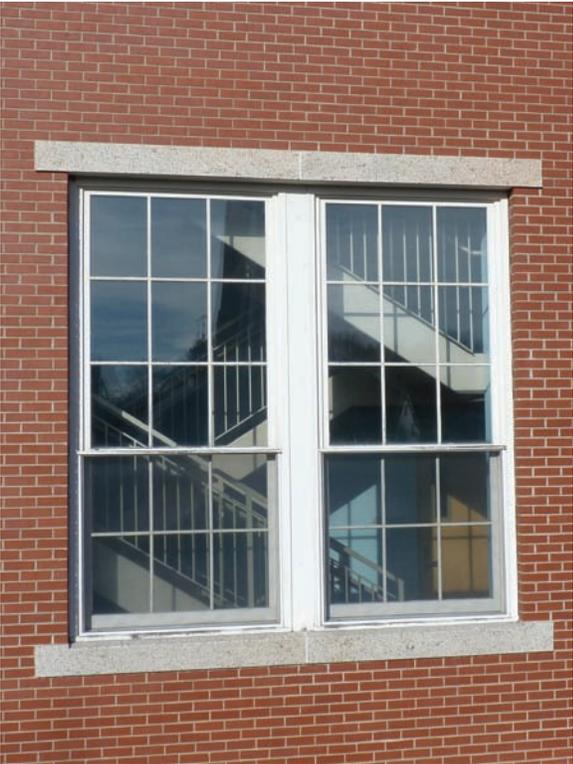
S010 (Exterior) - Exit Stair Tower

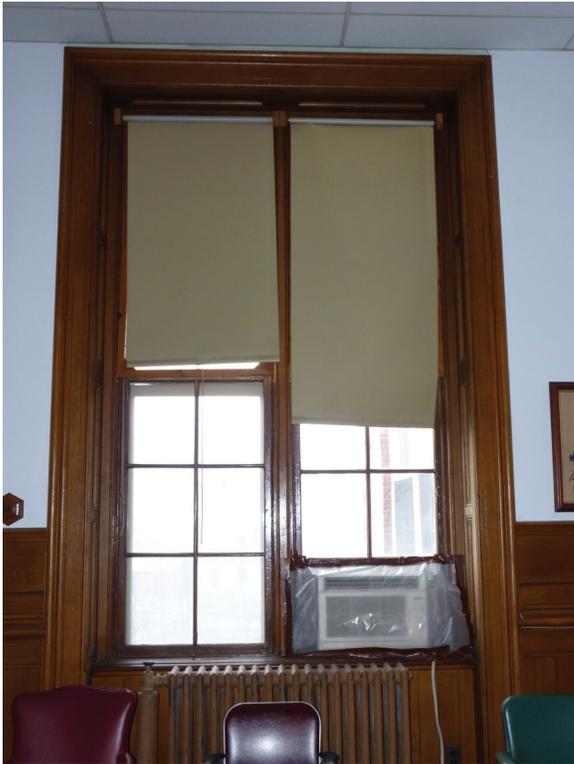
S011 (Interior) - First Floor

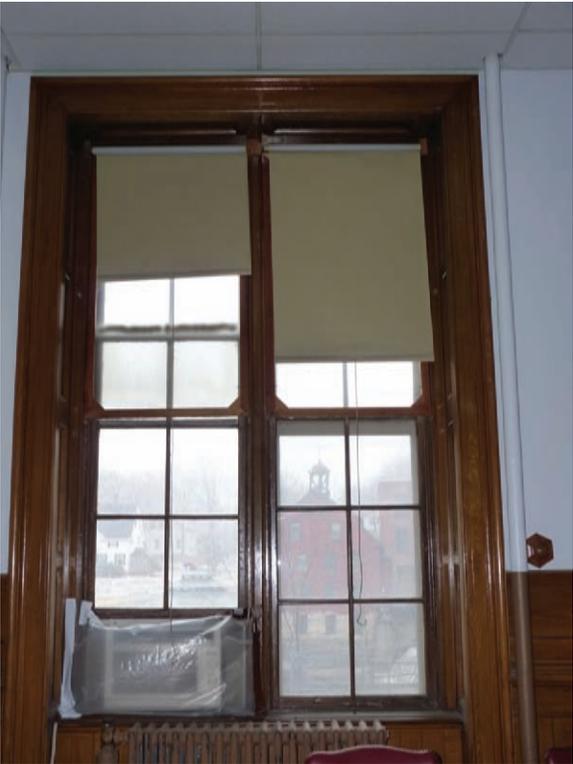
S012 (Interior) - First Floor

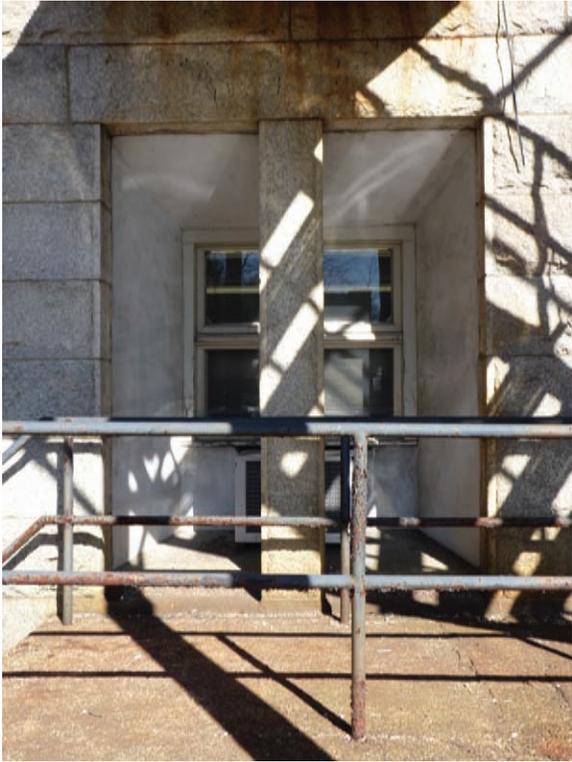
S013 (Exterior) - Basement Level

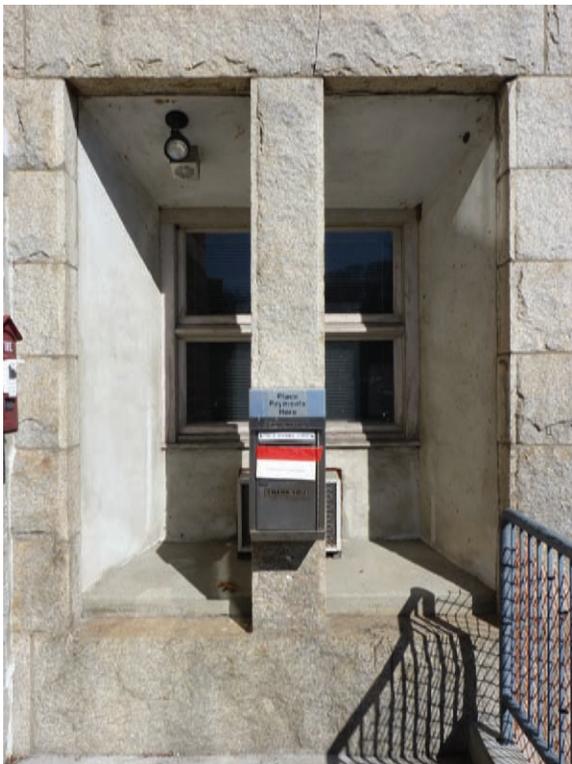
S015 (Exterior) - Basement Level

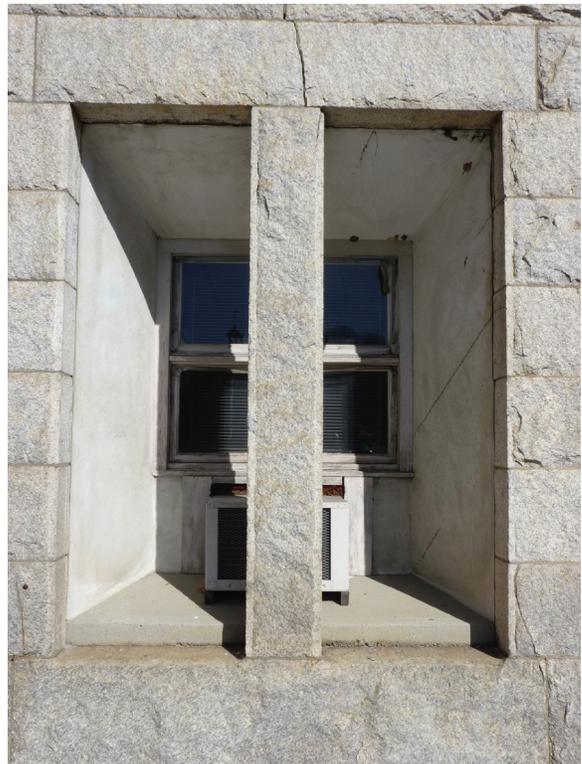
S016 (Exterior) - Basement Level

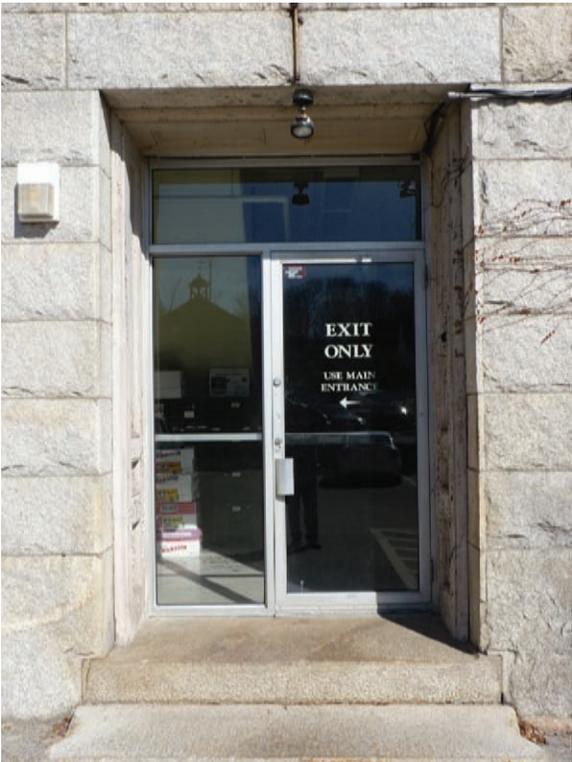
S017 (Exterior) - Basement Level Exit  
SD02 - South Elevation Exit Door

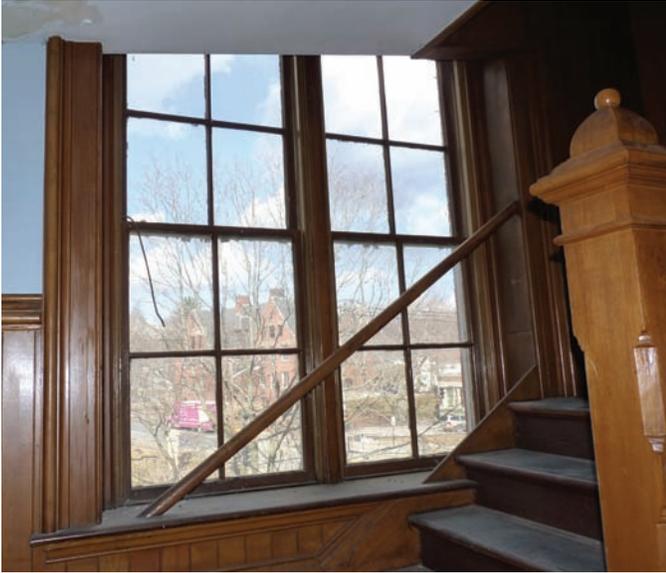
N001 (Interior) - Balcony Lower Half (1 of 2)

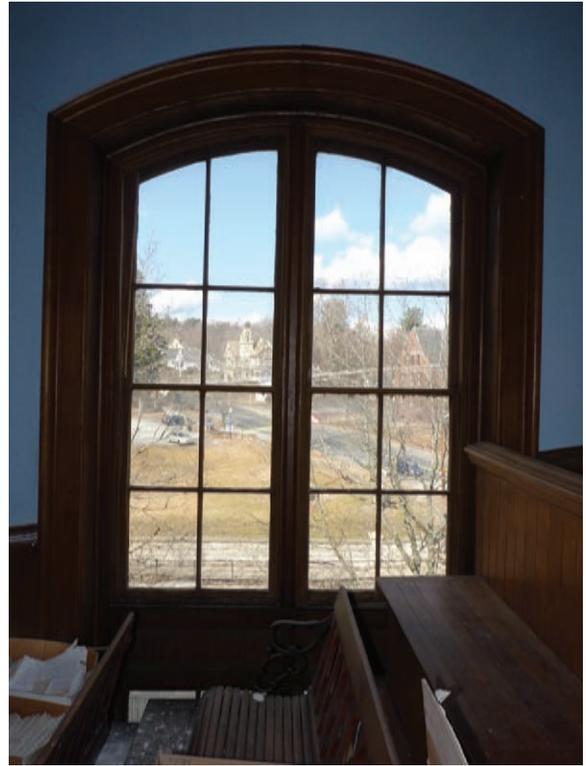
N001 (Interior) - Balcony Upper Half (2 of 2)

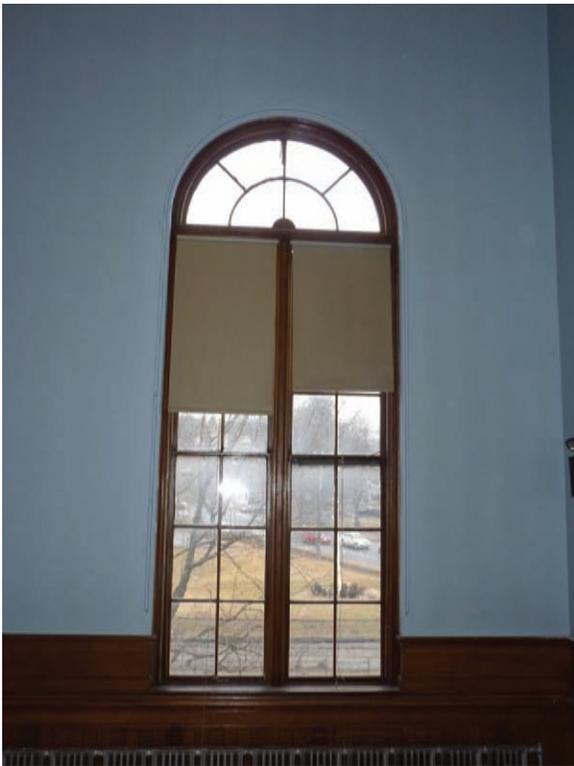
N002 (Interior) - Great Hall

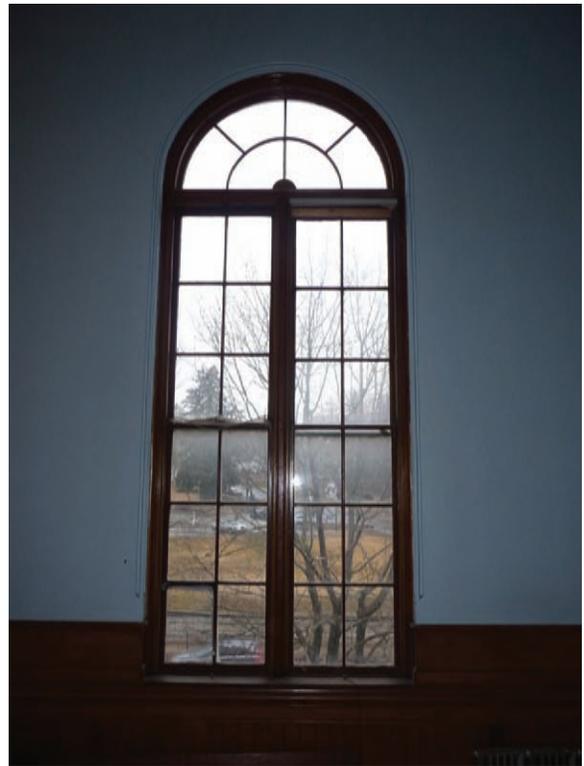
N003 (Interior) - Great Hall

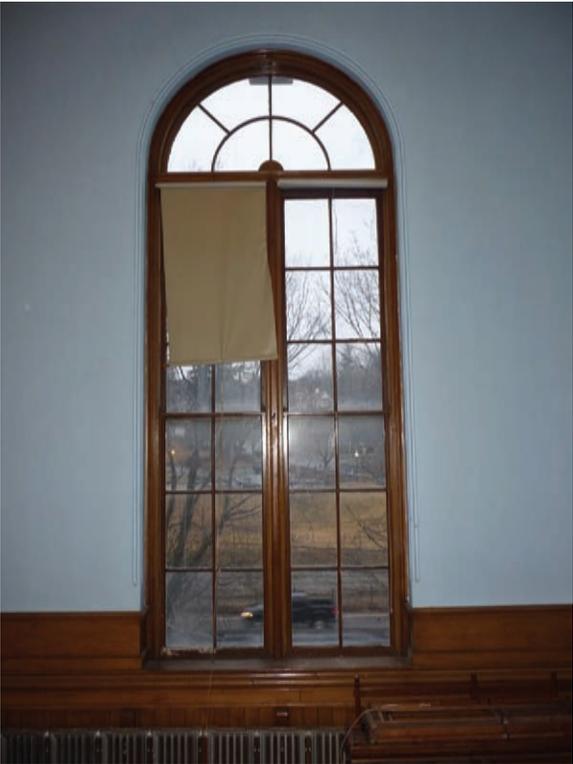
N004 (Interior) - Great Hall

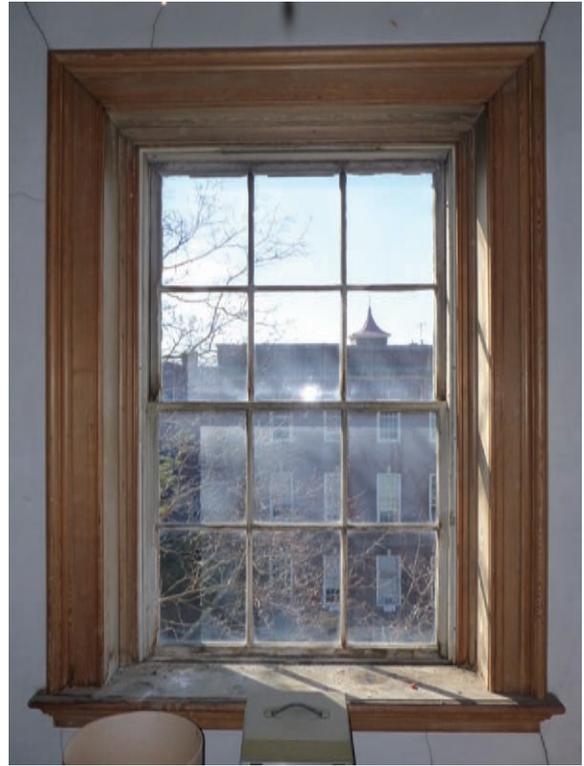
W001 (Interior) - Attic, Replacement and Salvaged Historic Sash (Lower Right)

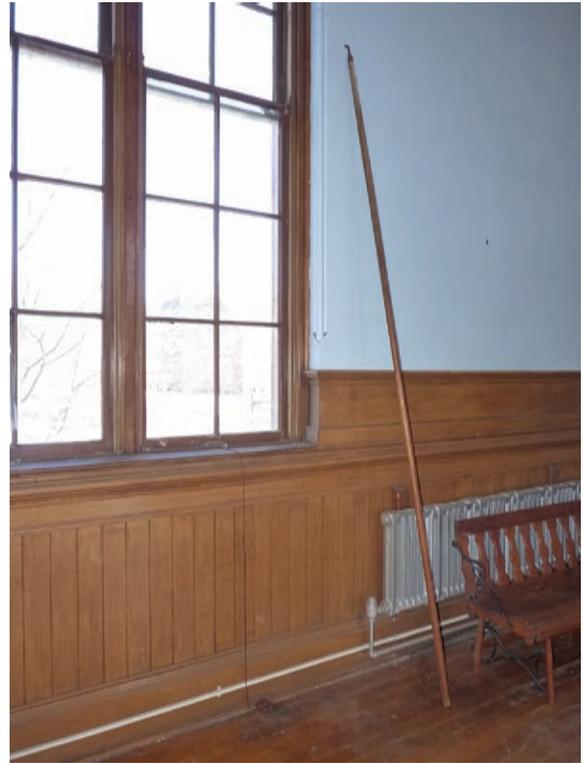
Hardware 001 - Broken Cotton Sash Chord, Shade Hardware and Screws Fixed to Upper Sash at Great Hall
